Step-by-step retrofitting building

Treviana Social Housing\_Madrid

This report provides an overview of the retrofit actions carried out for the step-by-step refurbishment project OP23.

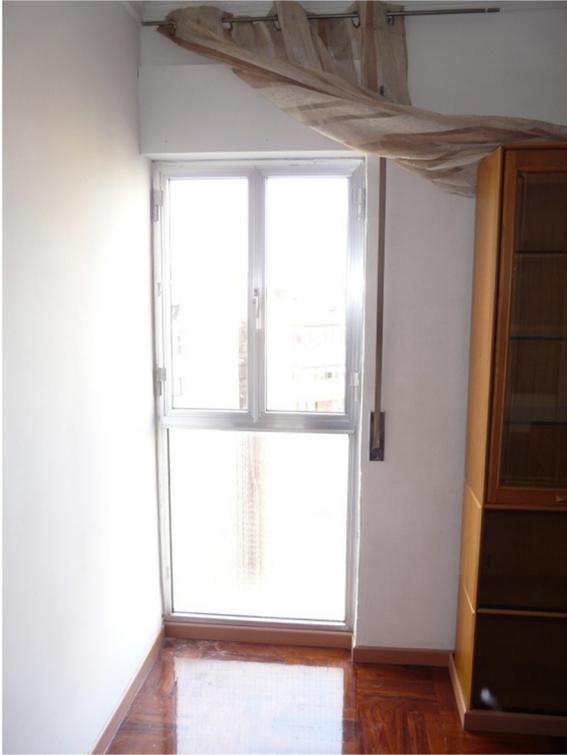
Description : Single glazing and aluminium frame without thermal break  
U-Value [W/(m<sup>2</sup>K)] : 5.7 W/(m<sup>2</sup>K) (standard value)  
Installation date : 1963  
Condition : Poor  
Next replacement : Step 1 (2015, apartment)  
Other : -

**Figure 10: Existing window**

Description	:	Deceunink, neo@zendow premium U <sub>f</sub> = 1.03 W/(m <sup>2</sup> K), Glazing: 4Guardian Sun/16arg/4/16arg/premium4 U <sub>g</sub> -value =0.50W/(m <sup>2</sup> K), g -value = 35%
U-Value [W/(m <sup>2</sup> K)]	:	1.11 (average)
Installation date	:	2015
Condition	:	
Next replacement	:	
Other	:

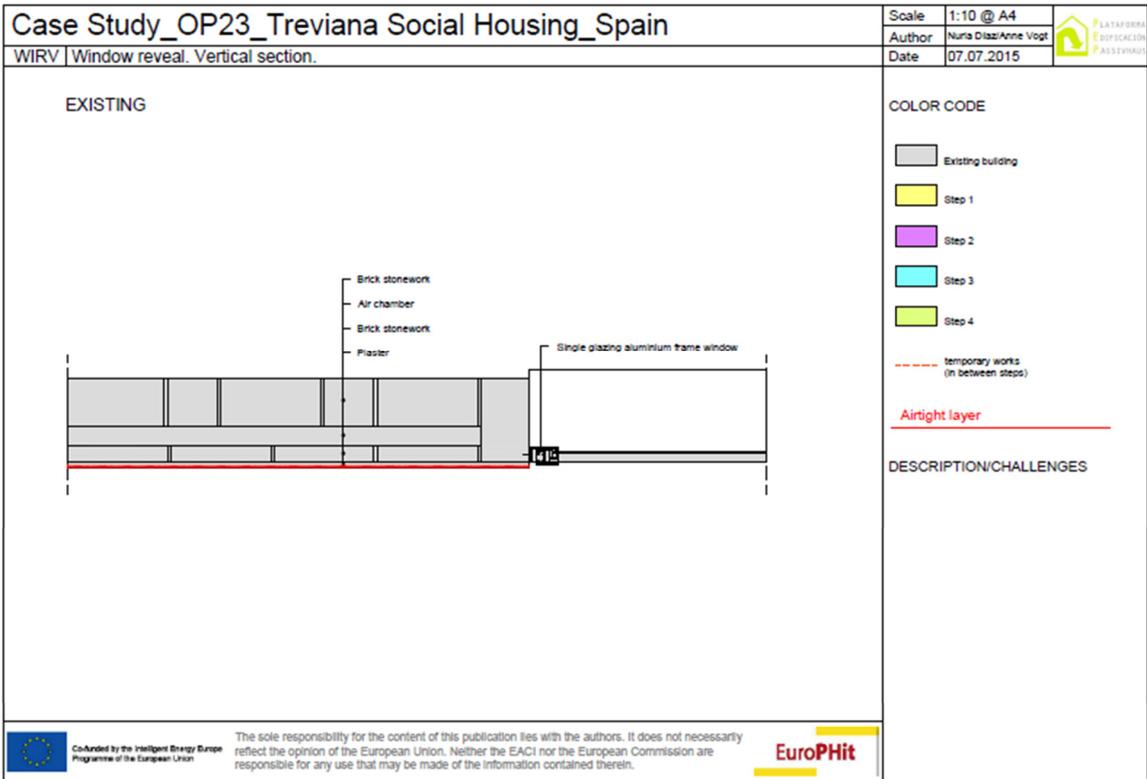
**Figure 13: Existing window installation**

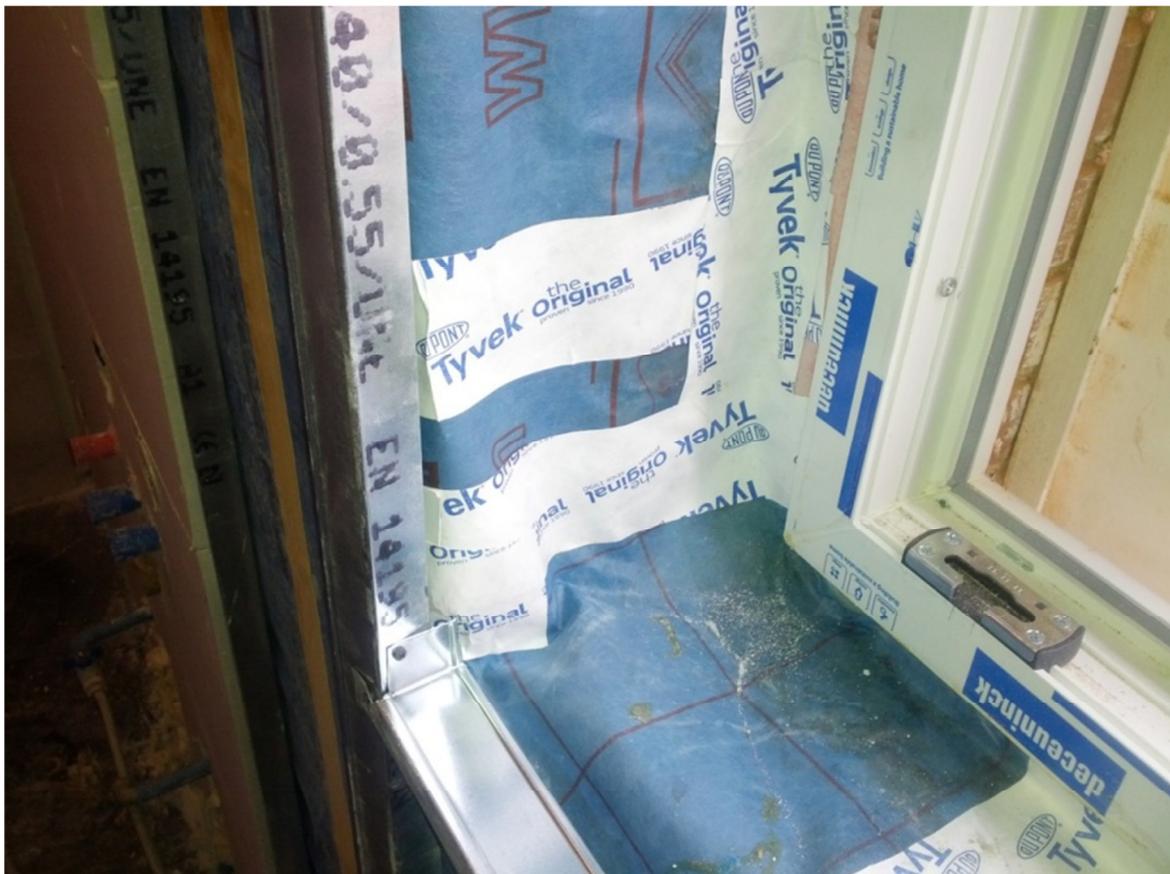
Figure 19: Window-wall airtickness

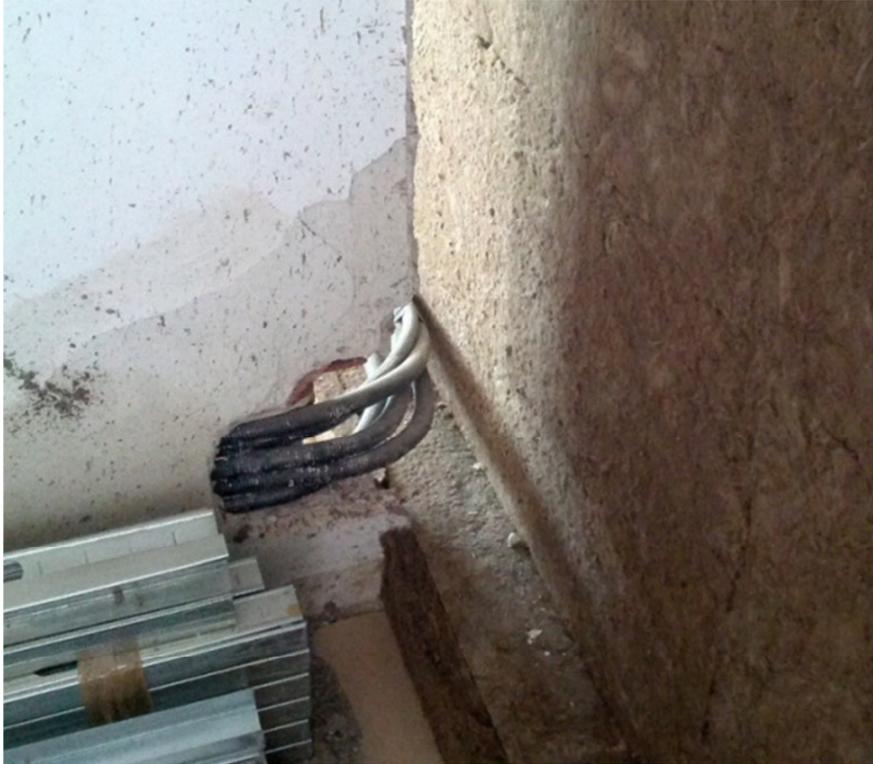
**Figure 20: Continuous inner insulation layer**

Description	:	40 mm mineral wool insulation, air chamber and plasterboard. The inner brick layer will be kept.
U-Value [W/(m <sup>2</sup> K)]	:	0.531 W/(m <sup>2</sup> K)
Installation date	:	2015
Condition	:	
Next replacement	:	
Other	:

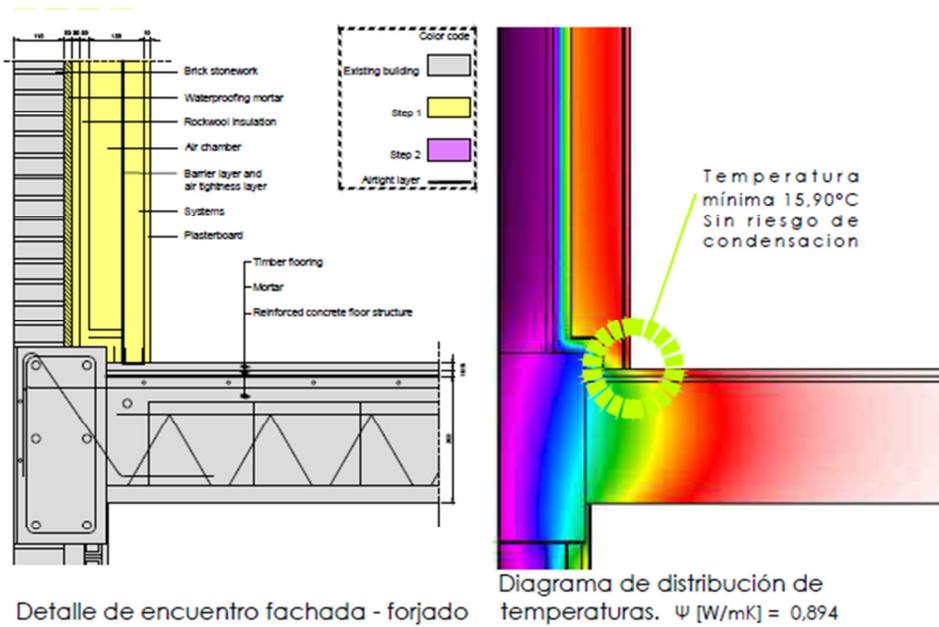
Construction details were designed focus on not only reducing the heating demand but avoiding the risk of condensation since the insulation is collocated on the inside and is not possible to eliminate all the thermal bridges.

Figure 23: Hygrothermal study - exterior wall and floor structure connection detail, step 1
