Passivhaus Project Object Documentation

1.1 Abstract

Detached House with 2 Bedrooms, Kindar Coach House, New Abbey

1.2 Detached House with 2 Bedrooms, Kindar Coach House, New Abbey

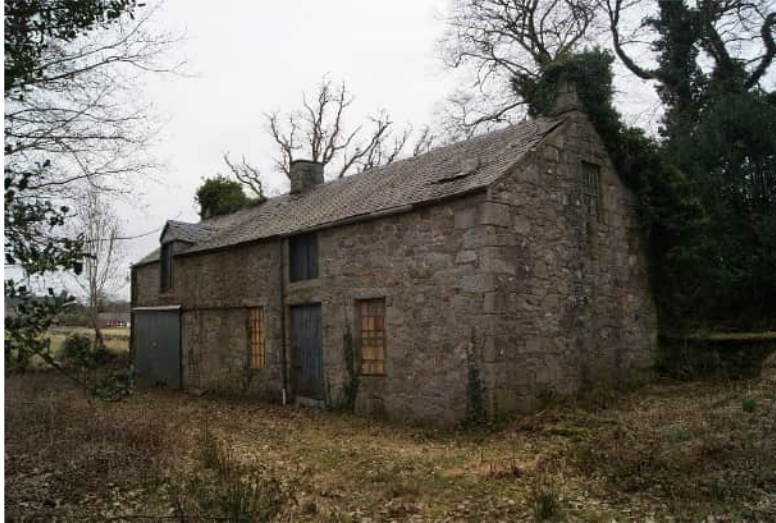
South & West Elevations

The existing building was vacant and derelict with collapsing roof and timber upper floors, water penetration, no windows and structural problems with the stone walls.

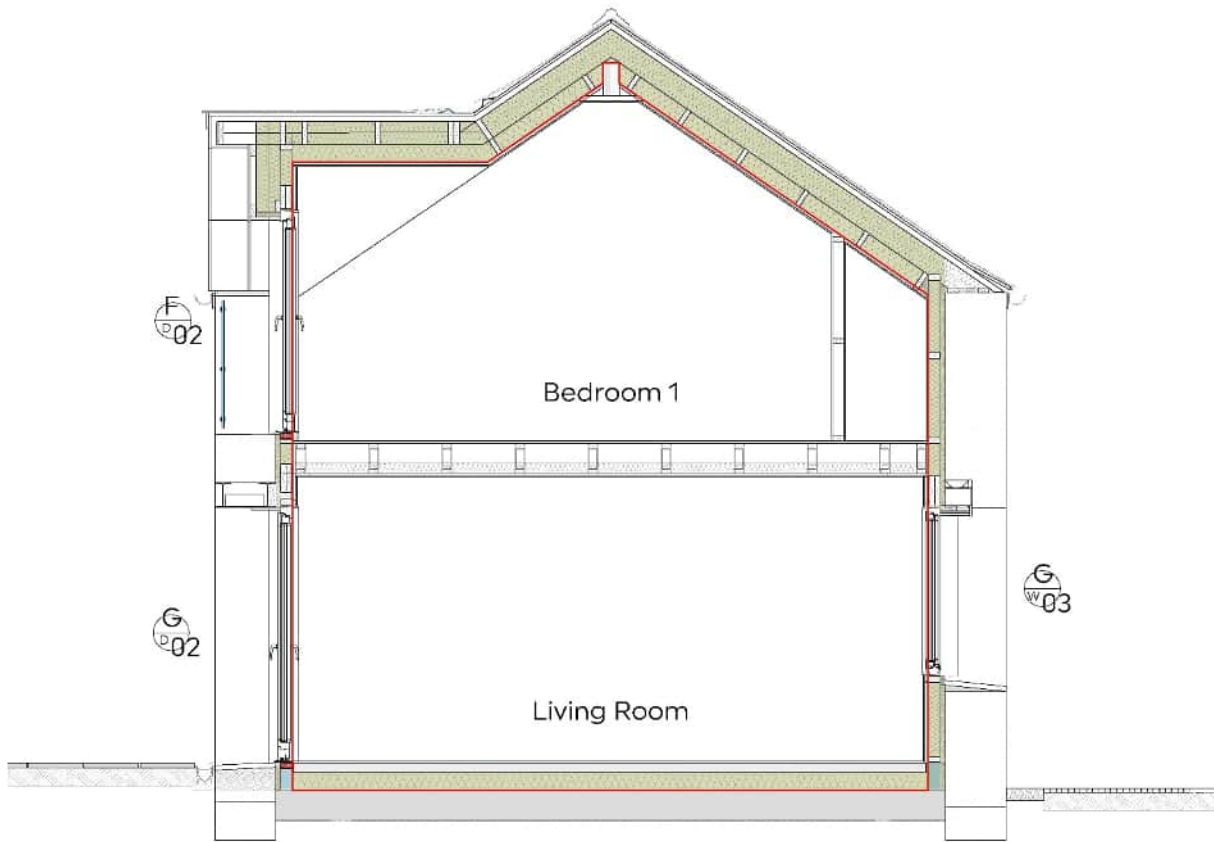
SECTION 1

The existing building was solid natural stone walls. To ensure the long term health of the building fabric a homogenous breathable internal insulation specification was used with Diathonite Evolution insulating lime render to the inside of the walls providing a smooth surface with Gutex Thermoflex woodfibre insulation between a new timber frame. The ground floor is a ground bearing concrete slab with rigid PIR insulation and a screed with underfloor heating. Due to limited headroom the ceilings are sloped with mineral fibre insulation within a new timber roof structure. A double membrane was used below the slate roof with a membrane below the slate on timber sarking and a ventilated void below the sarking with a windtight membrane over the roof insulation.

The section drawing shows the continuous insulation envelope has been maintained around the external fabric of the house. Doors and windows are sitting in the timber frame, making a recessed feature of the existing openings and primarily to limit thermal bridging.

Careful consideration was given to the junctions for floor, wall and roof. Blue hatching indicates locations where lightweight concrete block work was built in.

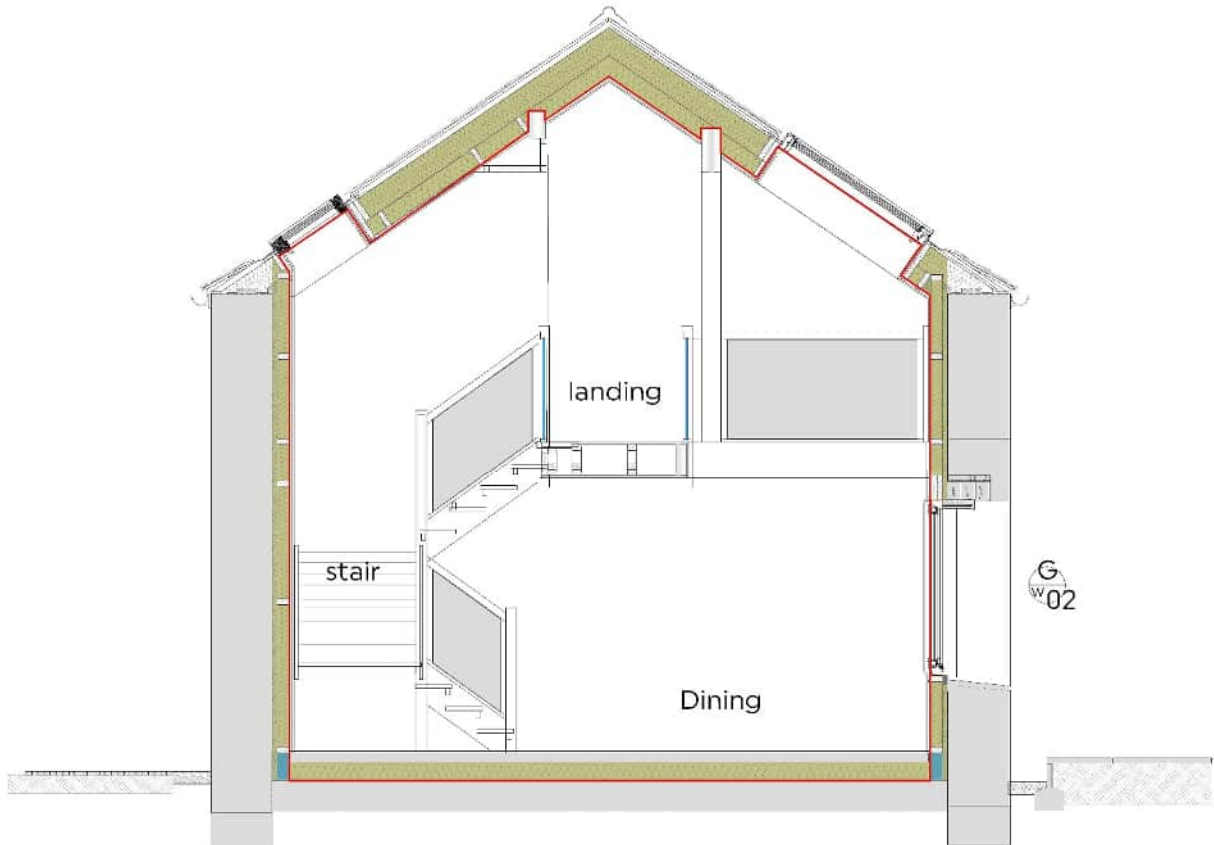
SECTION 2

Section 2 shows the continuous insulation and air tightness layers around the laminated timber roof beams and roof windows.

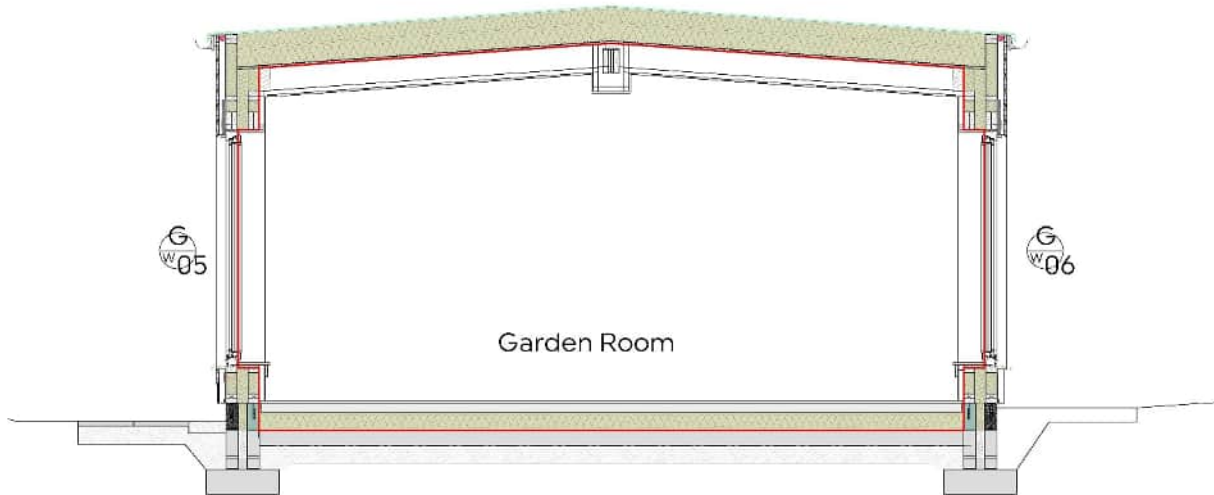
SECTION 3

A key design aim was to preserve the historic building, allowing the original form of the building to be visually dominant. The new garden room extension is a single storey timber frame with a shallow pitch roof and timber cladding. The extension provides a light, modern addition to complement the existing traditional building.

The ground floor is the same specification throughout the house. The extension walls are a double timber frame Larsen Truss fully filled with mineral fibre insulation. The roof is a proprietary single ply membrane insulated roof.

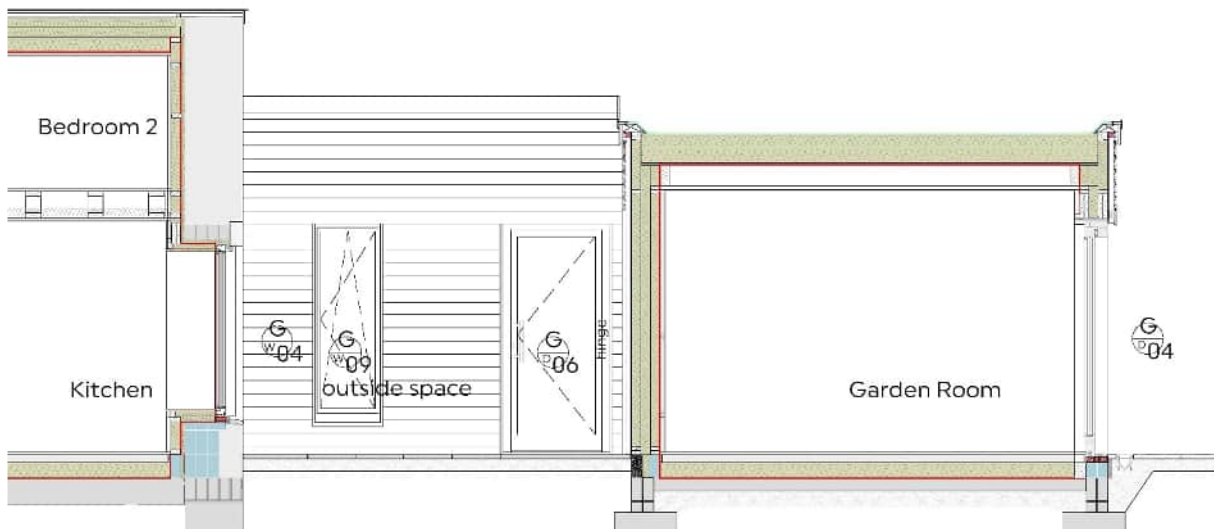
SECTION 4

The connection of the new extension to the existing building was carefully detailed to ensure continuity of insulation and the air tightness membrane.

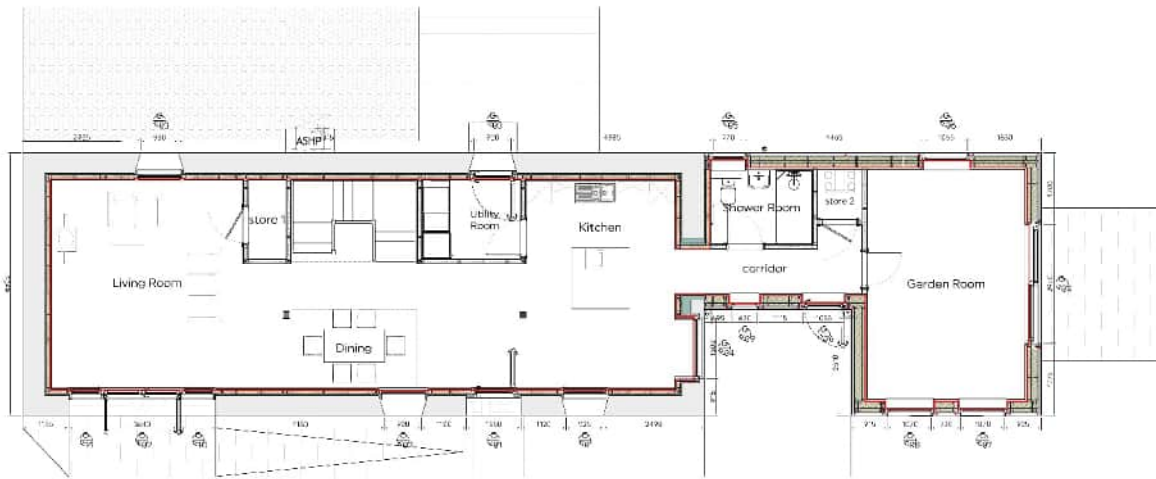
GROUND FLOOR PLAN

The existing building was a 2 storey workshop with natural stone walls. A key design aim was to maintain the existing building form and although ceiling heights were restricted, the construction of the additional space in the extension allowed the layout of the main house to be open plan with high linked spaces around the central stair and gallery.

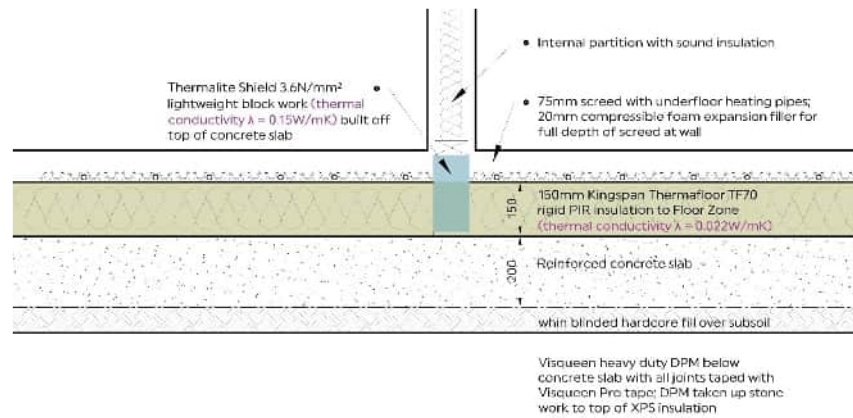
INTERNAL TIMBER PARTITION & GROUND FLOOR JUNCTION

Internal timber partitions have a course of lightweight blockwork to limit thermal bridging through the floor insulation.

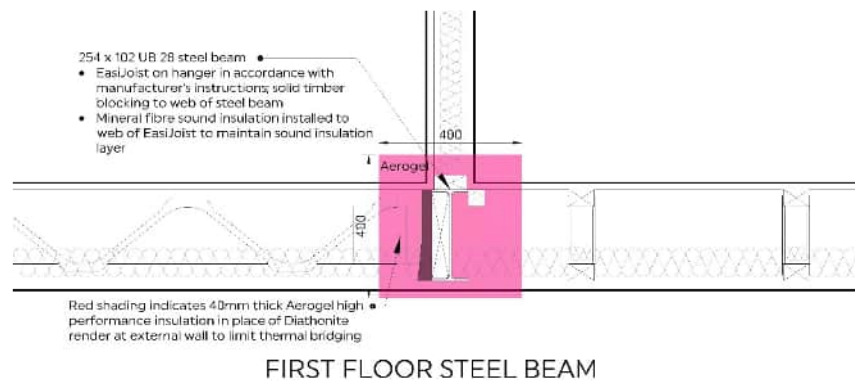
A single steel beam was needed within the first floor to support a change in direction of the lattice floor joists. This is supported on the timber frame at the external walls, so a section of high performance Aerogel insulation was included between the end of the steel beam and the existing stone walls to limit thermal bridging.

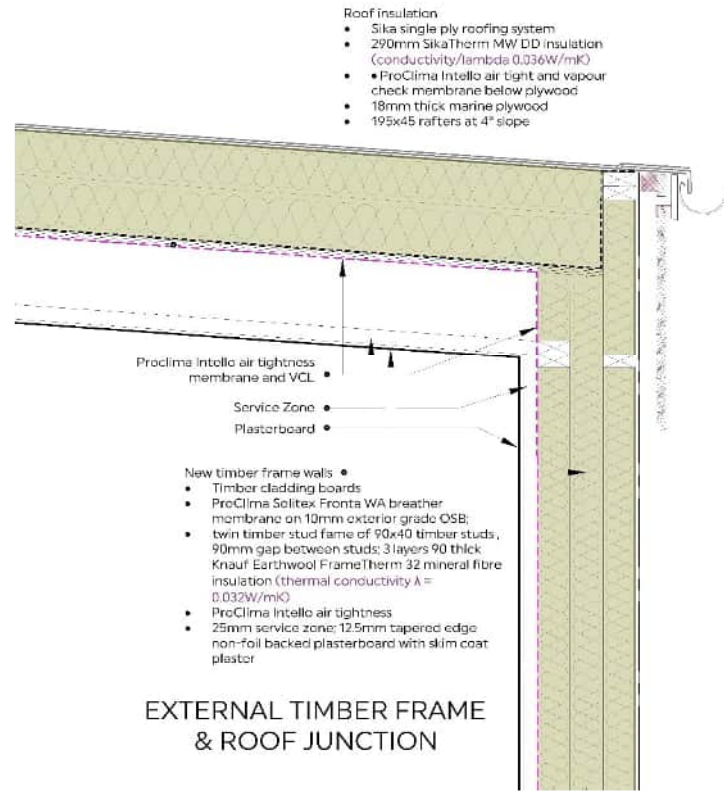
New timber kit detail

The extension roof is a low pitch single ply membrane with rigid insulation on a plywood deck. The timber frame was stepped at the top to provide support for the rafters and provide continuous insulation from walls to roof.

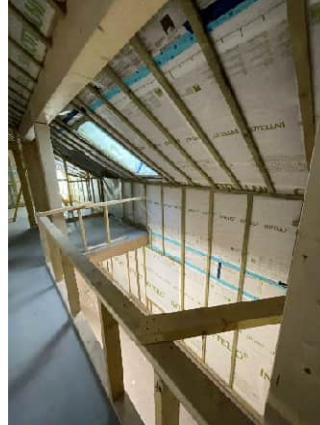
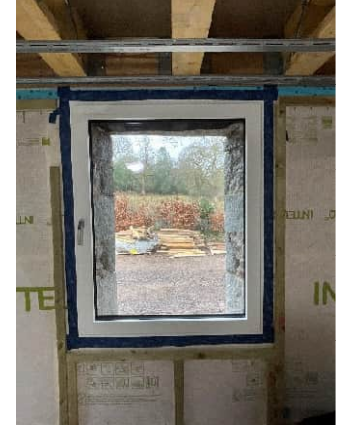
Air tightness tapes were used to seal from the ProClima Intello airtightness membrane onto the window and door frames

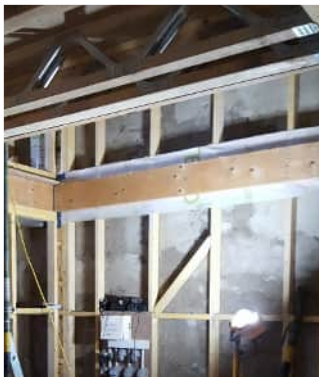
A strip of air tightness membrane was installed behind the first floor bearer beam before installation with a generous overlap to allow sealing onto the wall membrane when it was installed.

The same approach was taken to the timber ridge beams and the steel beam ends ensure easy sealing of the membrane.

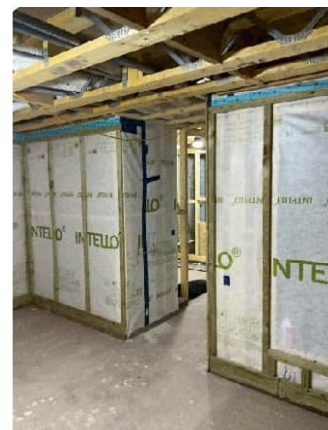
The new opening between the existing building and the extension was oversized to allow for continuous insulation, services in the ceiling space, and the air tightness membrane to be continuous between the rooms. This detail kept the existing stone walls outside the insulation and air tightness envelopes.

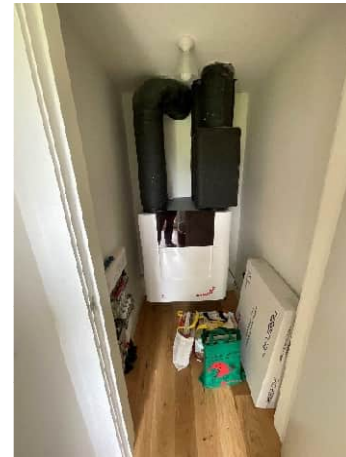
The ventilation system is a Zehnder ComfoAir Q350 unit with a combined external wall vent. Lindab spiral steel ducting was used for primary runs from the ventilation unit to manifolds with semi-rigid PE ducts Lindab to room valves.

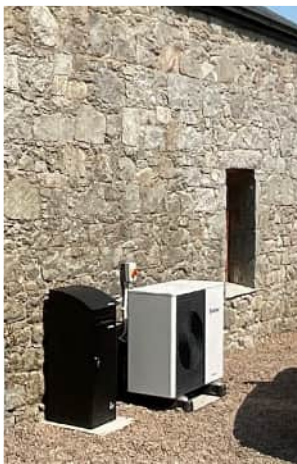
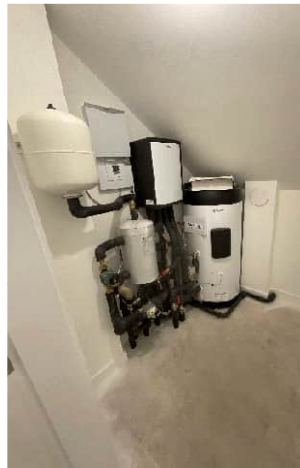
The heating and hot water system is from an air source heat pump with a hot water storage tank in a first floor services cupboard.

Space heating distribution is underfloor heating at ground floor and radiators at first floor.

The first floor services cupboard has been fitted with an extract valve from the MVHR system. This provides a successful drying room and avoids the need for a tumble drier.
