1. Summary

South Elevation of the University of Chicago Warren Woods Field Station

- **Project Name:** University of Chicago Warren Woods Ecological Field Station
- **Location:** Western Michigan, USA
- **Year of Construction:** 2013-2014

- **Design Architect:** Timothy Lock, AIA – GO Logic (now OPAL)
- **Energy Modeling:** Svea Tulberg
- **Certifying Body:** Passive House Institute (PHI)
- **Certification ID:** 9117-9118_PH_20140708_SG
- **Passive House Database Project ID:** 4080
- **Author of Documentation:** Timothy Lock
- **Date and Signature:**

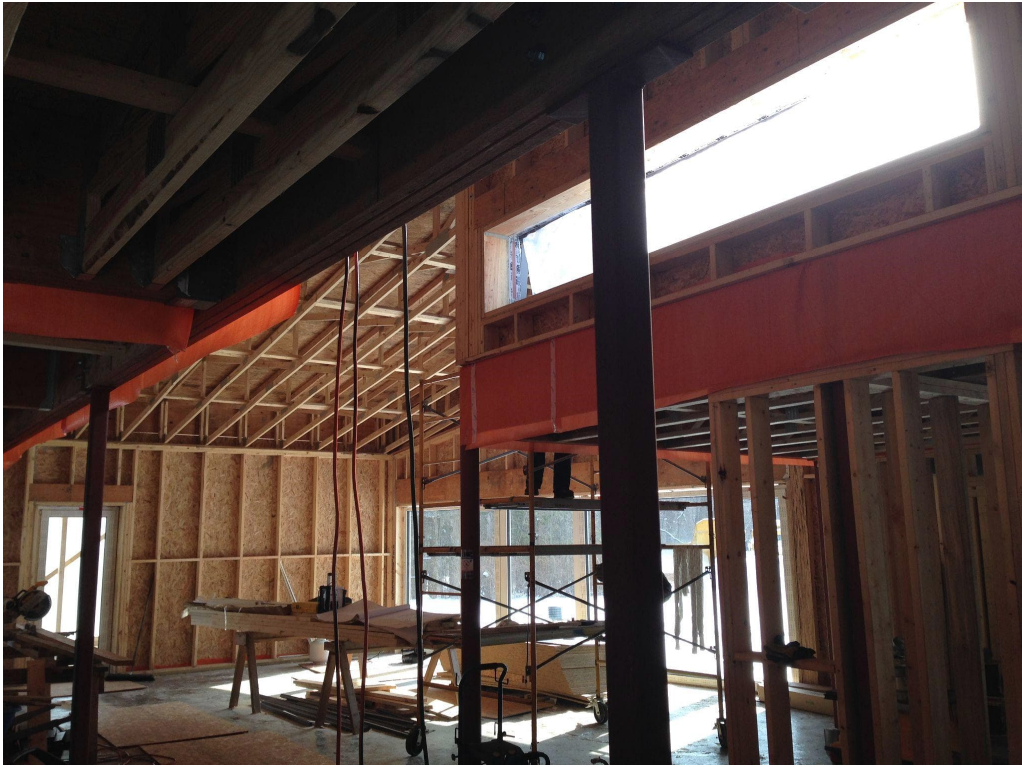
View of pre-installed flexible air barrier transitions during framing

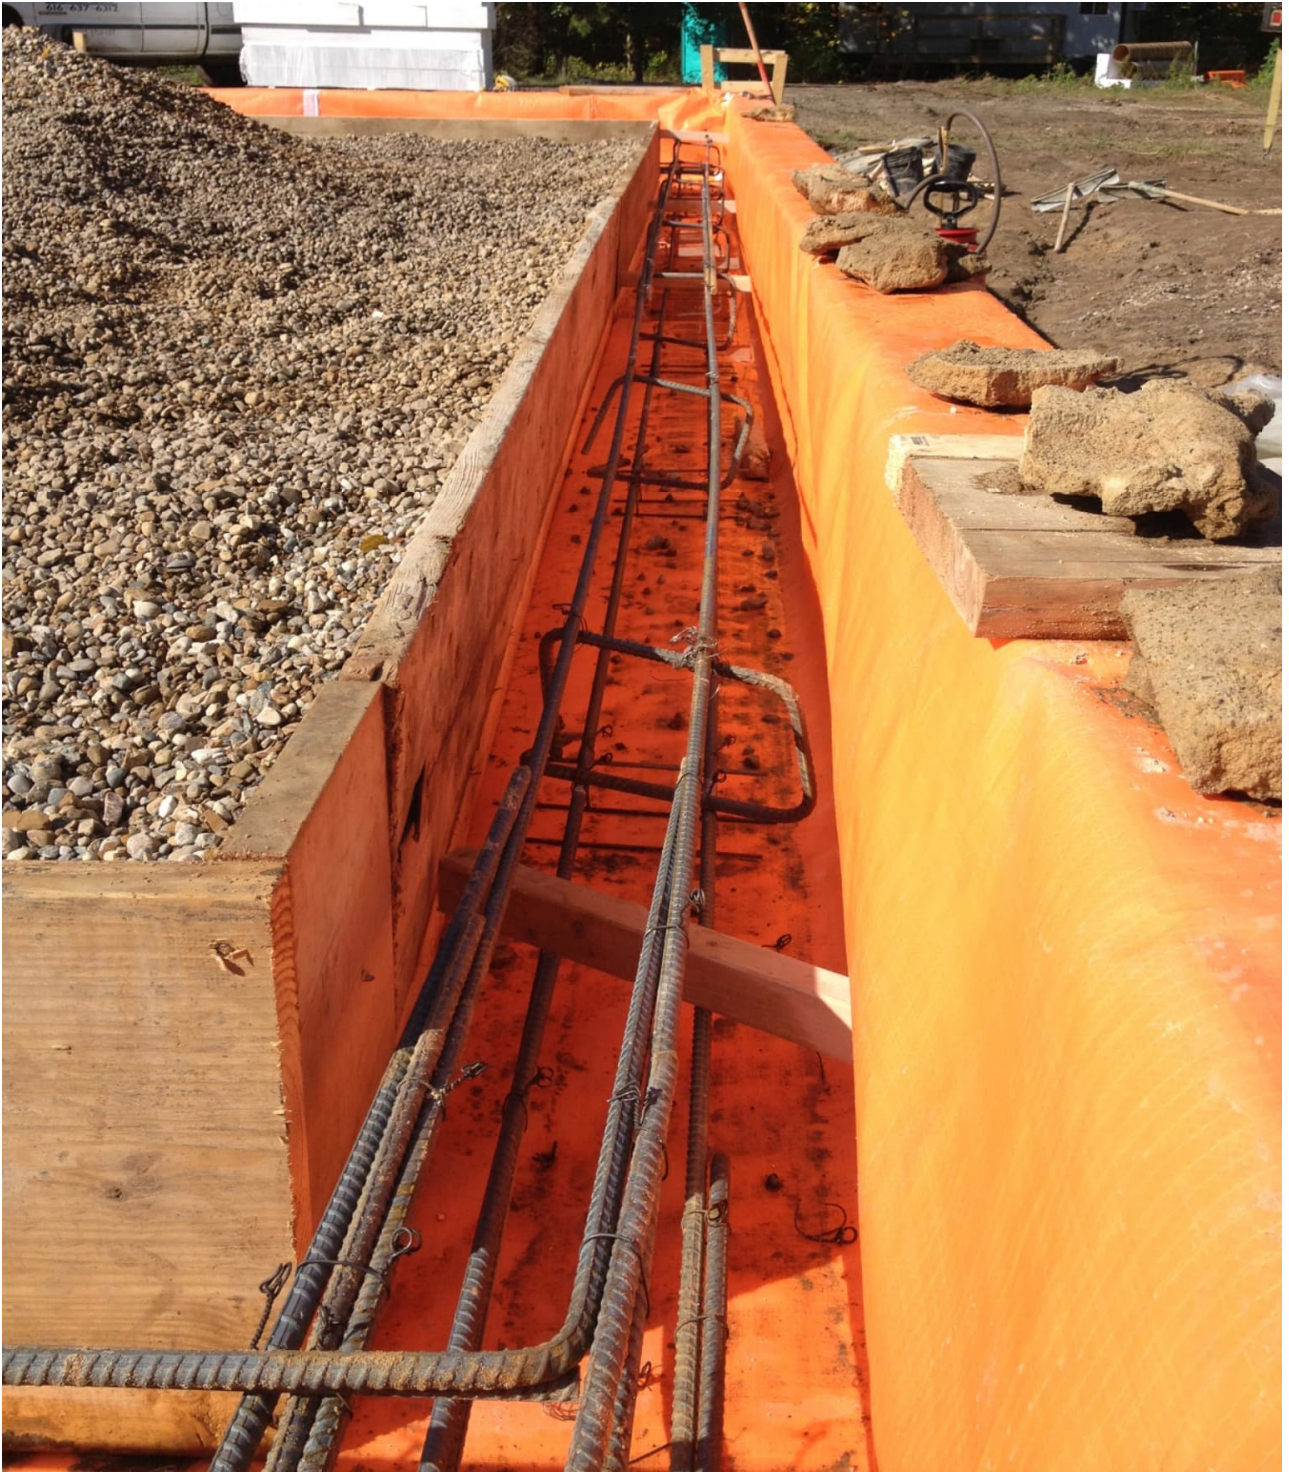
Underslab air barrier at foundation edge

Air sealing was accomplished using a variety of products and connection/transition details. Under the slab, a 15mm, fully taped, Viper Vaporcheck cross-woven air sealing membrane was used. The walls were air sealed on the interior face of the SIPs, while the roof was air sealed from below using a combination of Zip sheathing, Proclima Intello, and Viper Vaporcheck. Given the complex building form, many flexible portions of the air barrier, particularly at transitions, were pre-installed during structural framing to tape into other continuous surfaces later in order to maintain continuity. The continuous air seal is indicated in green in the sections below:

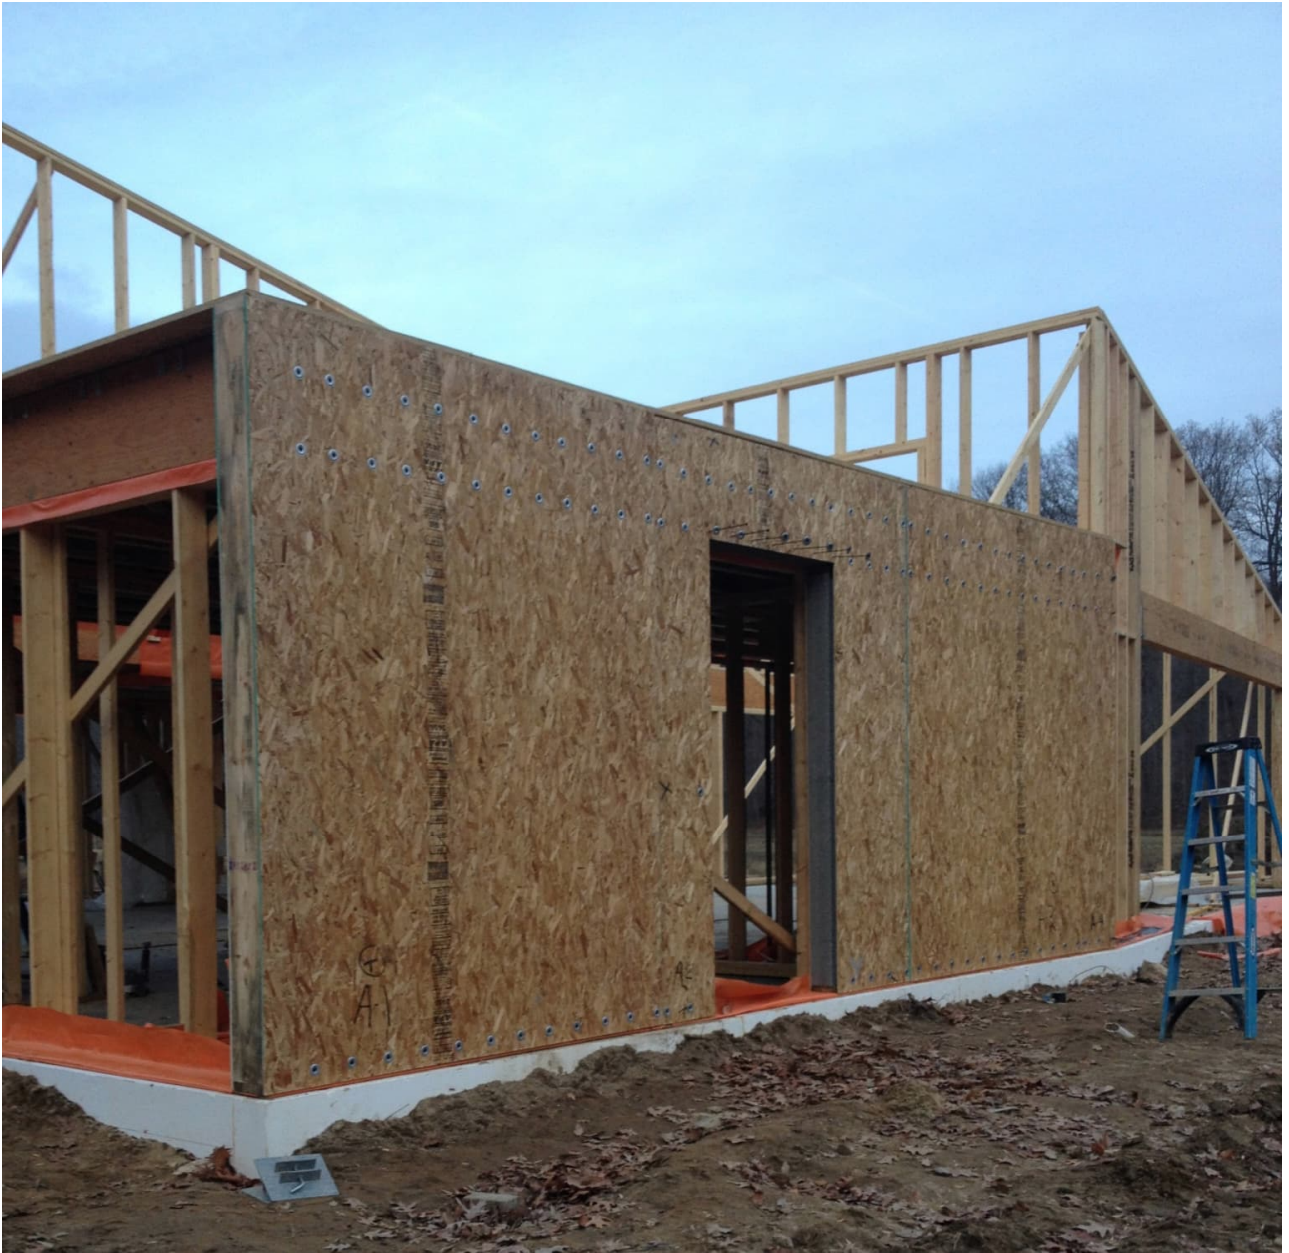
Panel installation

The exterior walls are two-part construction, with a wood-framed service wall and 7.25 inch structural insulated panel constructed with graphite infused expanded polystyrene. All air sealing is provided at the interior side of the SIP.

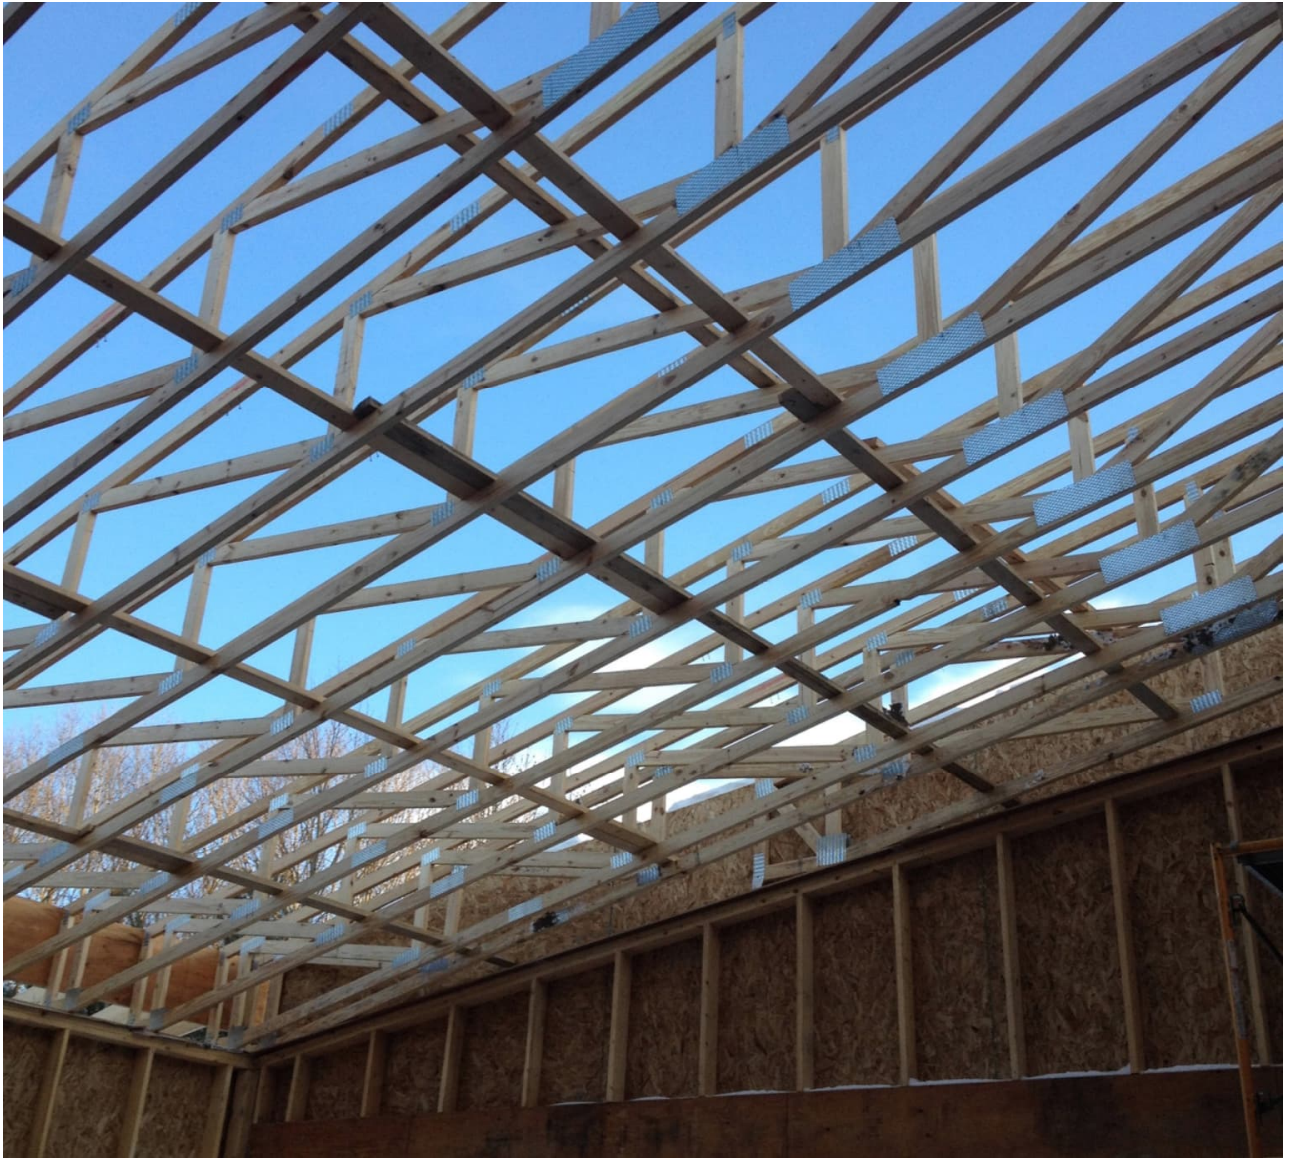
Roof truss installation

The roof is constructed of custom, open-web, wood trusses throughout, both on the sloped and flat portions of the building. The air barrier is fixed to the underside of the truss throughout. The truss cavity is filled with dense pack cellulose insulation. The trusses were baffled intermittently during insulation installation to ensure proper density of insulation throughout.

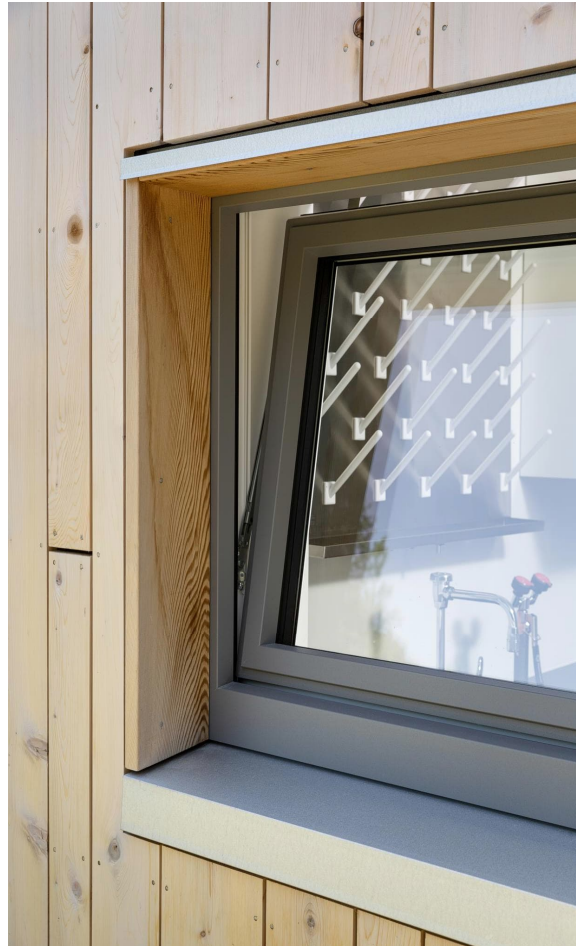
Window detail from exterior

We worked with our partners at Kneer-Sudfenster to provide Passive House-level triple-pane windows throughout this project. All window frames are provided with insulation extensions on the exterior to cover frame thermal bridging. The windows are UPVC with aluminum cladding.

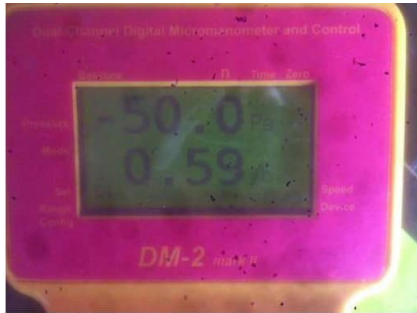
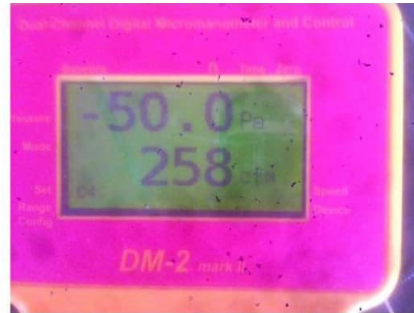
Infiltrometer Air Leakage Test Results, In Compliance with ASTM E-779-10, Warren Woods, 02-25-2014

1. Airflow at 50 Pascals:
(50 Pa = 0.2 w.c.) 186 CFM50 (+/- 1.4 %)
0.41 ACH50
2. Leakage Area: 10.2 in² LBL ELA @ 4 Pa
3. Building Leakage Curve: Flow Coefficient (C) = 11.5 (+/- 10.3 %)
Exponent (n) = 0.712 (+/- 0.028)
Correlation Coefficient = 0.99920
4. Test Settings: Test Standard: RESNET Multi-Point Test
Test Mode: Depressurization
5. Accuracy Level Standard Level of Accuracy Test

The building, as designed, met the Passive House criteria with an annual heating demand of 12 kWh/m²a and primary energy consumption limit with a predicted result of 64 kWh/m²a. The field pressurization test was also in compliance, yielding a result of .5 ACH at 50 Pascal. The challenge on this project was the documentation of usage of laboratory equipment given the high heat load when in use. We used a separate schedule for this equipment and reviewed it directly with PHI to maintain compliance.

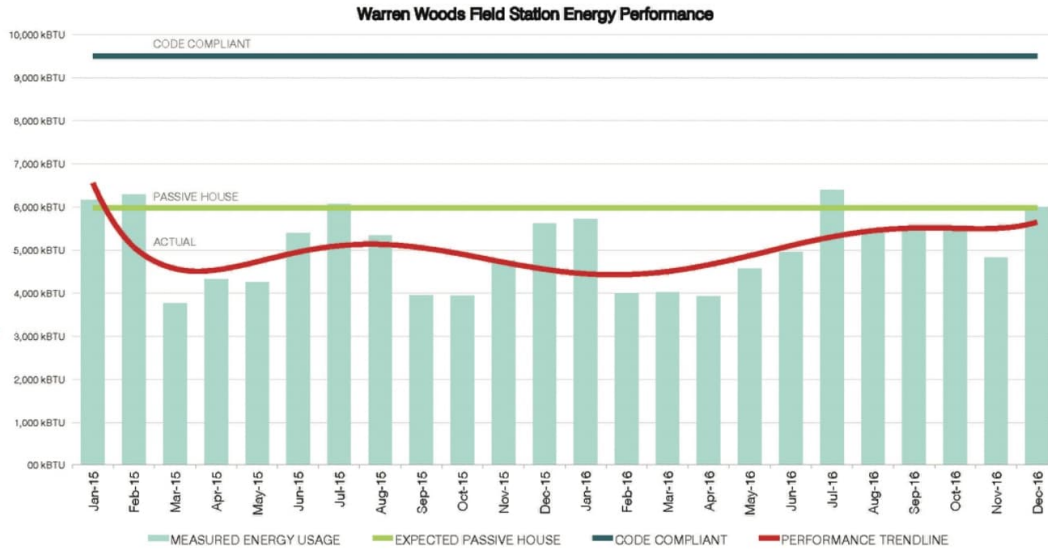
- 24-month average monthly documented total energy usage | 5,034 kBTUs
- Estimated Passive House monthly energy total usage | 5,976 kBTUs
- Documented monthly laboratory refrigeration energy usage | 2,828 kBTUs
- Documented monthly remaining building energy usage | 2,206 kBTUs
- Percentage of remaining building energy usage for heating | 3%
- Percentage of remaining building energy usage for cooling | 15%
- Percentage of remaining building energy usage for domestic hot water heating | 21%

We were able to conduct a Post Occupancy Evaluation after one year of occupancy and the results were consistent with the Passive House approach and PHPP predicted energy use. Additionally, it was interesting to see the success of a Passive House approach in that nearly all of the space heating needs were being covered by the lab equipment, and the heating system was very rarely running.
