Submission for renewal of CEPH Designer qualification by Paul Mallion, BSc(Hons) MSc(Arch) FRICS

Project Documentation

Top Barn, Sandwell, Kent, UK

Barn conversion into 3 bed detached house, Maidstone, Kent, England

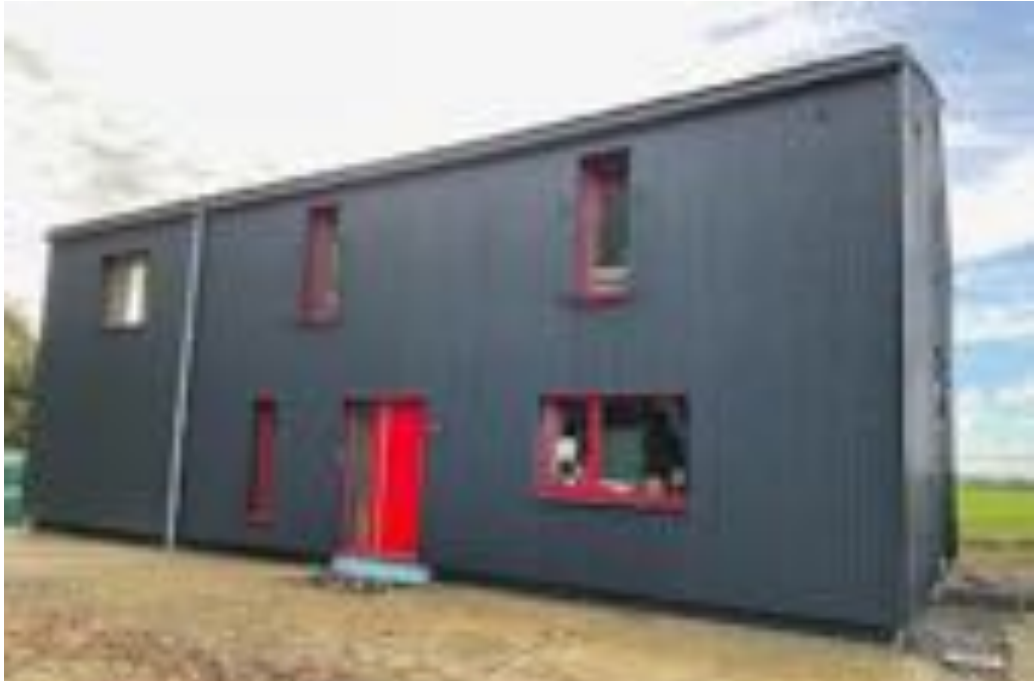
East elevation: faces the site access but has very limited views and fronts the working farm yard. Small windows were used to reduce risk of overheating and retain privacy, the large first floor window at the south end is into a double height space.

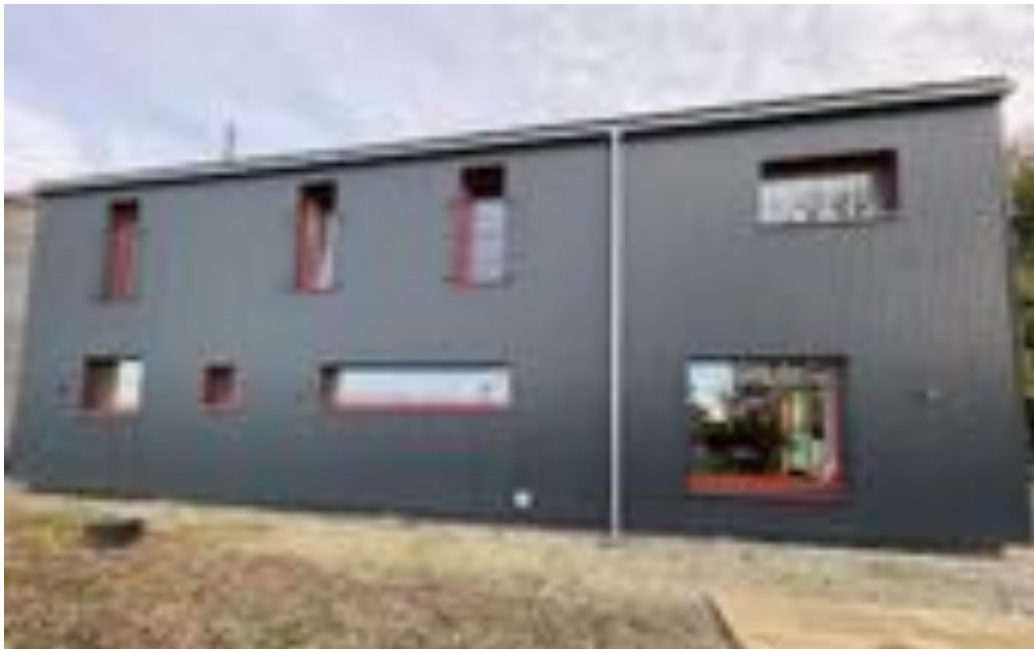
West elevation: faces open fields and has good views, so larger windows are possible although carefully sized to avoid overheating and deeply recessed. The large ground floor window is to the lounge, and the wide slim window provides a panoramic view from the kitchen.

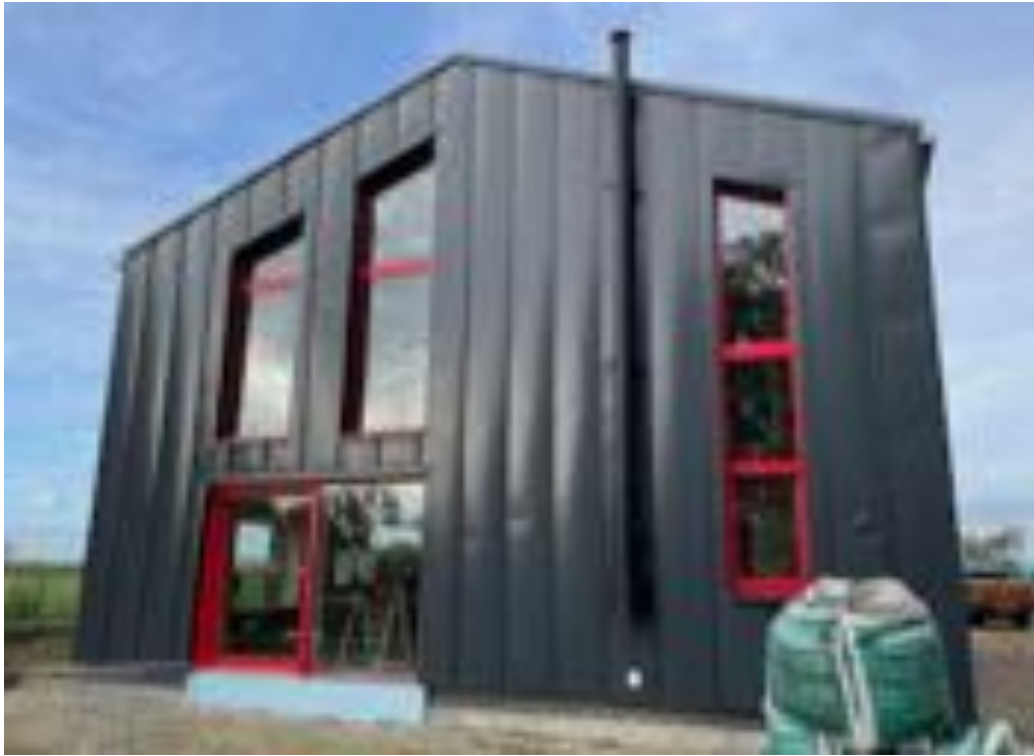
South elevation: faces a secluded area with high trees and overlooking a sloping garden. Overheating was mitigated by recessing the windows and using tall slim windows to create deep reveals. Note the small fresh air inlet below the flue for the stove.

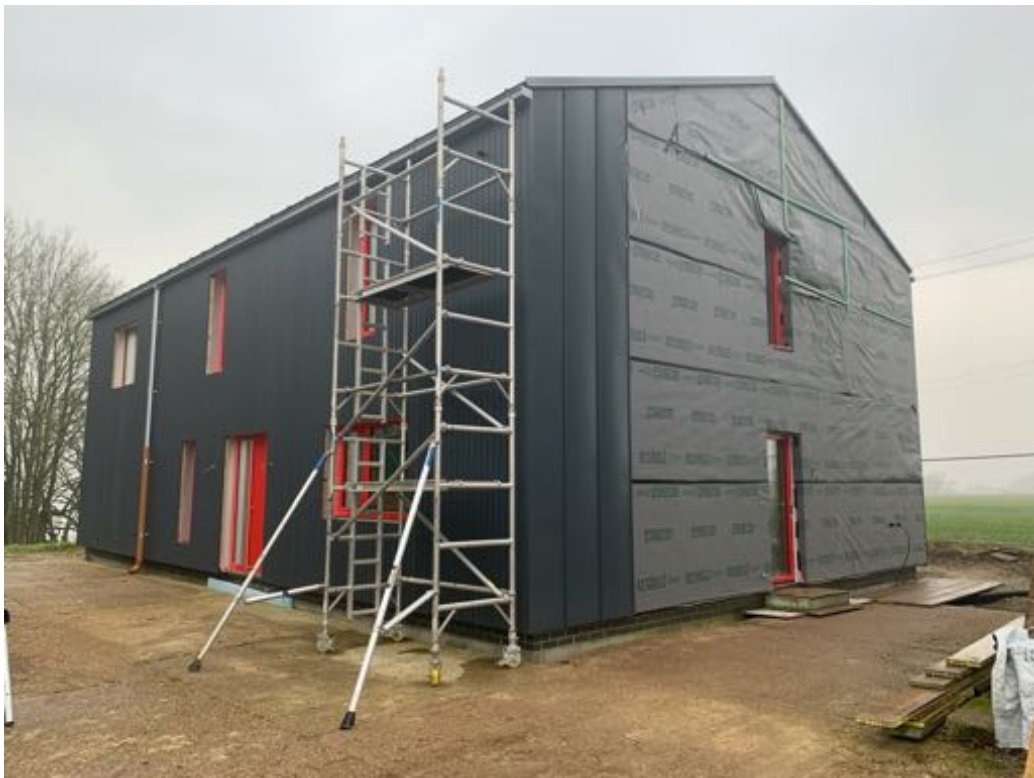
North elevation: during cladding works- there are only two openings on this elevation as there is no view due to the existing grain silos, see photos below.

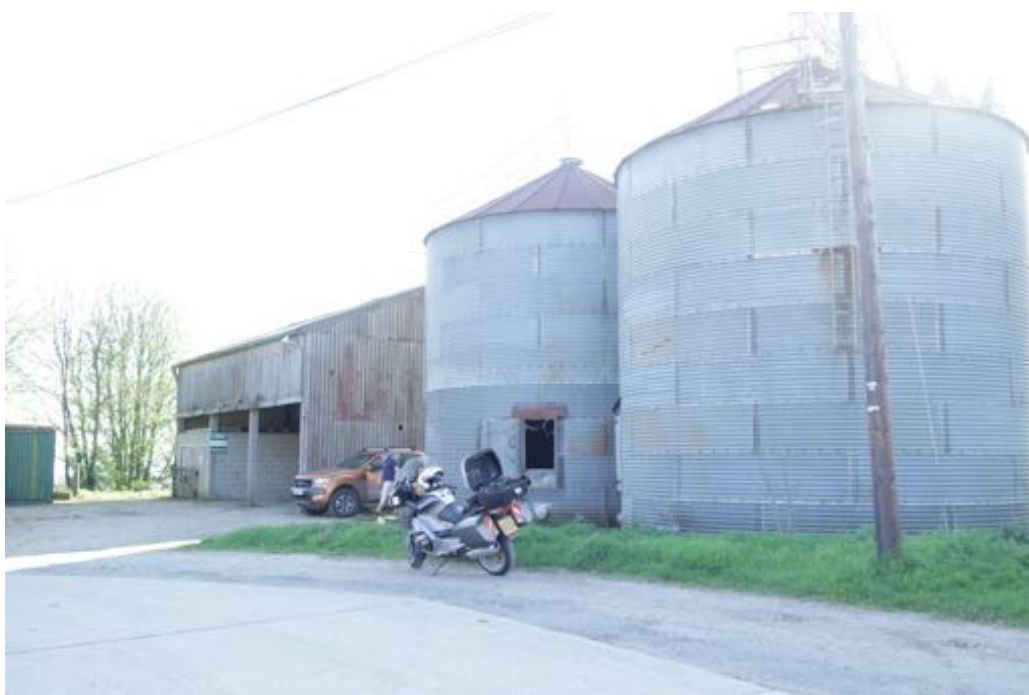
View from the north east of the original barn: the barn is clad with asbestos cement sheet and consists of 3 bays.

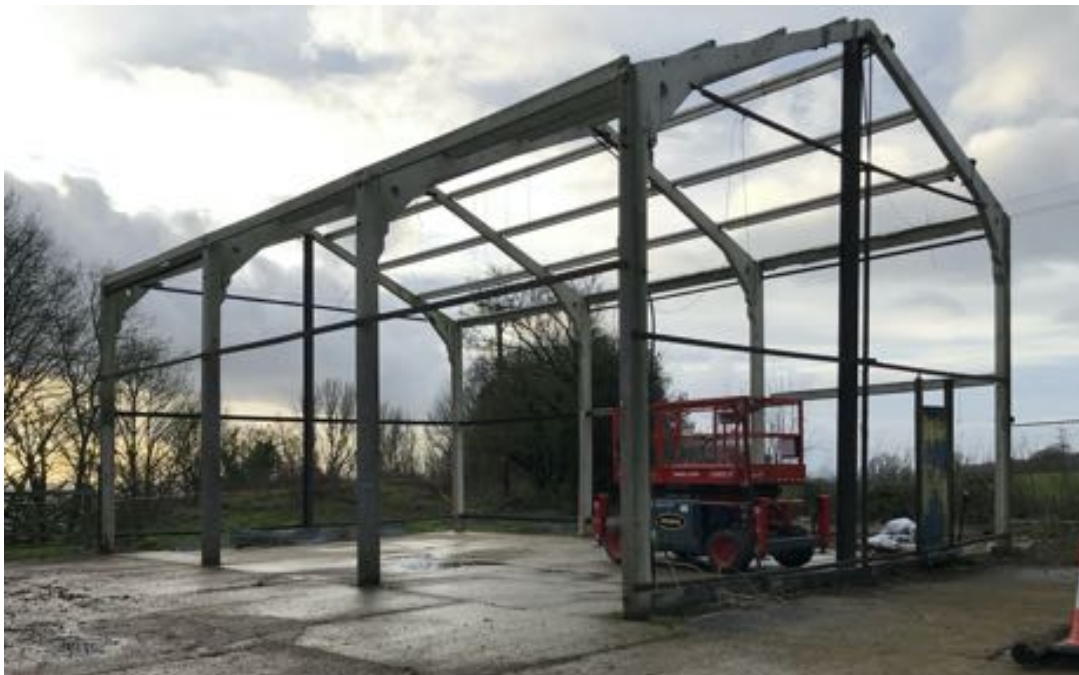
View of the concrete portals: once the cladding was removed the purlins were removed allowing the new timber frame to be inserted around the portals.

Retaining the concrete portals was a particular challenge due to cold bridging risks, as well a technical challenge owing to their shallow foundations and being constructed to an 'agricultural' standard i.e., not vertical or level. Balancing the solar gains and overheating risk was also difficult, whilst exploiting the views to the south and west.

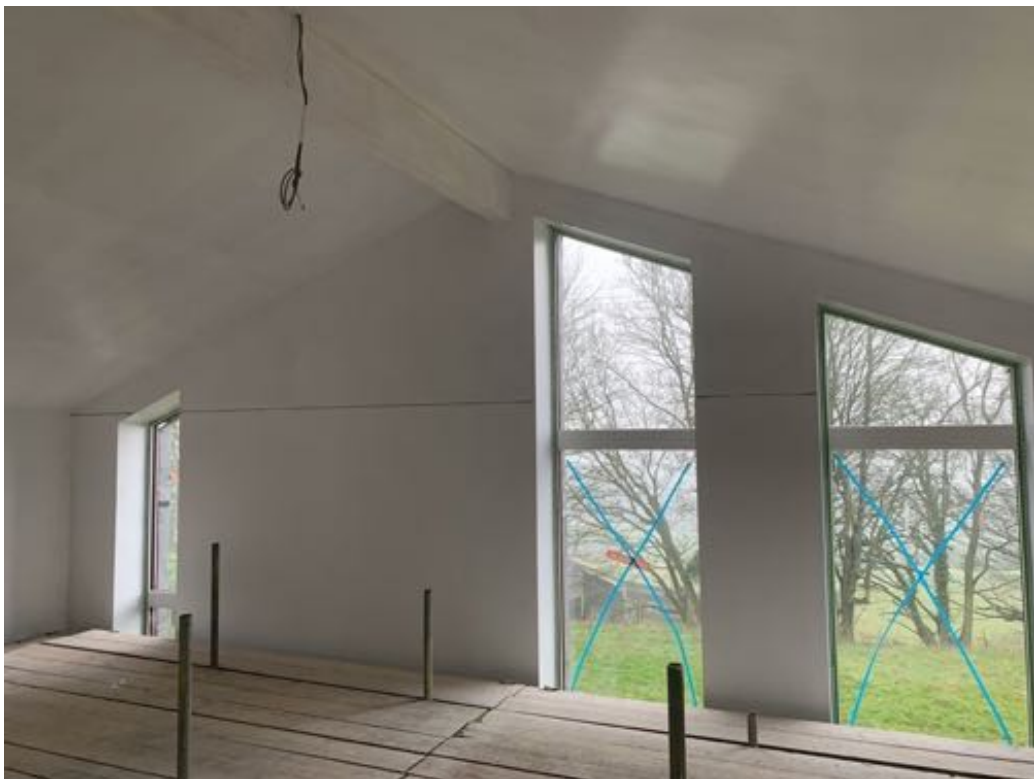
Internal view from the double height windows during construction with the crash deck in place, showing the trees on the site boundary in the distance.

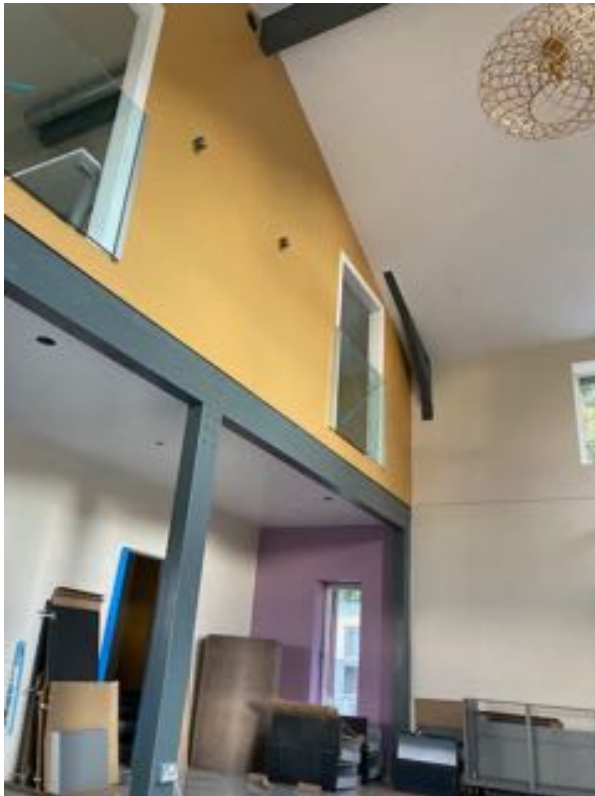
Internal view of the double height space looking back towards the gallery, two bedrooms overlook the space and have large openings so that they can also exploit the views out through the south facing windows. Ventilation return grille can be seen at the top of the yellow wall.

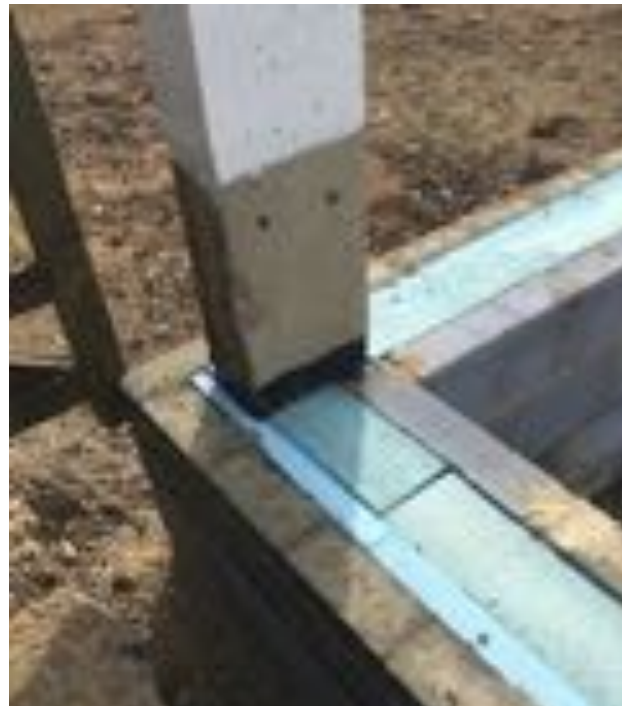
5.1.1. A cavity wall plinth was constructed between the concrete portal legs, but as the legs were not constructed accurately the plinth wall had to be very carefully set out to avoid clashing with the legs. A small amount of insulation was wrapped around each. Blocks with very low conductivity were used, and the insulation was laid in two layers to ensure overlap of joints.

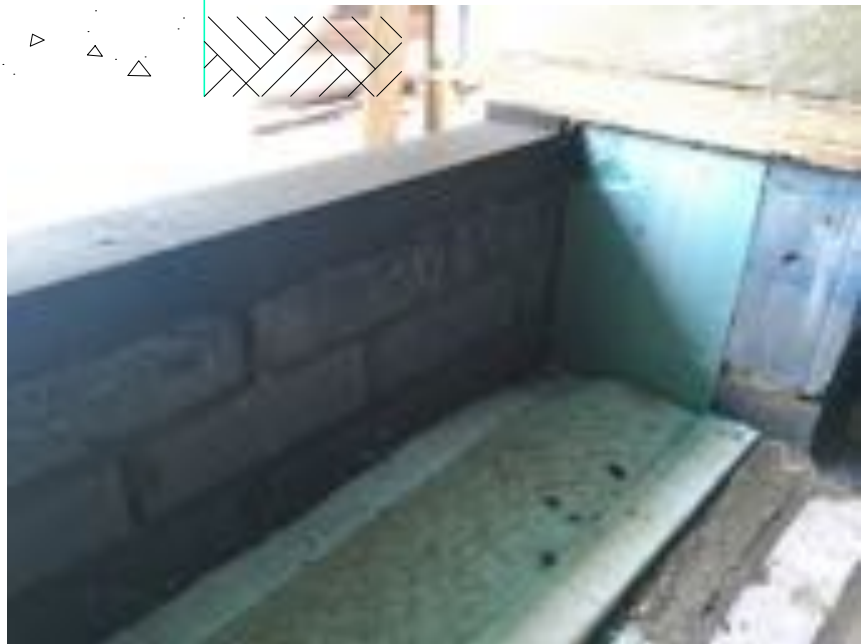
5.1.2. Thresholds to the external doors are located over a strip of foamed glass insulation on the outer leaf and have an external insulation board placed against the brickwork (not visible in the image) to reduce thermal bridging. The image below shows the laminated sole plate across the cavity wall.

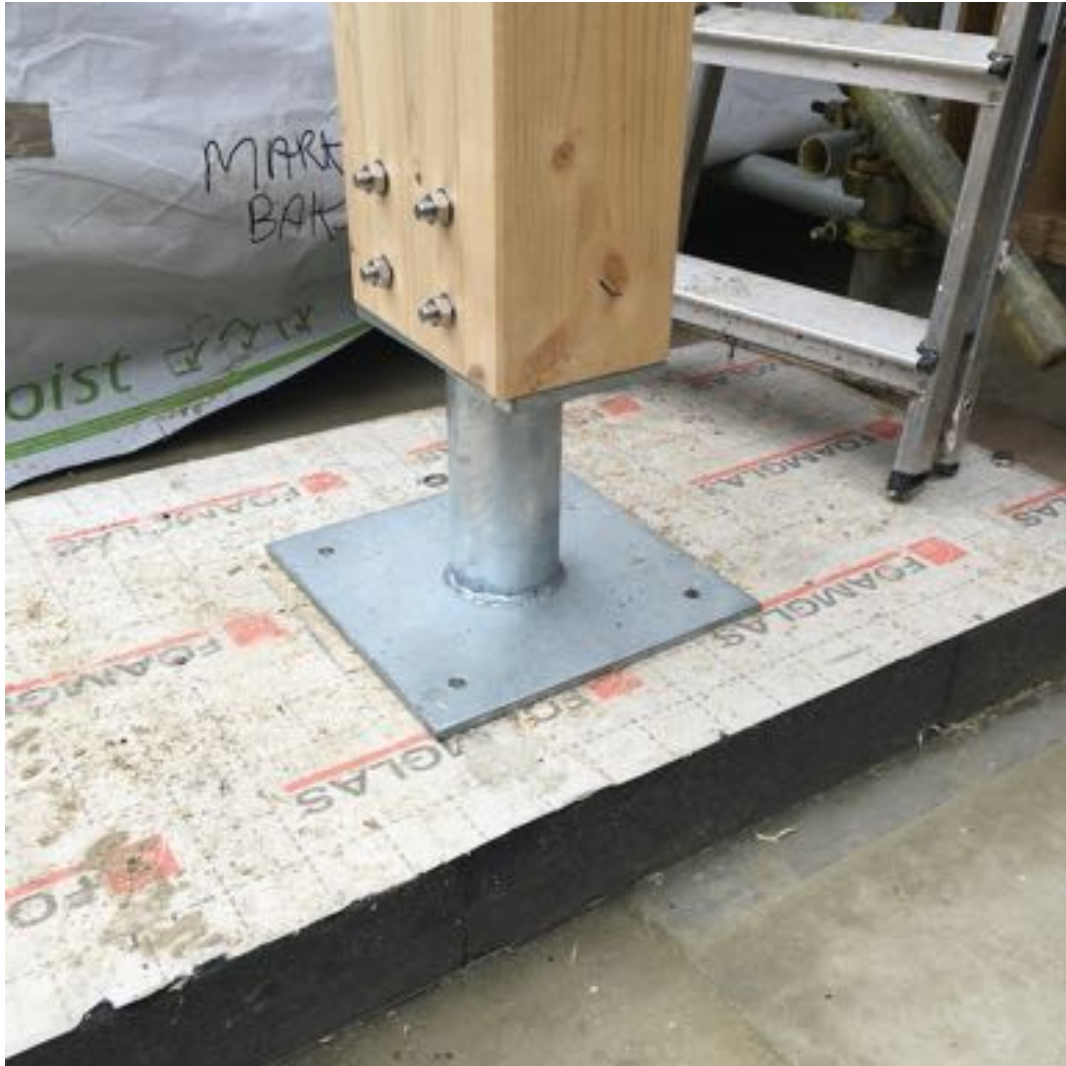
- 5.1.4. The engineer required the ground floor partitions to sit on the structural floor to carry the loads from above, therefore they penetrate the insulation and vapour barrier. This was a difficult detail to execute as the VCL had to be carefully lapped up the face of the partitions and taped to the studwork. The studs extending below the screed were also a minor repeating thermal bridge and were accounted for within the U value. In the future I would design out this detail.

- 5.1.5. Three posts penetrate the floor to support the gallery above, each post sits on a block of Foamglas to avoid a direct thermal bridge.
- 5.1.6. **Ground floor** showing VCL rising at internal partitions in the background before being sealed to the studwork, prior to screeding.

Ground floor	Beam and block floor; DPM; 240mm XPS insulation; VCL; 75mm screed.	U-Value 0.149 W/m ² K
---------------------	--	--

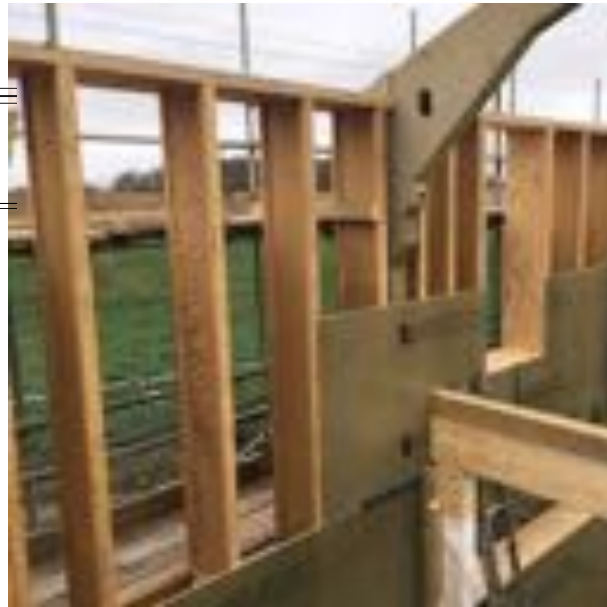
DETAIL 03
(1:10)

- 5.2.1 The detail above shows the 400mm wide 'I' joist (Steico SJ45 x 400) fully filled with insulation, and 60mm thick woodfibre sheathing board to the outside. The interior was lined with airtight sheathing board 'Vapourblock' by Unilin. Lintols were formed using the same sized joists. The photograph above shows the concrete portal being enclosed by the wall system. Interstitial condensation checks were made to ensure the concrete was not a risk.
- 5.2.2 Photographs showing woodfibre insulation being injected through holes cut into the sheathing board, and the injection machine located on a truck with the insulation material in bags waiting to be loaded into the hopper. Each hole in the sheathing is taped over with a square patch.

External wall	Steel cladding on boards over a ventilation layer; 60mm dense woodfibre insulation boards; 400mm I joists at 600mm centres fully filled with woodfibre insulation; airtight OSB board 13mm thick with joints fully taped; batten void, 12 mm plywood and plasterboard. Timber fraction is cautiously accounted for at 20% for chord and 5% for web.	U-Value 0.094 W/m ² K
----------------------	---	--

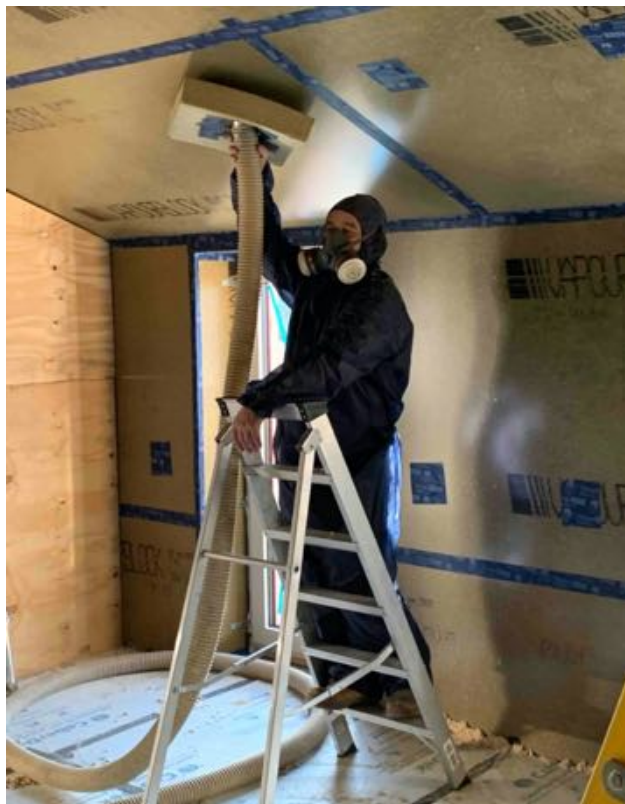
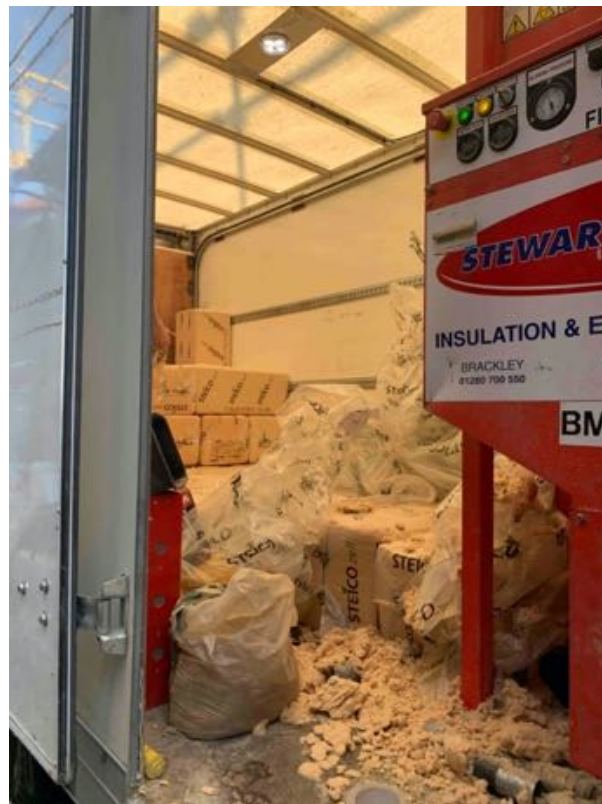
5.2.3 At the locations of the concrete columns an additional layer of insulation was added between the service void battens, to mitigate the thermal bridge.

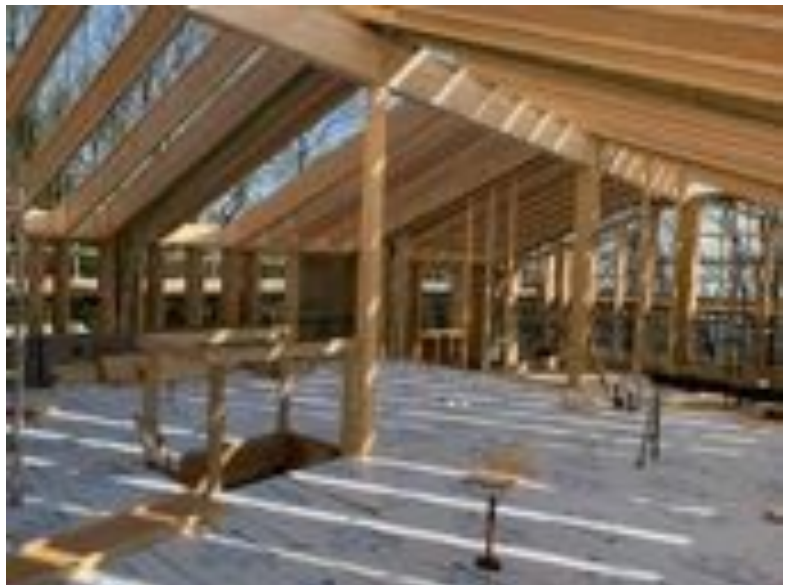
- 5.3.1 The roof is constructed from 400mm I joists at 600mm centres, sitting on a plate at the eaves and a ridge beam, with plywood reinforcing gussets at the ends and to join them at the ridge. The ridge beam is below the rafters to ensure continuity of insulation. The exterior of the roof is enclosed with a 60mm insulation board.

Roof	Steel cladding on boards over a ventilation layer; 60mm dense woodfibre insulation boards; 400mm I joists at 600mm centres fully filled with woodfibre insulation; airtight OSB board 13mm thick with joints fully taped; batten void and plasterboard. Timber fraction is 12% for chords and 3% for webs.	U-Value 0.089 W/m ² K
-------------	--	--

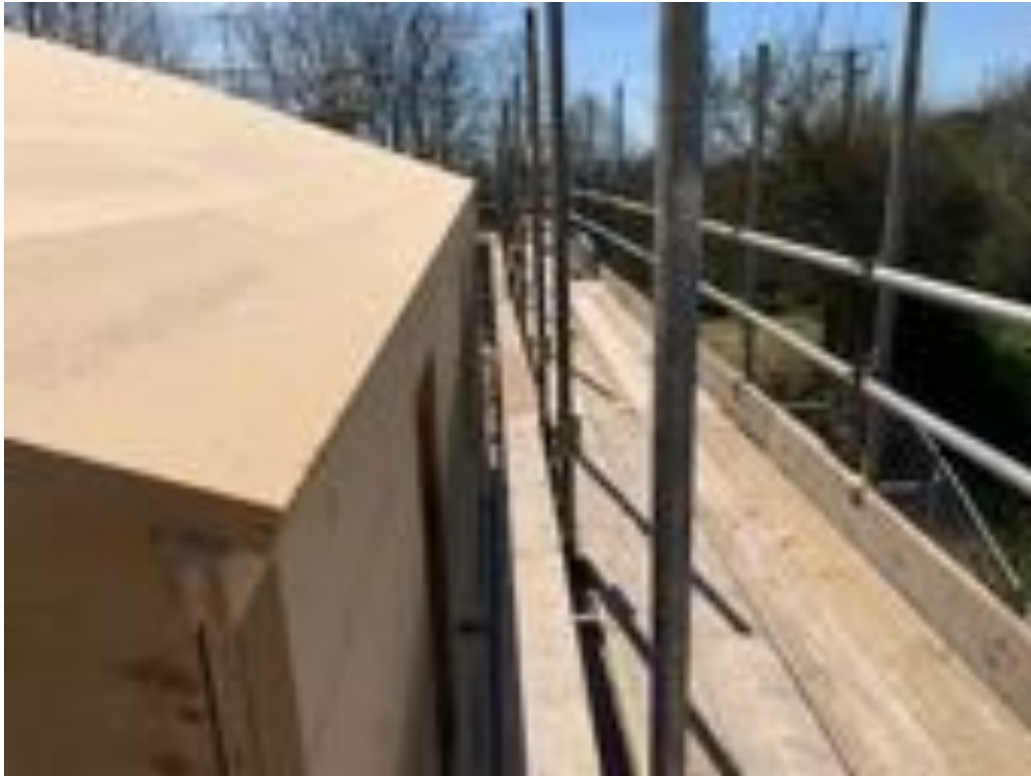
- 5.3.2 **View of roof** showing external woodfibre board laid over rafters, with tongued and grooved joints it forms a windtight layer.

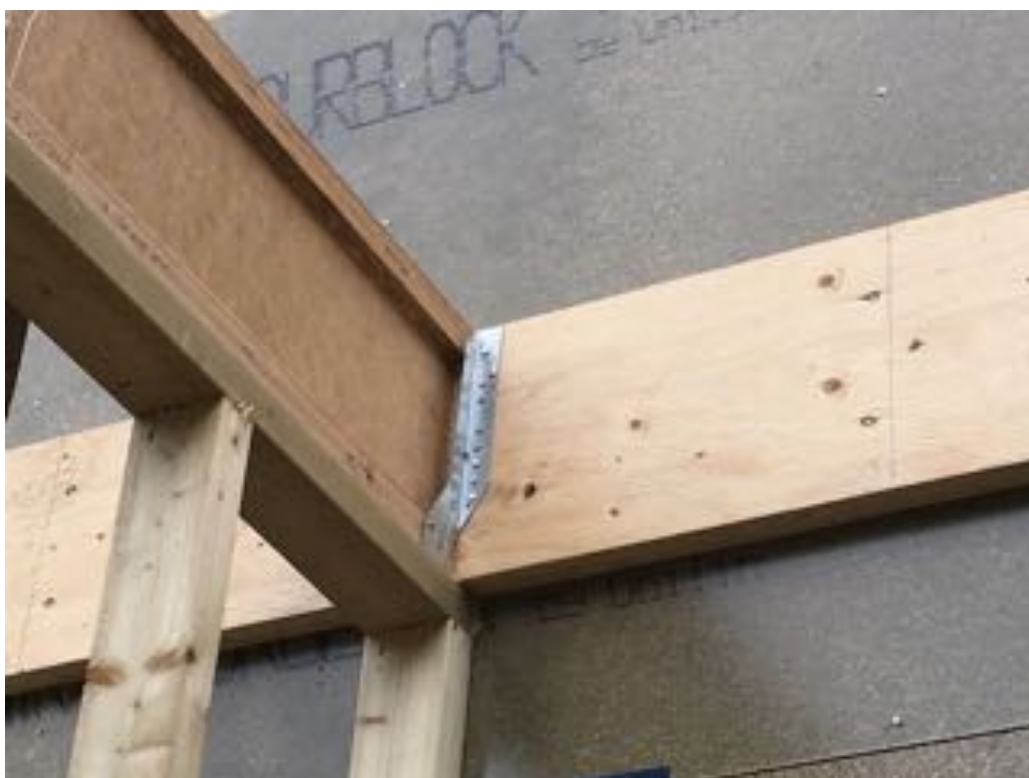
6.1 The main airtight layer is the internal OSB sheathing board which has a phenolic coating. Joints in the boards are taped using ProClima Tescon Vana. A balloon timber frame was adopted. With a conventional design the intermediate floor rests on the ground floor walls and the upper walls are built on top of the floor joist ends. This causes the air tight layer to snake around the plates and joists ends, with risk of air leakage and condensation as the VCL gets very close to the exterior surface. I designed the walls to extend directly from sole plate to the eaves plate with the sheathing applied to the walls before a ledger plate (or rim board) was fixed through the sheathing to the studs, from which the first floor joists are hung.

6.2 **Internal image** of 'rim board' to which first floor joists are hung.

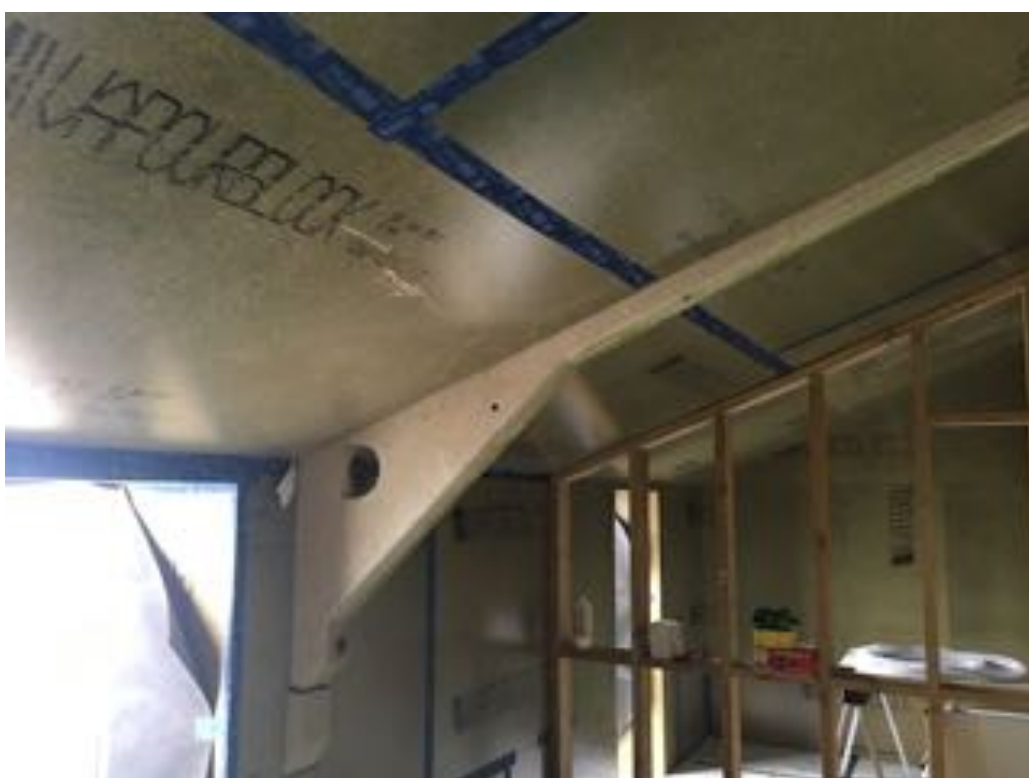
6.3 **Internal image** of airtight board to underside of roof with taped joints.

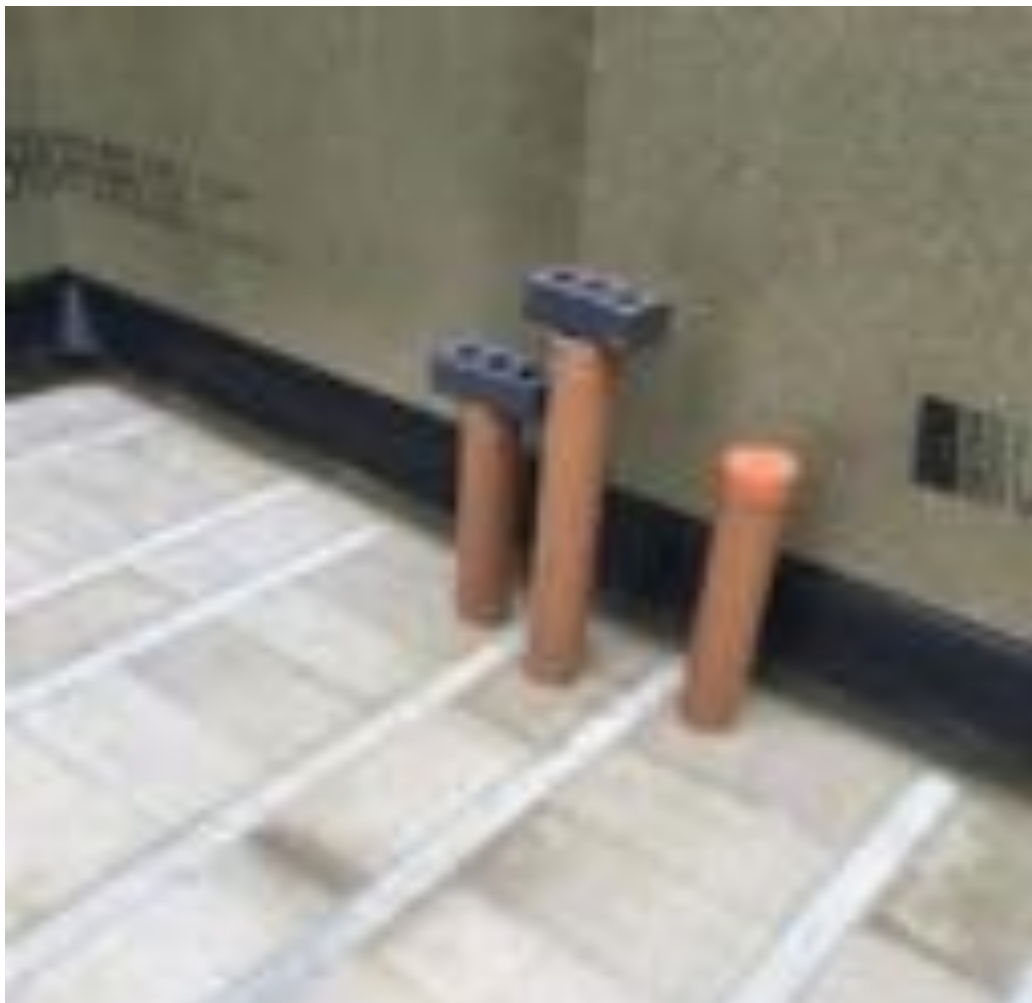
- 6.7 **View of incoming** services through floor, spaced to allow them to be individually taped to the VCL.
- 6.8 Results of air leakage test by Airtight, ATTMA registration number 0008 on 22/07/2021. The average of the pressurisation and depressurisation was 0.49 air changes per hour.

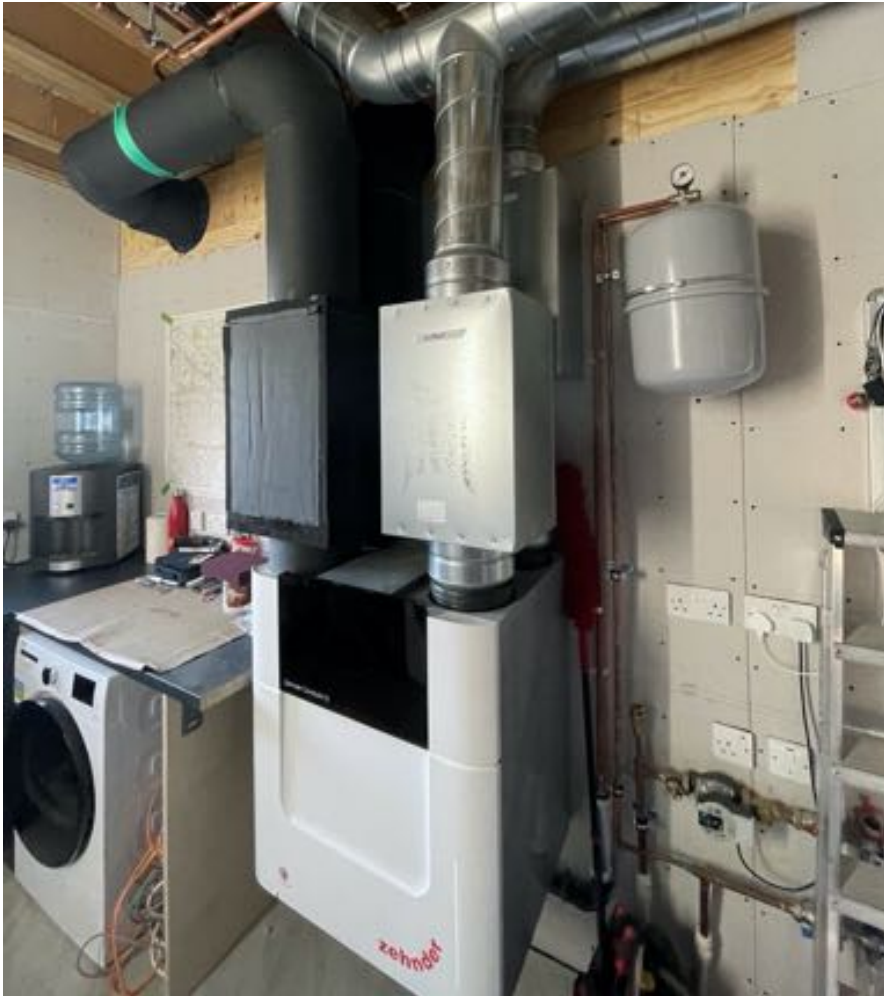
7.2.4 **Ventilation unit** in utility room

- 7.2.1 The unit is a certified Zehnder ComfoAir Q350 which is located at a convenient height for easy inspection and replacement of the filters. The unit can operate from 70 to 270m³/h so it can suit a wide range of projects.

- 7.2.2 The unit has a heat recovery rate of 90%, and a SFP of 0.24W/m³h.
- 7.2.3 A 1.7kW pre-heater is built in for frost protection. A humidity sensor automatically raises the air flow rates if RH rises above a set level.

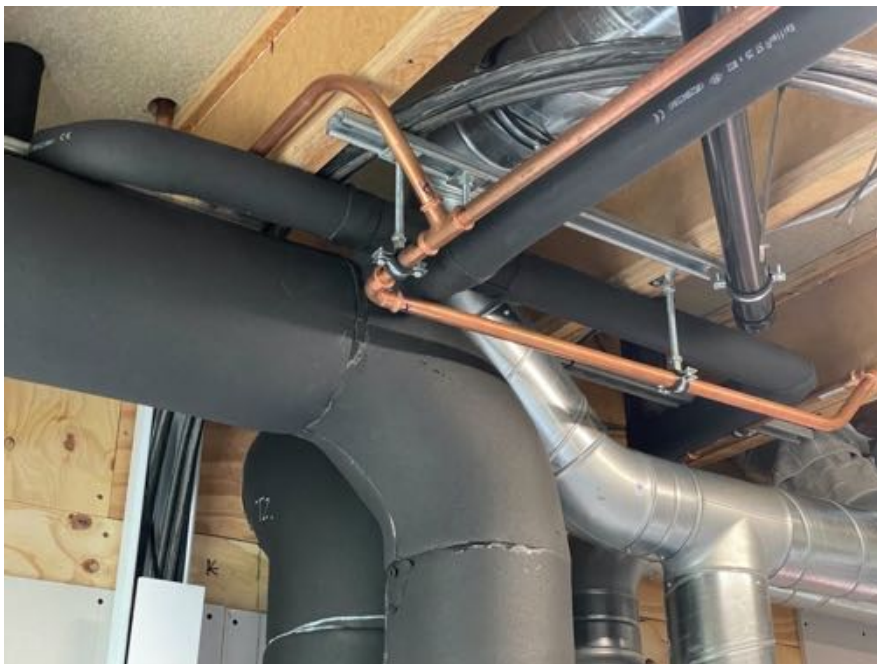
7.2.5 **Insulated ductwork** to exterior. Galvanised steel ductwork secured with rubber mounted brackets.

- 7.1.3 Supply and extract ductwork is 160mm diameter galvanised steel spiral, although plastic pipework is available I have found that workmanship often falls short. Steel ductworks needs a little extra skill to install but repeatedly proves to yield better quality installations. Ducts reduce to 125mm to run to each room.
