Project Documentation Gebäude-Dokumentation

Arthur Street Townhouse

Brief Description

The Arthur Street Townhouse project commenced on site in May 2021, was completed in March 2023, and achieved certification in November 2022.

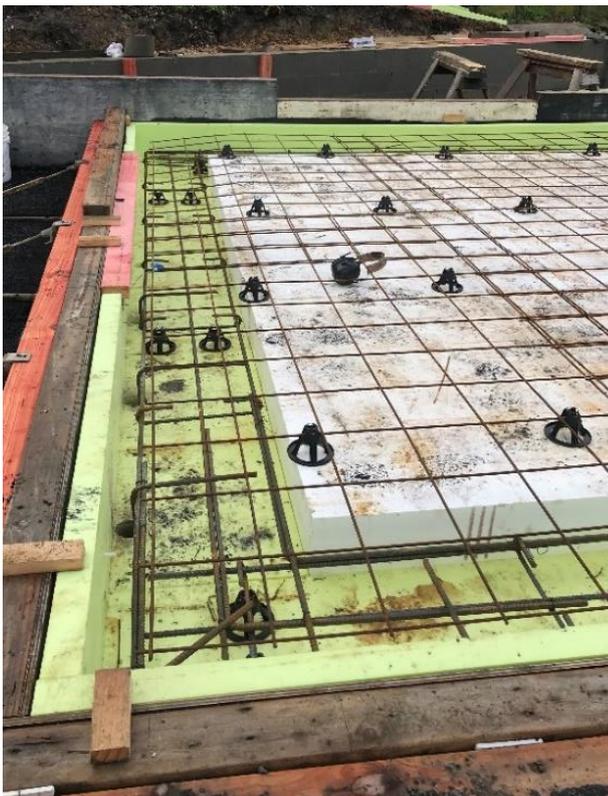
The reinforced concrete floor slab is 100mm thick and sits on 220mm of expanded polystyrene (EPS) insulation. The slab edges and structural thickenings are 260mm thick and insulated with 60mm thick extruded polystyrene (XPS) which also return up the side of the foundation. The XPS has a higher compressive strength compared to EPS and is required under load-bearing walls. The slab edges are protected from water and UV light with the use of an acrylic render system which is applied to the outside face of the insulation. The render is dressed down onto the damp proof membrane which is laid under the whole slab.

Photo : Concrete Slab Edge

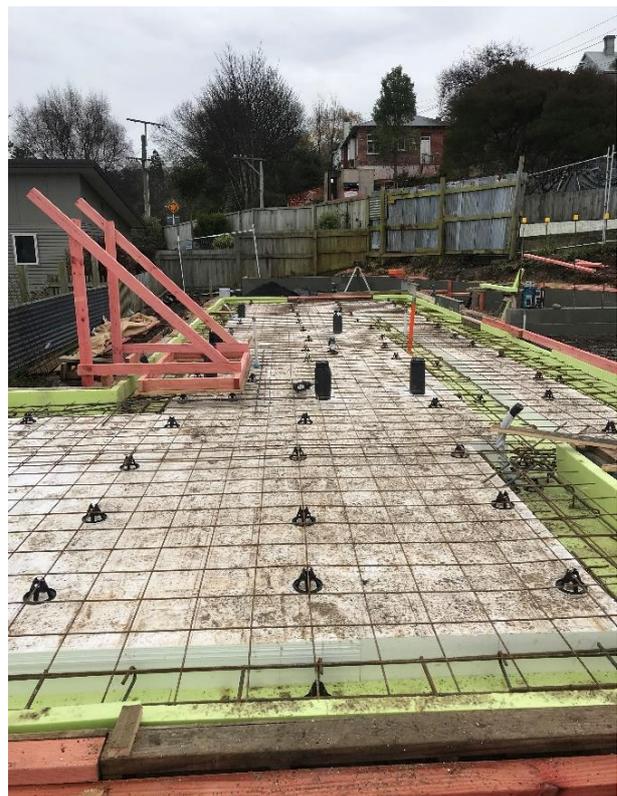
Photo : Concrete Slab Insulation

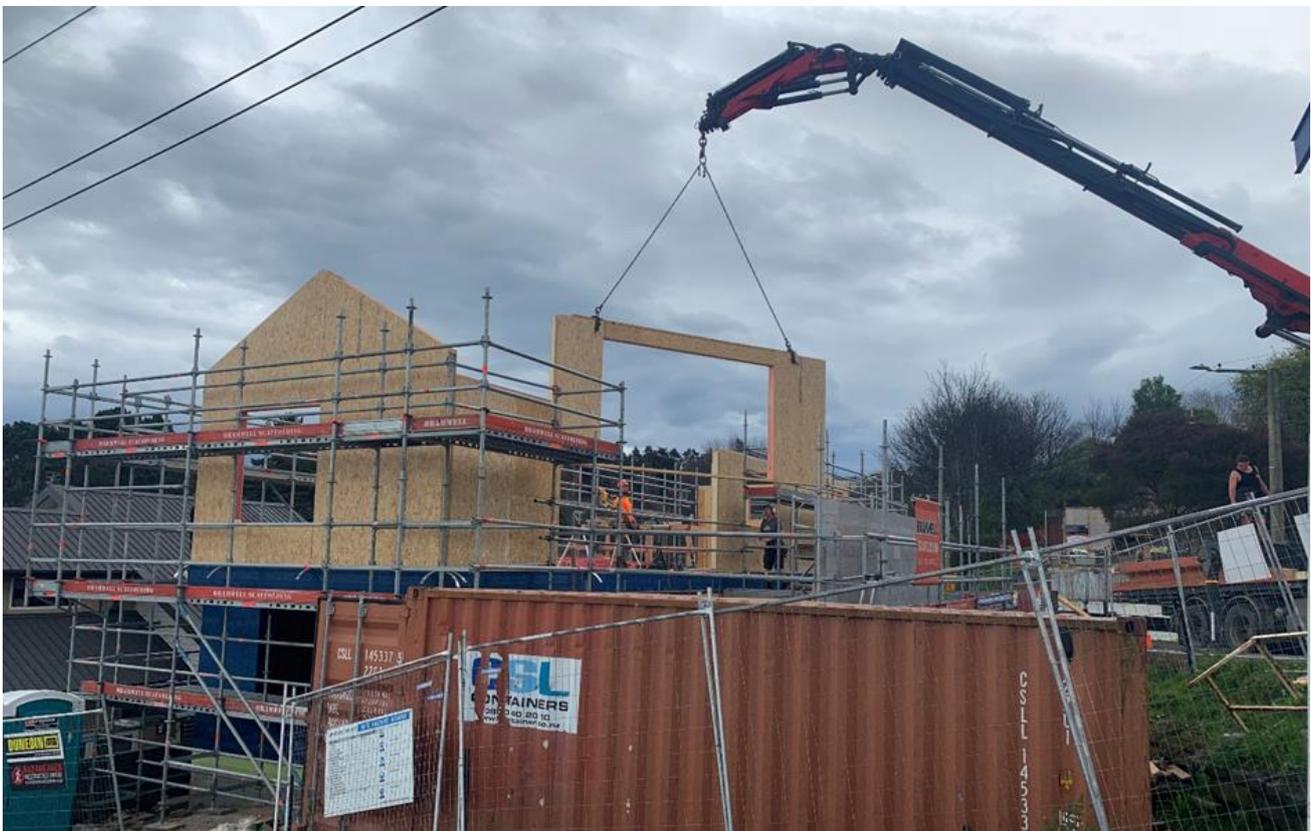
The exterior walls of the house are structural insulated panels or SIPs which are also lined with a polyisocyanurate (PIR) backed plasterboard. Kingspan Tek Panels were specified which compose of a 142mm PIR core with a thermal conductivity of $0.024[W/(mK)]$, sandwiched between two sheets of 15mm Oriented Strand Board (OSB).

The SIPs were pre-manufactured offsite and installed in a timely manner.

Photo: SIP panel installation

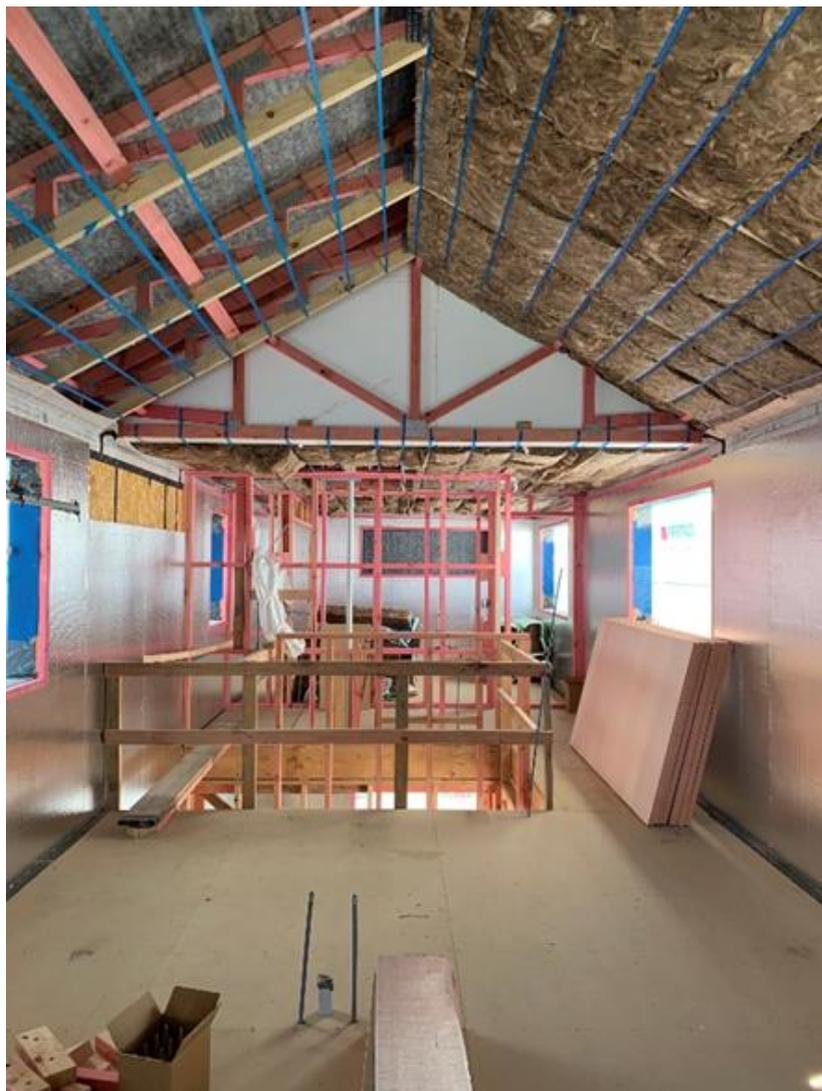
The roof was constructed using commonly available timber trusses. A heel height of 300mm was required for the parallel chord scissor trusses which conveniently provided sufficient depth for dense glass wool batt insulation. Insulation was also carefully fitted between the webs of the trusses to ensure there were no uninsulated gaps. Polypropylene strapping was fixed between the trusses to support the batts before the airtightness membrane was also applied to the underside of the trusses. This membrane was then taped to the inside face of the SIPs.

Photo: Roof insulation being installed

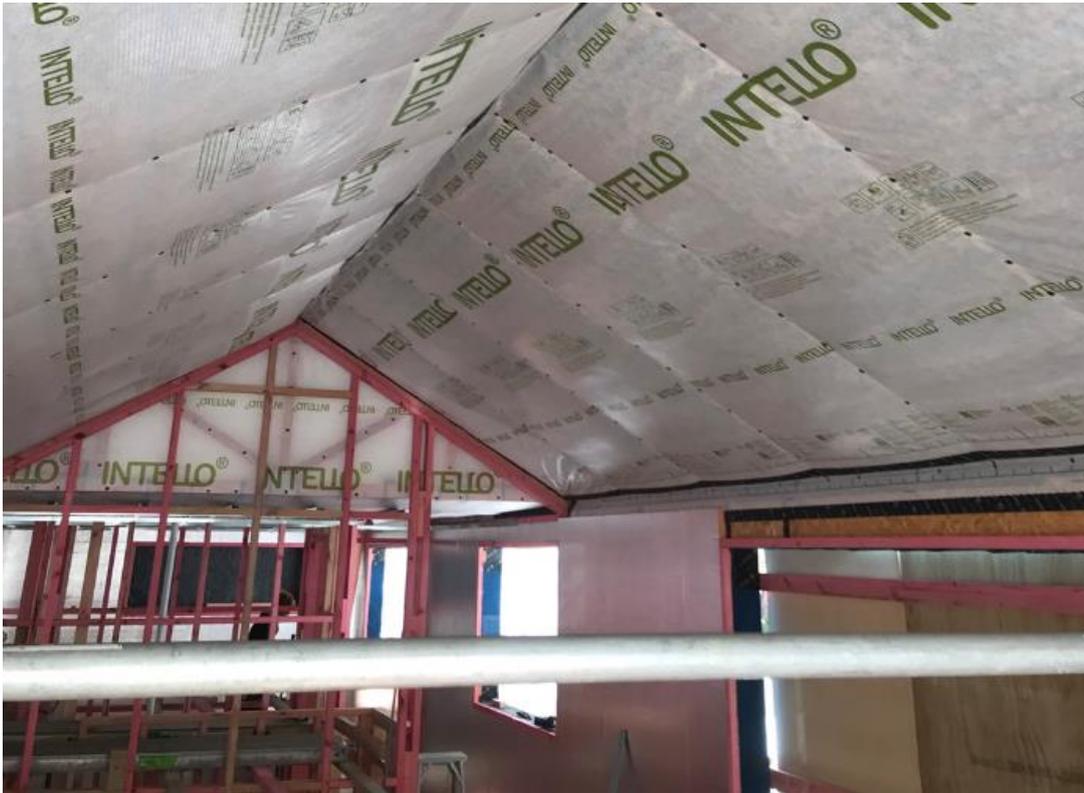
An airtight envelope was formed by connecting one section of the thermal envelop to the next. The concrete floor functions as the lower floor airtightness layer which, as discussed, is sealed to the SIPs, which are in turn sealed to the Proclima Intello fixed under the roof trusses. Sealing is generally achieved using Pro Clima Tescon Vana tape and Orcon sealing glue. The windows and doors are also a key part of the airtight envelop which are also taped to the OSB of the SIP walls.

Photo: Airtightness control layer

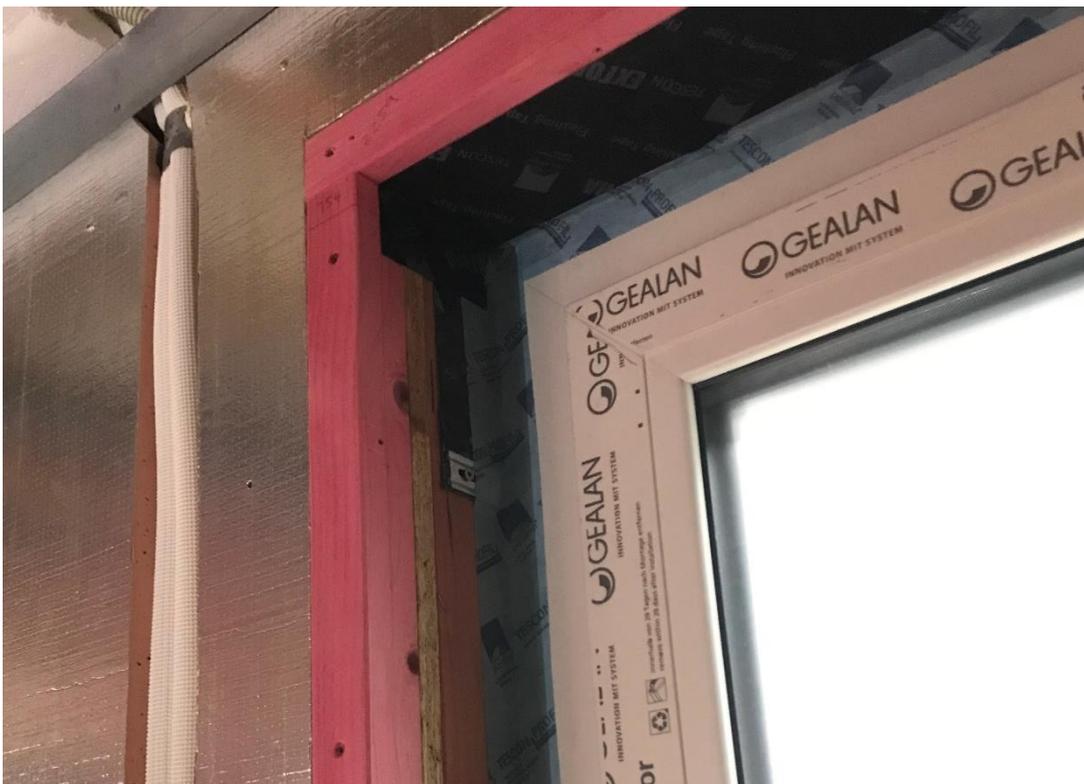
Photo: Air tightness tape to windows

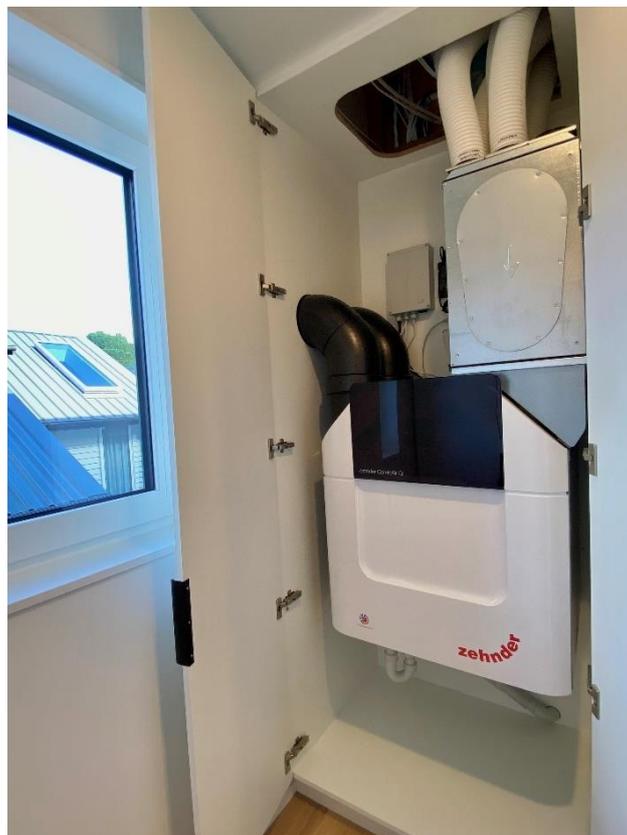
The location of the ventilation unit was also planned at a very early stage in the design process. The intention was to locate the unit in an accessible, central location and to reduce the length of duct runs and make changing the filters easy. It was also located to have good access to the outside air to reduce the length of the intake and exhaust pipes, thus reducing thermal bridging.

The system specified was a Zehnder Comfoair Q350. This system has an effective heat recovery of 88% and an electrical efficiency of 0.24 Wh/m³. The unit was located in the laundry as this location which best fulfilled the above requirements. Boost switches were installed in the bathrooms and kitchen and cables run back to the main unit. This allows occupants to boost the system during showers and while cooking. The system can also be control via a smart phone app.

Photo: Ventilation unit within laundry cupboard

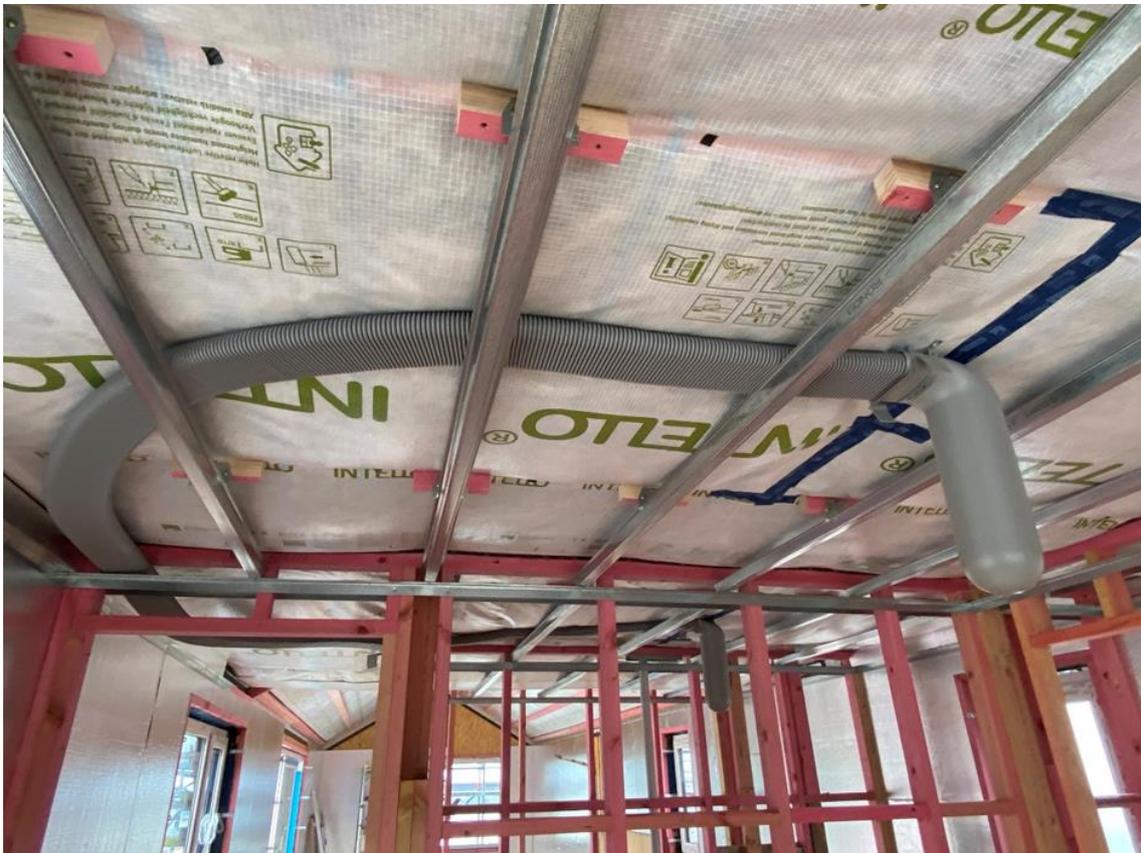
The strategy for the distribution of the ventilation ducting was established early in the design process. The layout is a "spider" design, meaning that each compartment is serviced by a separate, duct that returns to the main ventilation unit. The layout relies on the mid-floor and ceiling zones to run supply and exhaust ducts.

Smaller timber midfloor joists were specified above the hallway to allow for the ducting runs to the ground floor rooms. A dummy wall on the upper floor, directly above the ventilation unit, acts as a shaft to the upper floor ceilings. Timber blocking was installed between the airtightness barrier and trusses to create a services cavity. One floor mounted supply duct was also provided in the Living area which was run through the midfloor.

The ducts used were a combination of Zehnder ComfoTube (flexible 90mm round pipe) and Flat 51 (51mm oval, flexible flat pipe). Zehnder valves and other components were also installed.

Photo: Ventilation ducting installation

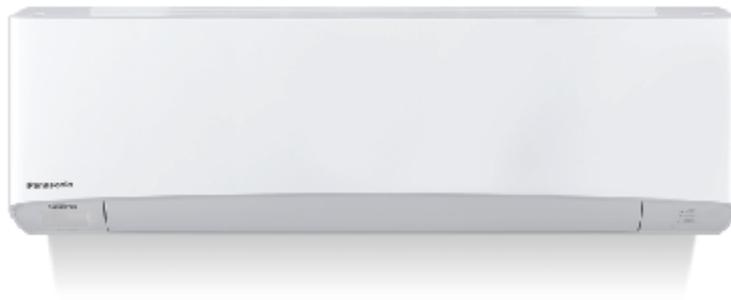
Heating and cooling for the house are supplied via a small Panasonic, split system, 2.0kW, air to air heat pump. This system can provide a maximum of 2.0kW cooling and 2.7kw heating. The selected model was a high wall unit mounted in the living area. The outdoor unit is located on the southern side of the dwelling, out of sight.

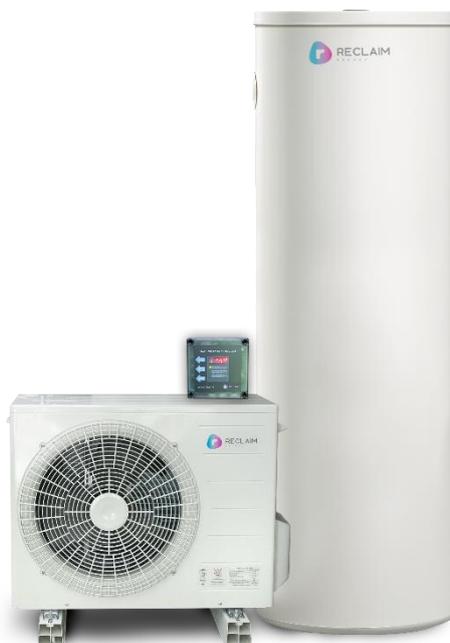
Hot water heating is supplied with a Reclaim Energy CO2 to hot water heat pump, split system. A tall stainless steel hot water tank with insulated hot and cold water pipes is located inside the laundry room while the outdoor unit is also located on the south side of the dwelling.

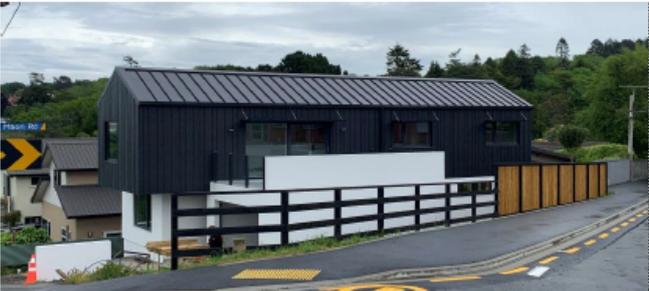
Passive House Verification

Specific building characteristics with reference to the treated floor area				Alternative criteria		Fullfilled? ²
				Criteria	criteria	
Space heating	Treated floor area m²	113.4				
	Heating demand kWh/(m²a)	16.39	≤	15	-	yes
	Heating load W/m²	10.20	≤	-	10	yes
Space cooling	Cooling & dehum. demand kWh/(m²a)	-	≤	-	-	-
	Cooling load W/m²	-	≤	-	-	-
	Frequency of overheating (> 25 °C) %	2.06	≤	10		yes
	Frequency of excessively high humidity (> 12 g/kg) %	0.13	≤	20		yes
Airtightness	Pressurization test result n ₅₀ 1/h	0.42	≤	0.6		yes
Non-renewable Primary Energy (PE)	PE demand kWh/(m²a)	101.60	≤	-		-
	PER demand kWh/(m²a)	44.56	≤	60	60	yes
Primary Energy Renewable (PER)	Generation of renewable energy (in relation to projected building footprint area)	0.00	≥	-	-	yes
