Template project documentation

Detached house Enerphit, Sheffield England

Enerphit - Sheffield

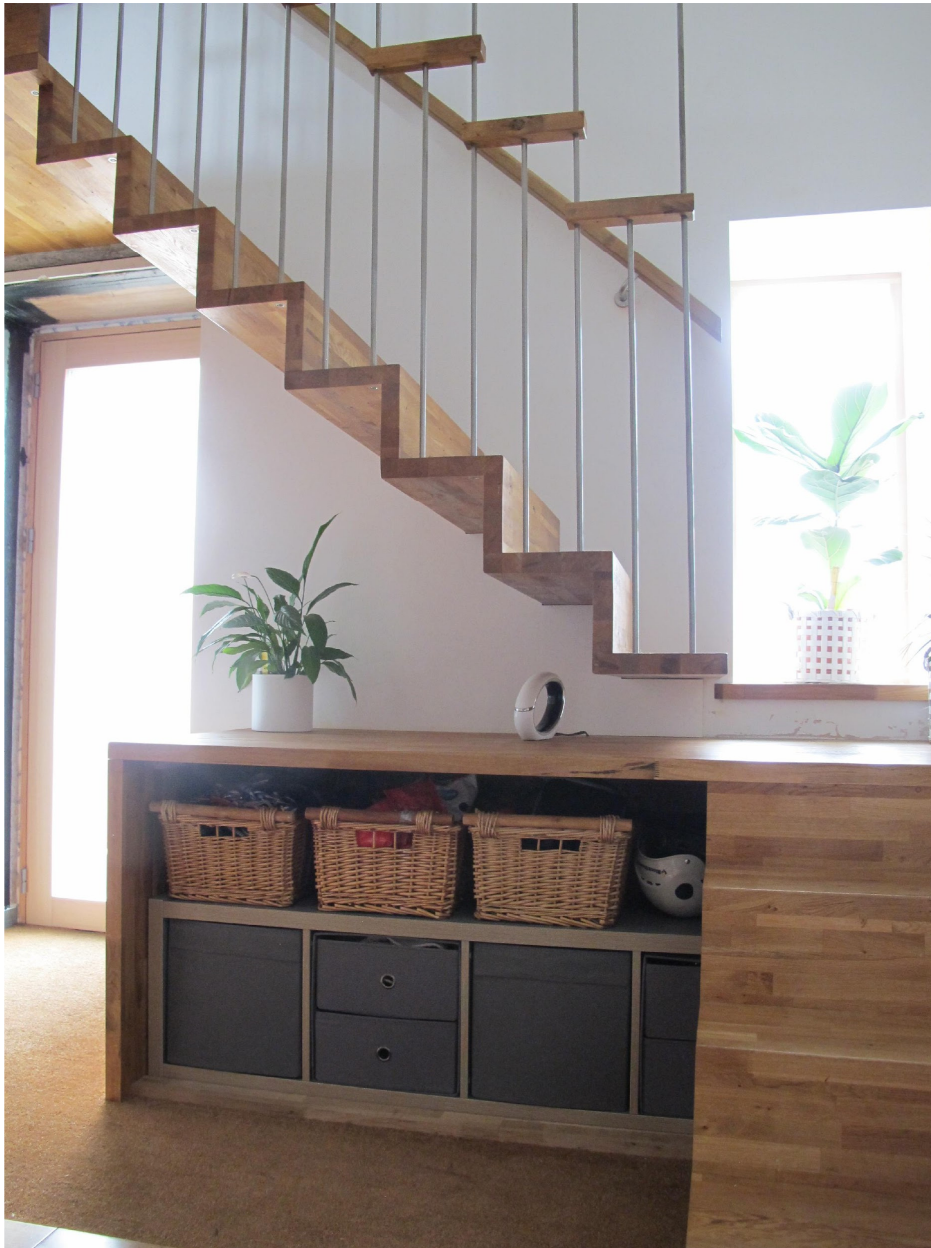
Hallway - the internal masonry walls form cold bridges, so the stair wall support was replaced with a hanging detail, removing the cold bridge and opening up the hallway. Air tightness tapes and paint can be seen in the background around the front door frame and projecting boxings.

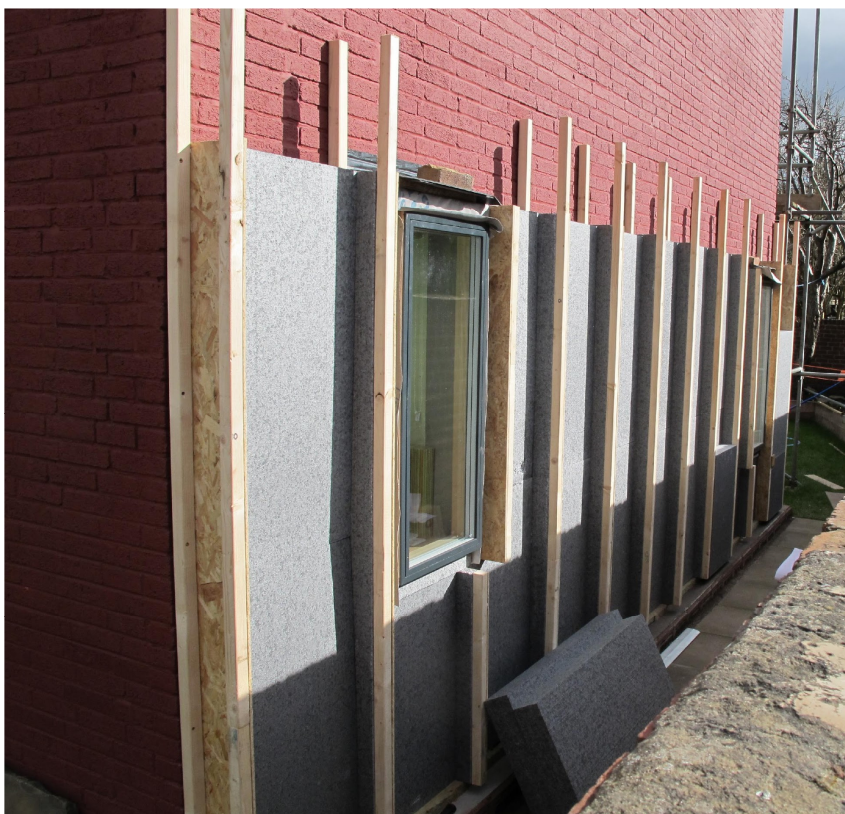
External insulation being installed

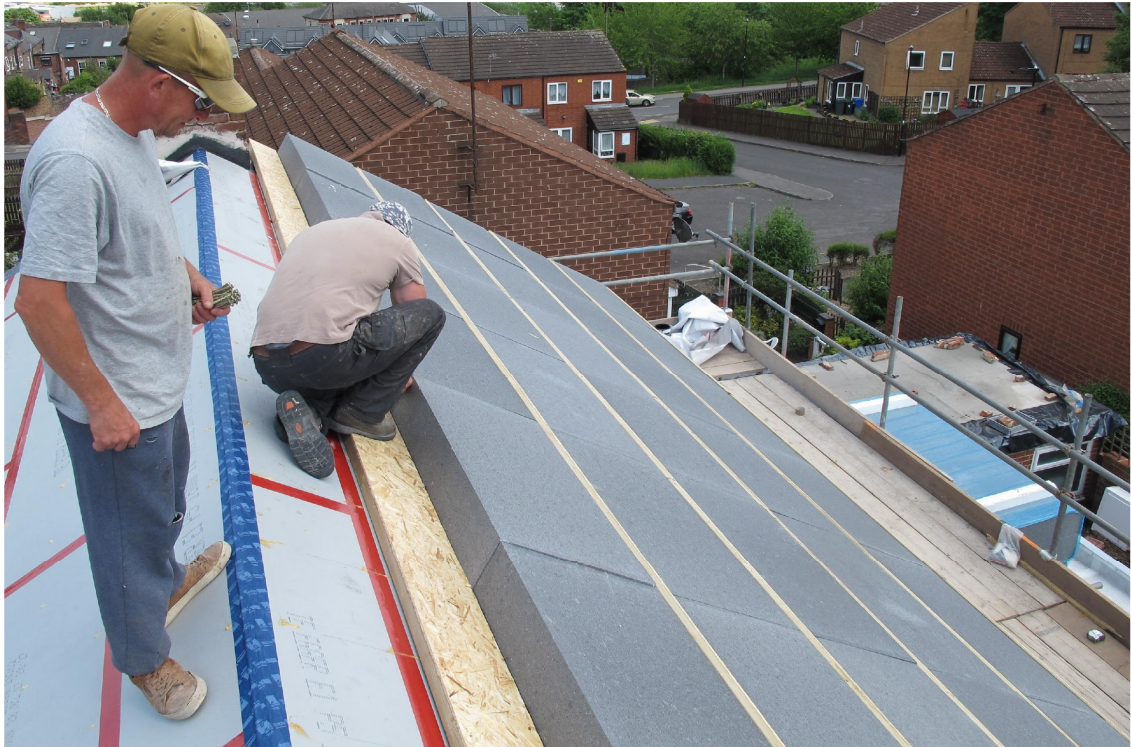
Air tight roof deck in place being over laid with 240mm EPS

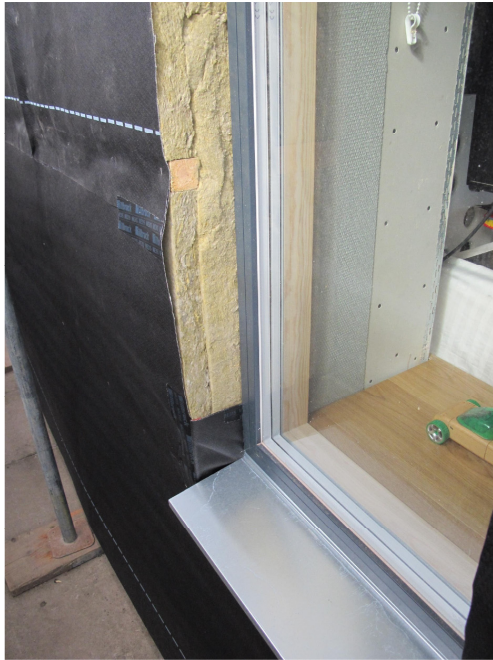
Weather proof membrane installed over mineral fibre insulation, returned into window reveals.

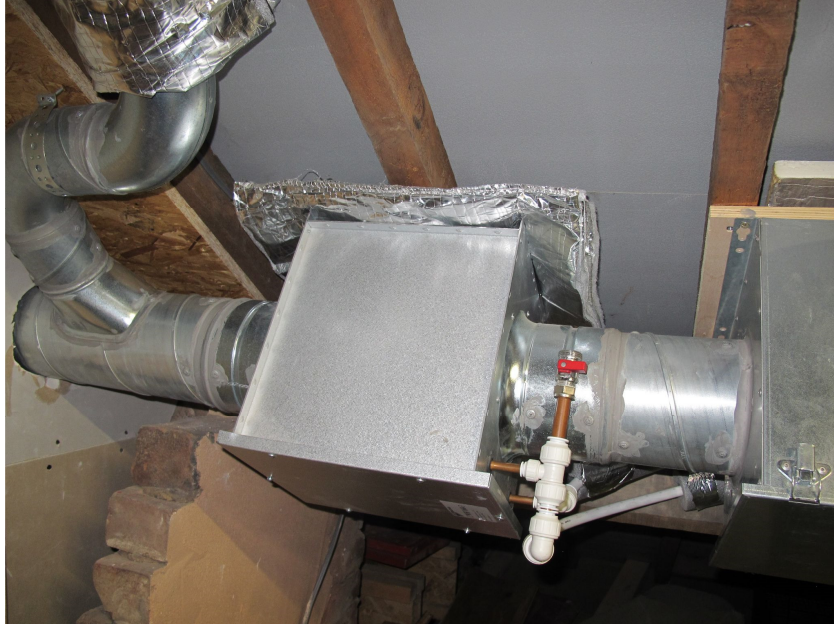
Duct heater fed from Condensing Combi Boiler

The house was originally fitted with a condensing combi boiler which was re-used to supply hot water and heating. Space heating is provided via towel radiators in bathrooms, one radiator in the hallway and the rest of the house is heated via a wet heater battery on the ventilation supply ductwork, positioned after the pollen filter.
