## Harpenden EnerPHit Plus

## Brief Description

1960s 4 bedroomed detached property of cross-wall construction in the Harpenden conservation area, which has been retrofitted to EnerPHit Plus standard. Home to 2 people and 2 cats.

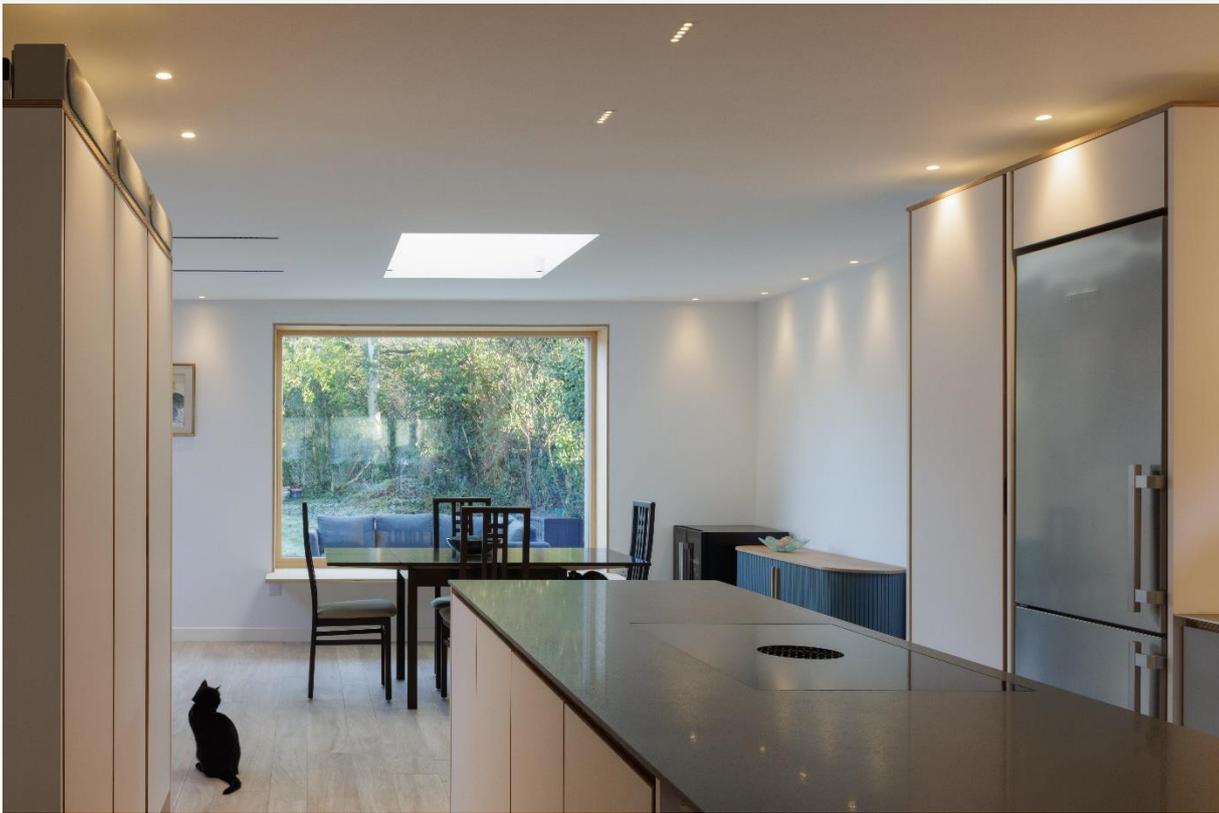
Interior view from the kitchen towards the dining area with the rooflights above to allow incoming air for the stack ventilation strategy

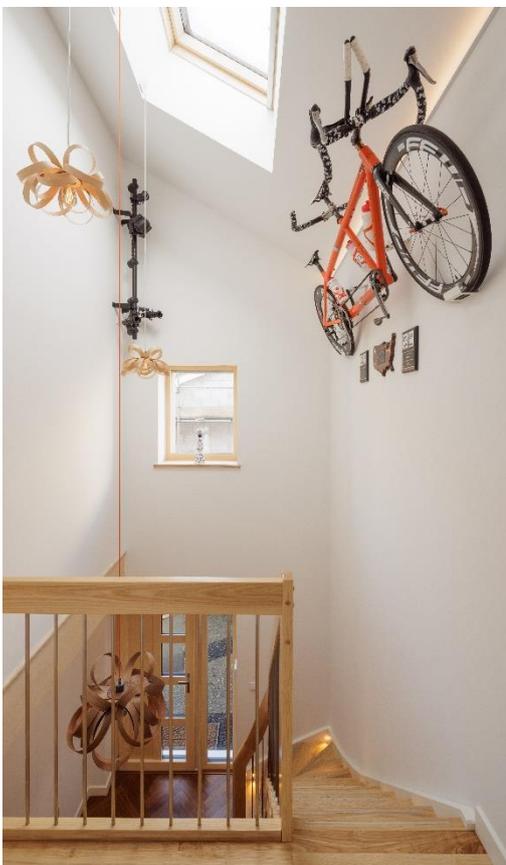
Interior view of vaulted stairwell with rooflight at the top to increase natural light in the centre of the property and allow the hot air to purge out of the building within the stack ventilation strategy

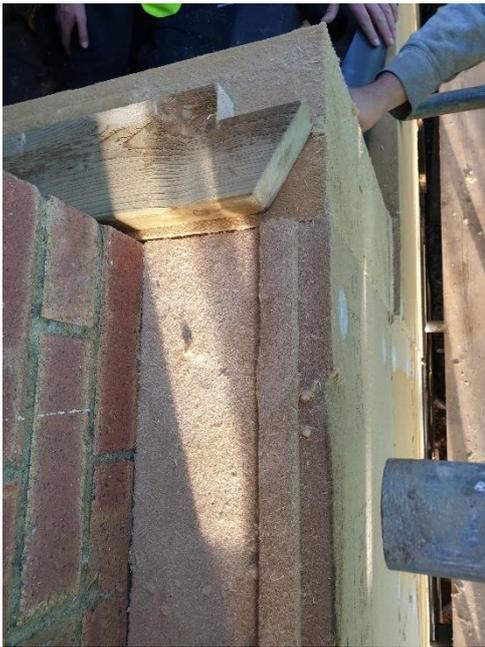
Existing cavity walls had the cavity wall insulation topped up with EPS beads and were externally insulated with Isolair woodfibre insulation above dpc. Below dpc they were insulated with 180mm XPS insulation down to the top of the foundation. The Isolair was finished with silicone render or battens, counter battens and timber cladding. Internally the walls were sheathed with Smartply OSB for airtightness, battened off to form a service void and finished with plasterboard and skim.

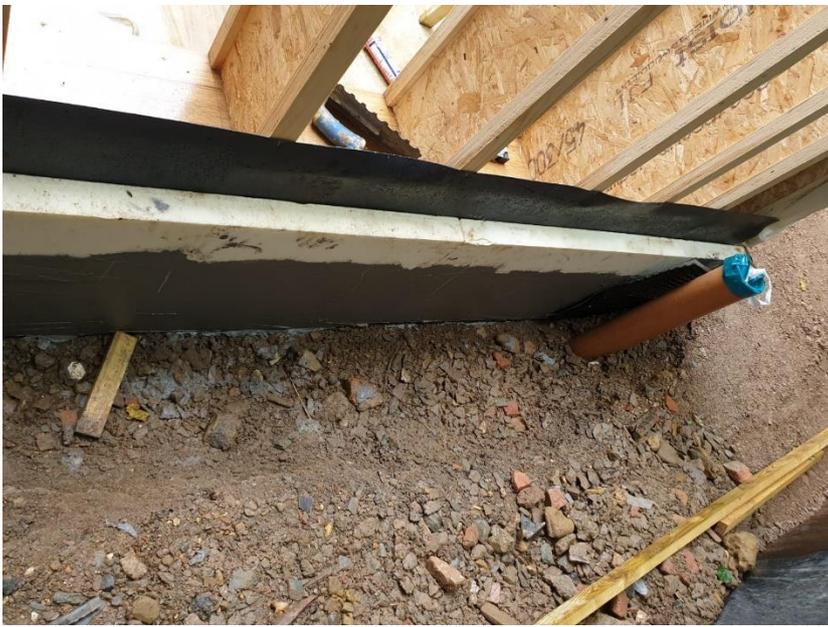
New curtain wall infill panels and walls to the rear extension were constructed from 300mm timber I-studs with Warmcel cellulose insulation in between. The walls were externally sheathed with Isolair and either rendered with silicone render or battened, counter battened and timber clad. Internally the walls were lined out with Smartply OSB for airtightness, battened off to form a service void and finished with plasterboard and skim.

Extension walls on insulated box beam with XPS insulation below dpc

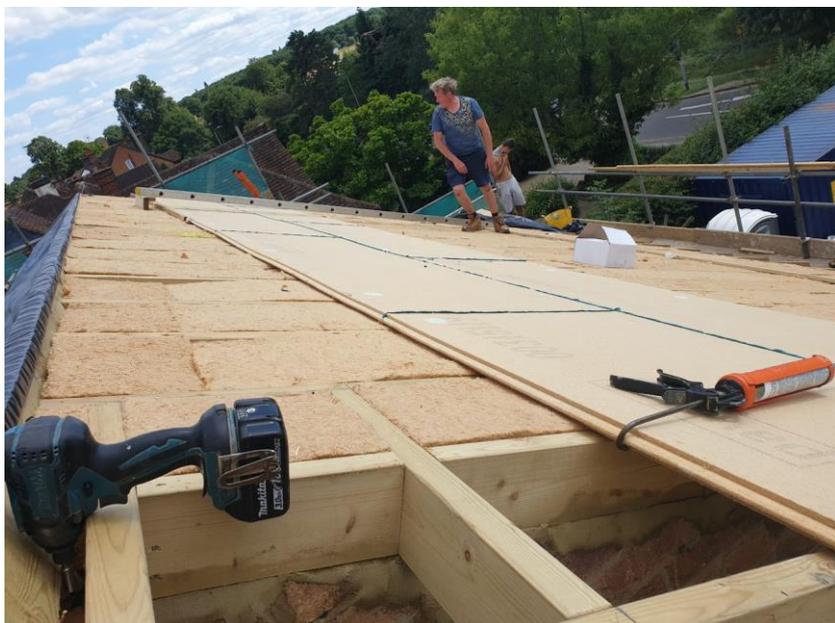
The rafters of the existing house were retained with additional timbers set out over the top to create enough depth for the 240mm Pavaflex insulation in between. Isoair was laid over the top and underneath was finished with Pavatherm Combi. Underneath this was a airtight membrane, battened off service void, plasterboard and skim. Airtight tape was carefully applied around existing trusses in the roof to ensure no air leakage occurred here.

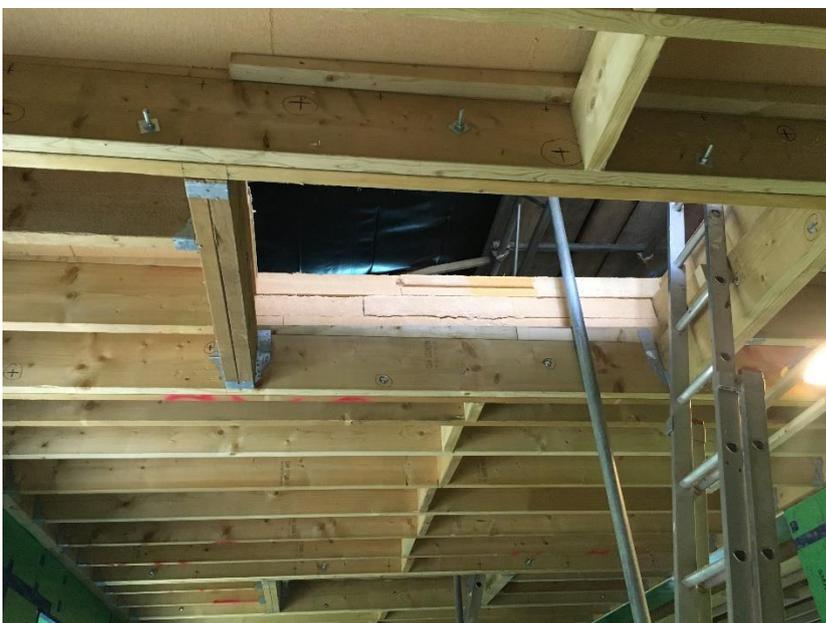
The new flat roof to the extension was a warm deck build up with 200mm Pavatherm laid over the structural deck on firrings with a further 100mm of Isolair laid over the top. A wbp ply deck was laid over this with an EPDM roof finish bonded to it. Below the roof structure was Smartply OSB to provide airtightness and a 125mm service void to accommodate the MVHR ducting. This was finished with plasterboard and skim.

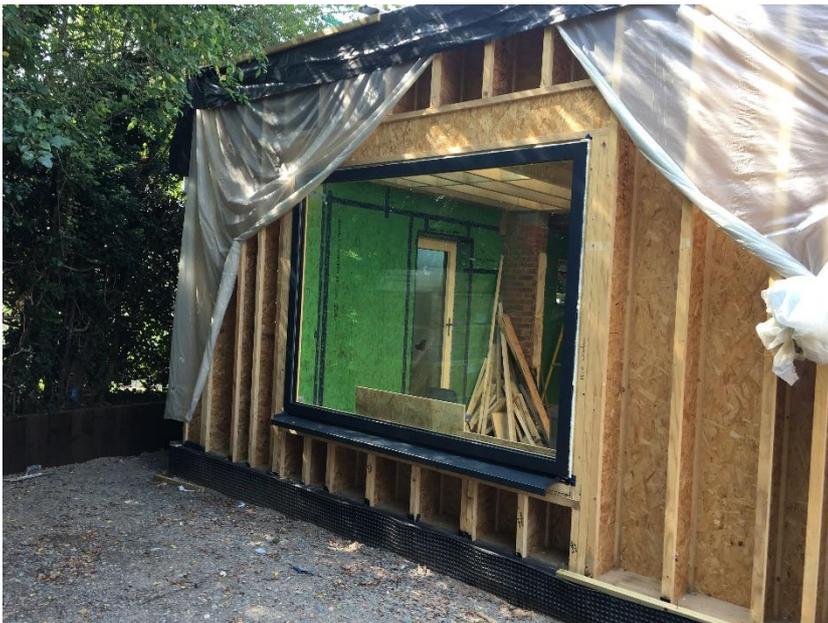
Triple glazed aluminium clad windows and glazed doors throughout with the front windows and master bedroom units having integrated blinds behind a further pane of glass externally. Fakro quadruple glazed rooflights used in both the pitched roof and flat roof extension.

We have two installation variations: existing brickwork openings and new timber framed openings.

Window installed in rear extension timber frame

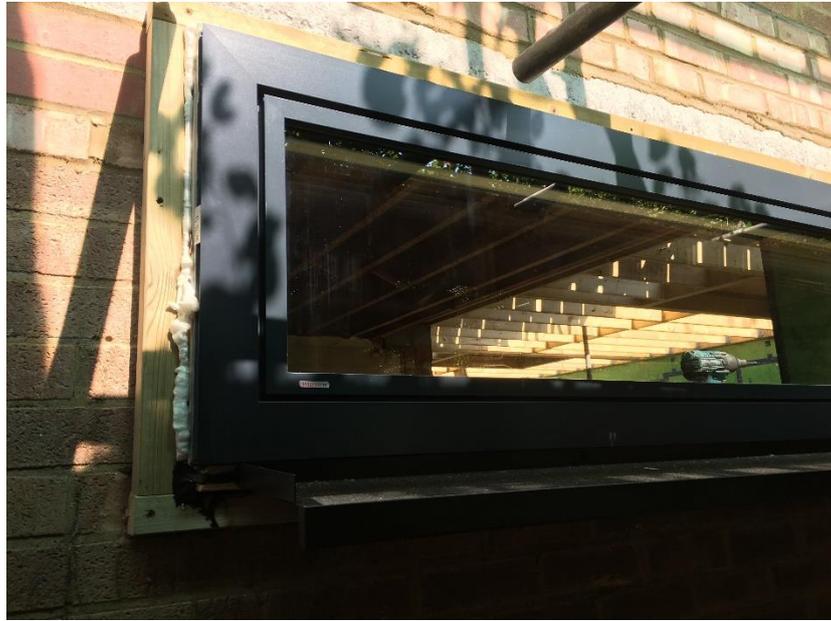
Window installed in existing brickwork wall

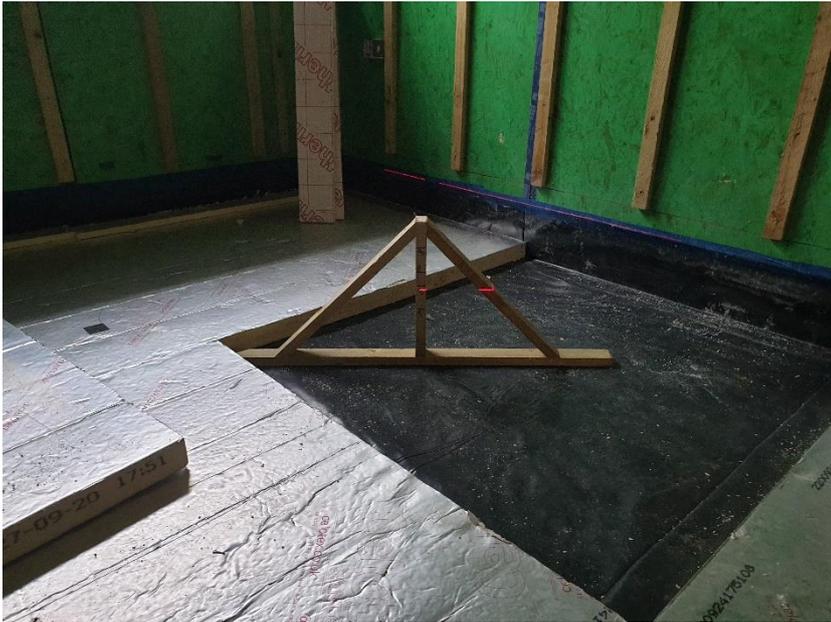
The floor has a dpm which is taped up into the Smartply OSB airtight layer of the walls and all service penetrations were made tight with proprietary grommets taped to cleaned and primed surfaces. The floor screed laid over the insulation adds further airtightness to the build-up.

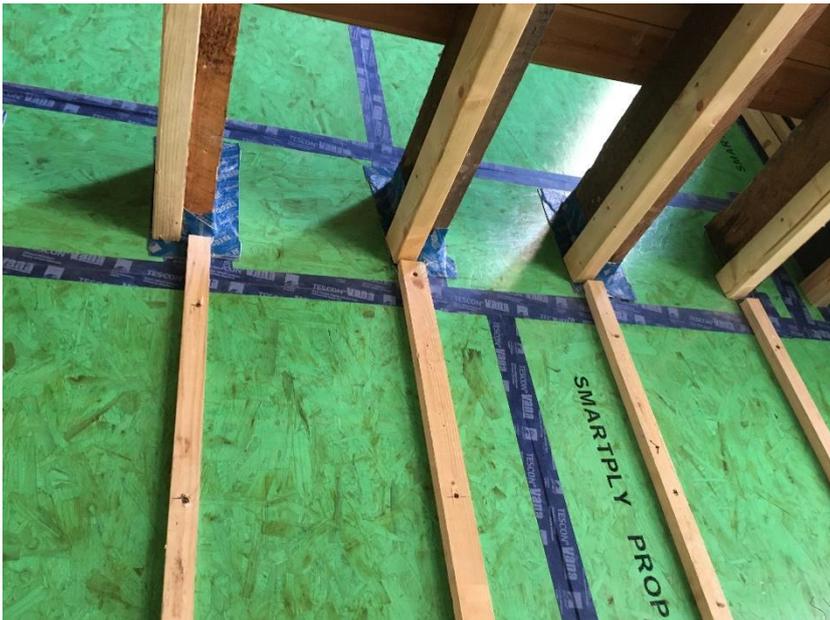
All external walls were lined with Smartply Propassiv which was taped into the airtight membrane in the floor and roof. Care was taken to tape around existing joists, some of which had to be doubled up for structural reasons. A service void was formed to ensure that plumbing and electrical services etc did not breach the airtight layer.

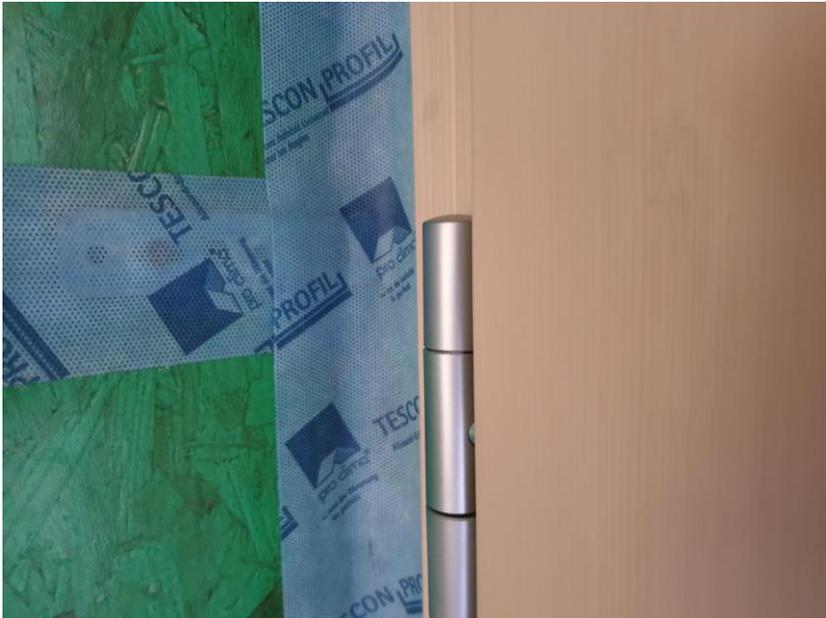
Windows and doors were installed within the insulation layer and carefully taped to the surround Smartply to retain good airtightness. Brackets were also carefully taped.

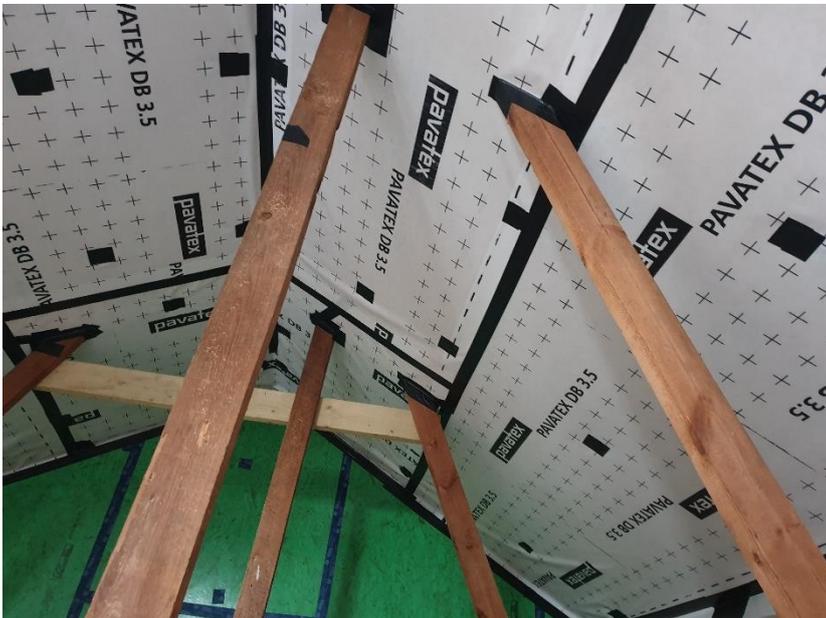
The roof is predominately airtight with a membrane in the loft area. In the vaulted hallway area Smartply was used for structural and practical reasons. The biggest challenge in the loft area was airtight taping around the existing truss structures.

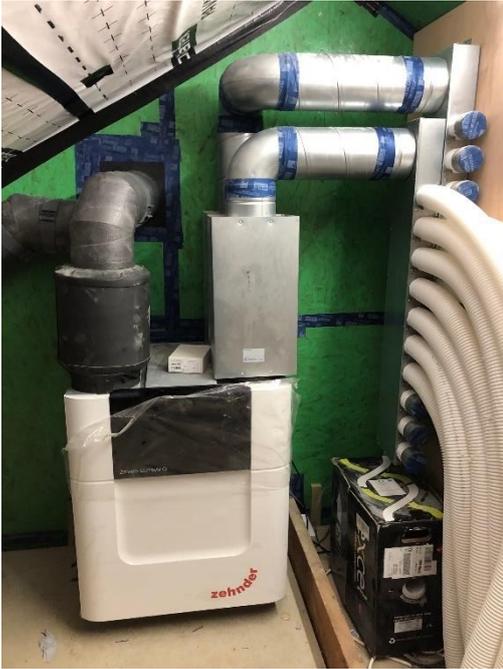
A Passivhaus certified Zehnder ComfoAir Q350 Enthalpy heat exchanger unit was selected to run the MVHR system.

It has an effective heat recovery efficiency of 86%, humidity recovery efficiency of 73% and electric efficiency of 0.22Wh/m<sup>3</sup>.

The unit is located in the loft space in order to make running ducts to the upstairs rooms easier as the existing solid timber joists were retained. Inlet and exhaust ducts were located high up on the northern gable wall.

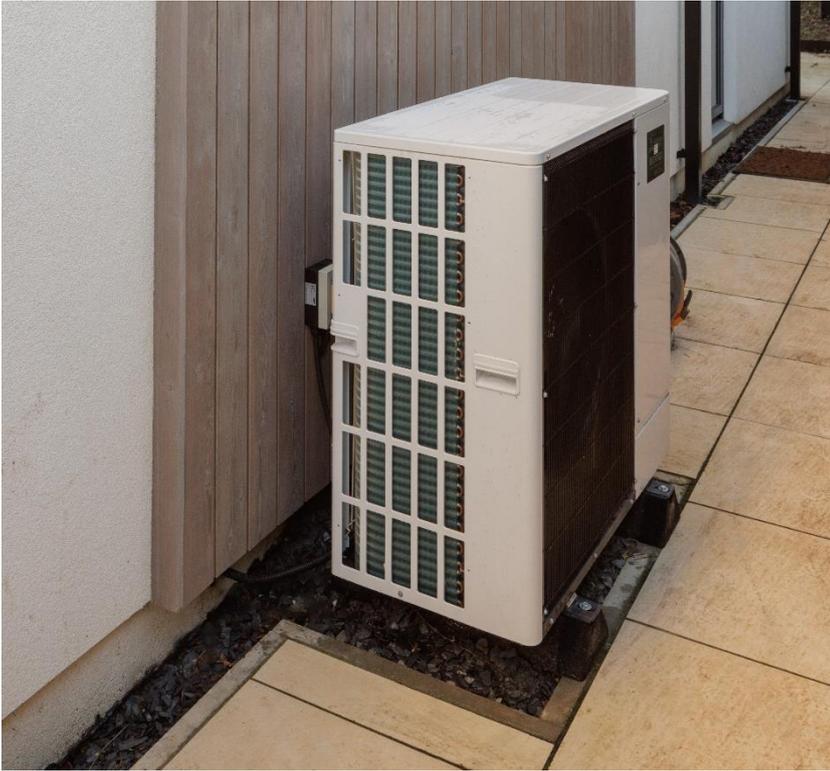
An air source heat pump (air-to-water) provides space heating and domestic hot water. The heating is provided by underfloor heating downstairs and dual fuel radiators in the bathrooms. Domestic hot water provision has been carefully designed to reduce system losses.

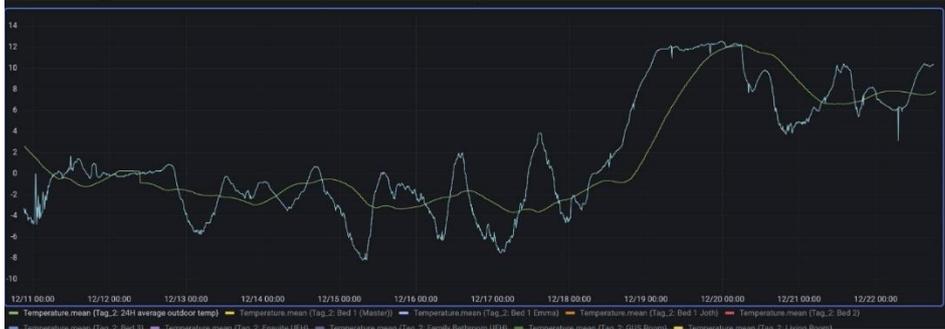
External temperature: -8 to 11°C fluctuation  
Green line = daily mean ext. temp.; blue line = ext. temp
