TEST REPORT

HINGE SCREWED TO WINDOW FRAME

TENSILE AND SHEAR STRENGTH

Hinge screwed to window frame

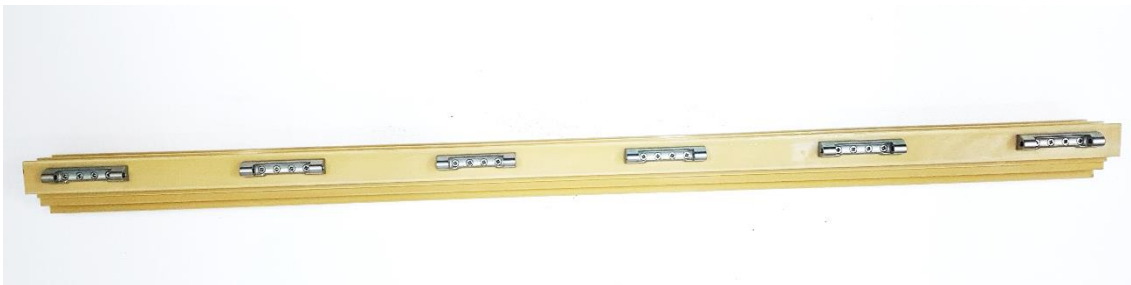
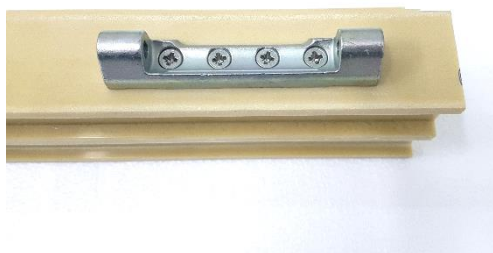
Detail of the sample supplied

The client supplies the laboratory with two samples of polyurethane window frames, each with six hinges screwed onto it. One sample is used in the tensile strength test, and the other in the shear strength test. The hinges are secured to the profile using four countersunk lag screws measuring 4 x 45 mm in diameter.

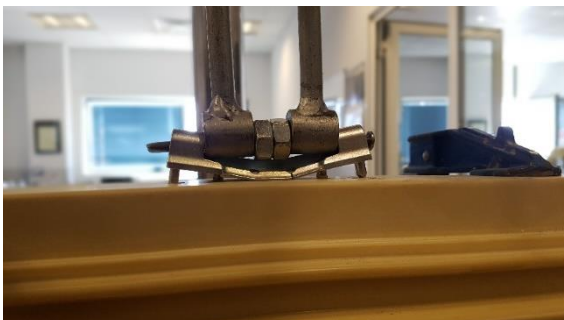
Pull-off tensile test

For the tensile test, the sample is fixed horizontally to the press and the pull-off load is applied by means of a pin inserted in the hinge.

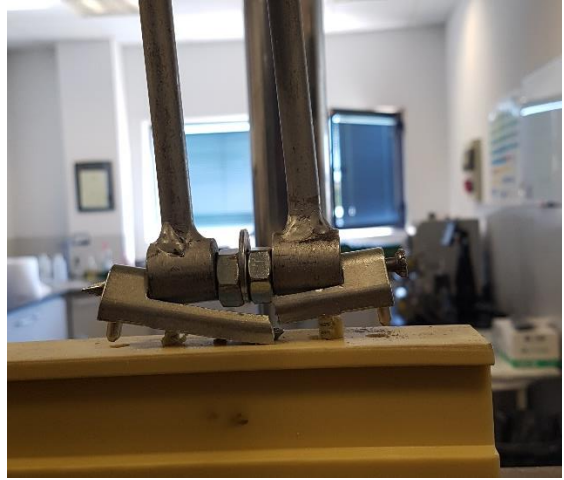
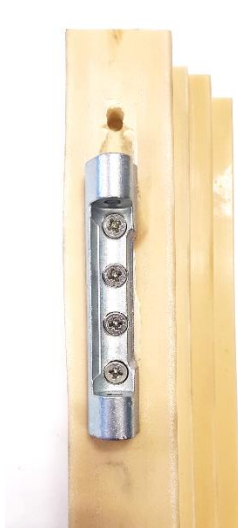
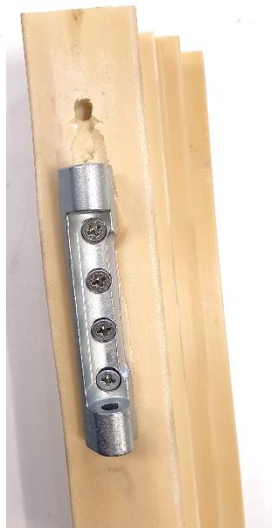
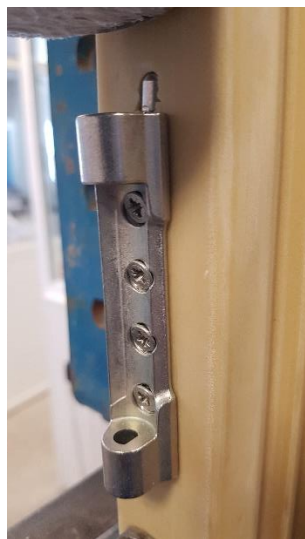
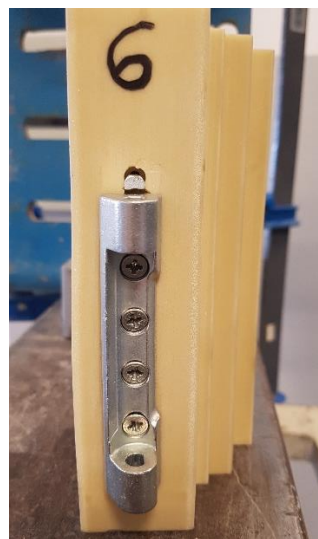
Shear test with tearing and breakage of the guide pin

For the shear strength test, the sample is fixed vertically to the press and a direct and constant load is applied to the hinge until it moves relative to the profile.

Observations: In samples 2, 3, 4, 5 and 6, the upper guide bolt of the hinge breaks.
