# **Project Documentation**

8 detached and 6 semi-detached homes in Hellesdon, Norwich, UK

# 1.1 Data of building – Plot 3 (detached 4 bed home)

# Carrowbreck Meadow, Hellesdon, Norwich, UK

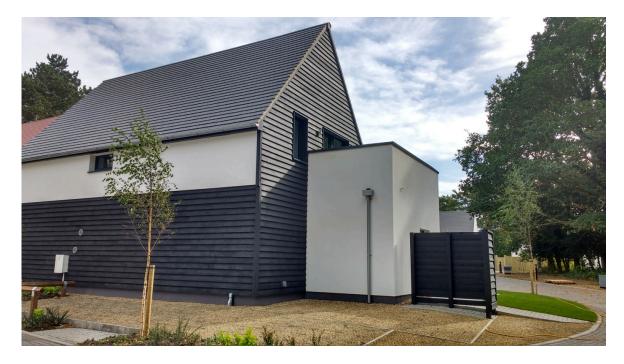
North – limited fenestration, the MVHR outlets and electric meter are visible (Photograph: Sarah Lewis)

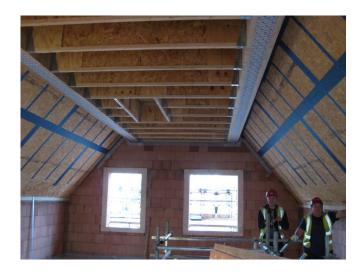
At roof level - The airtightness layer was installed as an OSB3 board, with taped joints. The contractor assigned a site based airtightness champion, who took on this role with great enthusiasm and dedication and played a key role, along with the site foreman, in the excellent air pressure tests on all of the homes. Special care was required to ensure a good connection from the OSB boards back to the clay block walls, ProClima airtightness products were used throughout. Photo of the taped OSB ceiling boards below.

At floor slab level – the airtightness was the ground slab, with tapes connecting this to the clay walls, which were then coated in the lime parge coat on the walls. Levelling latex was installed locally along the perimeter of the slab to protect the tapes. This was important as the new occupants arranged for the floor finishes to be installed, the latex prevented this tape becoming damaged before the floors were in place. All penetrations through the slab were sealed with airtightness grommets.

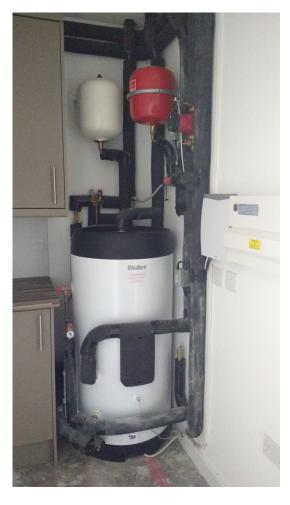
A traditional gas condensing boiler is used to supply heating and hot water (DHW). There is a hot water storage tank in the utility room adjacent to the boiler.

Installation Photo in the utility room
