PROJECT DOCUMENTATION

Detached single family dwelling in Radstock, UK

Deasil is a self-build house to the south of Bath; constructed, managed and now lived-in by the architect and his family. Sited in a conservation area in the former Somerset coal fields, it required pitched roof forms and a low building height, leading to a challenging form heat-loss factor.

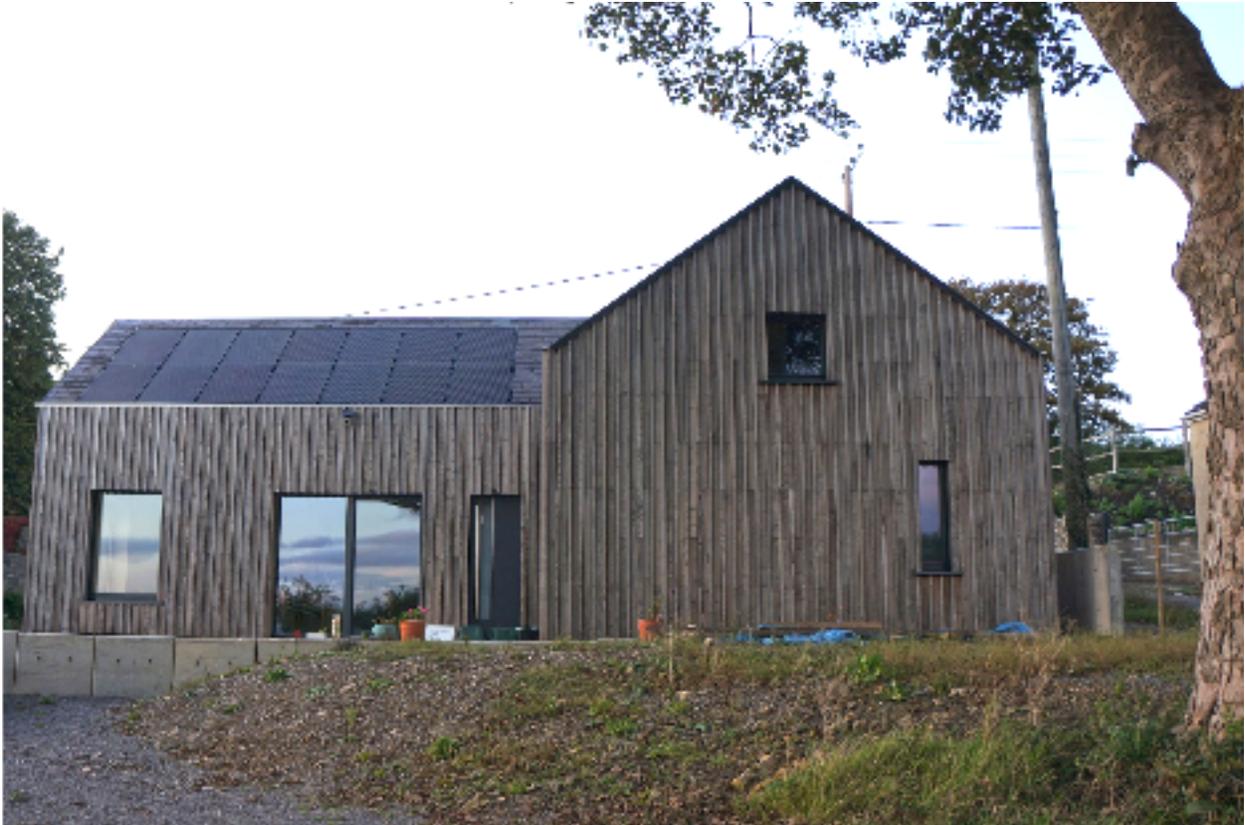
South. The main elevation of the house faces mature trees, with glazing sized for views and adequate daylight.

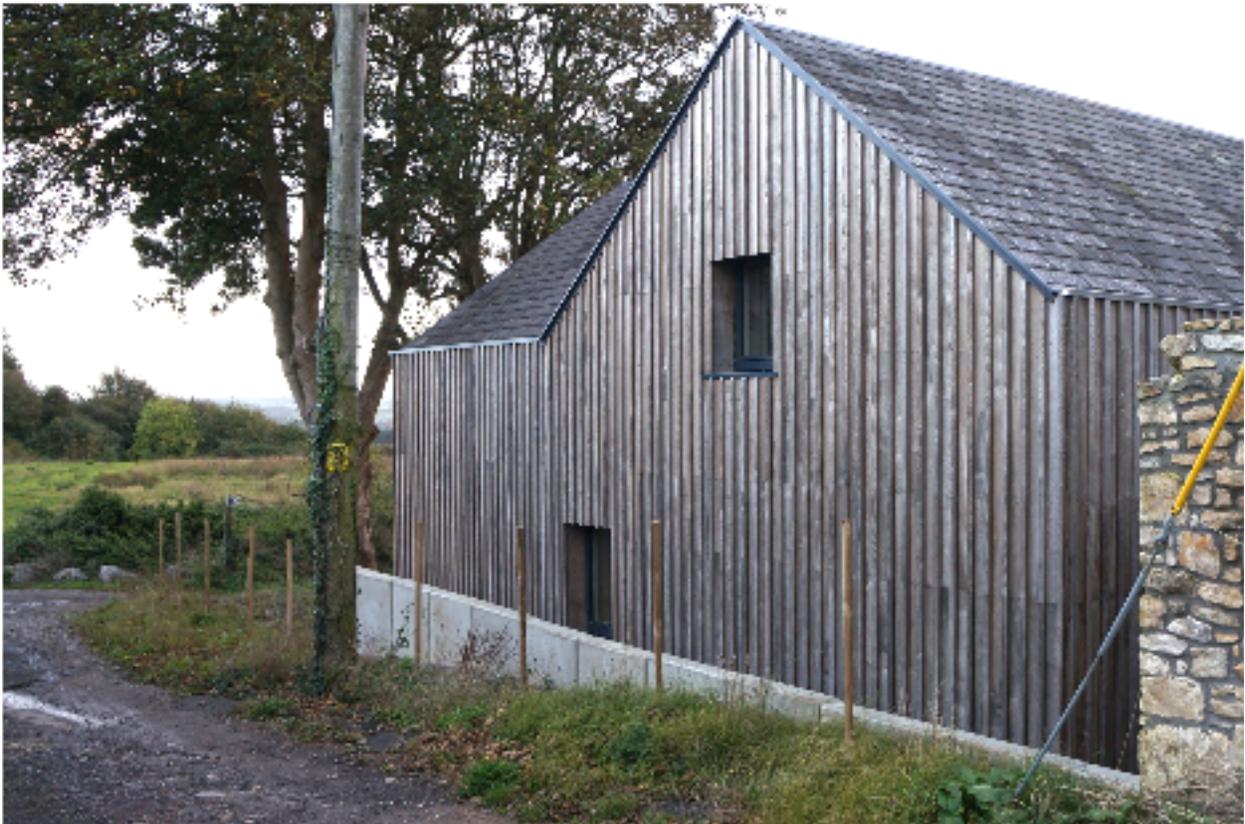
East. This elevation faces the road with windows into the mezzanine and 3rd bedroom.

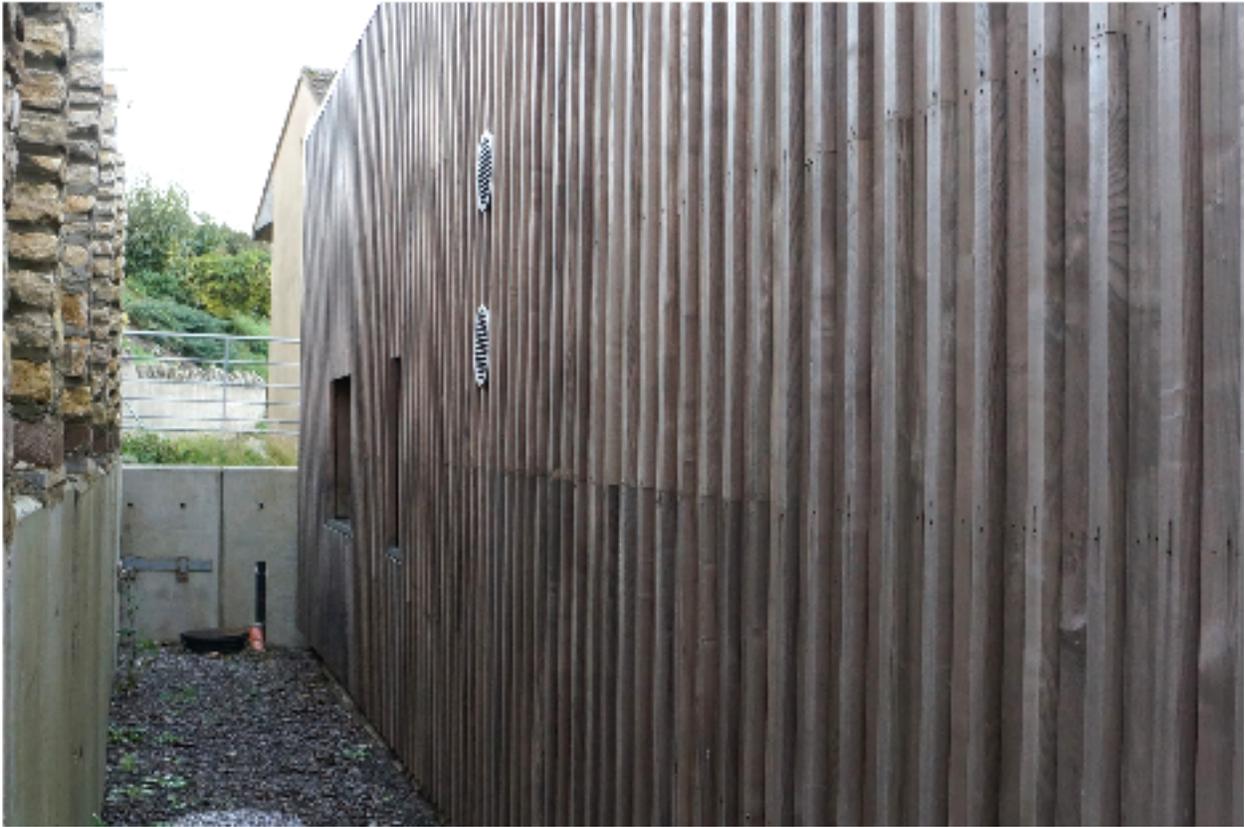
North. Rear elevation with minimal glazing. MVHR intake & exhaust terminals visible.

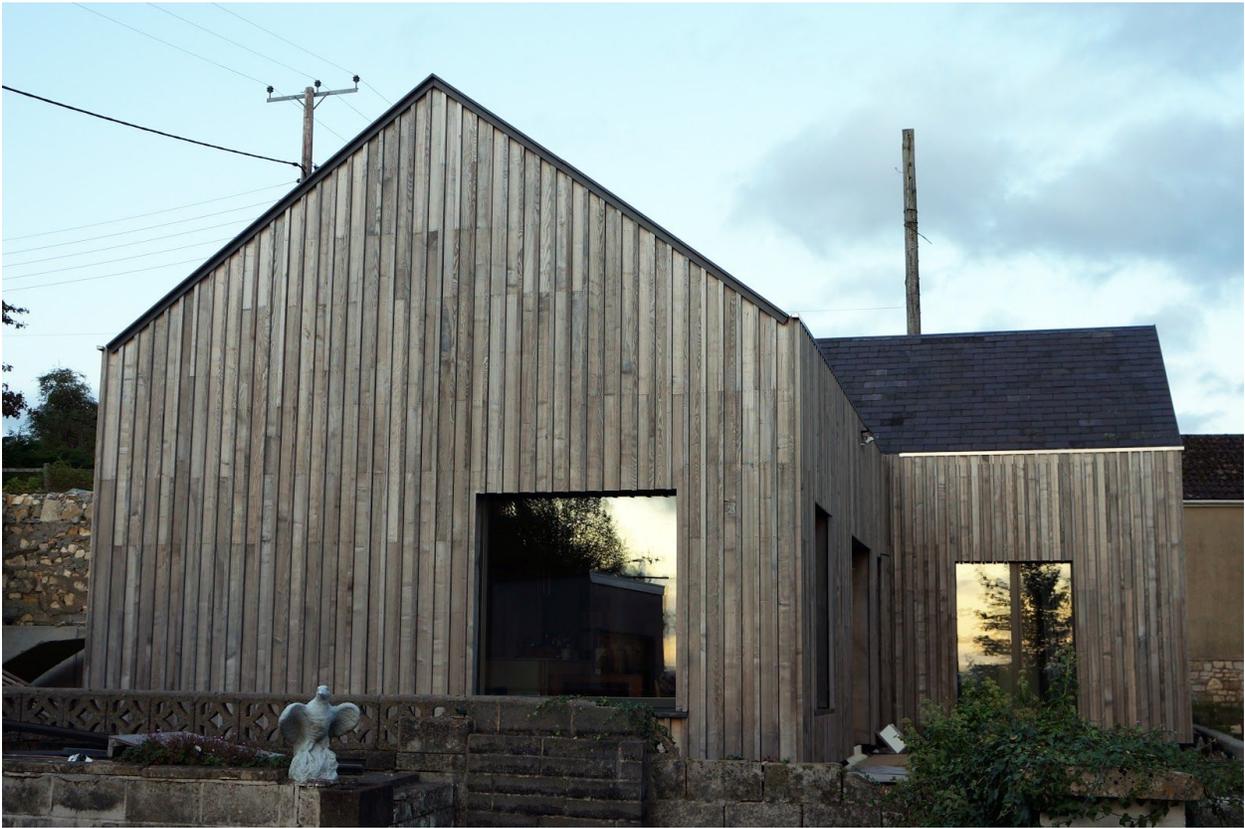
West. These elevations face open fields, with picture windows to the main bedroom and the living area.

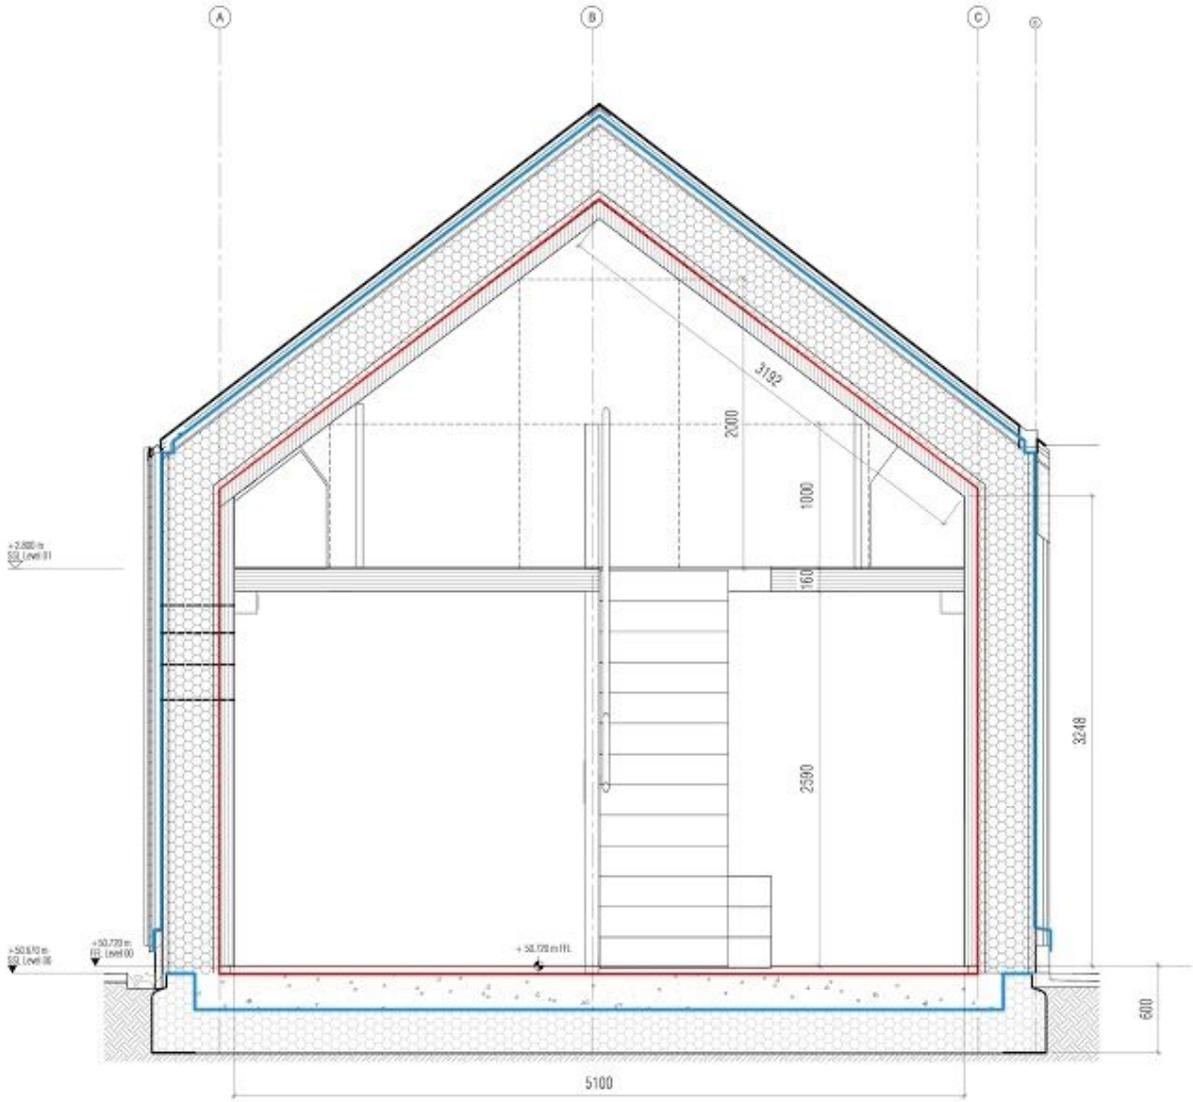
Typical Cross-Section. Indicating simple, continuous thermal envelope strategy. Blue line represents the weather barrier, the red line is airtightness. Dashed lines on the left (North) indicate penetrations for MVHR.

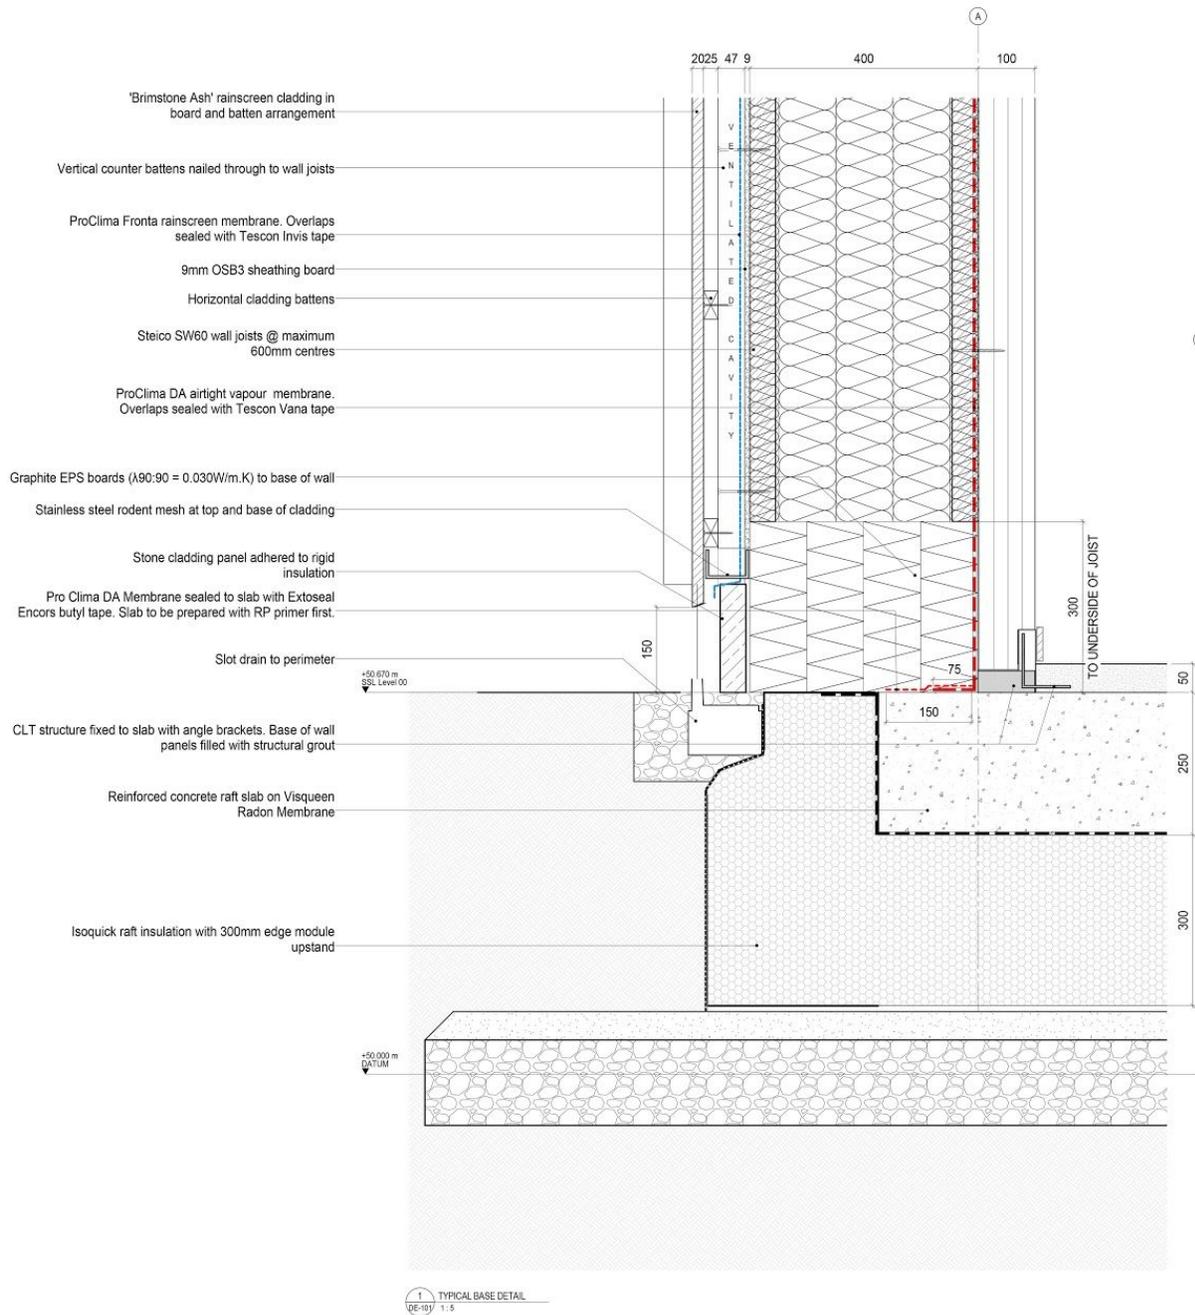
The Ground Floor slab is constructed from a raft of reinforced concrete on an Isoquick insulation/formwork system with upstands (0.033 λ W/(mK)). At thresholds, lengths of dense Compacfoam insulation (0.046 λ W/(mK)) were laid with stainless steel threaded bar cast into the slab edge to reduce thermal bridging and provide adequate compressive strength.

λ W/(mK)	mm
Solid Timber	0.160	25
Cement Screed	1.150	45
Concrete Slab	2.300	250
Insulation	0.033	300

0.105 W/m²K

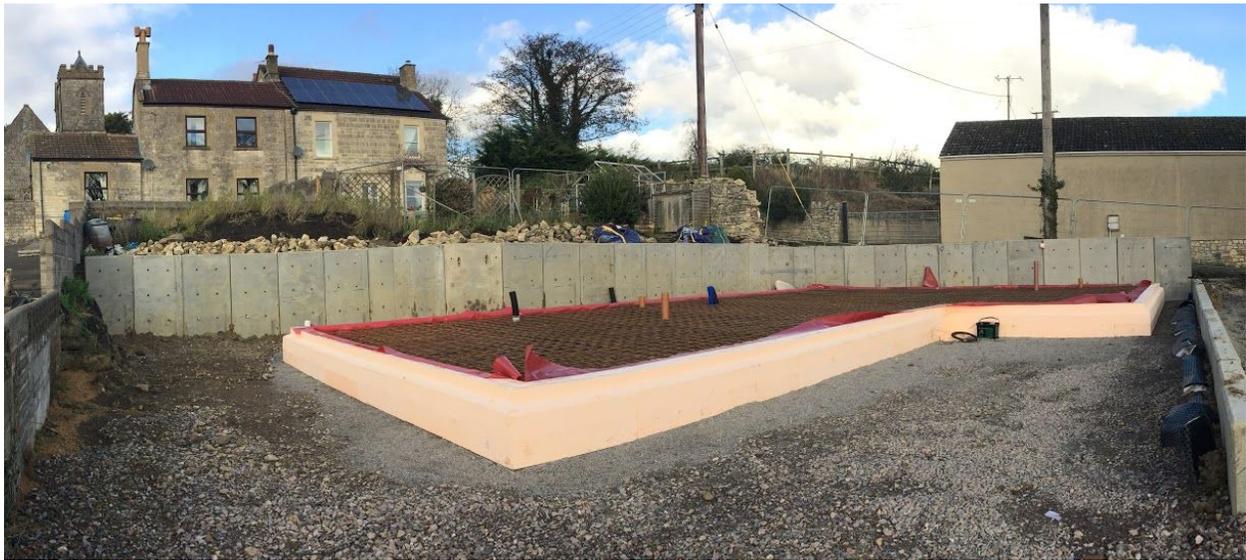
FLOOR DATA

U-VALUE

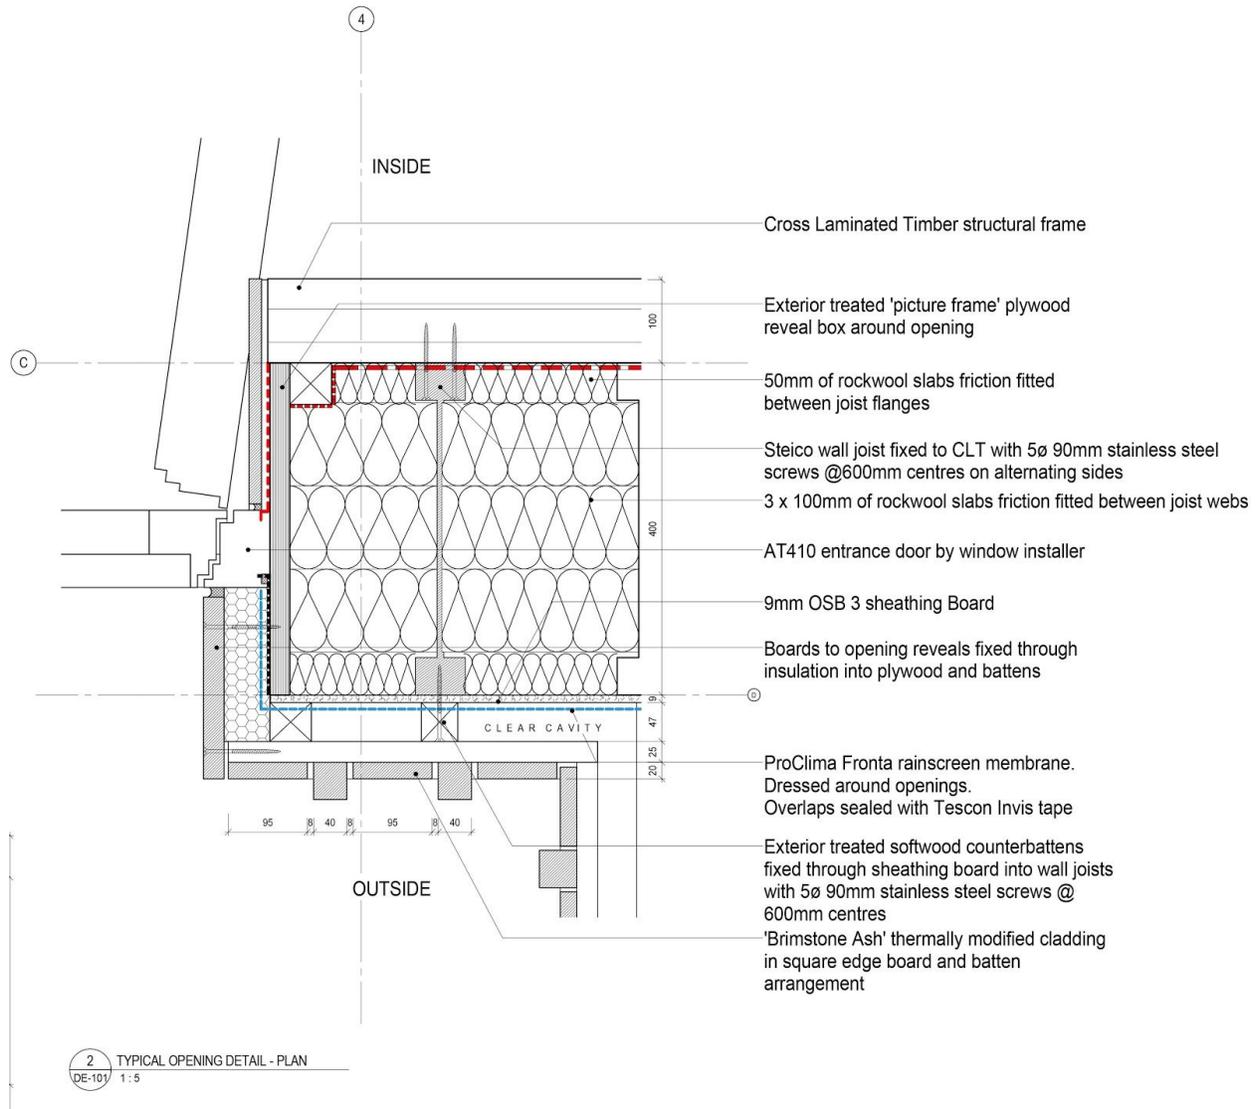
The external walls are constructed from a structural frame of Cross-Laminated Timber, fire-treated and exposed on the inside face and wrapped in ProClima DA airtight vapour check on the outside face. This is overlaid with mineral wool insulation slabs fitted between a 'Larsen Truss' system of engineered timber joists that support an outer sheathing board carrying the breather membrane.

The junction above indicates a typical opening (door/window) supported off a plywood box that cantilevers from the main frame (see section 5.4). The Larsen trusses above/below support these ply boxes and, aside from the openings and the trusses themselves, the insulation layer is continuous both around all corners of the building in plan and up and over the roof.

A sub-grid of battens and counterbattens carries the ventilated timber rainscreen. The mineral wool and trusses stop around 300mm above the external ground level and the remaining insulation is graphite EPS slabs to form a continuous thermal line from the isoquick upstands around the slab.

λ W/(mK)	mm
CLT	0.130	100
Vapour Barrier	0.500	0
Rockwool (with timber fraction)	0.034	400
OSB	0.130	12

0.084 W/m²K

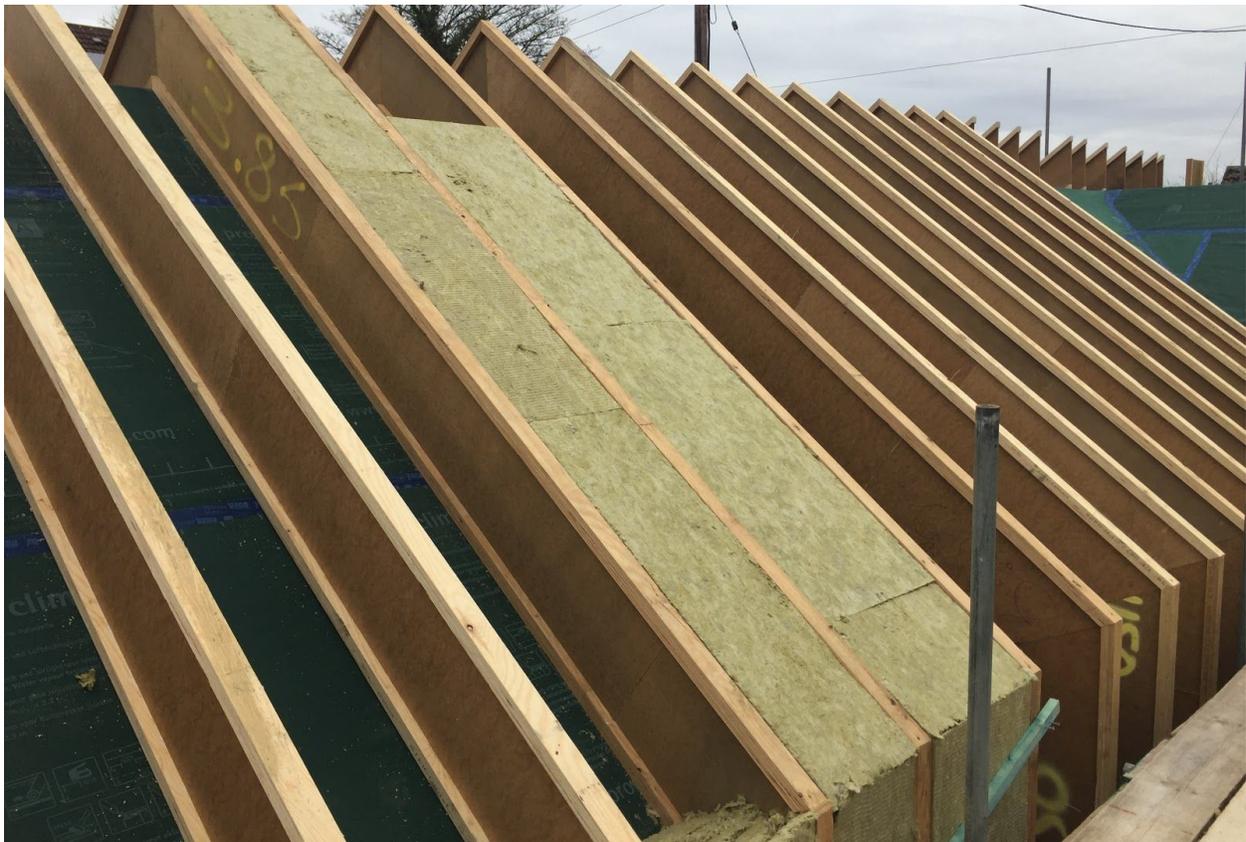
Construction photo showing the 'Larsen Trusses' with mineral wool infill.

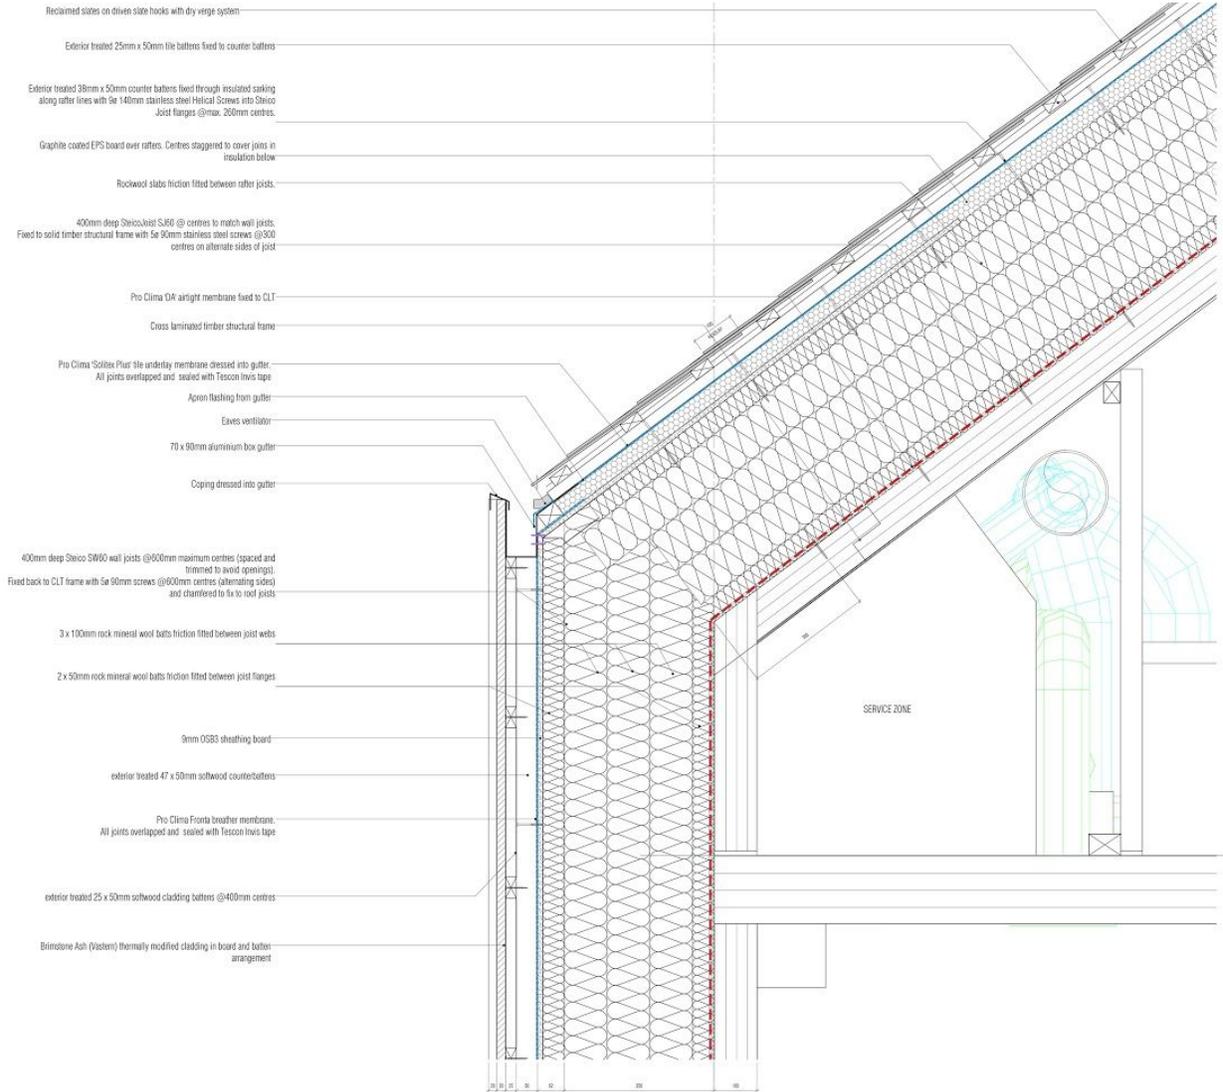
EAVES DETAIL

Like the external walls, the roof is constructed from a structural frame of Cross-Laminated Timber. The 'Larsen Trusses' wrap up and over the ridge and the mineral wool fill continues in the same arrangement. Where the construction differs is an outer layer of 50mm graphite EPS slabs laid over the sheathing board to provide extra insulation, with the roof battens fastened using helical screws into the outer chord of the engineered joists. Ventilated slates and a roofing membrane complete the enclosure.

λ W/(mK)	mm
CLT	0.130	100
Mineral wool insulation (with timber fraction)	0.034	400
Platinum EPS sarking	0.032	50

0.076 W/(m²K)

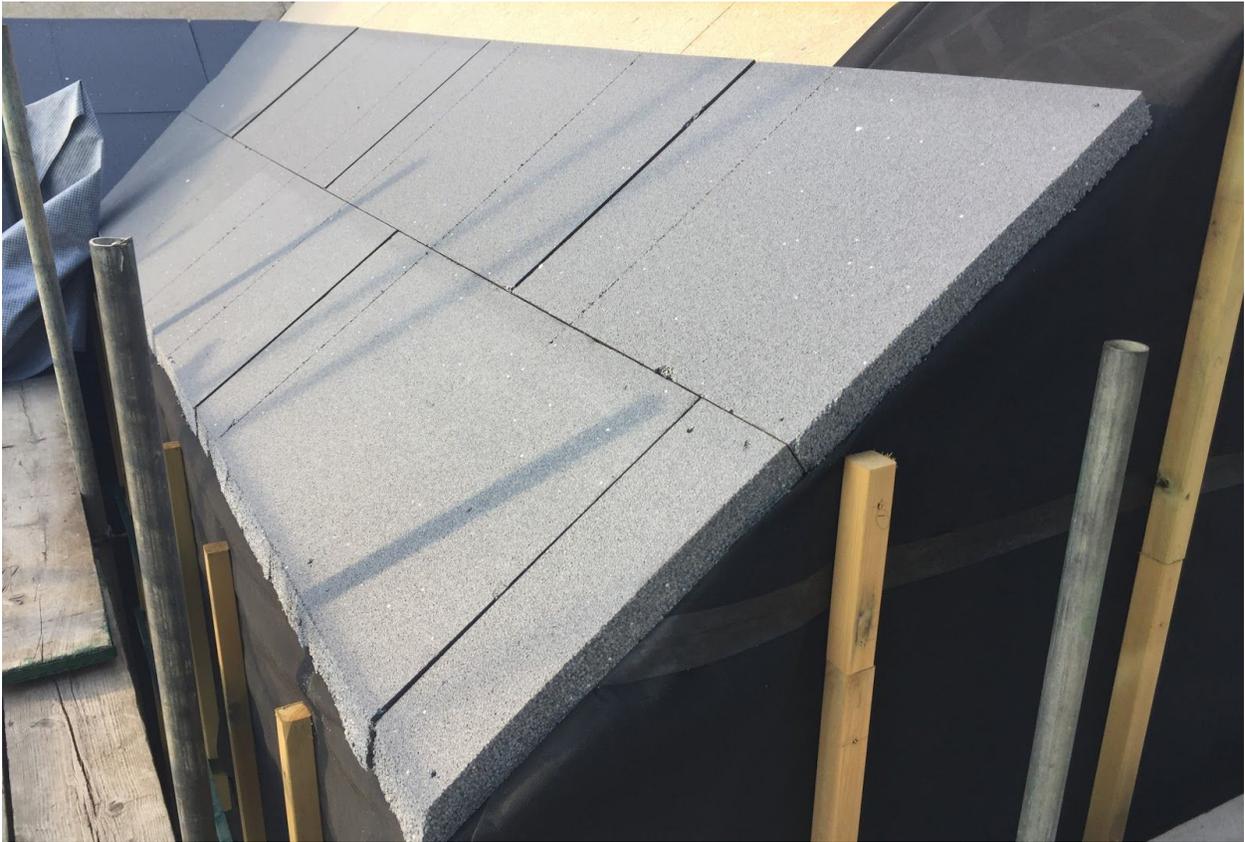
Construction photo showing EPS sarking temporarily pinned over OSB sheathing, prior to roof battens and membrane fixing

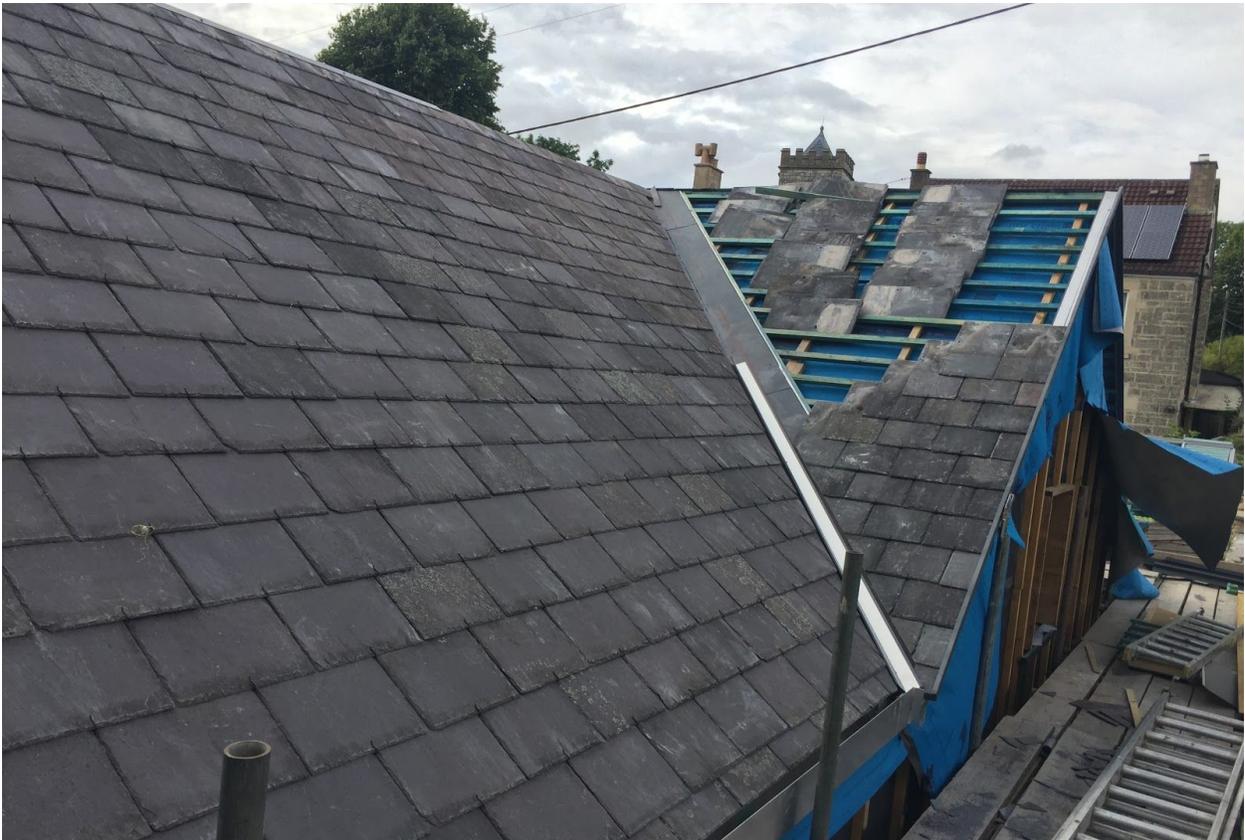
Construction photo nearing completion of the roof, showing reclaimed slates and concealed gutter

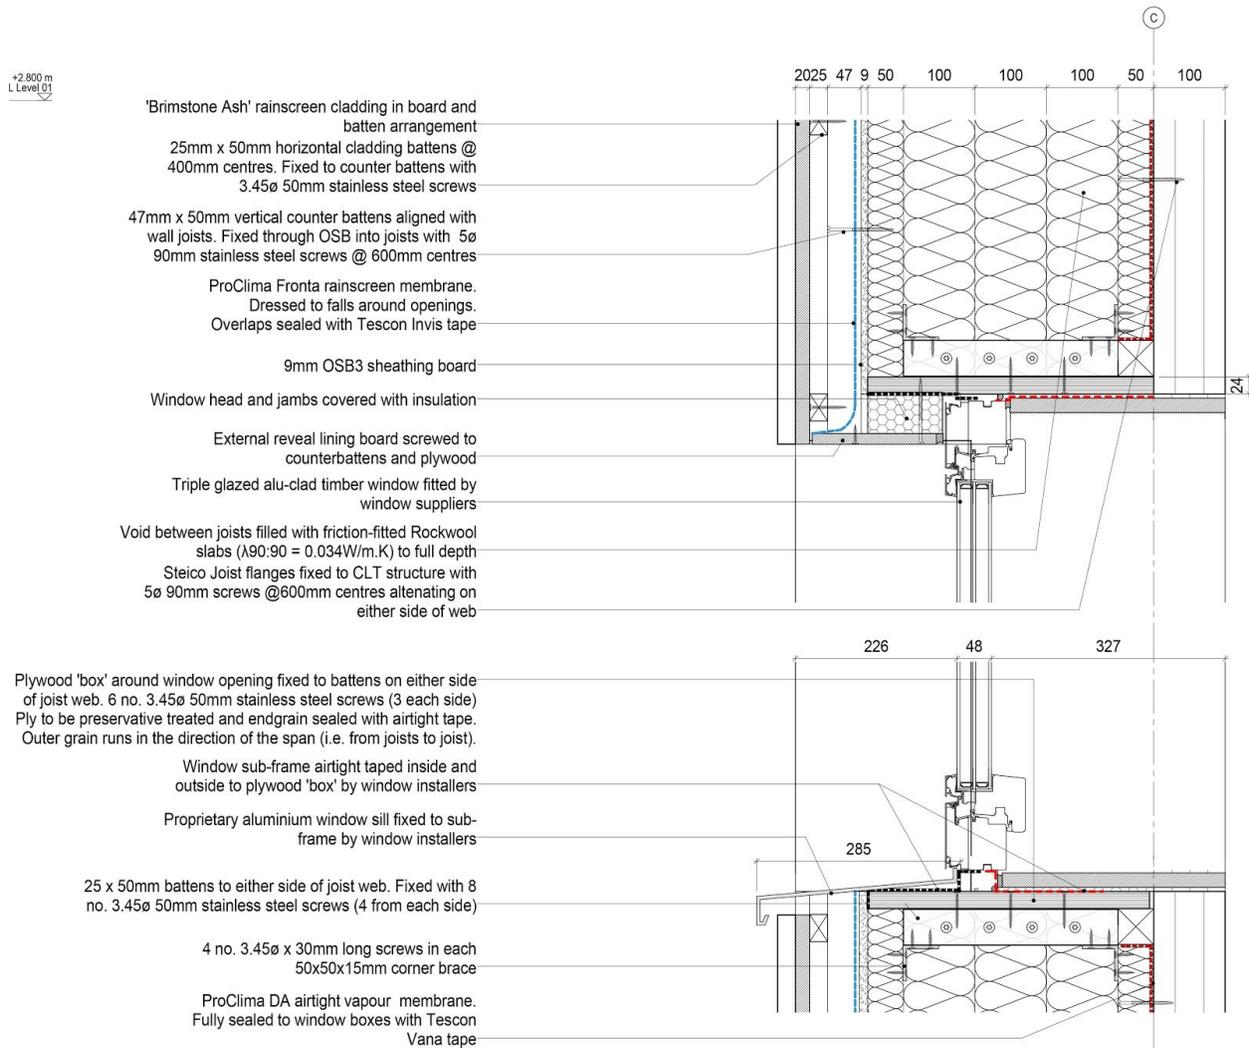
The windows, sliding door and entrance door were supplied and installed by Internorm. HF310 windows are timber-aluminium composite with an average U_f -value of $0.790 \text{ W}/(\text{m}^2\text{K})$. They open inward to allow wrapping of the frames externally with graphite EPS and are fixed into plywood boxes that cantilever out into the insulation zone and reduce the potential thermal bridging from installation. Glazing is triple glazed with warm edge spacers and an average U_g -value of $0.548 \text{ W}/(\text{m}^2\text{K})$.

Triple low-e glazing with argon gas and ISO warm edge spacer. Timber aluminium composite frame.

U-VALUE (average)	0.865 $\text{W}/(\text{m}^2\text{K})$
g-VALUE (average)	0.477

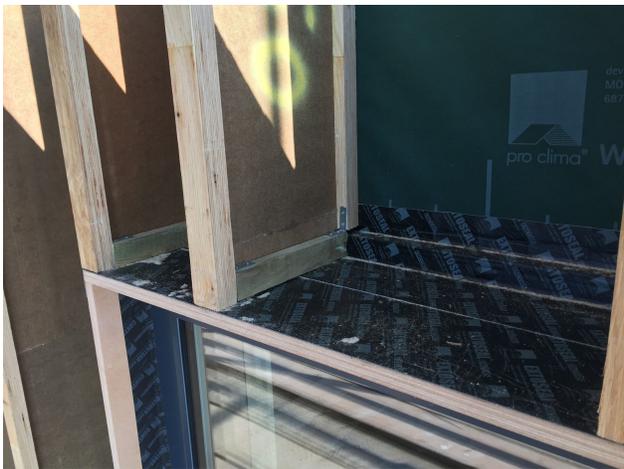
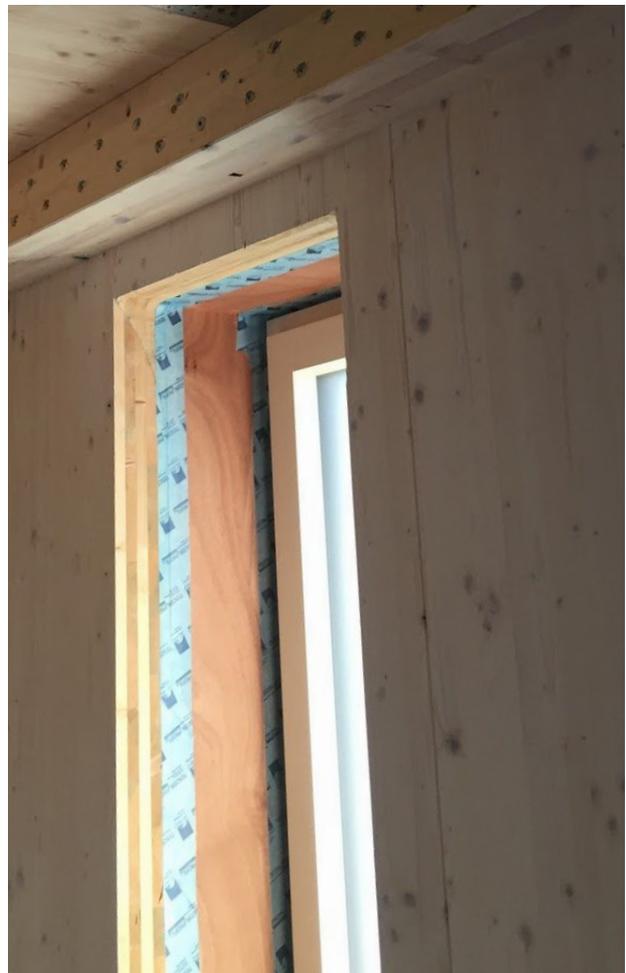
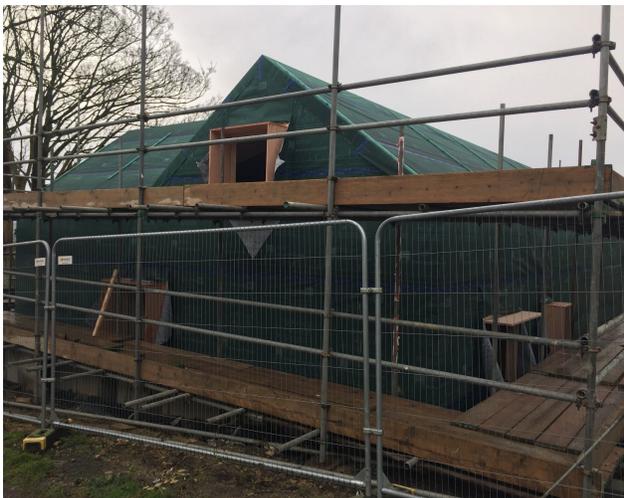
The airtightness strategy begins with the inherent air resistance of CLT panels - minimal joints due to large format components & multiple glued layers in different orientations. Junctions were designed as overlapped, then glued and over-taped on the external face by the frame contractor. Once the frame was in place, the roof and walls were covered in a ProClima DA membrane as a secondary airtight vapour check and temporary weatherproof line.

Windows and doors were surrounded with insulating foam by the installers and then sealed to their plywood 'box' surrounds and the main CLT frame with ProClima tapes.

The poured concrete structural slab completes the airtight line, laid over a radon membrane between the insulation and the concrete. The external wall membrane is sealed down onto the slab with ProClima Extoseal tape around the perimeter.

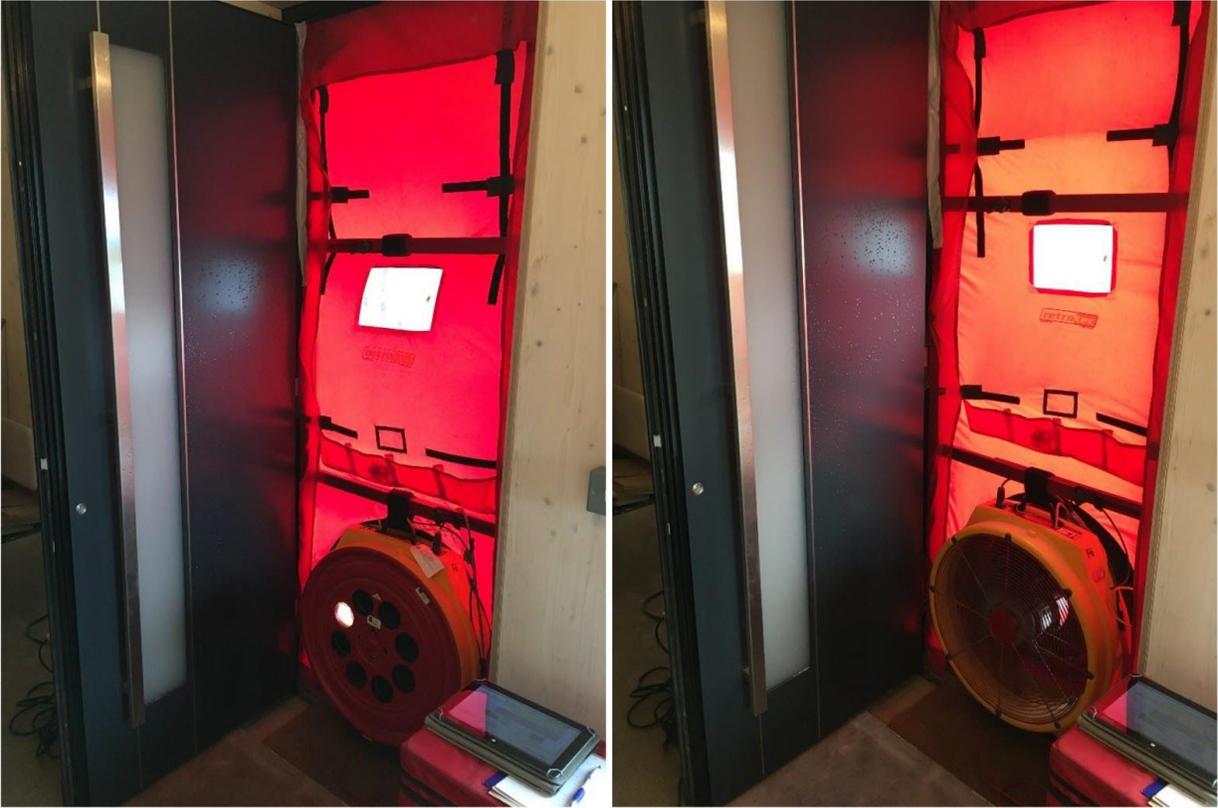
The airtightness was tested after these initial measures and then again at completion. Both tests were undertaken by Melin Energy Consultants and the final n_{50} result averaged 0.28 h-1 (0.27 pressurisation, 0.29 depressurisation) @ 50 Pa.

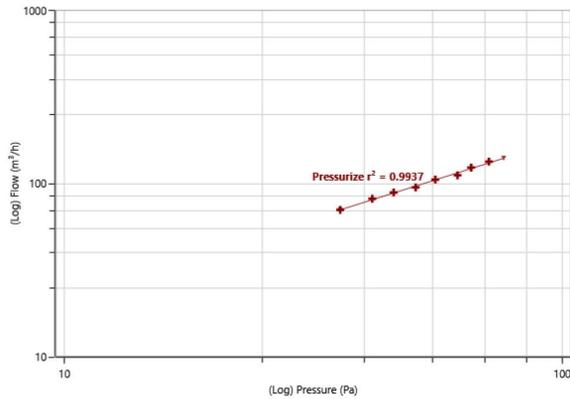
Induced Pressure vs. Flow (Pressurize Set)

Test Analysis		
Correlation, r^2 :	99.367	95% confidence limits
Slope, n:	0.906	0.83342 0.97781
Intercept, C_{int} [$m^3/h/m^2$]:	2.8026	2.106 3.729
	Results	Uncertainty
Air flow at 50 Pa, Q_{50} m^3/h	96.456	+/-1.6%
Air changes, n_{50} :	0.2681	+/-1.6%
Equivalent leakage area at 50 Pa [cm^2]	7.994	+/-1.6%
Permeability at 50 Pa, AP_{50} [$m^3/h/m^2$]	0.2431	+/-1.6%

Induced pressure [Pa]		34.7	40.4	44.7	49.6	54.4	60.4	64.4	70.0				
#1, Range C1	Fan Pressure [Pa]	51.4	61.7	69.1	76.9	86.8	96.0	106.5	118.0				
	Flow [m^3/h]	68.15	79.00	85.79	91.85	101.9	107.9	119.5	129.4				
Error [%]		-0.1%	1.3%	0.6%	-1.8%	0.3%	-3.2%	1.2%	1.7%

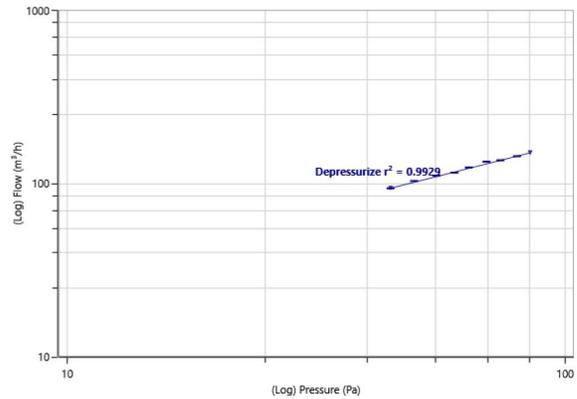
Induced Pressure vs. Flow (Depressurize Set)

Test Analysis		
Correlation, r^2 :	99.294	95% confidence limits
Slope, n:	0.727	0.66569 0.78819
Intercept, C_{int} [$m^3/h/Pa^n$]:	6.0335	4.690 7.762
	Results	Uncertainty
Air flow at 50 Pa, Q_{50} m^3/h	103.22	+/-1.7%
Air changes, n_{50} :	0.2869	+/-1.7%
Equivalent leakage area at 50 Pa [cm^2]	18.86	+/-1.7%
Permeability at 50 Pa, AP_{50} [$m^3/h/m^2$]	0.2602	+/-1.7%

Induced pressure [Pa]		-45.5	-50.6	-56.0	-60.8	-64.9	-70.3	-74.9	-80.8				
#1, Range C1	Fan Pressure [Pa]	27.8	32.6	36.6	39.1	43.8	49.7	51.2	56.0				
	Flow [m^3/h]	92.87	102.3	109.7	114.2	122.4	132.1	134.5	142.1				
Error [%]		-0.8%	0.9%	0.4%	-1.6%	0.4%	2.2%	-0.7%	0.8%

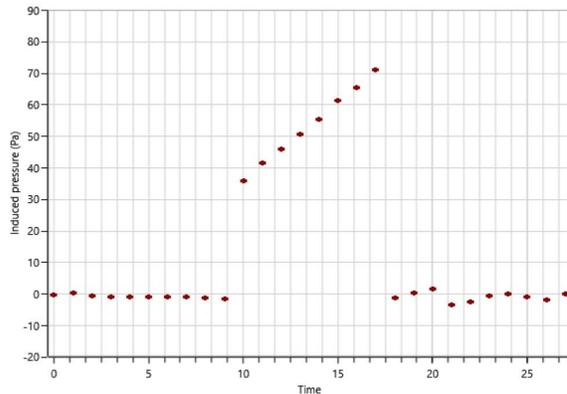
Building Gauge Pressure (Pressurize Set)

Static Pressure Averages:			
initial [Pa]	$\Delta P01$ -0.95	$\Delta P01$ -1.08	$\Delta P01$ + 0.20
final [Pa]	$\Delta P02$ -0.97	$\Delta P02$ -1.63	$\Delta P02$ + 0.57

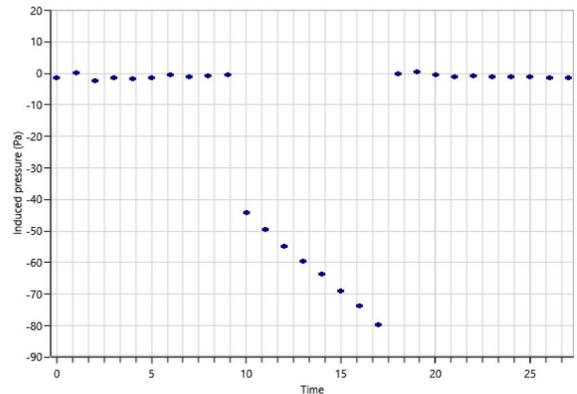
Building Gauge Pressure (Depressurize Set)

Static Pressure Averages:			
initial [Pa]	$\Delta P01$ -1.22	$\Delta P01$ -1.22	$\Delta P01$ + 0.00
final [Pa]	$\Delta P02$ -0.95	$\Delta P02$ -1.08	$\Delta P02$ + 0.20

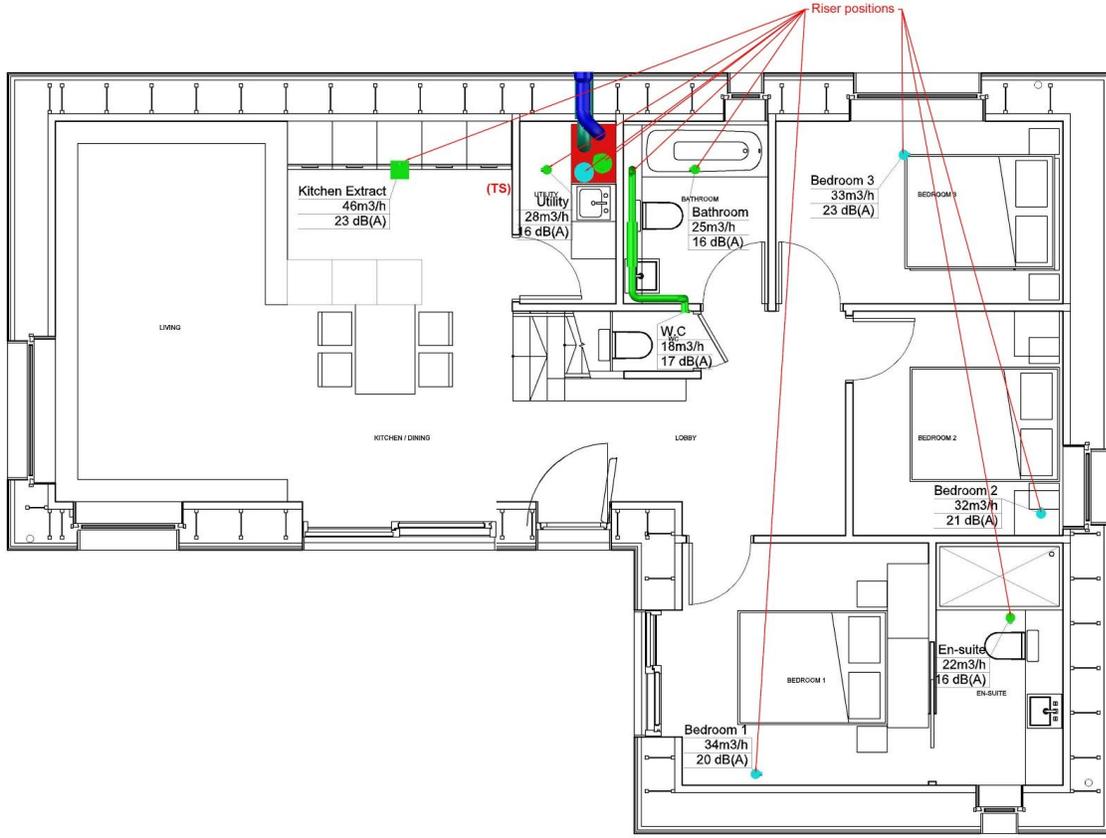
Ground Floor ventilation layout

KEY: MVHR (red), Intake (navy), Exhaust (dark green), Supply (turquoise), Extract (green)

A Paul Novus 300 MVHR unit is located in the Utility Room at Ground Floor in order to be close to the external wall and roughly central in plan. The cooker hood is recirculating with a charcoal filter. The intake and exhaust are wrapped in 15mm pre-formed EPS insulation and a layer of 25mm taped armafex lagging. The effective heat recovery efficiency is 90.6% with a specific power input of 0.24 Wh/m^3

Fresh air is supplied to all bedrooms, the living area and the mezzanine floor. It is extracted from wet rooms (bathroom, en-suite, kitchen), using the lobby as a transfer path.

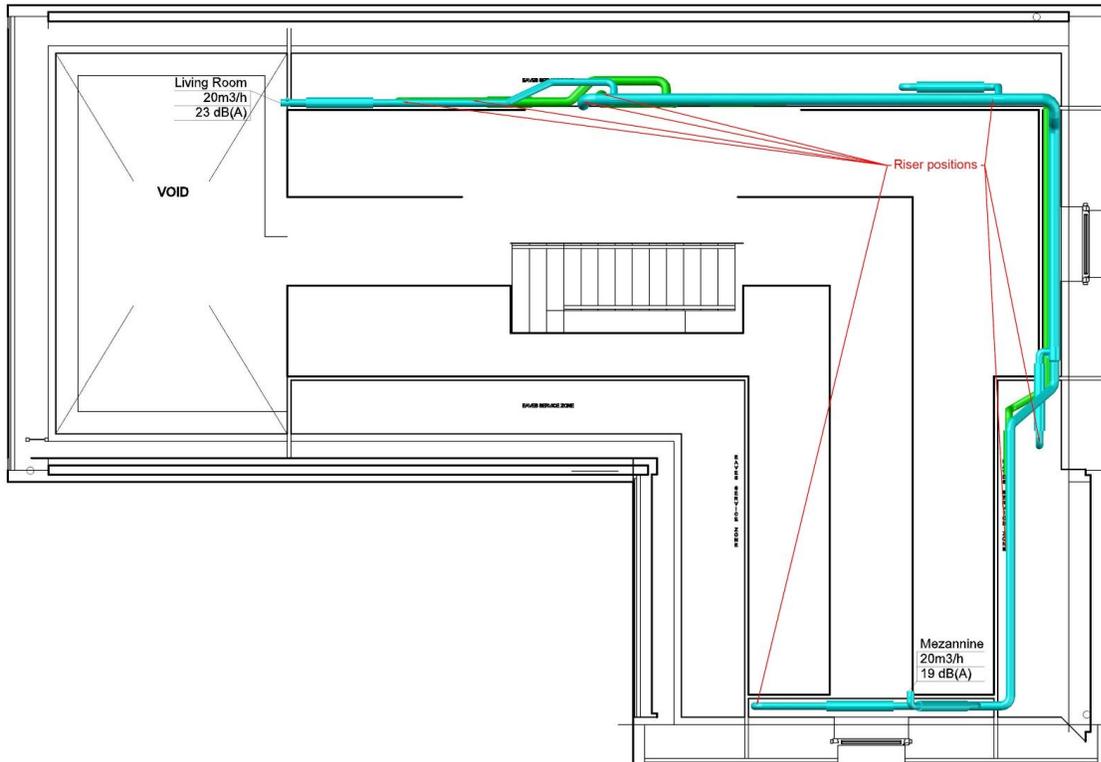
First Floor ventilation layout

Lindab rigid steel spiral wound ducts are used for distribution, with cross-talk attenuation to habitable rooms. The structural frame connections between First Floor, roof and walls are notched to allow larger ducts to pass over. This keeps all services within the eaves perimeter zone below 1m height, which is ignored in TFA calculations, thus maximising usable floor area.

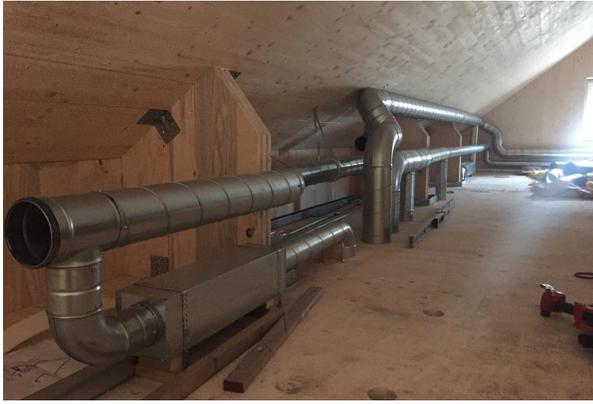
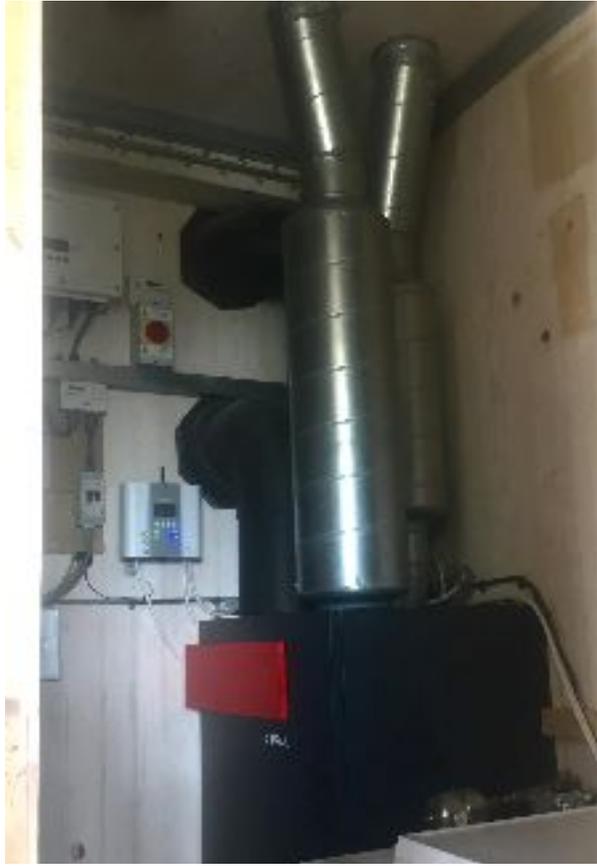
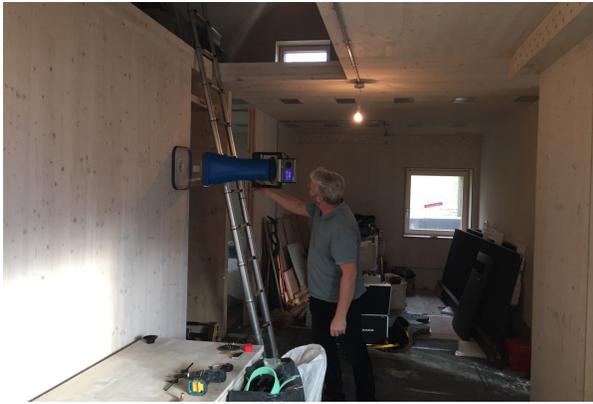
Construction photos of the duct install and terminal commissioning and a photo of the MVHR unit in place.
