PROJECT DOCUMENTATION

Detached single family dwelling in Radstock, UK

Deasil is a self-build house to the south of Bath; constructed, managed and now lived-in by the architect and his family. Sited in a conservation area in the former Somerset coal fields, it required pitched roof forms and a low building height, leading to a challenging form heat-loss factor.

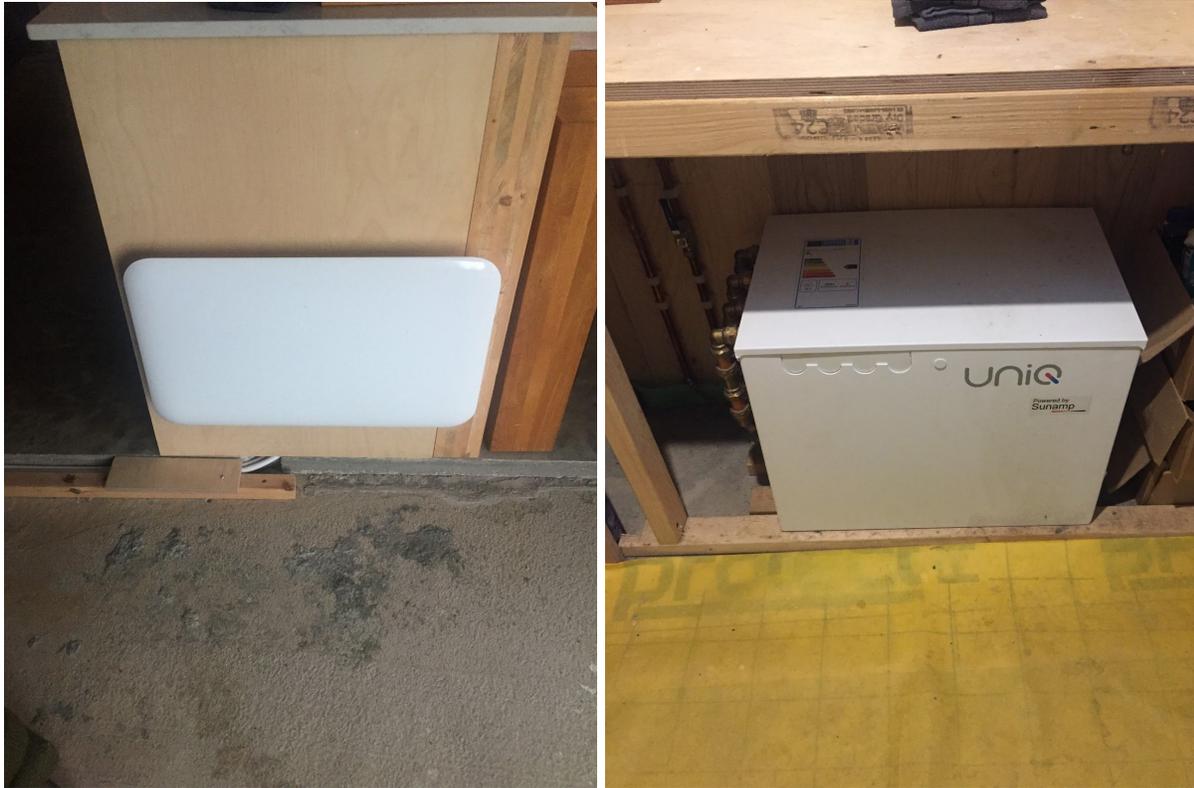
Construction photo of a panel heater (living space) and heat battery (en-suite) installed.

Space heating is supplied by two 600w electric panel heaters (Mill NE600) which are Wi-Fi controlled with manual override. One is located in the hallway outside the three bedrooms, the other in the main living space.

Domestic hot water is supplied through two SunAmp UniQ heat batteries. The larger 6kWh unit is located in the Utility room and feeds the kitchen and main bathroom. A secondary 3kWh unit is located in the En-Suite bathroom to supply the shower and sink here. Both store excess electricity from the roof-integrated PV array.
