# **Project Documation**

Cuicheng D 23#

#### 1 Abstract of building project

The function of the building is a disabled rehabilitation center. The building has a construction space of 2519 square meters with 3 stories above the ground and 1 story underground. The U-value of exterior is 0.14 by using 300 mm thick rock wool.

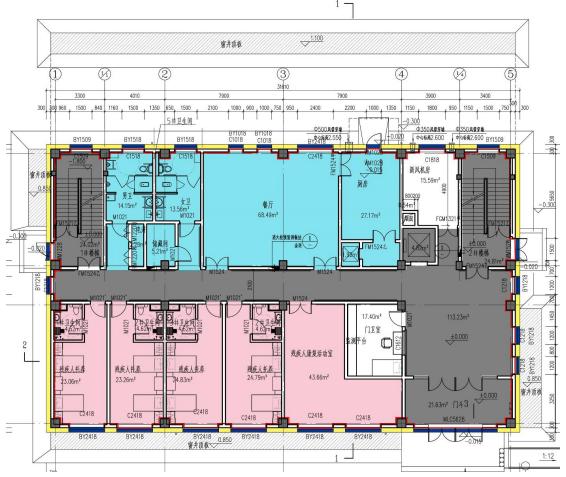
First floor plan

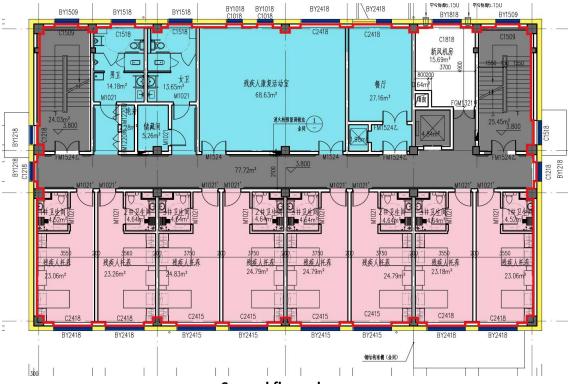
Second floor plan

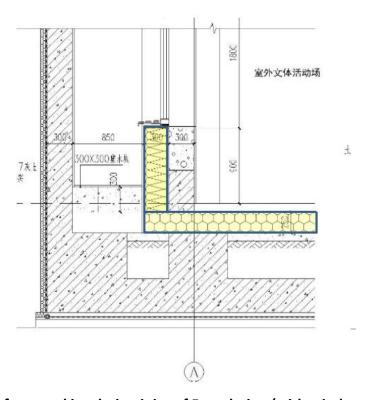
Design of external insulation joint of Foundation (with window well)

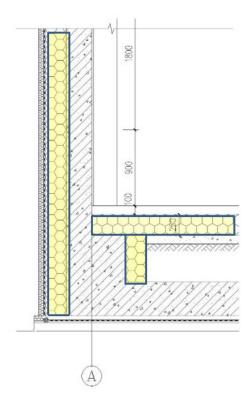
Design of external insulation joint of Foundation (no window well)

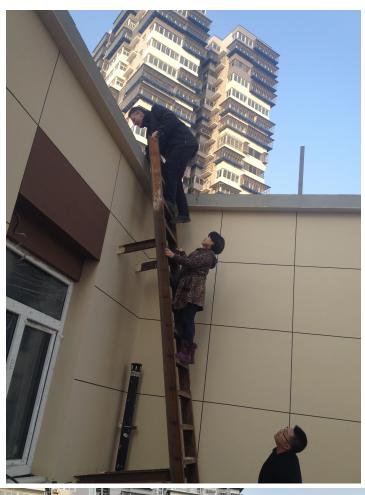
**Design of parapet joint**

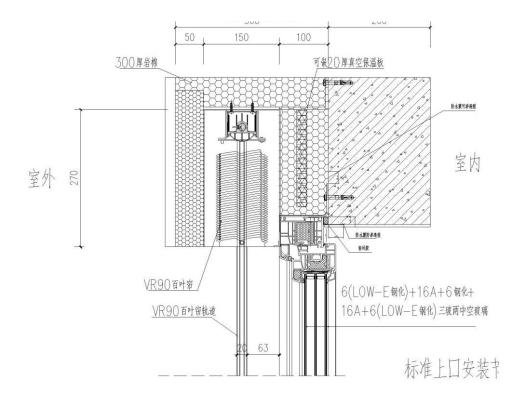
Installation node of louver and window upper opening

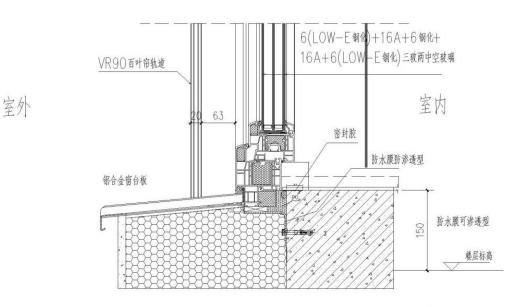
#### Installation node of louver and window lower opening

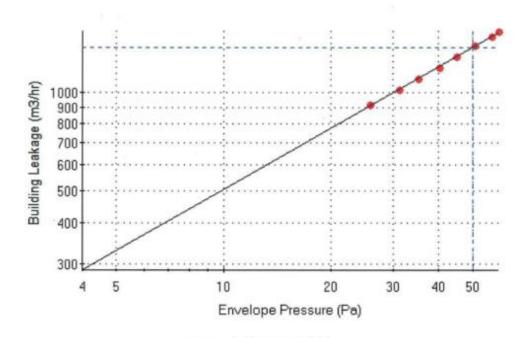
图 3 压差-漏气量曲线

根据压差与漏气量曲线可以得到-50Pa下漏气量为1368m²/h,换气次数为0.19h²。

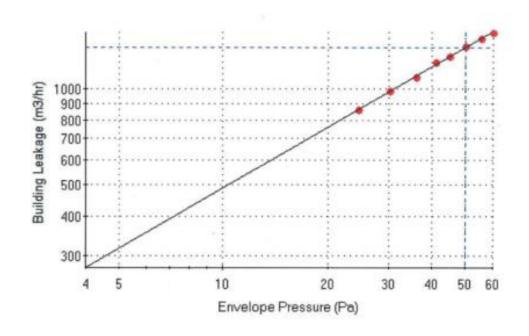
图 4 压差-漏气量曲线

根据压差与漏气量曲线可以得到 50Pa 下漏气量为 1353m³/h, 换气次数为 0.19h⁻。

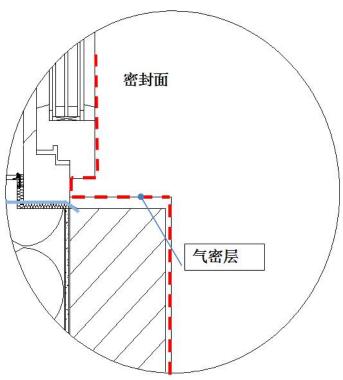
Air tight tape

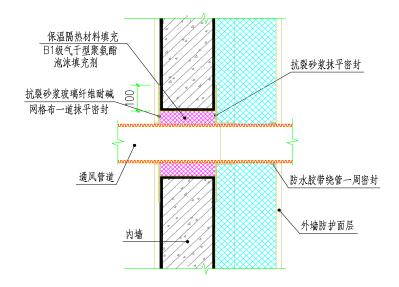
Joint of pipe passing through external

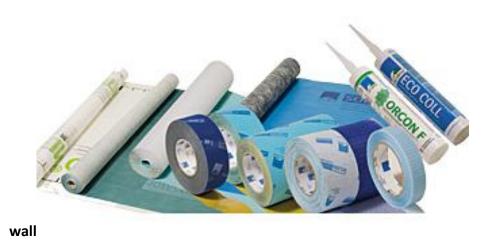
Air tight tape
