# Passivhaus project documentation

Pippin Barn, Rouncil Lane,  
Kenilworth CV8 1NN, UK.  
Passivhaus database ID: 6892

## 1 Abstract

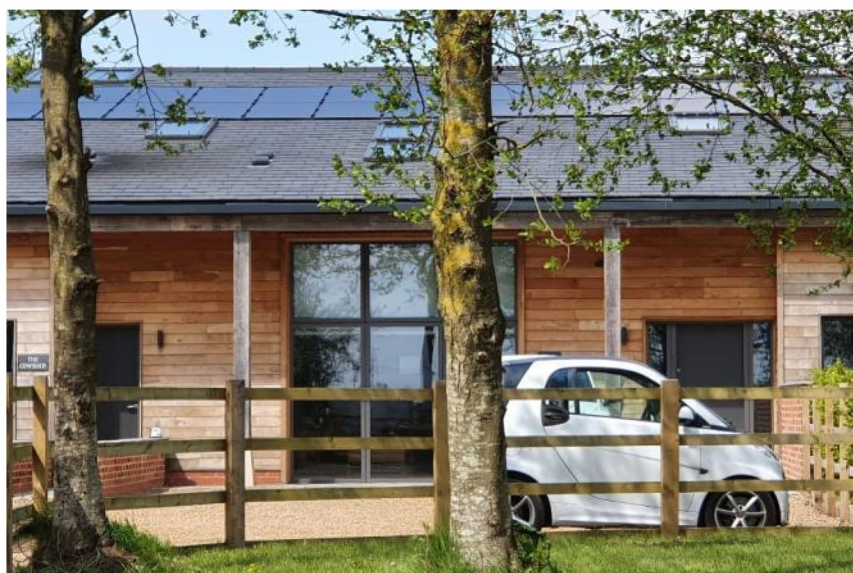
Figure 1: Front (south) elevation

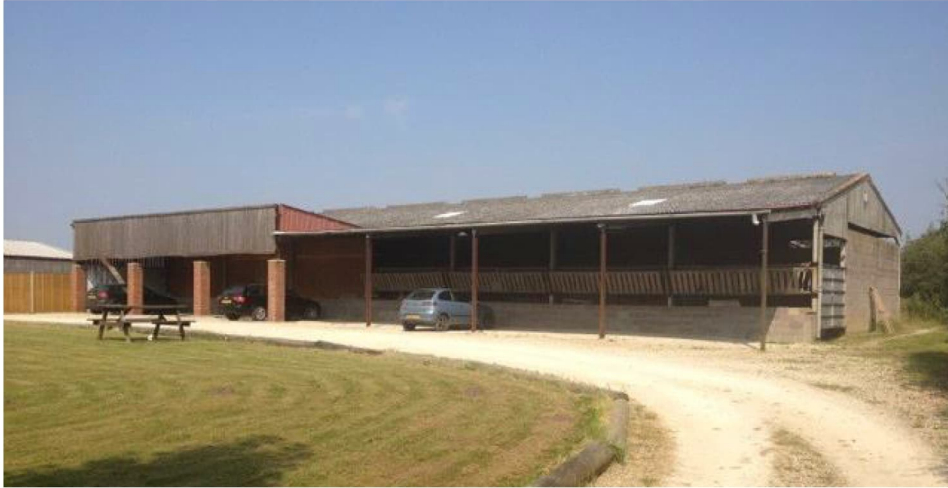
*Figure 2: Previously existing barn determined the form of the replacement building*

Planning permission was granted to convert an existing barn into a row of three dwellings in a rural location to the west of Kenilworth. As a result the form of the building was constrained in height to two storeys with a long roof slope to the south.

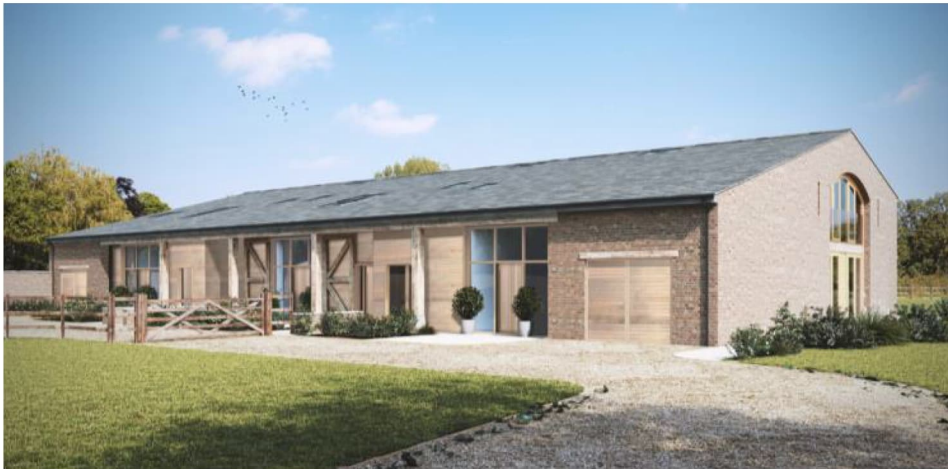
*Figure 3: Computer generated image of the front (south) elevation of the terrace*

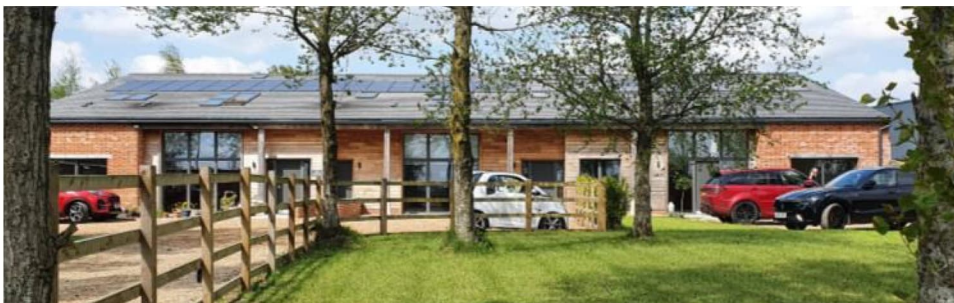
*Figure 4: Current image of the front (south) elevation of the terrace*

Pippin barn is the middle house.

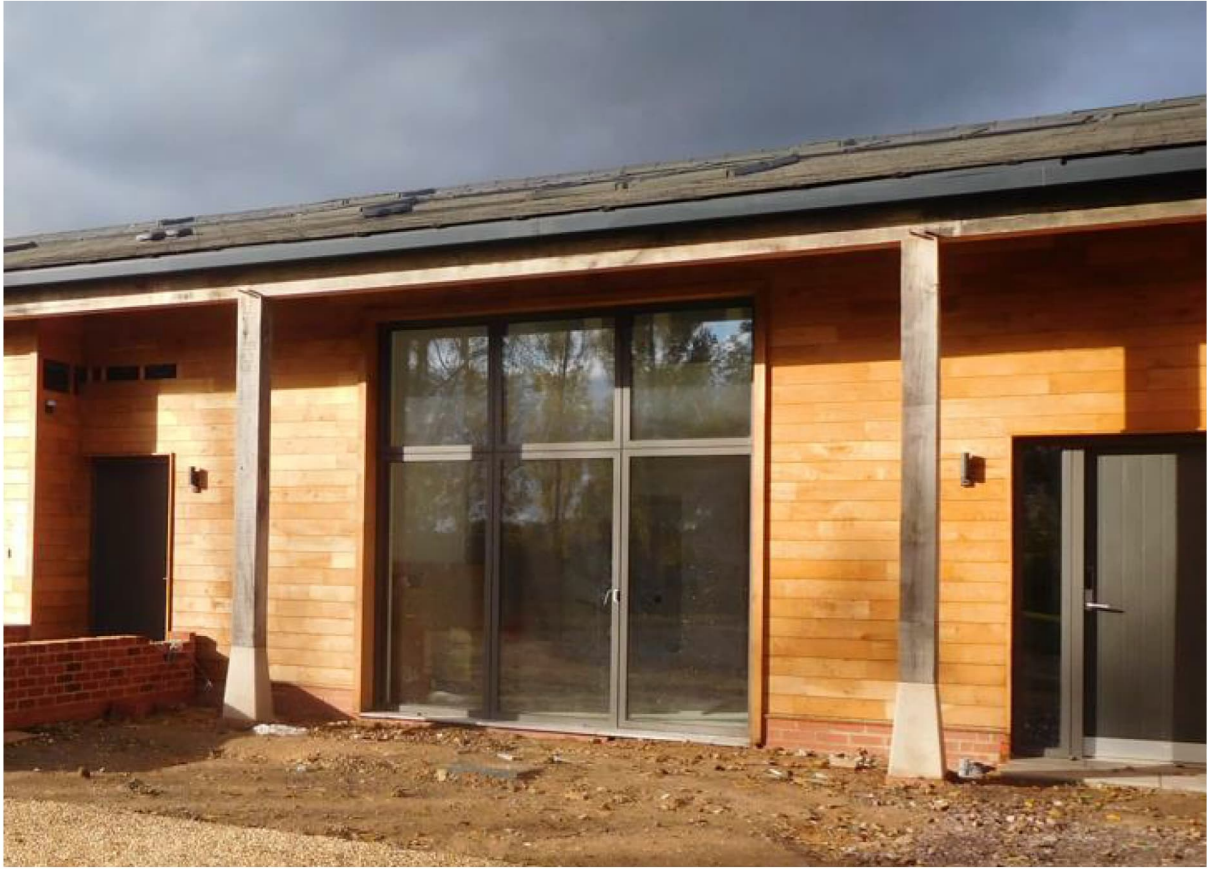
Figure 5: Front elevation (south)

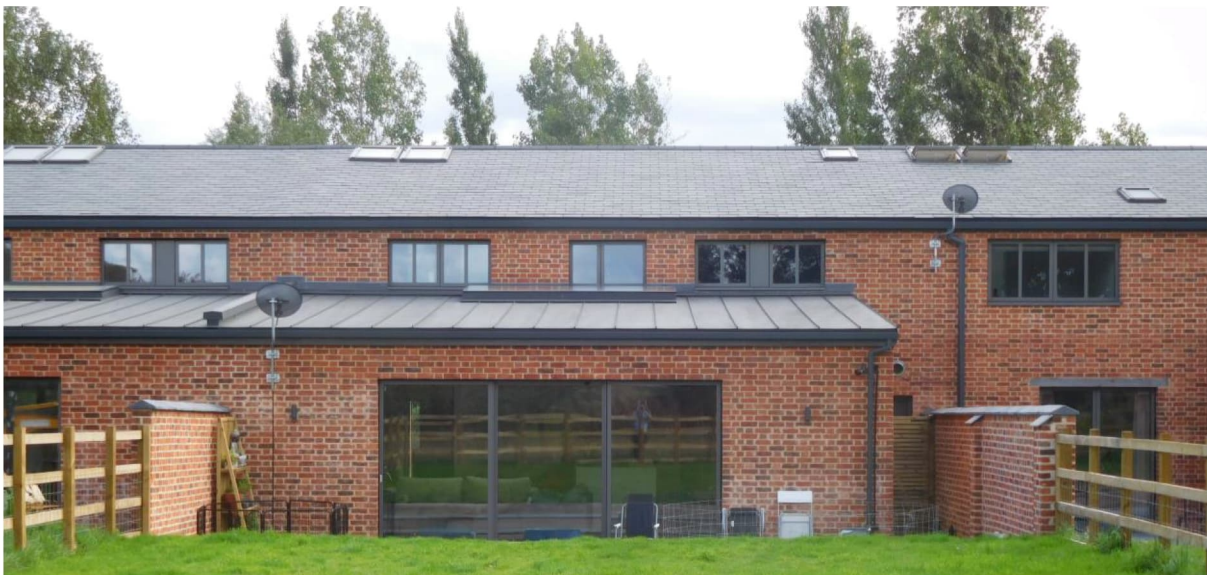
Figure 6: Rear elevation (north)

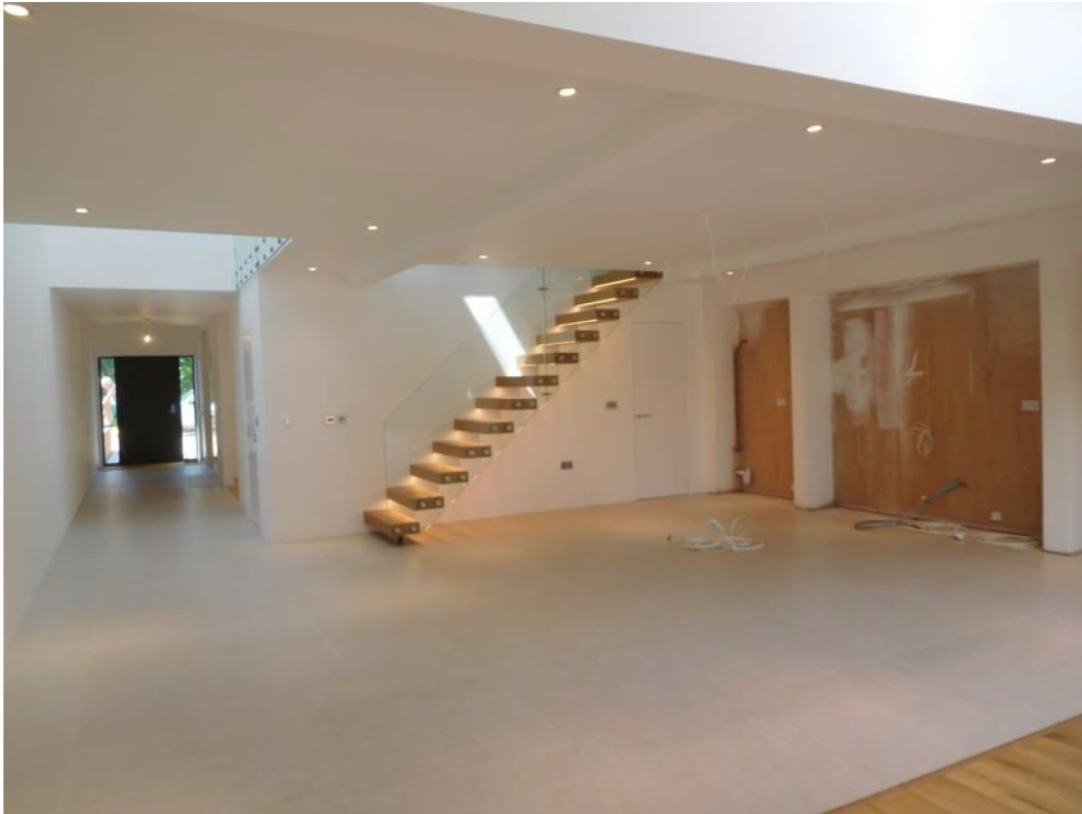
Figure 7: Ground floor

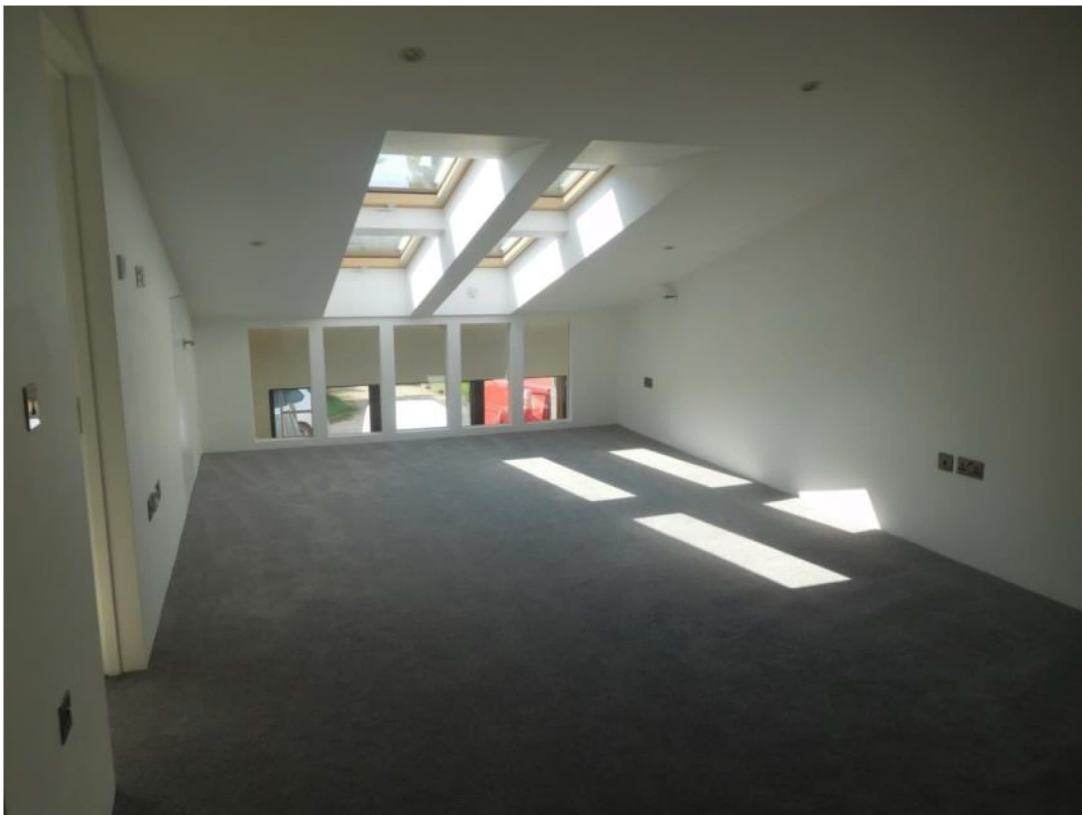
Figure 8: First floor

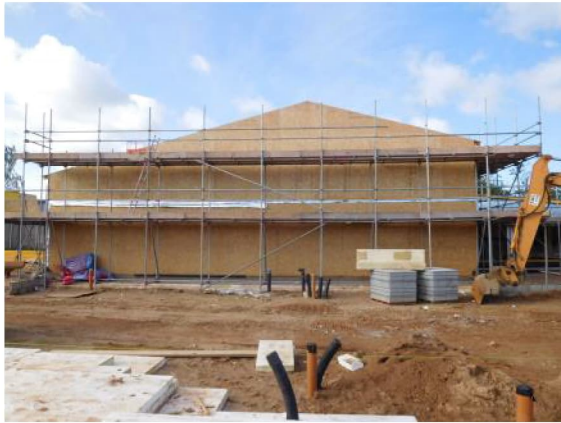
Figure 15: Pippin Barn was built between the insulation of the floor slab to the neighbouring dwelling in the foreground and the already erected frame the other neighbour in the background

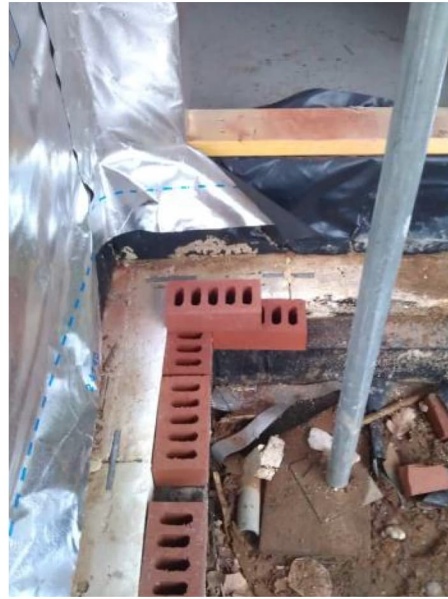
Figure 16: Brick outer leaf coming out of the ground alongside the insulated floor slab

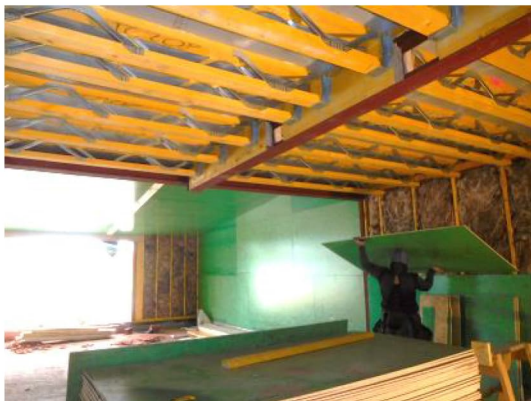
Figure 17: Propassiv airtight board being applied to insulated timber framed wall

An airtight floor was formed by screeded concrete which extended monolithically throughout the ground floor. The walls and roofs were lined with Medite Smartply Propassiv boarding which is an airtight OSB product. Tescon Vana was used to tape the joints between the boards and between the boards and windows. Exoseal tape was used to join to the floor. Penetrations were sealed with an appropriate grommet or Tescon No.1 tape. See figs 17, 20 and 22.

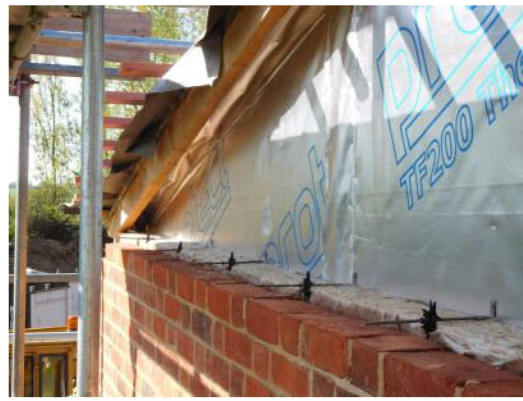
Figure 18: Brick outer leaf with insulated cavity under construction

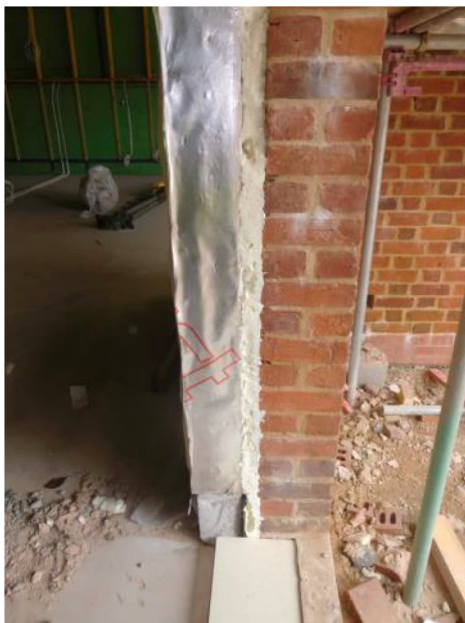
Figure 19: Insulated cavity closer

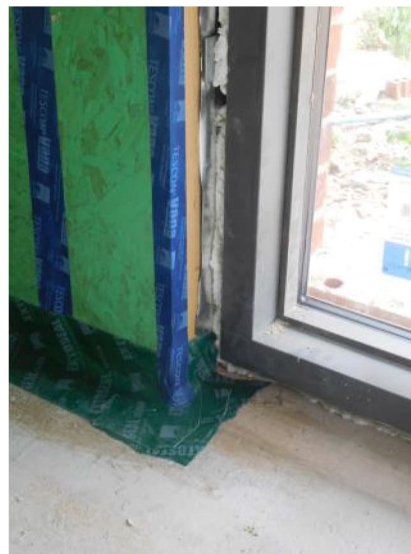
Figure 20: Airtightness connection between wall and floor

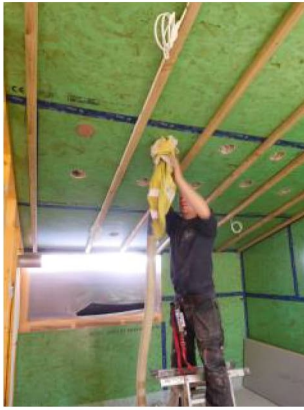
Figure 21: Warmcell insulation blown into roof cavity

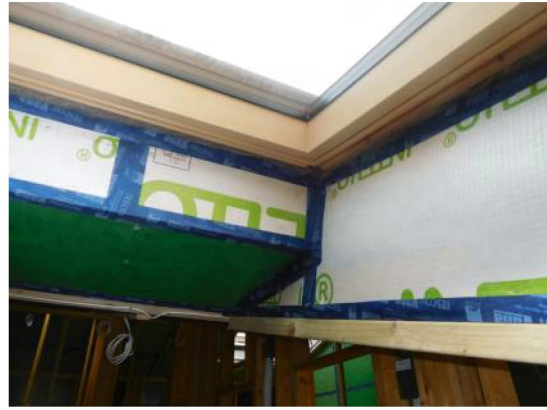
Figure 22: Airtightness detailing around rooflight

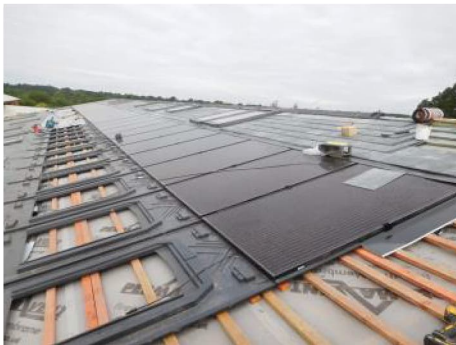
Figure 23: Slate roof with inline solar PV installation and rooflights

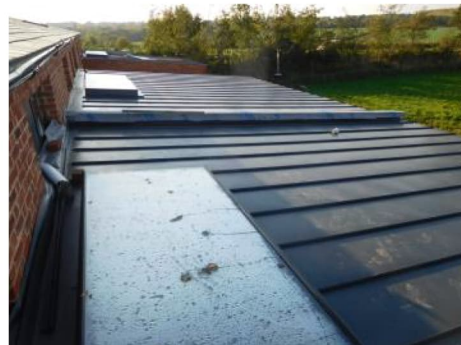
Figure 24: Standing seam metal covering to rear roof with 3m long rooflight

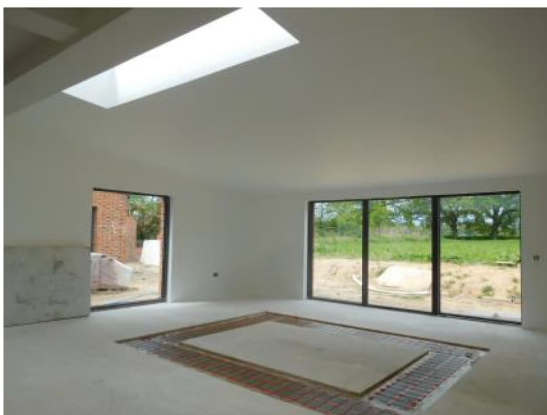
Figure 25: Sitting room with underfloor heating mat

Direct electric heating delivered by underfloor heat mats – see Figure 25 – thermostatically controlled room by room.

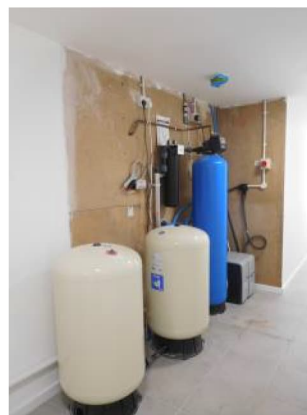
Figure 26: Borehole water purification unit

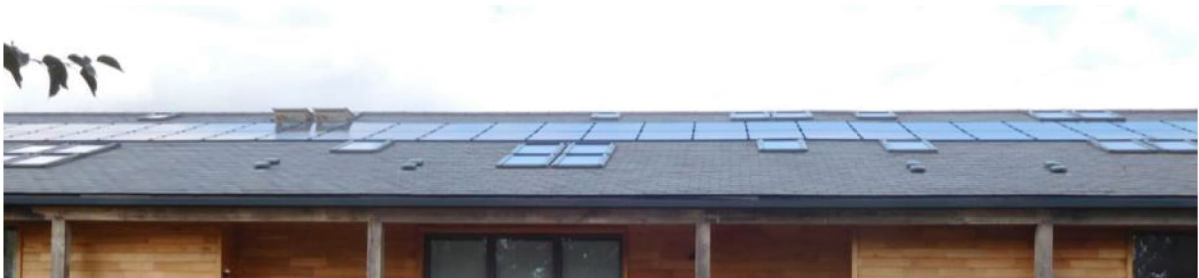
Figure 27: A 5.4 kWp solar PV system – inline roof installation

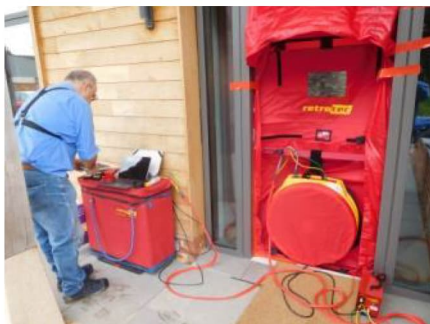
Figure 30: Air test being undertaken at Pippin Barn

<b>Location</b>	Pippin Barn, Rouncil Lane, Kenilworth CV8 1NN
<b>Date</b>	10 July 2020
<b>Undertaken by</b>	Jennings Aldas (2019) Ltd
<b>n<sub>50</sub> result</b>	0.63 h <sup>-1</sup> @50Pa

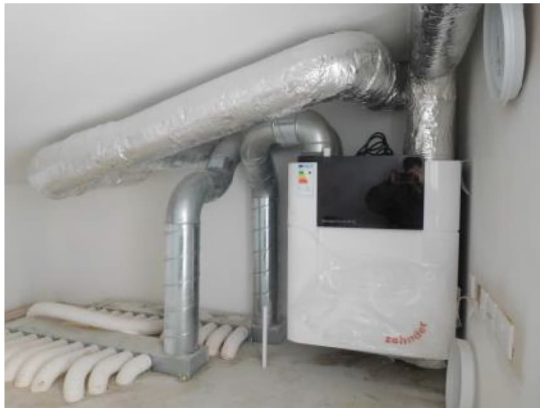
Figure 31: Zehnder MVHR unit

<b>Make</b>	Zehnder
<b>Model</b>	Comfoair 600
<b>Effective efficiency</b>	83.3%
<b>Electrical efficiency</b>	0.24 Wh/m <sup>3</sup>

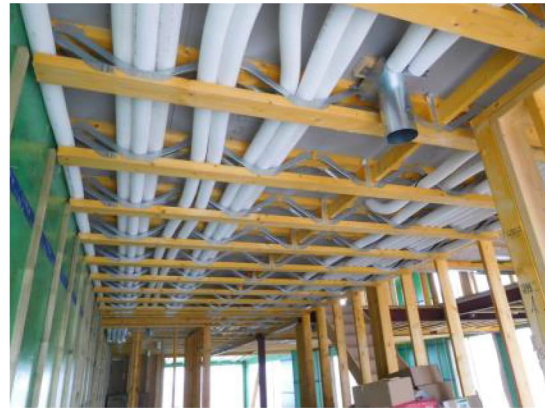
Figure 32: semi-flexible ventilation ductwork in intermediate floor void

Galvanised spiral ducts to distribution manifolds with radial semi-rigid distribution ductwork.

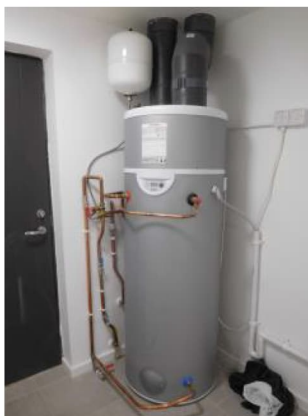
Figure 34: ASHP DHW cylinder

DHW cylinder with integral ASHP – see Figure 34: ASHP DHW cylinder.

<b>Make</b>	Dimplex
<b>Model</b>	Edel Hot Water Heat Pump
<b>Heat loss rate</b>	1.9 W/K
<b>Storage volume</b>	270 l
<b>COP</b>	3.5
<b>Achievable hot water temperature via heat pump</b>	60°C
