Project Documentation

Refurbishment of an 1850 Victorian detached house on Dartmoor, Devon (UK)

House W - Refurbishment of an 1850 Victorian detached house on Dartmoor, Devon (UK)

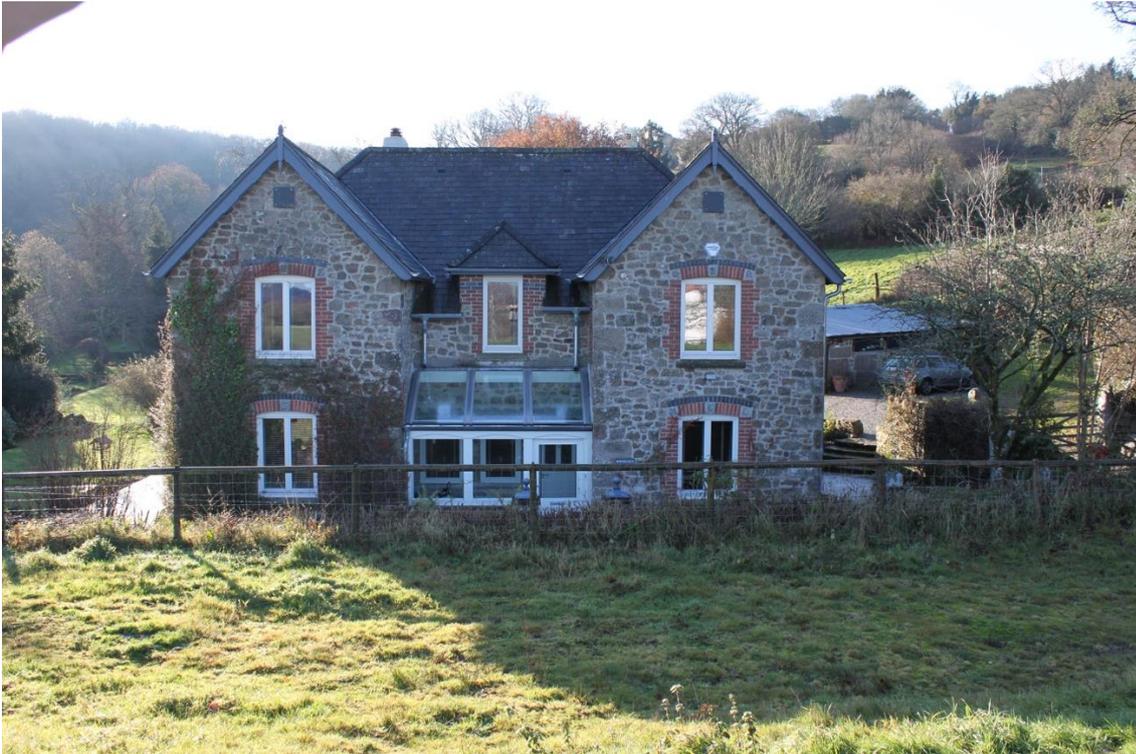
View from North: Dartmoor National Park planning policy required that the external appearance had to remain unchanged. To maintain all granite stonework walls were insulated internally.

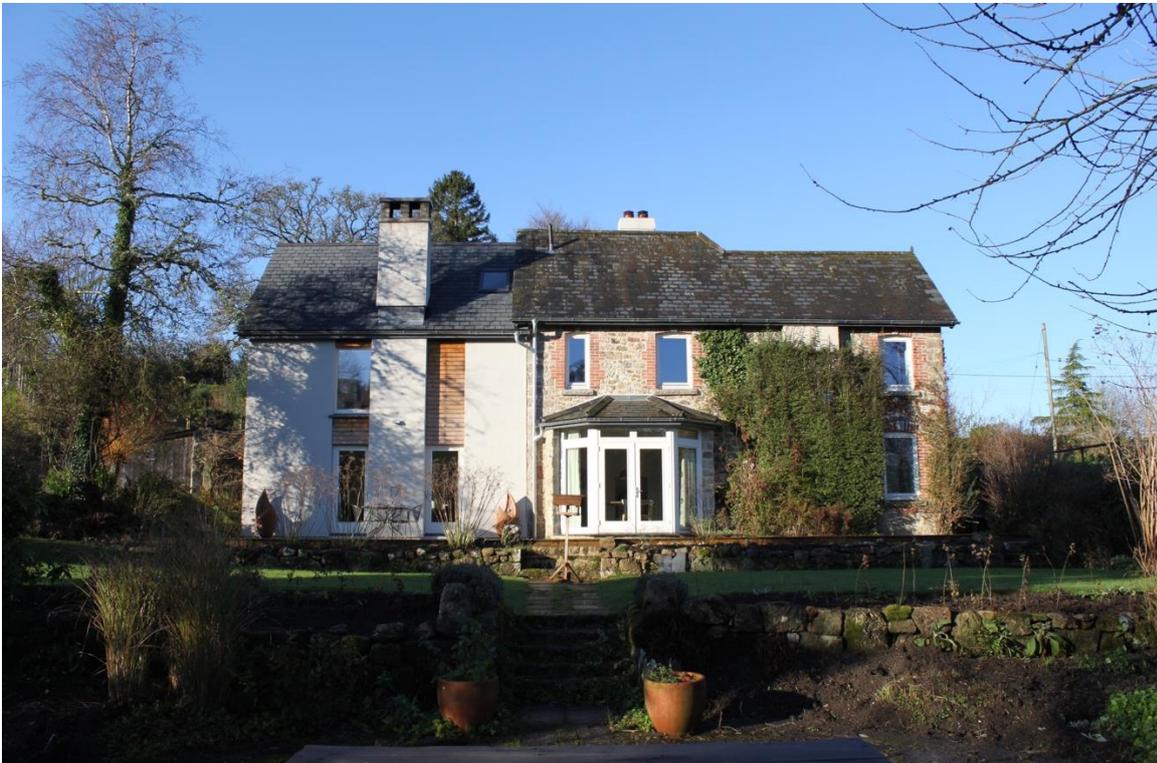
View from East showing the existing building and the new extension (rendered façade on the left).

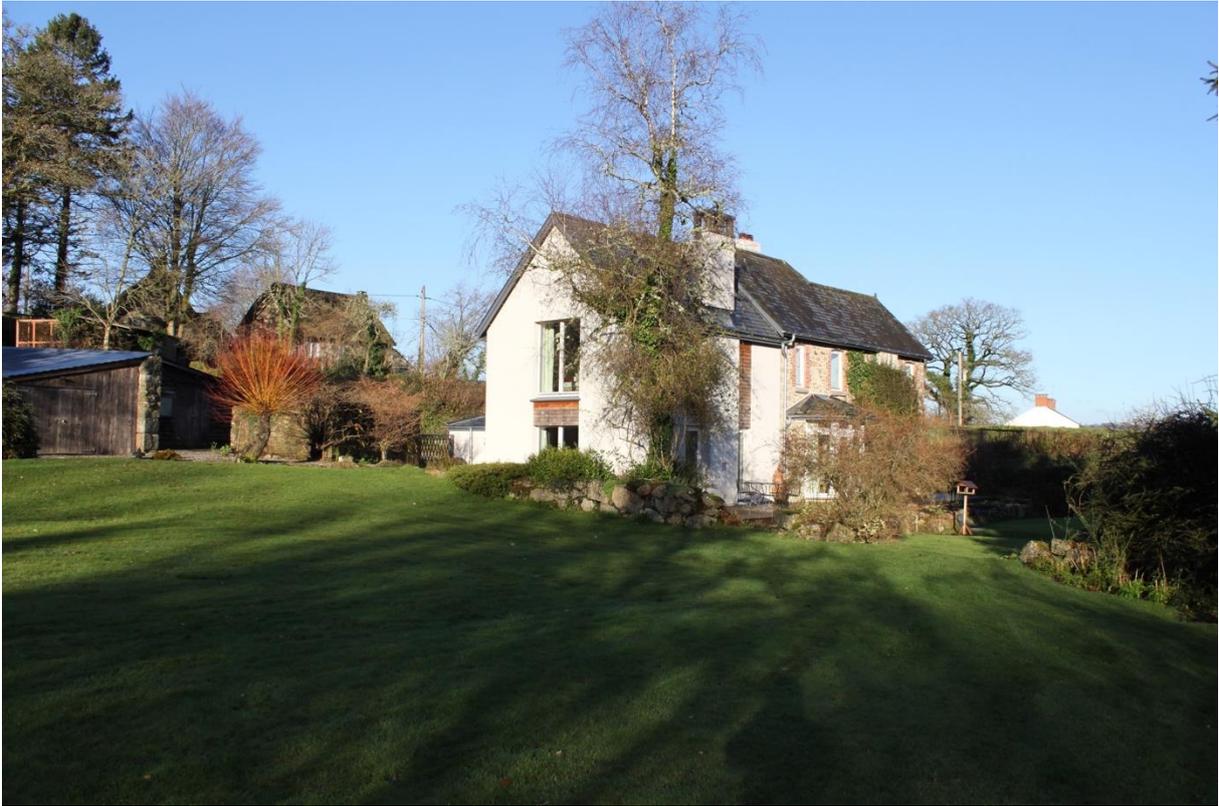
View from South East with the new two storey extension in the front.

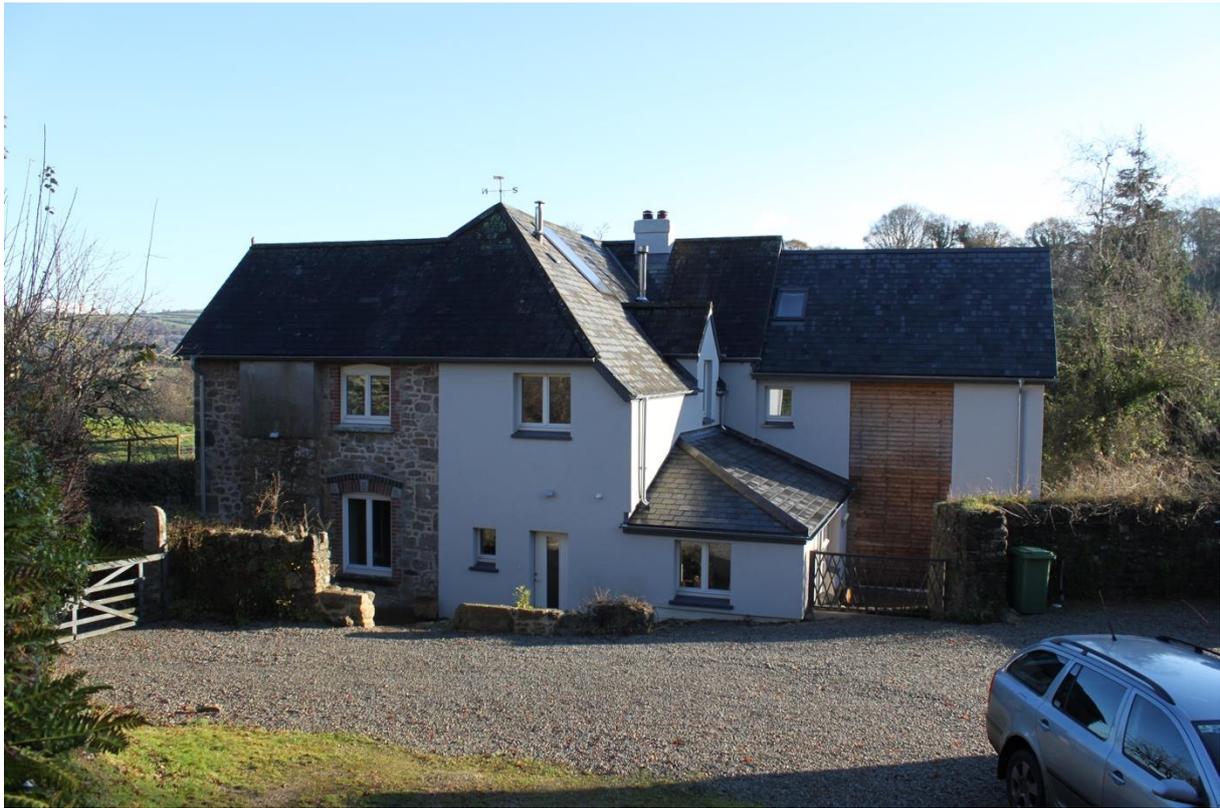
View from West; the 1960s single storey extension can be seen in the front right corner.

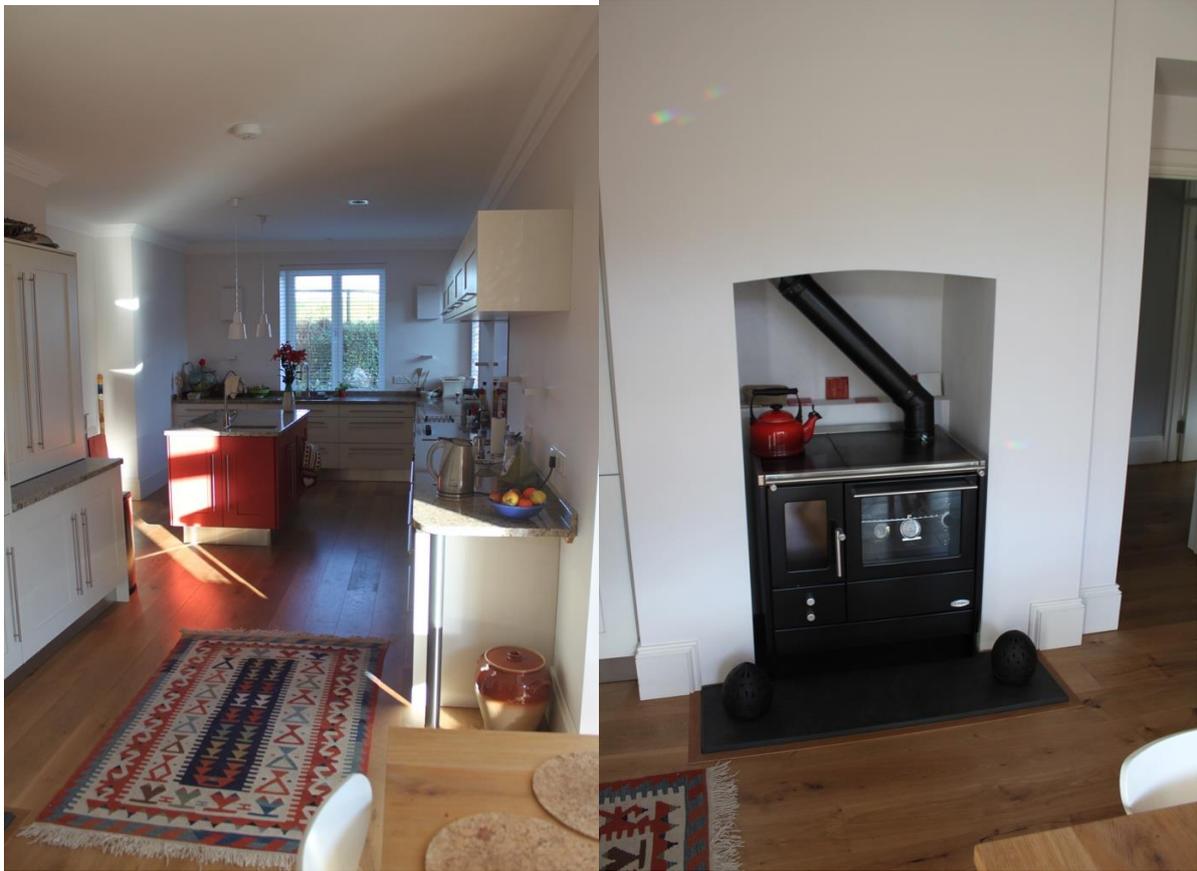
Kitchen/dining and air tight range cooker with backboiler option replicating a traditional feature.

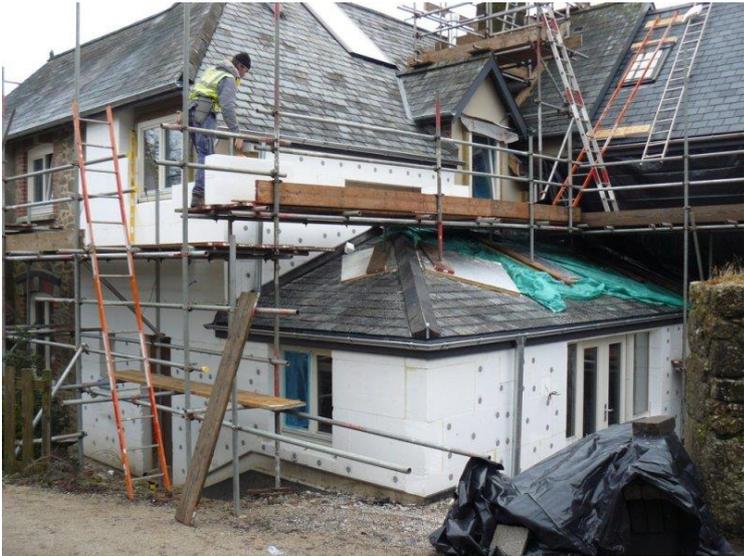
Wall type D: showing installation of EIFS

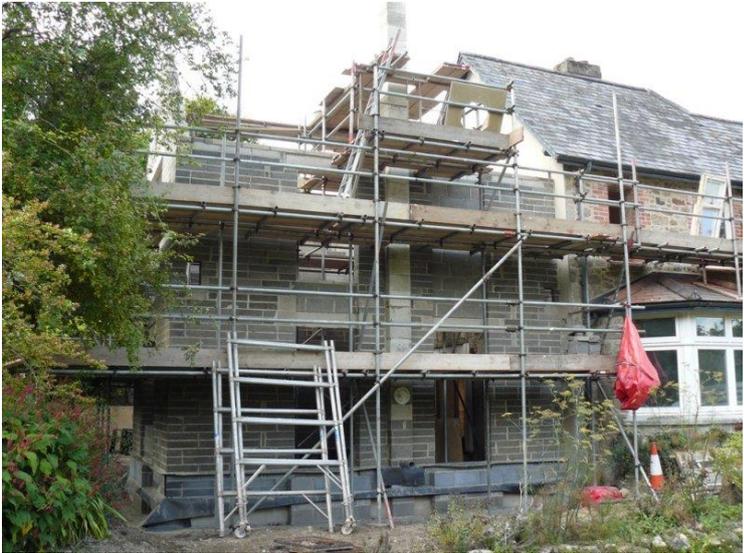
Wall type E/F: showing ,aerated block warm' foot detail

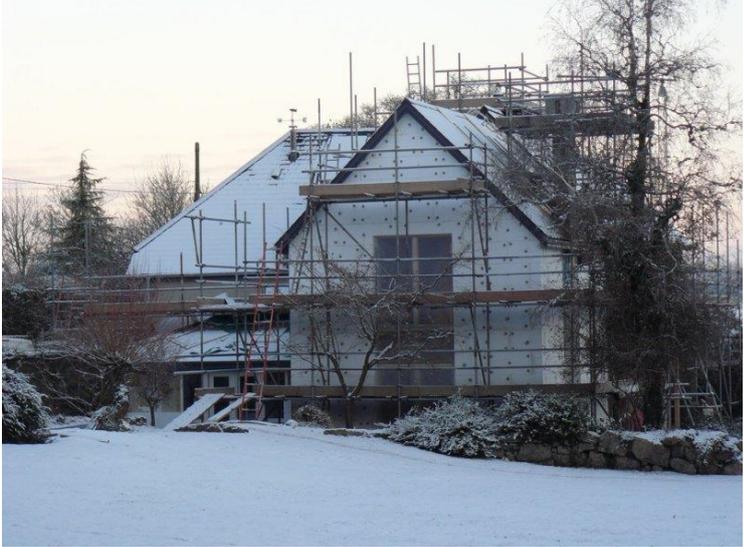
Wall type E/F: showing installation of EIFS

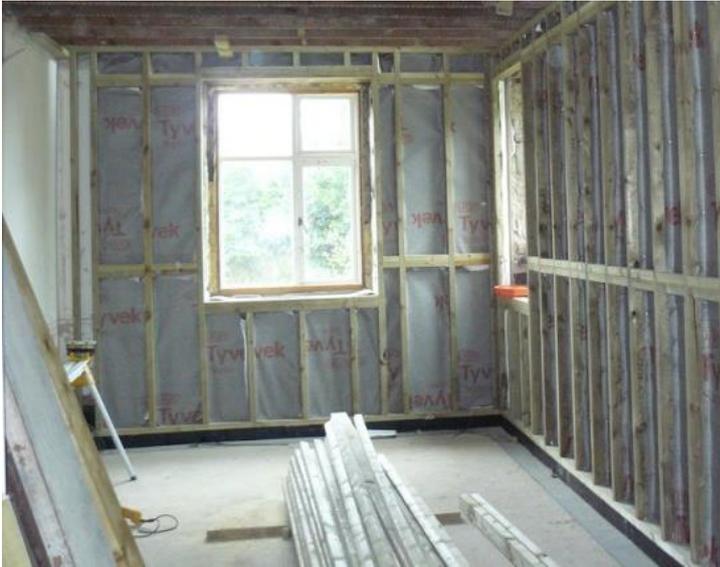
Wall type A: showing foamglass warm foot detail

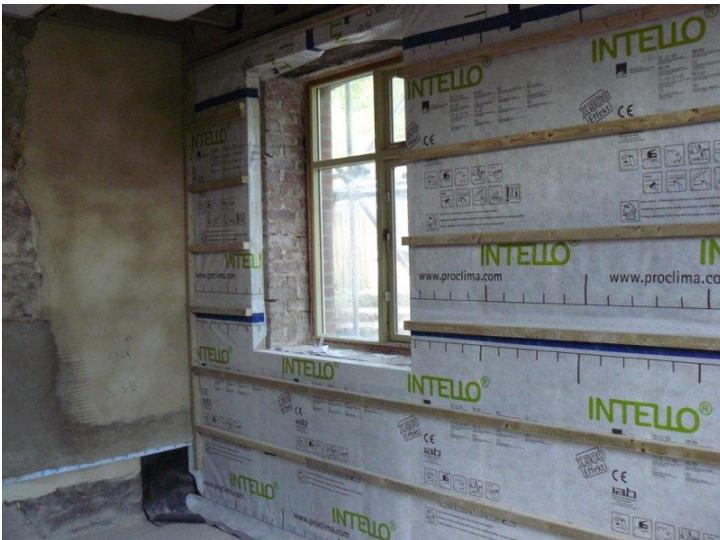
Wall type A: showing VCL and service void

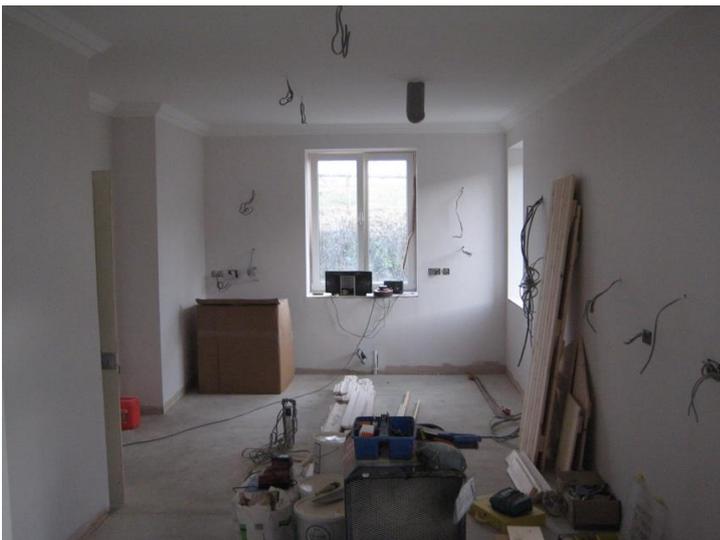
Wall type A: finished wall in kitchen

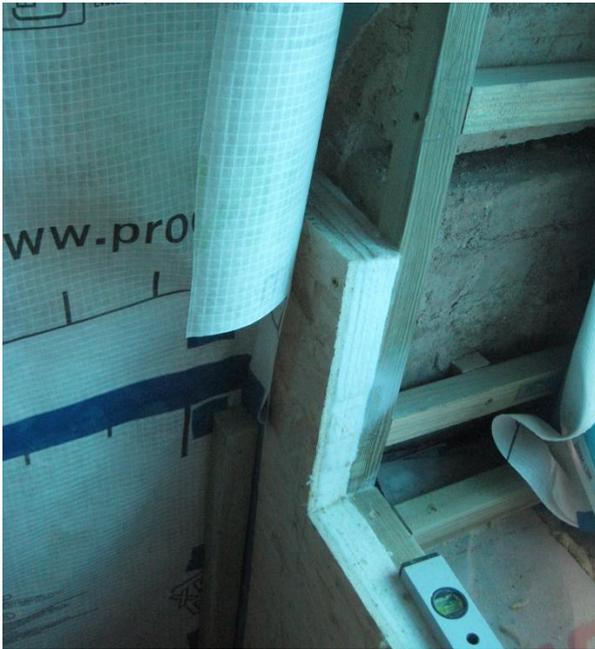
Wall type C: Aerogel insulation wall lining

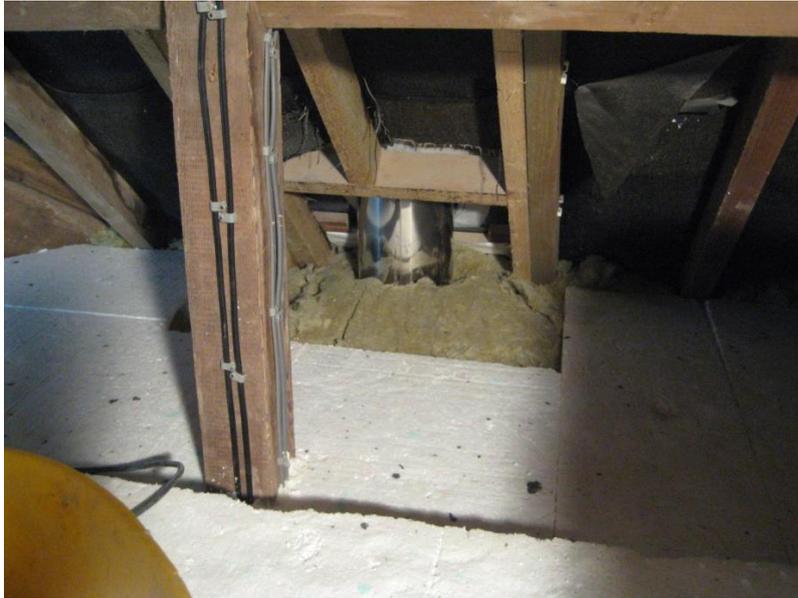
Insulation to existing roof:
Rigid EPS insulation was tightly fitted any penetrations. Any remaining gaps were packed with mineral fibre insulation.

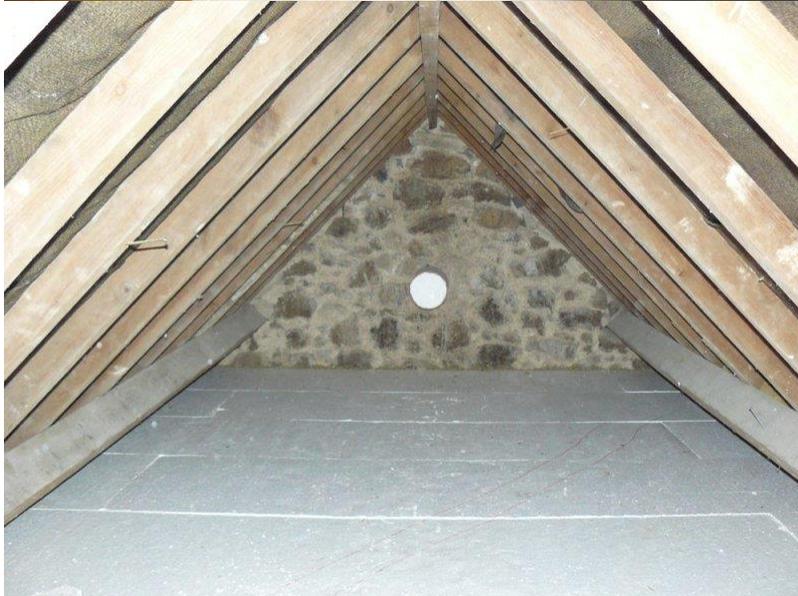
Rigid insulation fitted to existing roof.

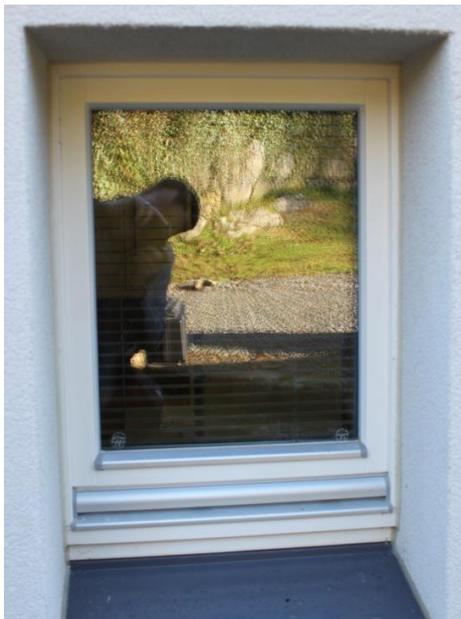
Inward opening triple glazed windows: frames are insulated over on the outside to improve thermal bridging performance.

Within areas of internal wall insulation the internal reveals were insulated to improve thermal bridging. Within the external wall insulation the windows were moved into the insulation layer and installed in timber sub frames.

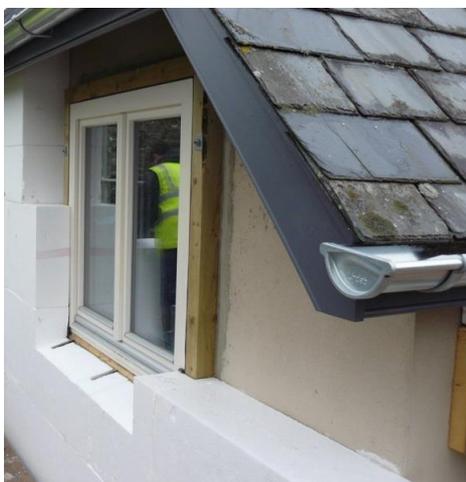
Windows are installed in subframes and moved into the insulation layer to improve thermal performance

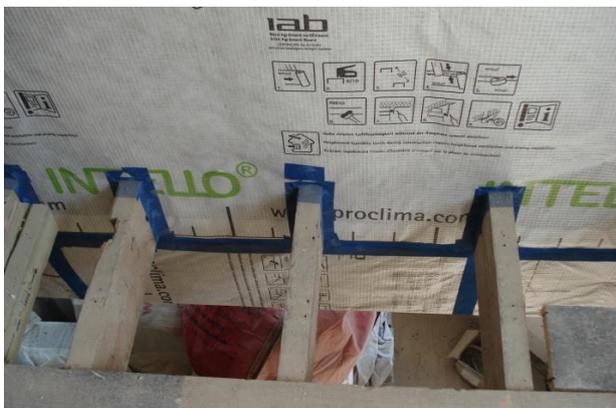
Air barrier to existing walls: existing intermediate floors were cut back to allow for the air barrier to be taped around floor joists

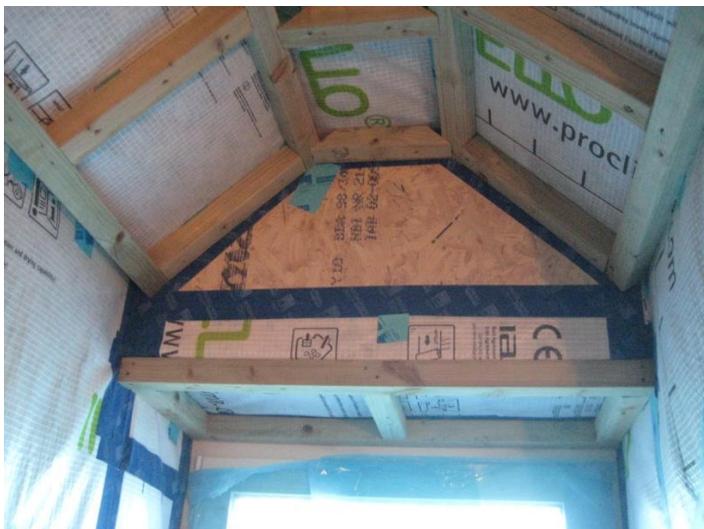
Air barrier to existing: A service void in front of the air barrier minimised service penetrations. To simplify complex geometries like e.g. dormers a combination of OSB boards and VCL membrane details was utilised...

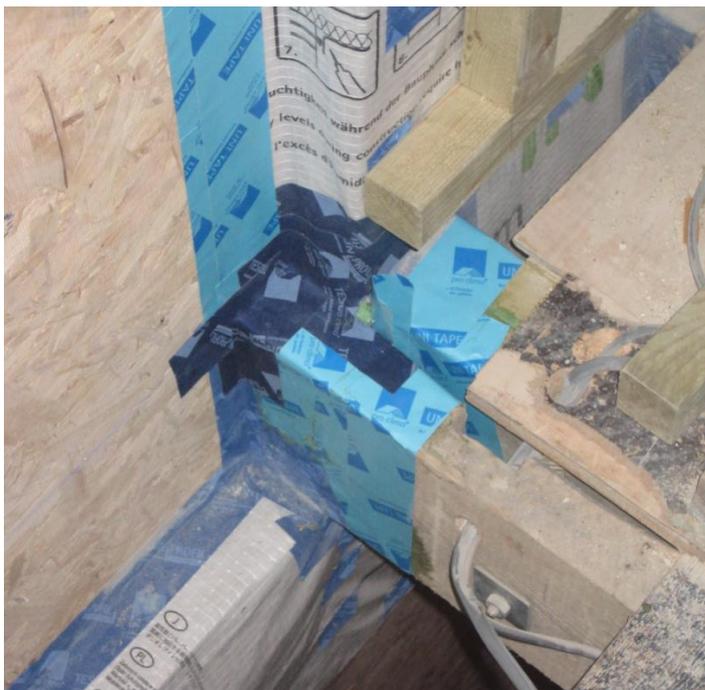
Air barrier to existing: ... still, some complex junction details within the existing structure were unavoidable

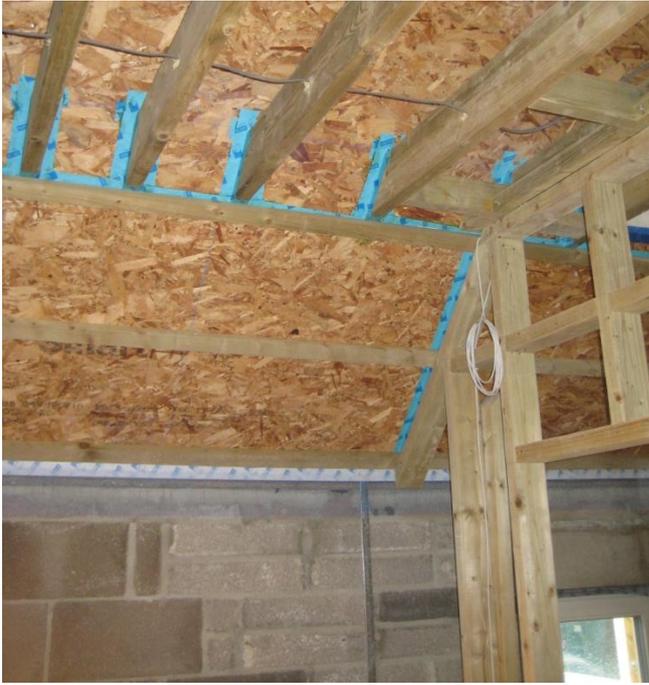
Air barrier to new extension: the air barrier in the roof was formed by OSB and linked to the plastered wall with a plaster tape.

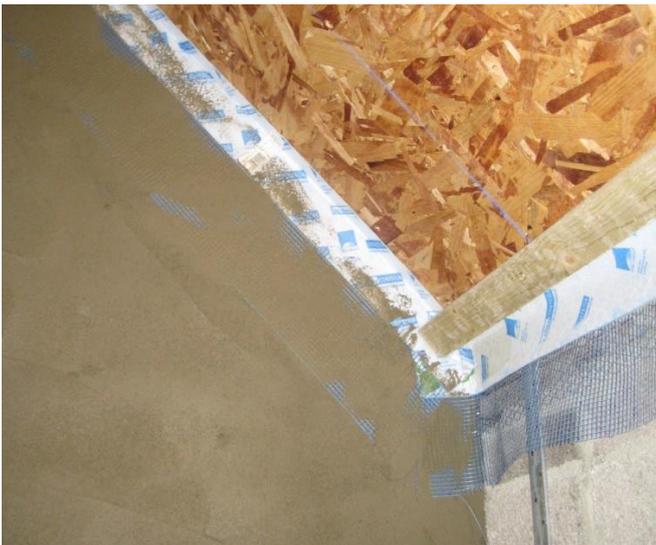
Air barrier to new extension: Reinforced plaster tapes were utilised at eave, verge and floor level and around all window openings.

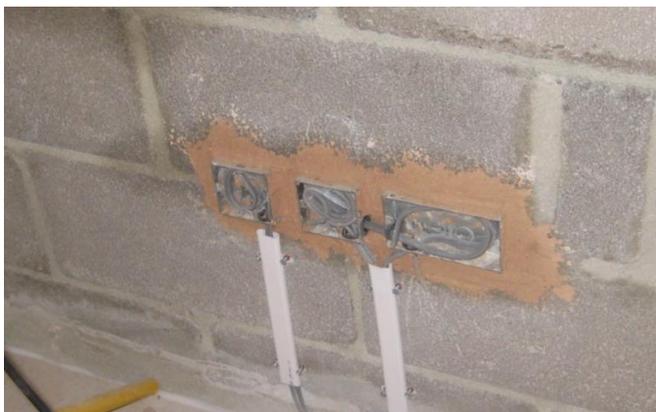
Air barrier to new extension: Sockets were fully bedded into mortar and trunking cut short to allow for continuous plaster layer (air barrier).

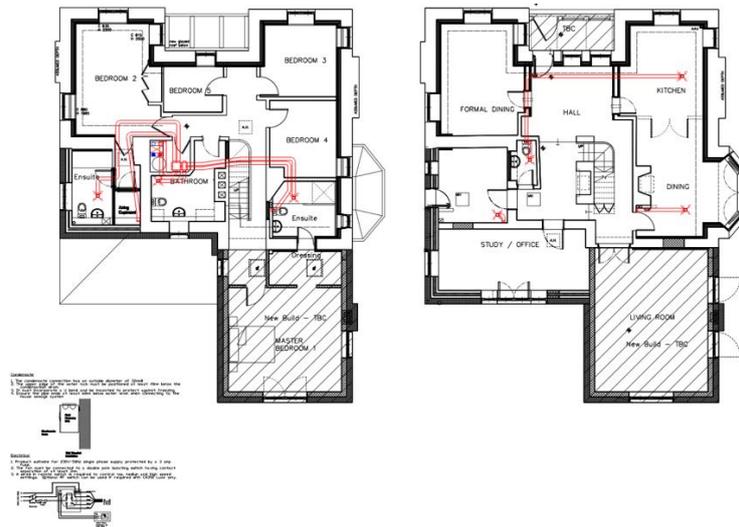
Suppliers installation drawings of ventilation duct layout – extract ducts

The ventilation system is located in a plant room on the first floor to allow for short cold ducts via the roof. Intake and exhaust are behind slate louvres at high level on the gables either side of the North façade. A flexible duct system (Zehnder comfotube) with central manifolds which also acts as cross talk silencers for supply and extract was specified. Air is supplied to bedrooms, formal dining, study and lounge and extracted from the kitchen and WC on ground floor and bathroom and ensuites on first floor. The hall, stairs and corridors are designed as transfer zones with all doors being undercut by 10mm as a minimum. The ground floor is slightly pressurised to assist with radon protection in this high radon location. Cold intake and extract ducts were insulated with 125mm fully vapour sealed insulation..

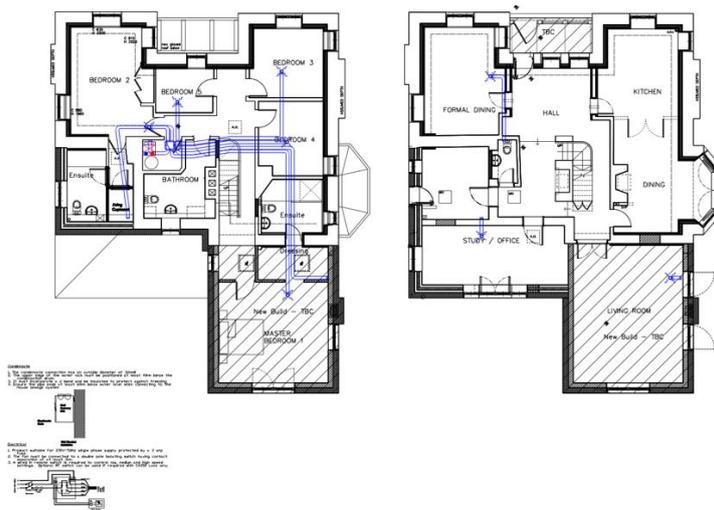
Suppliers installation drawings of ventilation duct layout – supply ducts

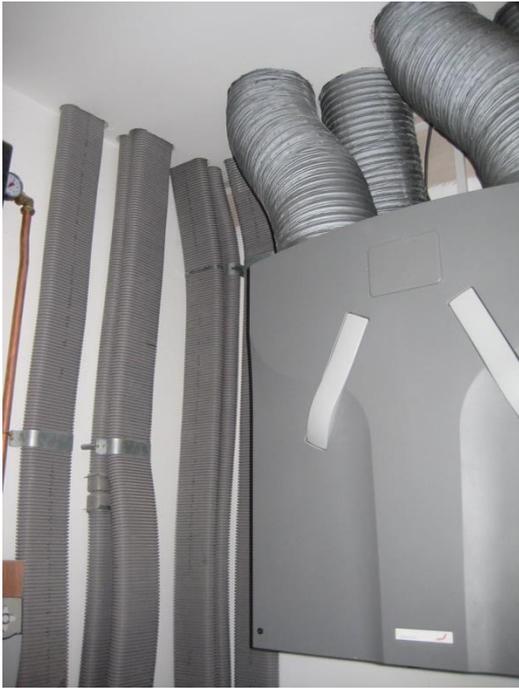
Ventilation unit and flexible supply ducts

Ventilation unit:	Zehnder Comfoair 350
Whole system efficiency (PHPP):	83.1%
Electrical efficiency:	0.31 Wh/m3

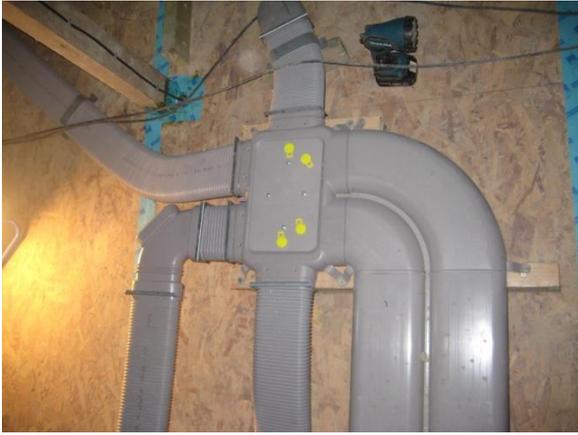
Supply and extract manifolds

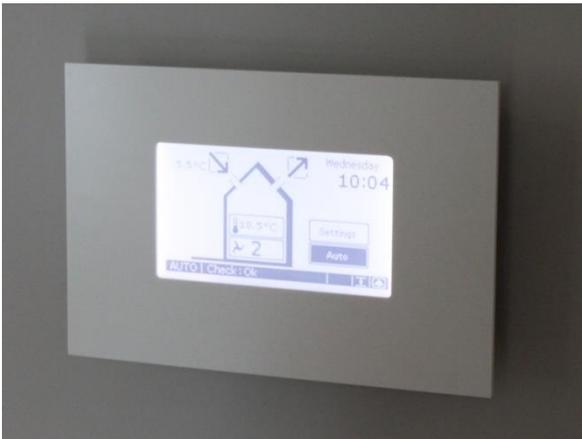
Ventilation control unit located in dining room

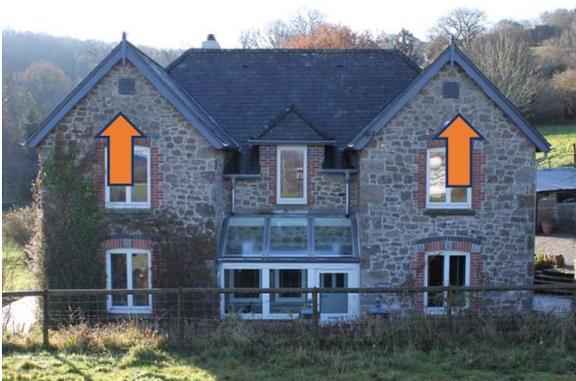
MVHR intake and exhaust behind slate louvres on north facing gables

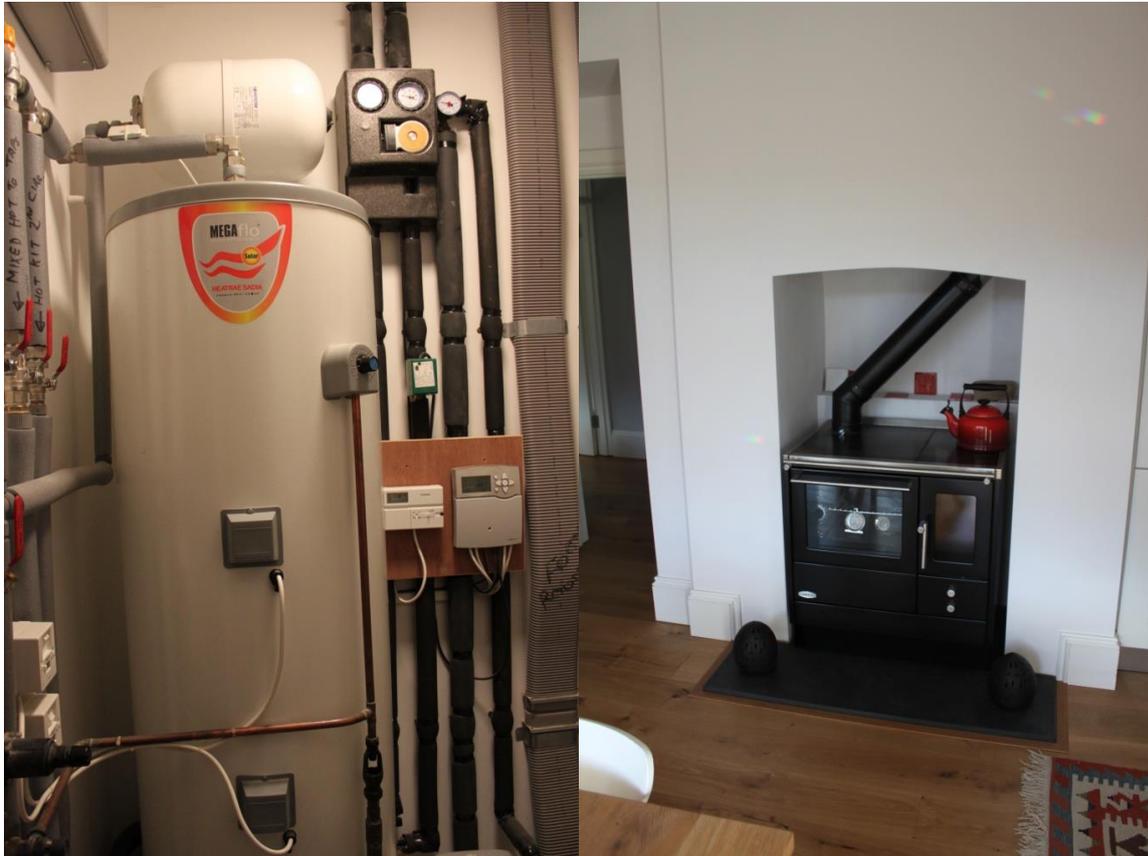
Thermal store and air tight range cooker with backboiler option replicating a traditional feature.

Domestic hot water is provided via a thermal store on the first floor connected to solar thermal panels on the south facing roof with electric immersion back up.

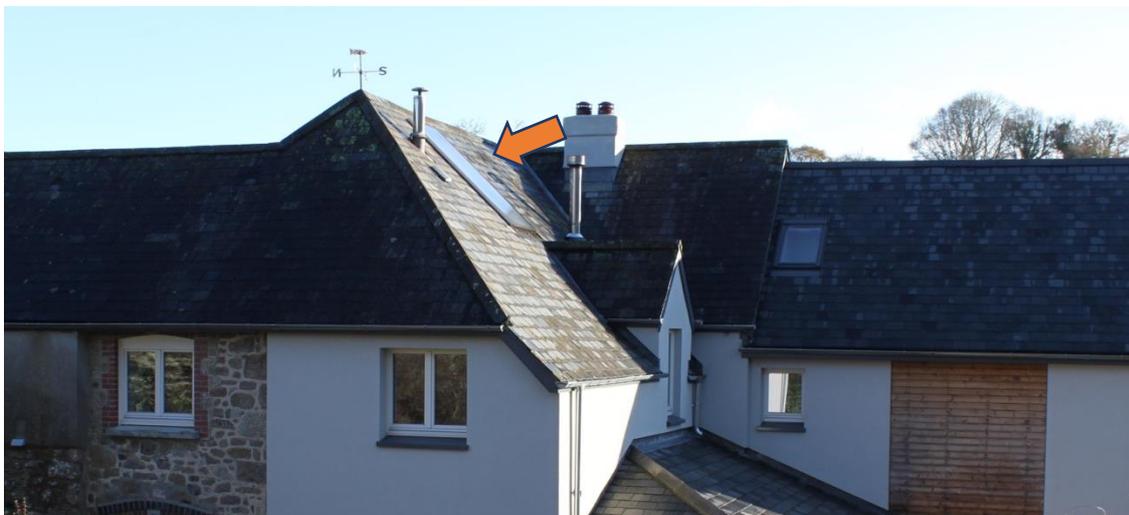
Solar thermal panels on south facing roof
