# Project Documentation – Shotover Passive House

## 1 Description of project

Single detached dwelling in Shotover country, Queenstown

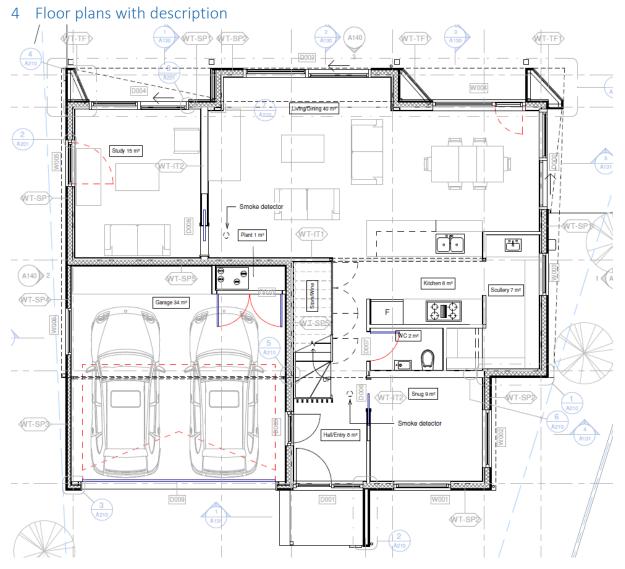
Ground floor plan

The ground floor plan contains the living spaces, kitchen, an office, WC and the garage (outside the thermal envelope). The location of the garage presented some challenges in terms the surface area and of detailing. The MVHR is located in the garage. The north elevation has some non-structural elements to provide shading

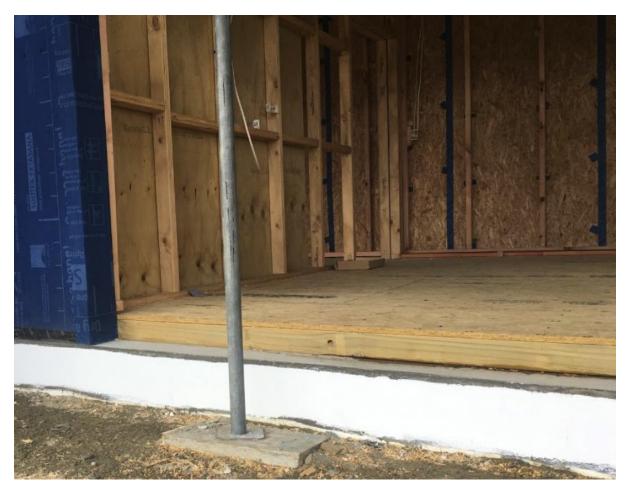
Edge of overlay insulation build up visible prior to installation of doors

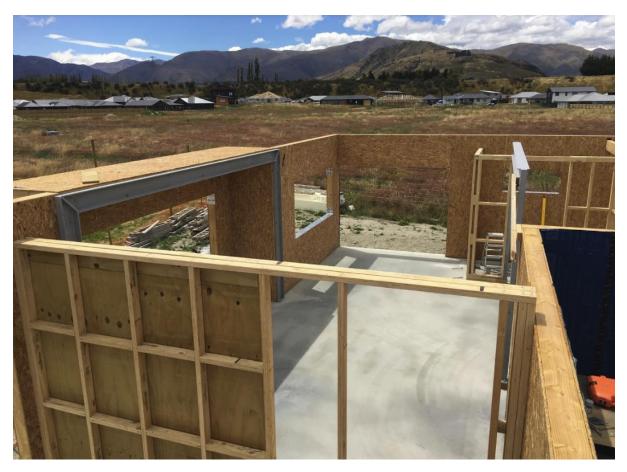
Ground floor SIP panels in place

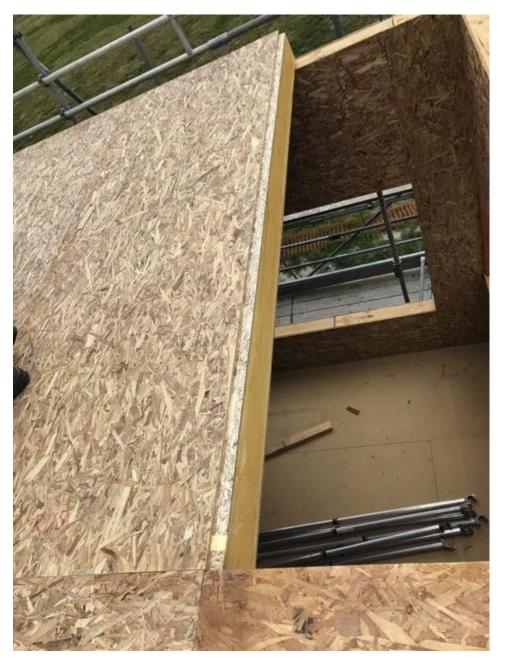
Roof panel installation

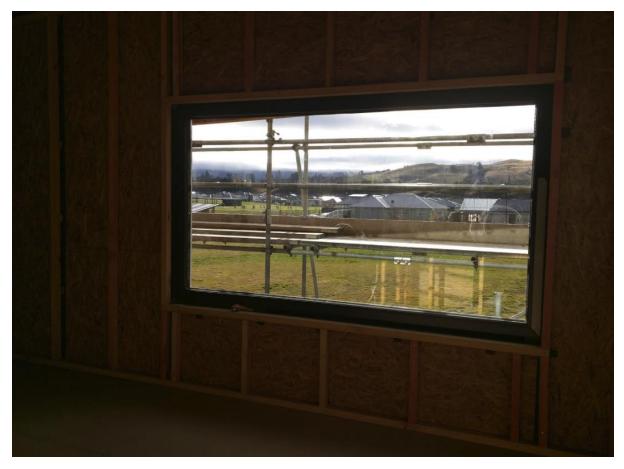
Installed window, prior to installation of internal insulation and linings. OSB airtightness layer.

Interior OSB layer of SIP panels forms the airtightness layer for the roof and walls (photo previous). The plywood overlay form the airtightness layer to the floor. All joints were tape sealed. Pressure test n50 result was 0.49 1/h

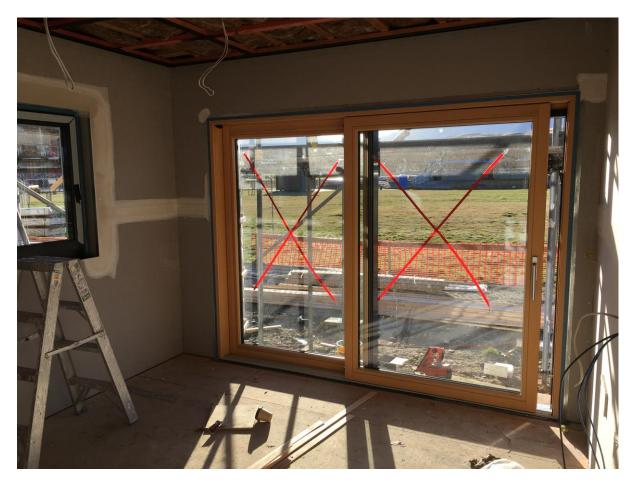
Installed sliding door

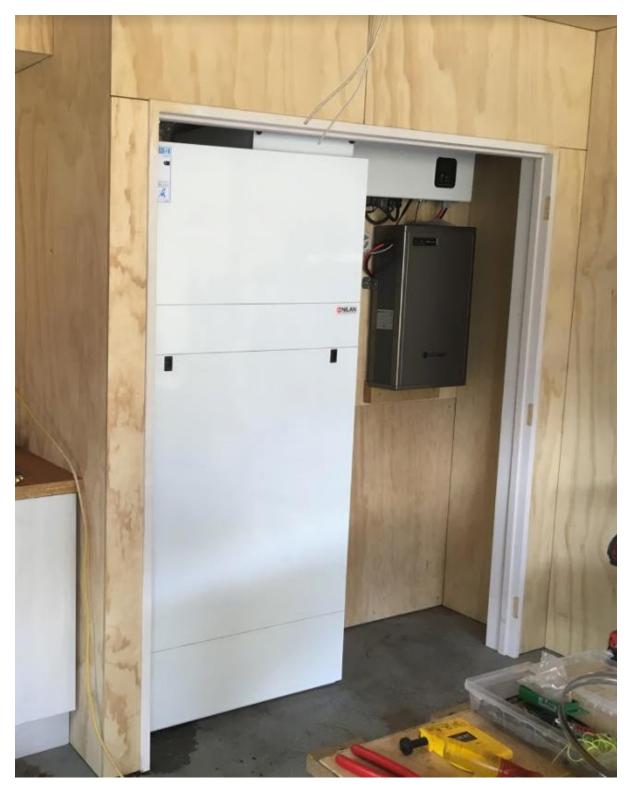
ventilation system make	Nilan Compact P
effective heat recovery efficiency	77.7%
electrical efficiency	0.4 Wh/m³)

3. Nilan compact P in garage

Nilan Compact P compact unit in garage. Supply air heating and domestic hot water.

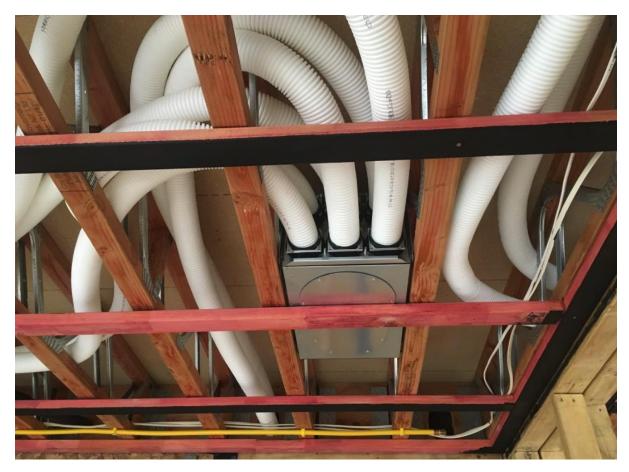
4. Supply air manifold between joist in intermediate floor.
