# Submission for renewal of CEPH Designer qualification by Paul Mallion, BSc(Hons) MSc(Arch) FRICS

**The Den, Ansty, Dorset.**

**Detached three bedroom house in Dorset, England**

### The Den, Ansty, Dorset

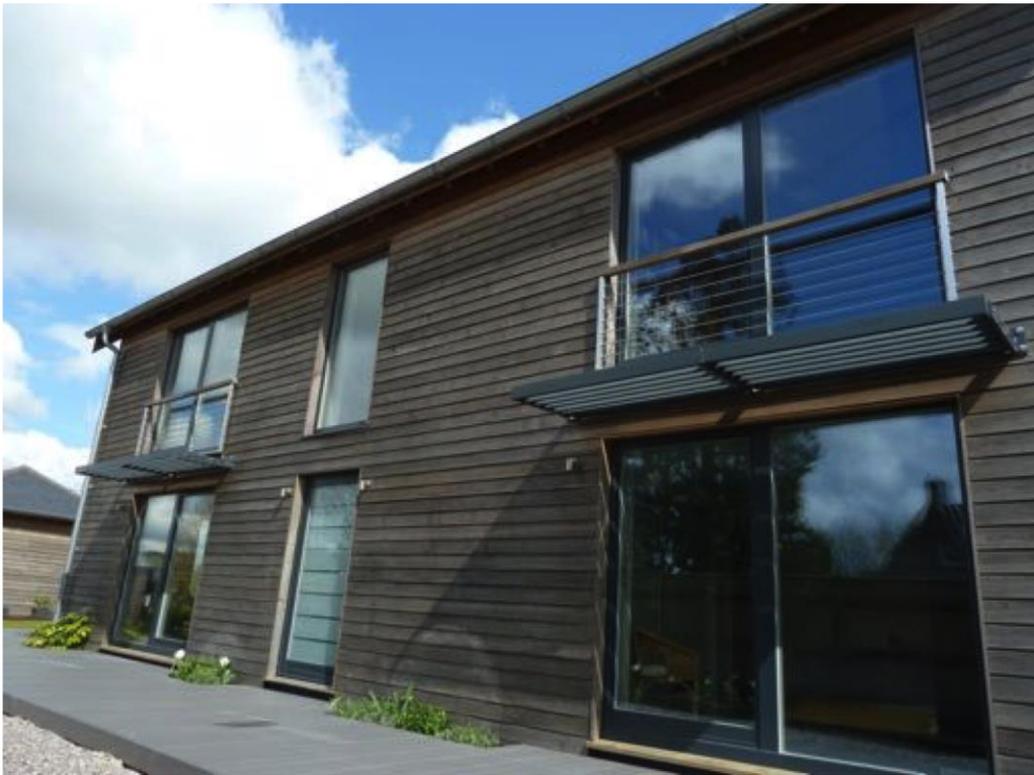
**South elevation:** main entrance door in centre. Sliding doors to main rooms and fixed window to stairwell above entrance. Fixed solar shading over ground floor windows. Deep roof overhang.

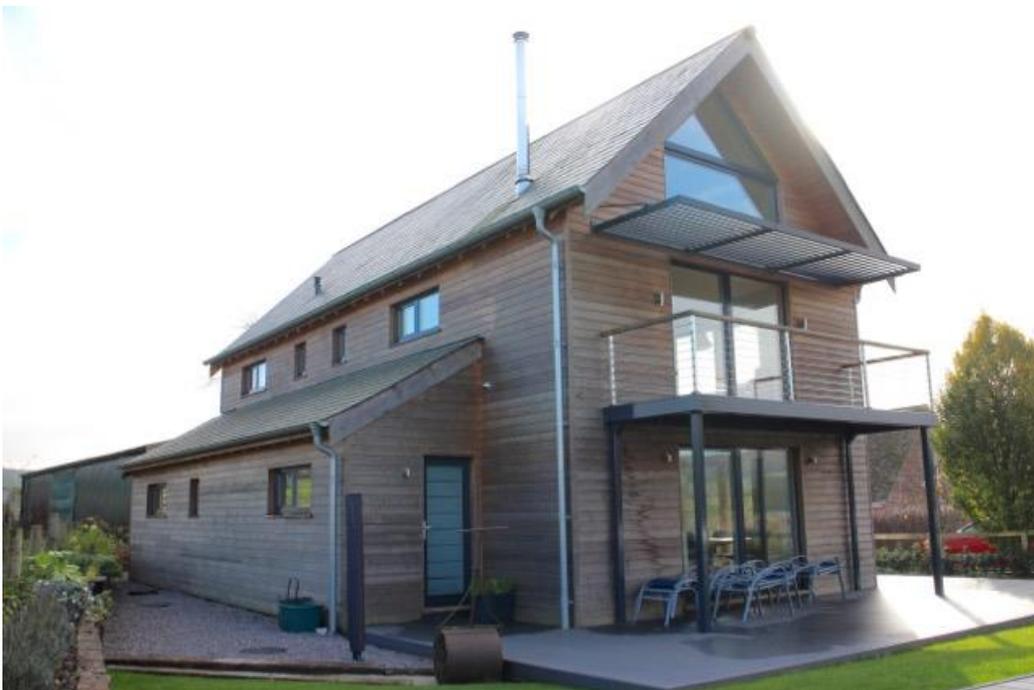
**View from north west:** Large west facing windows enjoy good views over countryside. Deep roof overhang, fixed shading and balcony provide shading.

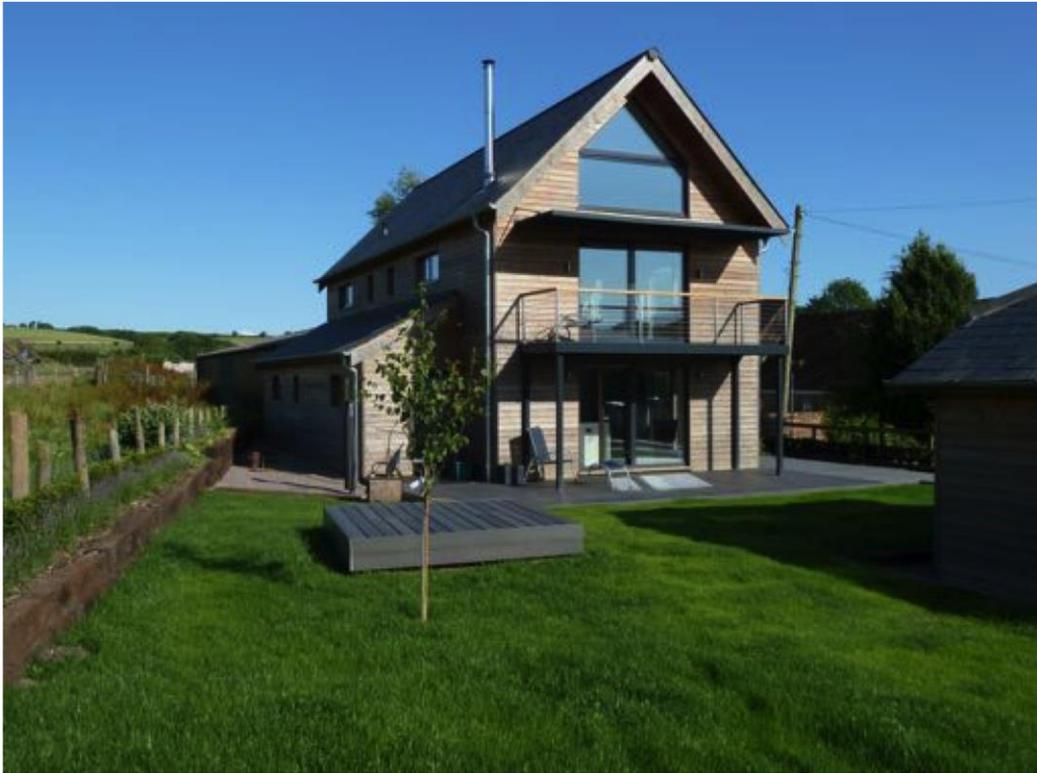
West view: showing solar shading. Decking in foreground covers aeration sewage treatment plant.

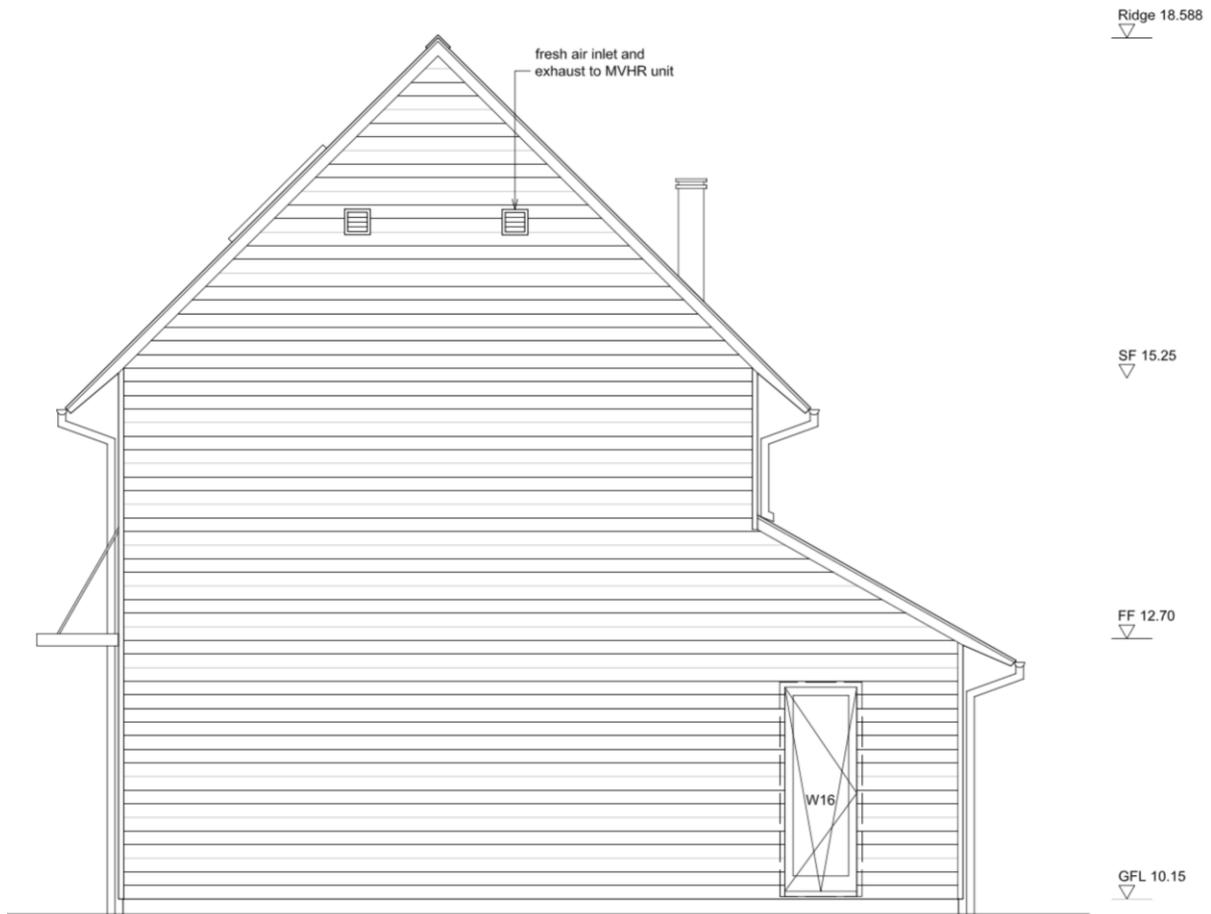
**EAST ELEVATION**  
(SCALE 1:50)

East view. The dwelling is located very close to the East site boundary on which is there is a pig farm and barn. It is not possible to access the adjoining site to take a photograph. The above image is from the design drawings.

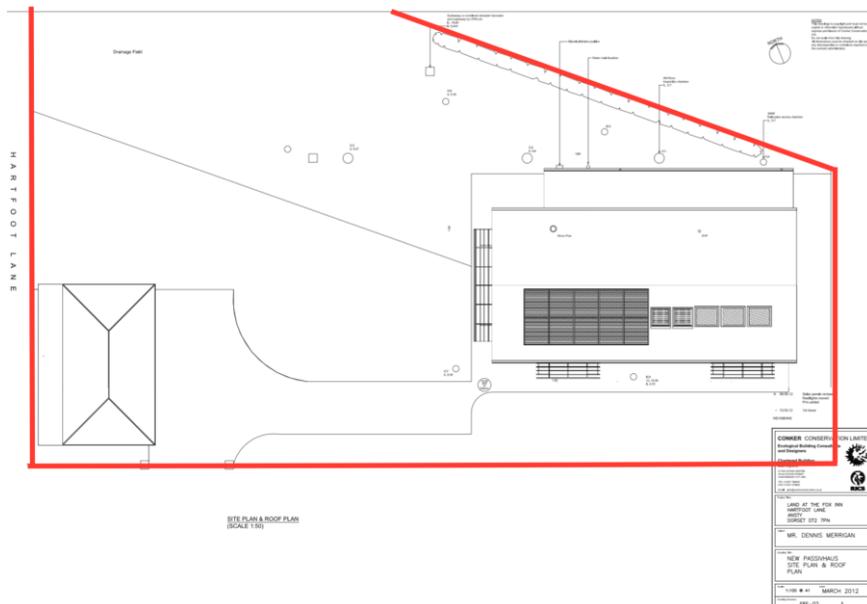
The plan to the left shows the site boundaries in red, indicating how close the East elevation is to the edge of the site.

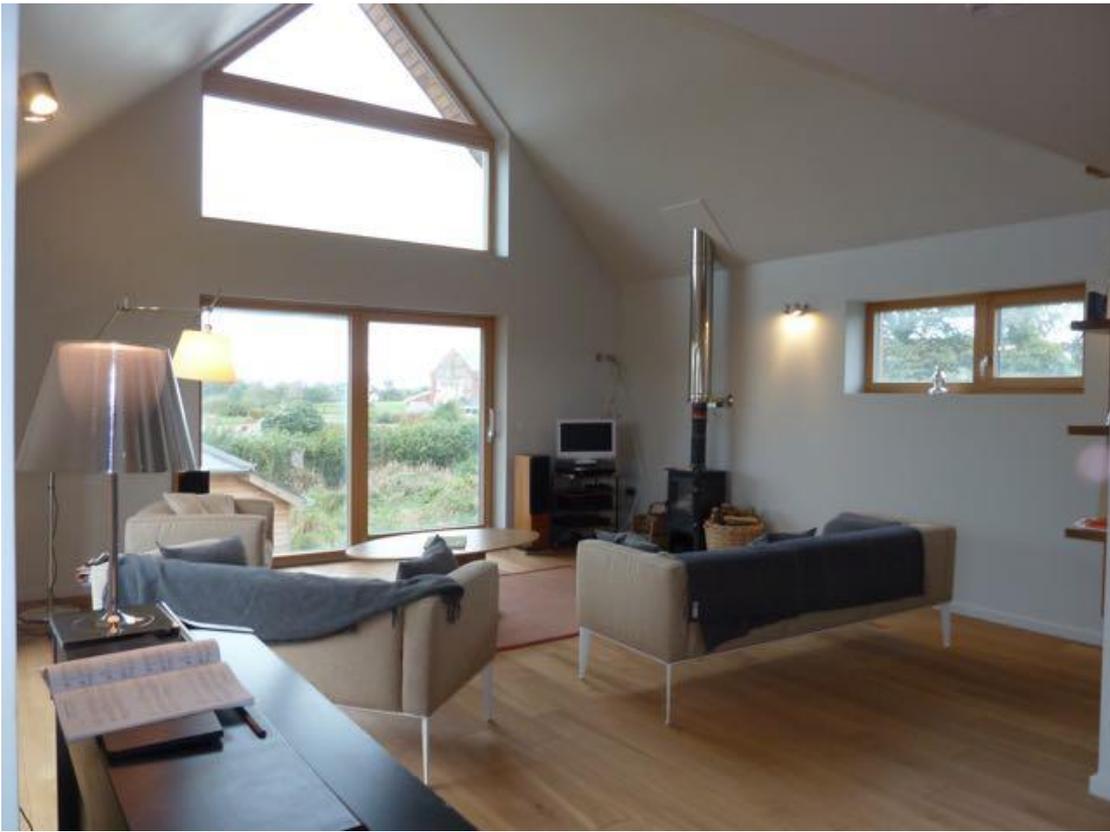
Internal view of main living space and wood stove in corner.

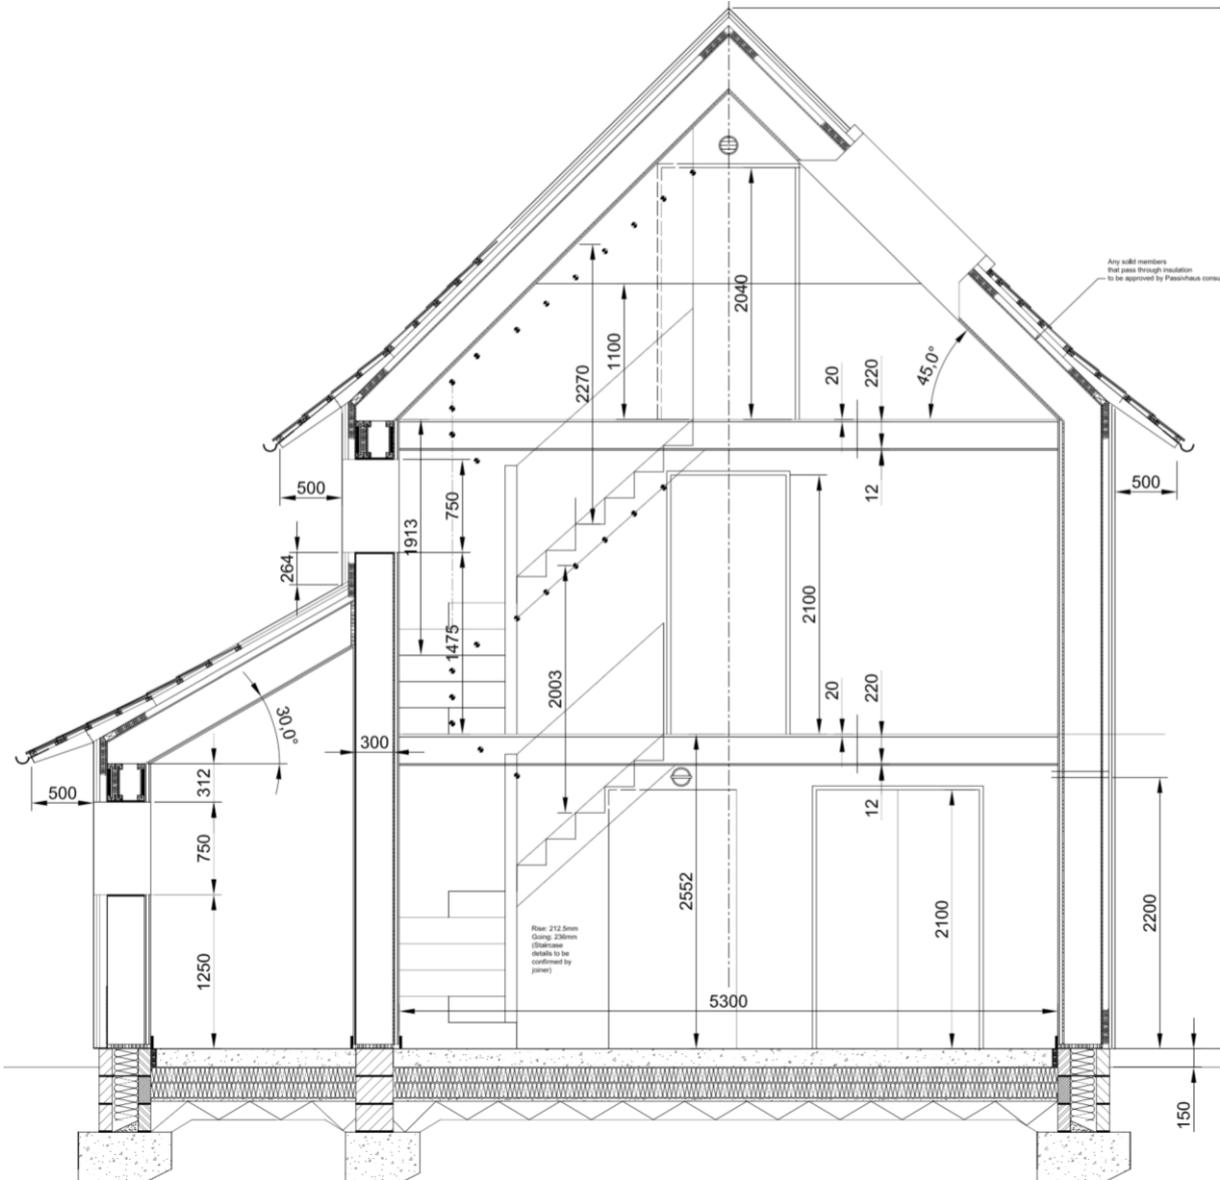
#### 3.1. Cross section drawing 486-05

3.2. Drawing shows a simple timber frame using 300mm I joists for walls, roof and intermediate floors. The junctions between ground floor/wall, wall/roof are shown on the detail drawings listed later.

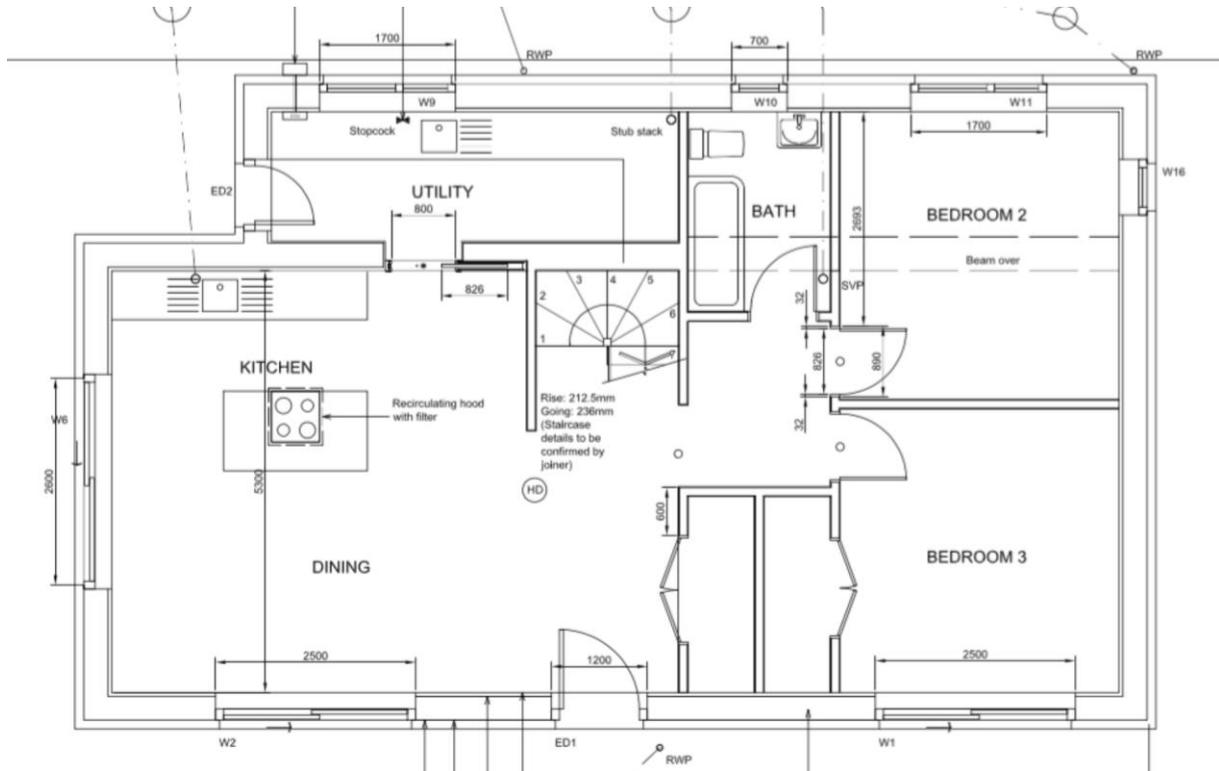
- 4.1. Proposed ground floor plan. The kitchen and utility room are on the ground floor, but also two bedrooms, as these rooms do not need to enjoy the views which are best from the floors above. The ground floor is also slightly cooler

owing to the thermal mass of the concrete floor slab. The utility room is on the north side of the house and also acts as a draught lobby and entrance for the owners. Bedroom 2 has the only east facing window, exploiting a narrow view of the hillside beyond the neighbouring pig shed. All the north facing windows are very shallow and wide, for good daylight but small overall area.

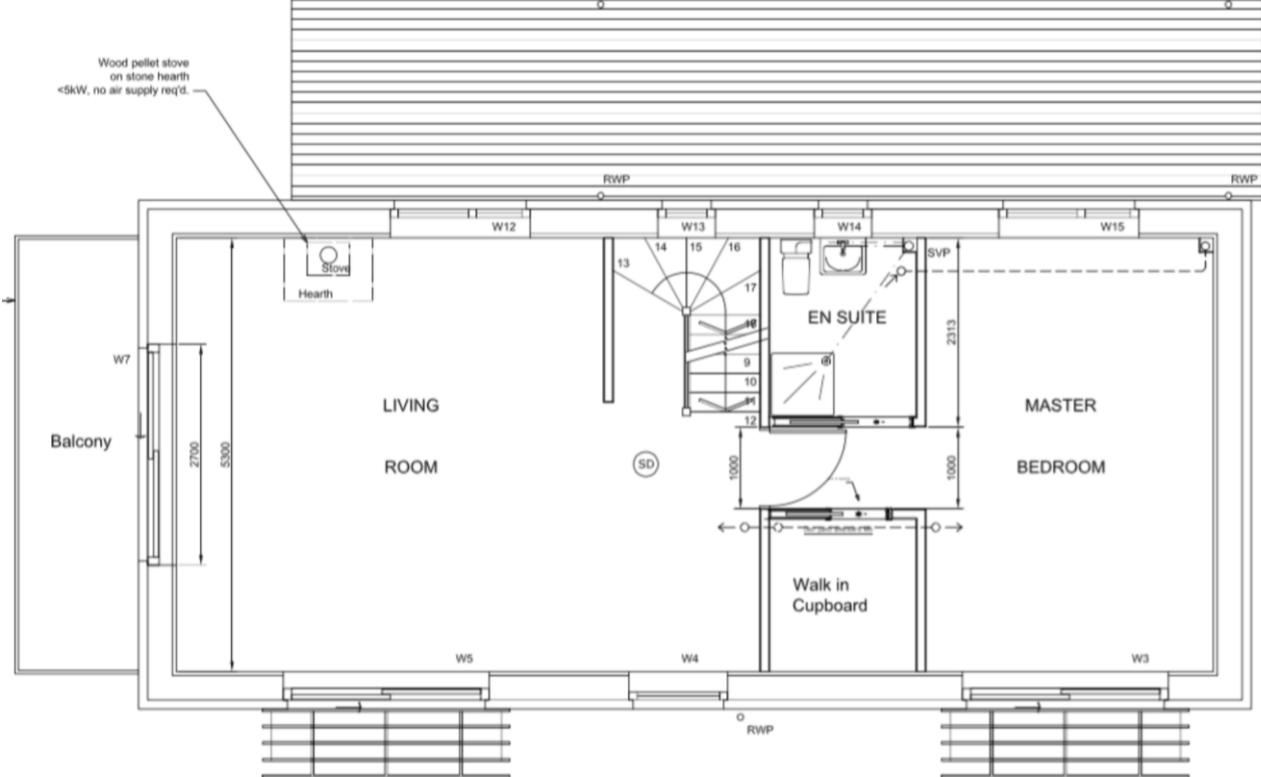
4.2. First floor plan. Mostly taken up with the living room so that it can enjoy good views across the country hedgerows and hillsides to the West. There are small north windows, but large south full height windows. To the west is a large sliding door opening onto a balcony. The balcony shades the kitchen doors below. The master bedroom is located at the east of the floor plan, with an ensuite and walk-in wardrobe.

The living area is double height, and contains the wood stove.

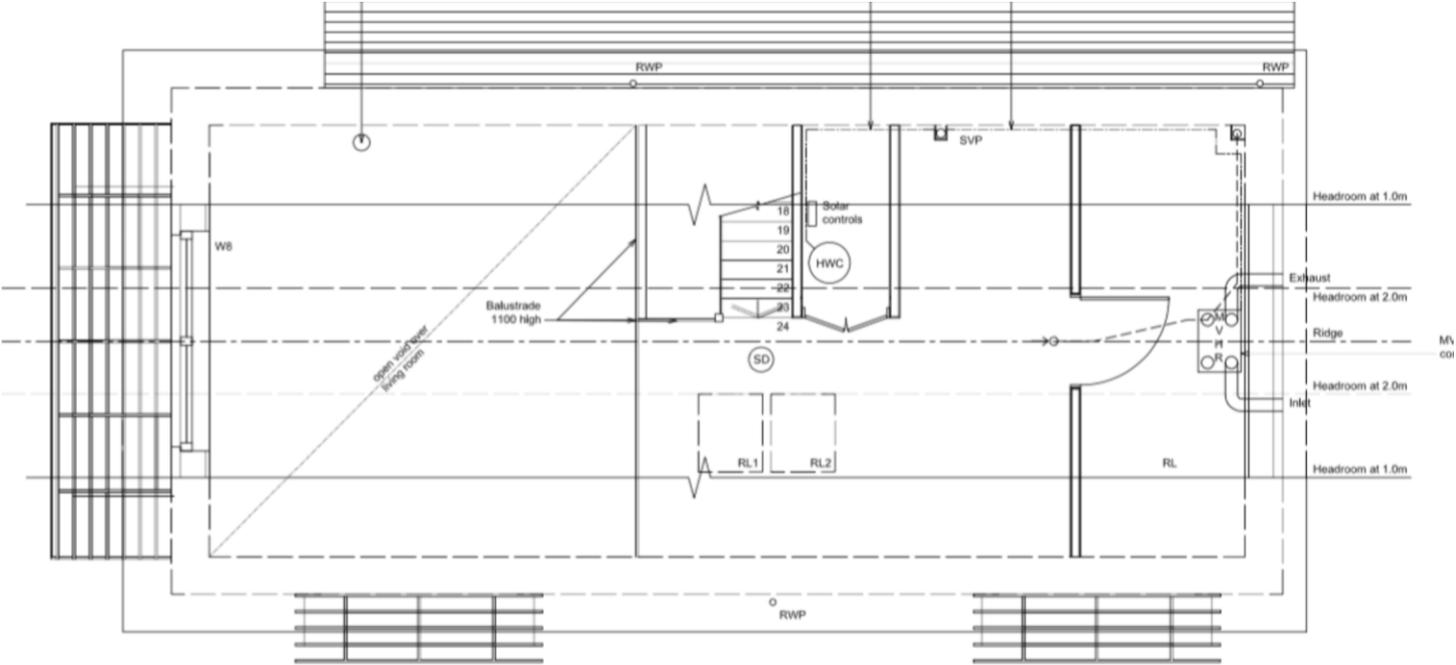
4.3. Second floor plan. At the top of the stairs is a mezzanine area which serves as a home office, but can also be used as a spare bed space. The plant room is at the east end. At the west end the floor is open to the floor below.

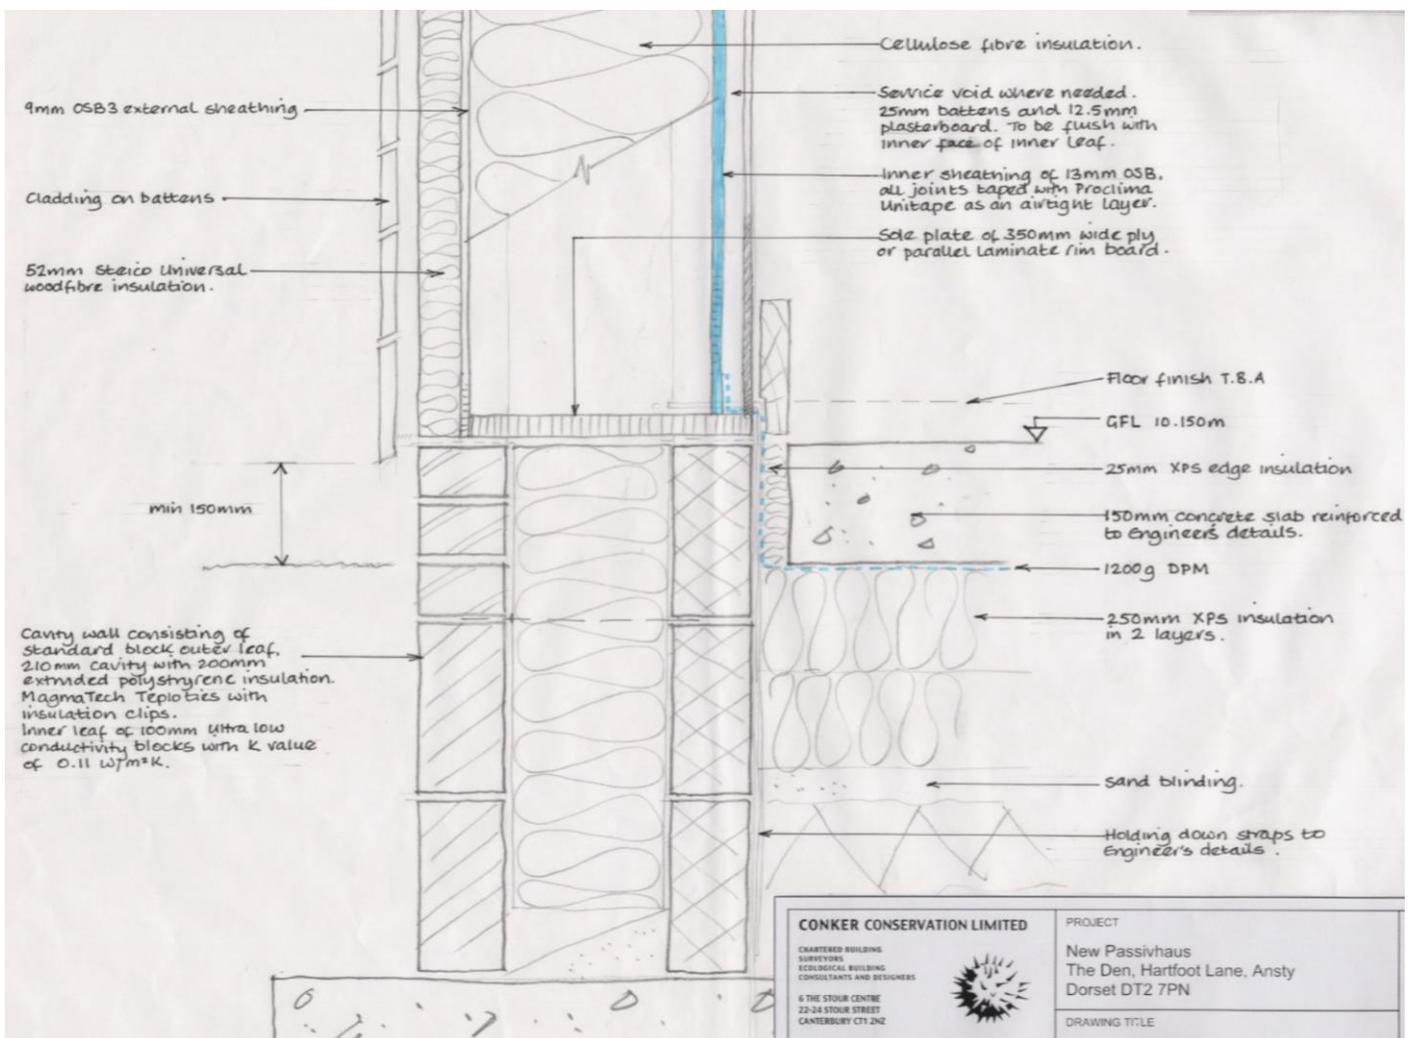
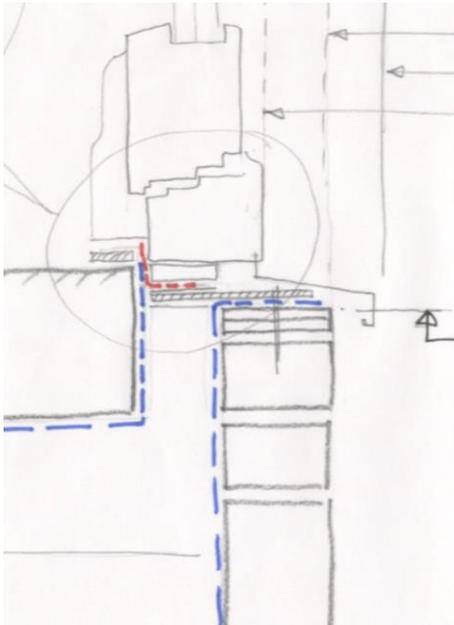
### 5.1 Floor slab/wall junction.

- 5.1.1 The ground floor is constructed as follows: 150mm reinforced concrete; damp proof membrane; 250mm XPS insulation; 25mm blinding and 150mm hardcore. The concrete was polished shortly after being laid and then had to be protected during the following works. This avoids the need for a screed. A cavity wall was used from the strip foundations up to damp proof course level, insulated with 200mm XPS and tied with low conductivity Teplo ties. Low conductivity blocks are used for the inner leaf, with a k value of 0.11 W/m<sup>2</sup>K. The cavity wall is capped with a sole plate for the timber frame.

- 5.1.2 Thresholds to the external doors are located over a strip of insulation to ensure no thermal bridges.

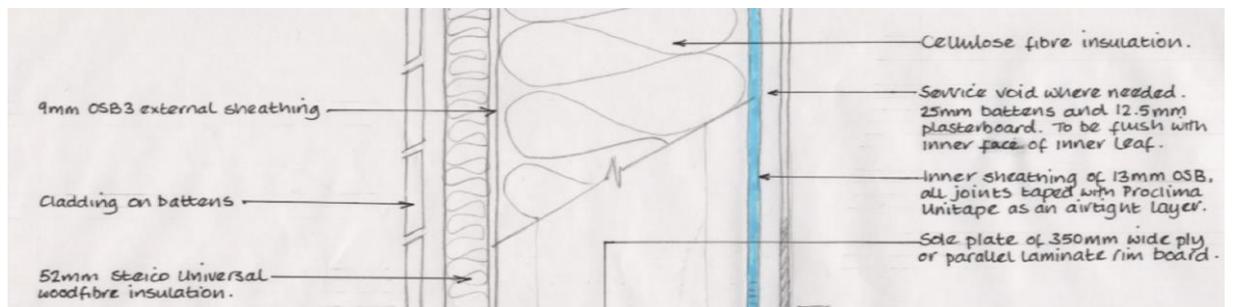
## 5.2 External walls.

- 5.2.1 The detail shows the 300mm wide 'I' joist (Steico SJ45 x 300) fully filled with insulation, and 52mm thick woodfibre sheathing board to the outside. A translucent fleece was fixed across the inside face of the timber frame before the insulation was injected, this allowed a full inspection of the insulation work to ensure no voids existed. The interior was then lined with OSB sheathing board. Due to the density of installation, the OSB pillows slightly between some of the studs, by battening (25mm thick) before plasterboarding the finish is perfectly flat.

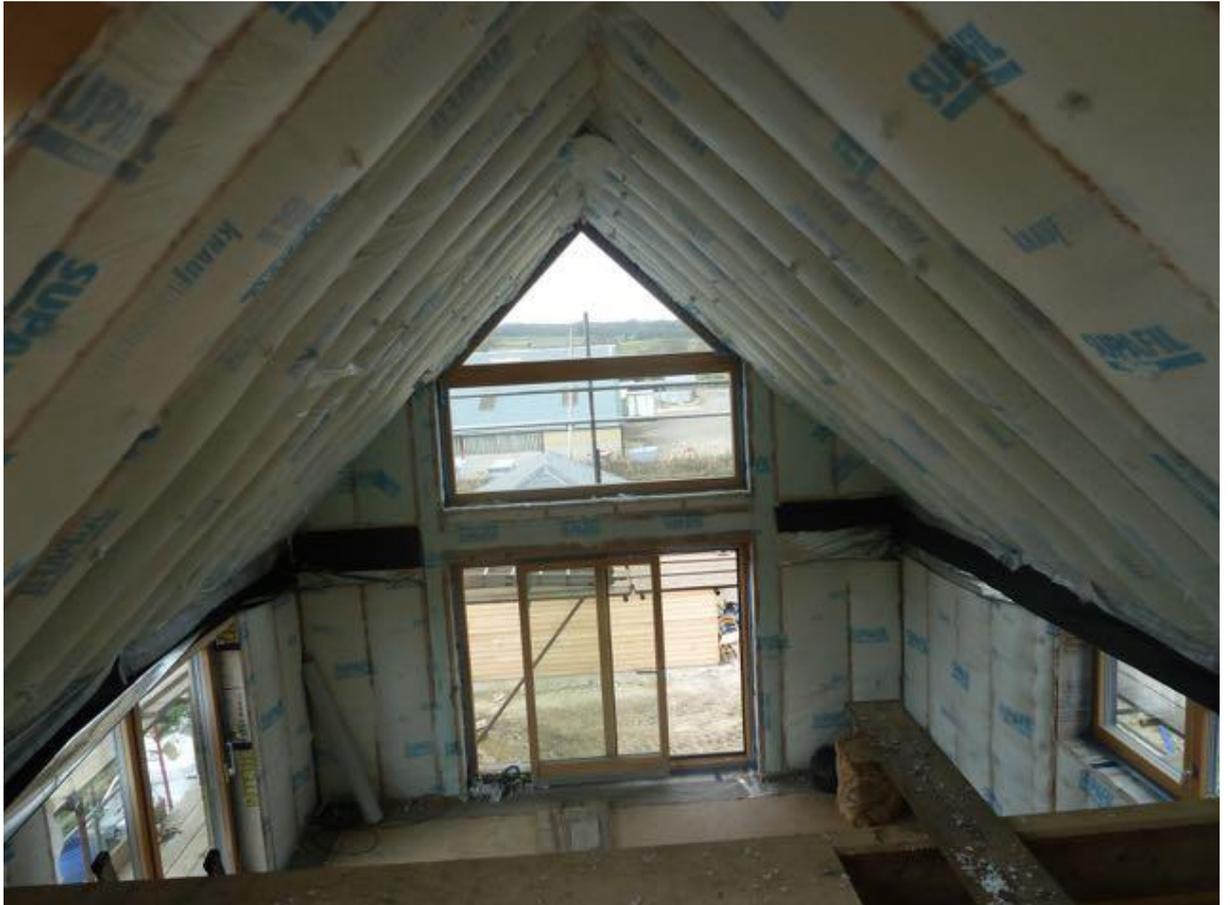
5.2.2 Photograph showing injected insulation retained by fleece.

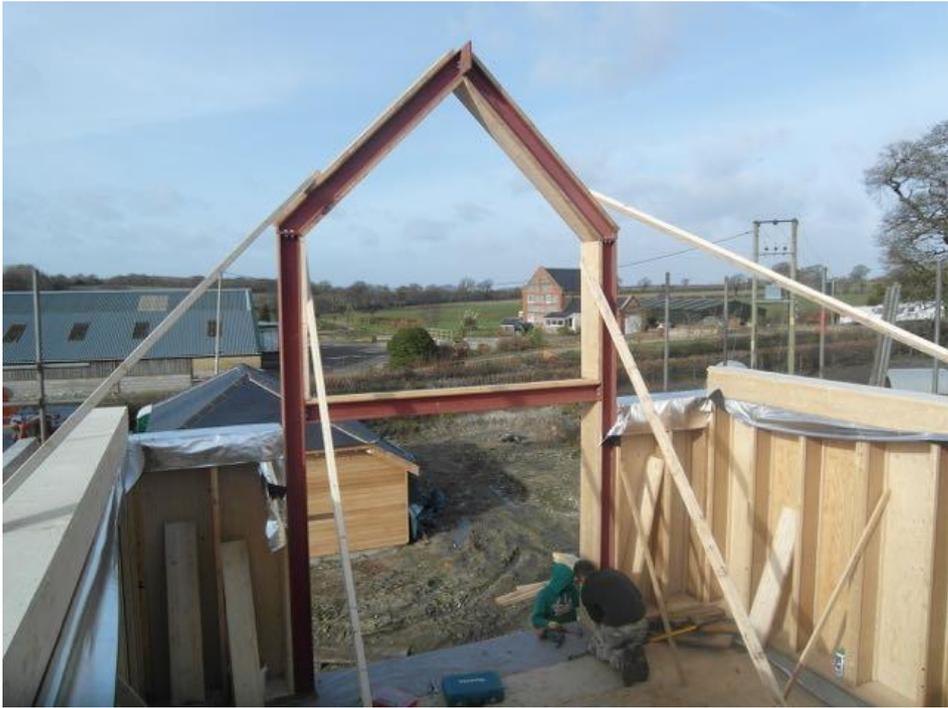
5.2.3 I was keen to avoid any steelwork in the structure so as to avoid cold bridges. Unfortunately the timber frame fabricator and their engineers were fairly traditional and would not entertain designing entirely without steel. A portal frame was required to the large west facing windows, but all other steel omitted. To mitigate the impact of the steelwork, I ensured that the steel was placed as close to the inside face as possible, with high performance insulation wrapped around it.

5.2.4 Steel frame for wind bracing. The airtight membrane can be seen placed underneath the wall plate, prior to the next level being raised.

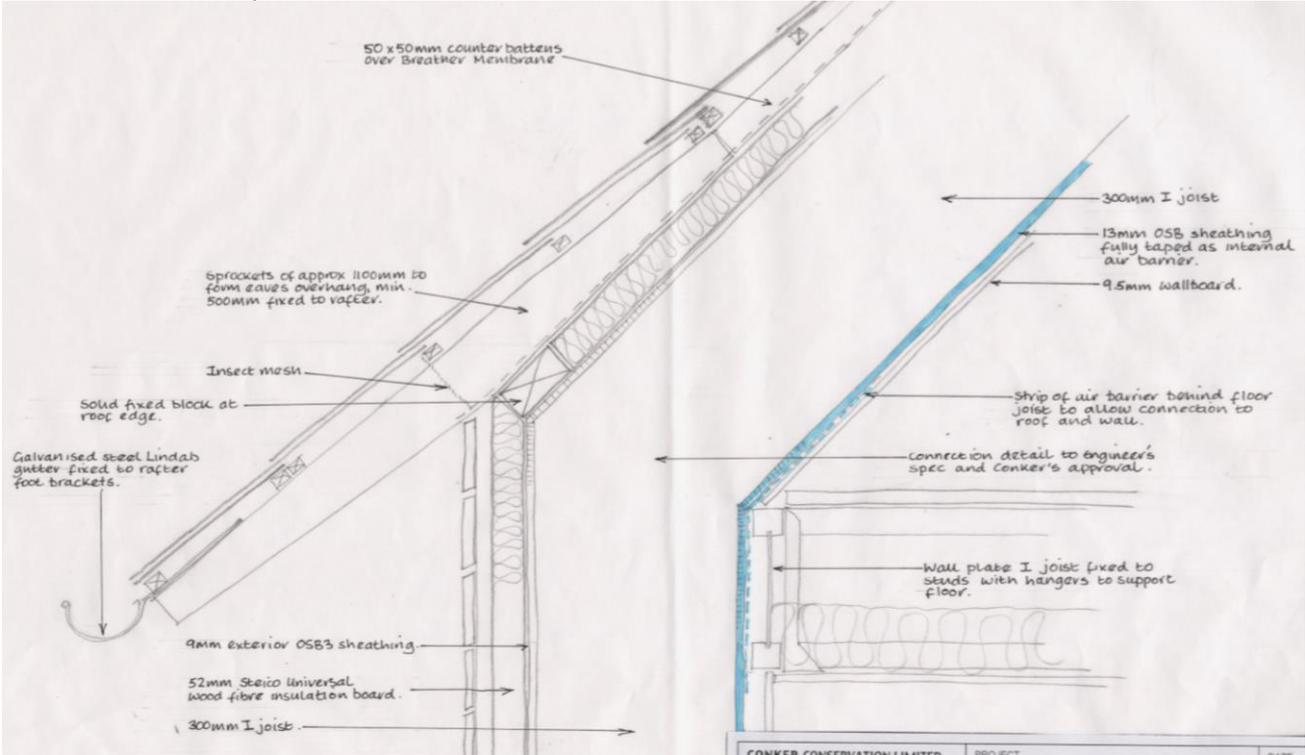
### 5.3 Roof

5.3.1 Roof construction is the same as the walls, apart from the finish. (300mm 'I' joists fully insulated with glass fibre, and 52mm dense woodfibre sarking insulation).

5.3.2 Sprockets are used on top of the roof surface to create the eaves overhang, without any components penetrating through the airtight, windtight or insulation layers. My original plan was to avoid using a traditional wall plate, but to use a portal frame principles with gussets joining the studs and rafters, as we did on the Greendale Studio Passivhaus. Unfortunately the timber frame contractor was not able to use this technique, so we settled for conventional construction using I joists, but paying careful attention to the placement of studs and the timber fraction.

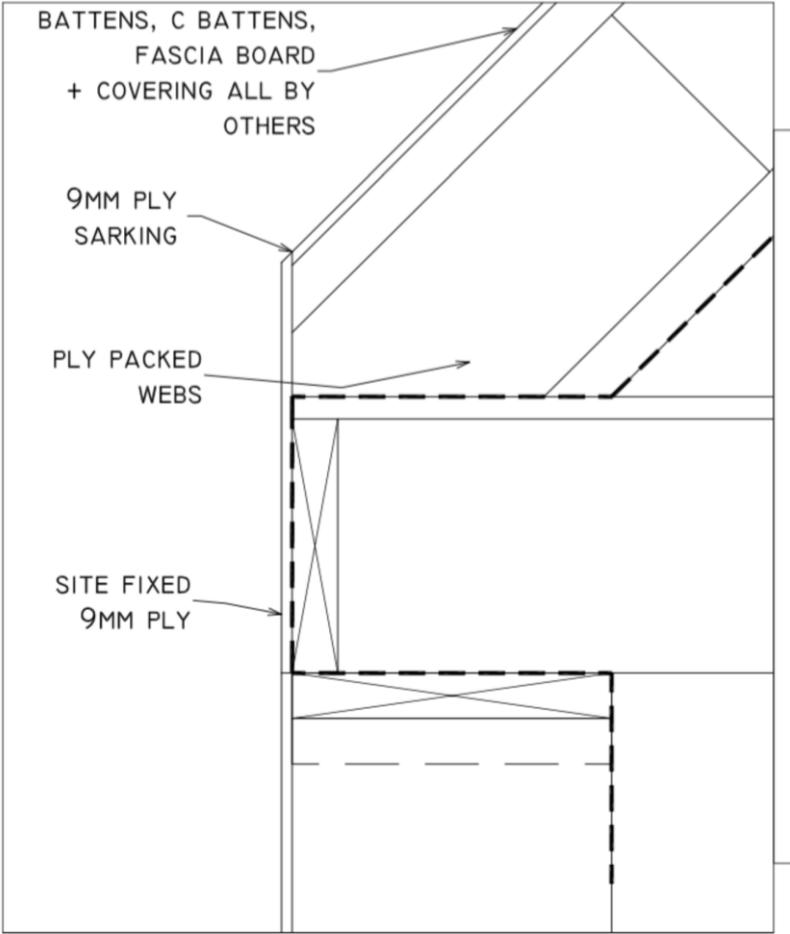
5.3.3 Timber frame manufacturer's detail of the eaves junction, showing continuity of the airtight membrane around the second floor structure.

- 6.2 Certain membranes had to be installed during the construction so that continuity could be ensured between each floor. The photograph above shows the membrane sandwiched under the ground floor structure. The principle is also shown in the drawing in 5.3.3.

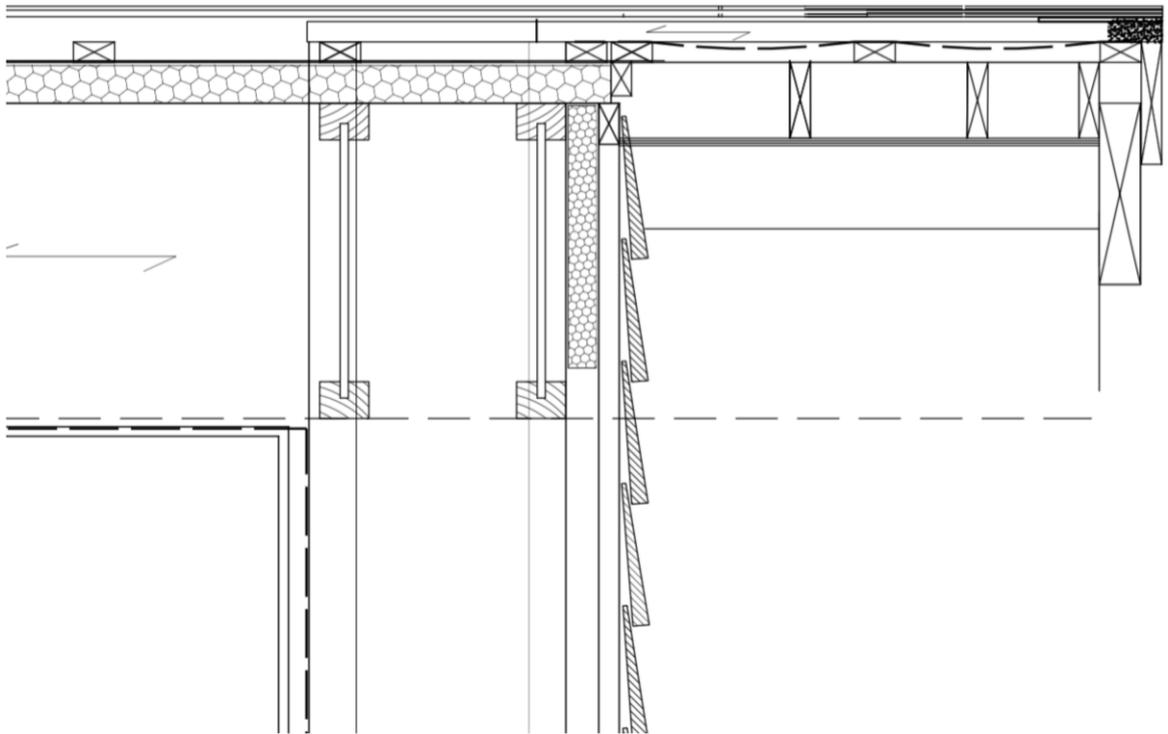
- 5.3.4 The verge detail at the junction of the roof and the gable end is shown below. This shows how the insulation continuity was achieved in both the injected glass fibre insulation and the external wood fibre insulation.

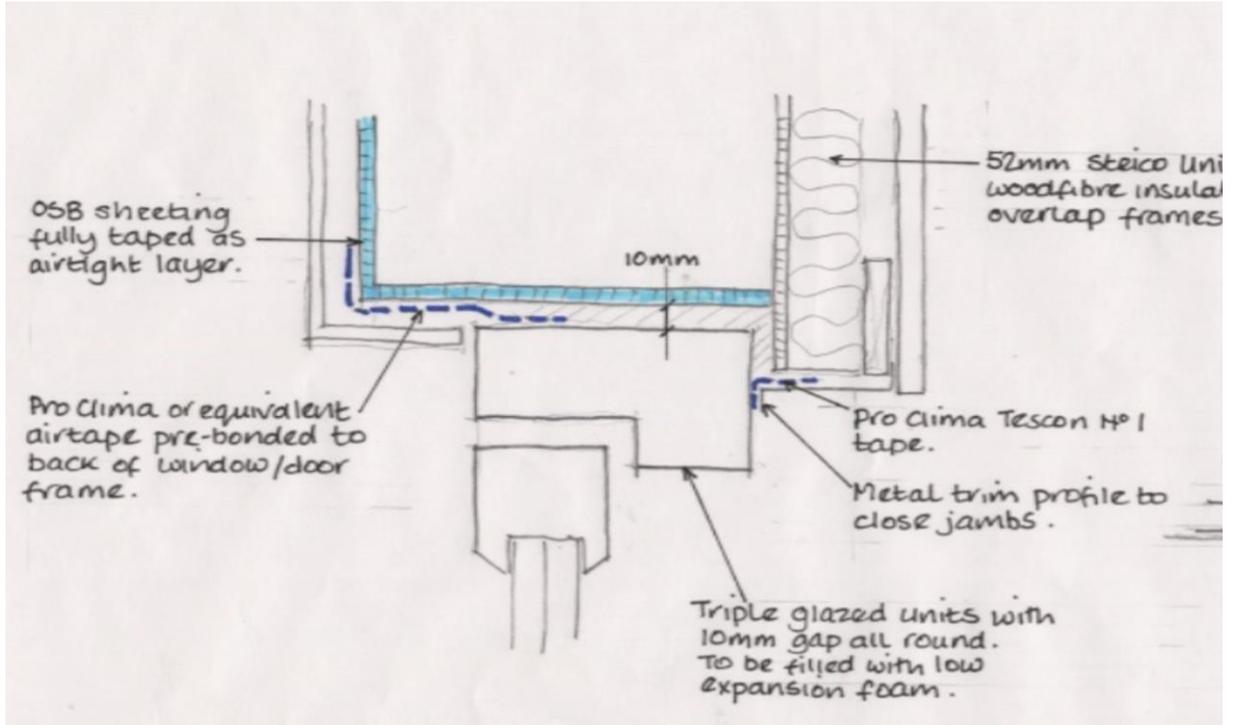
- 5.4.1 Windows were fitted flush with the exterior face of the timber structure, which allows the outer woodfibre board to slightly overlap the window and door frames. The gaps around the windows and doors has been designed at 11mm wide, which I have found to be ideal for injection with low expansion foam, which is trimmed flush before sealing with airtight tape.

5.4.2 Detail section through window jamb.

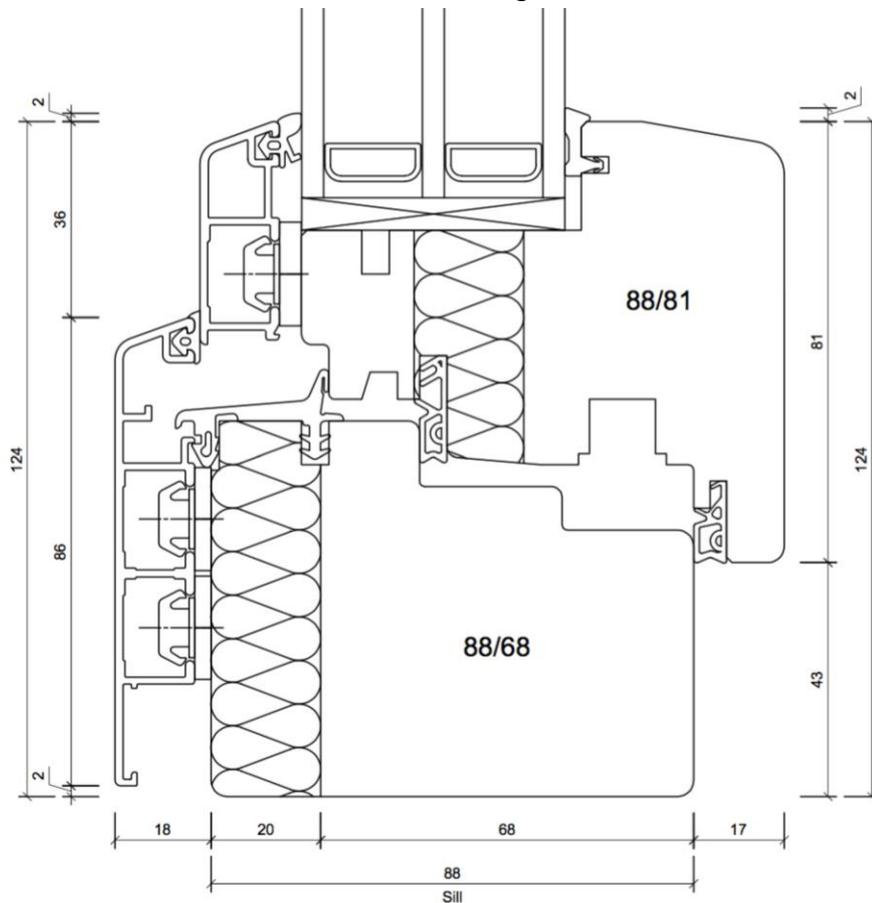
5.4.3 The window profile section shows the insulation layer incorporated into the frame and sash, and aluminium facing.

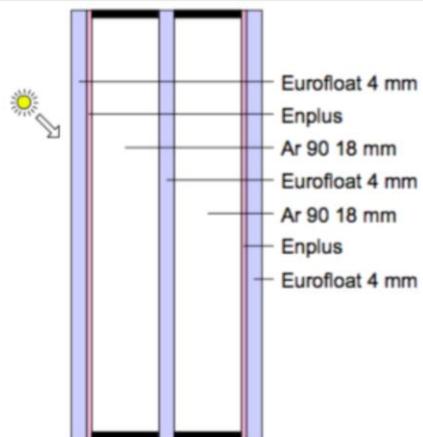
Window tilt angle: 90°

Thermal transmittance Ug:	0.528 W/m²K	EN673:2011	CE
Total solar energy transmittance (g-value):	49.29 %	EN410:2011	
Light transmittance:	70.42 %		
Light reflectance (outside):	18.21 %		
Light reflectance (inside):	18.21 %		
Light absorption:	11.37 %		
Solar direct transmittance:	41.75 %		
Solar direct reflectance (outside):	32.26 %		
Solar direct absorption:	25.99 %		
Secondary internal heat transfer Factor:	7.54 %		
UV-Transmittance:	16.58 %		
UV-Reflectance:	16.01 %		
UV-Absorption:	67.41 %		
General Color Rendering Index Ra (trans.):	96.42		
Selectivity (Lt / g-value):	1.429		
Shading Coefficient (g-value / 0.87):	56.66 %		
Shading Coefficient (g-value / 0.8):	61.61 %

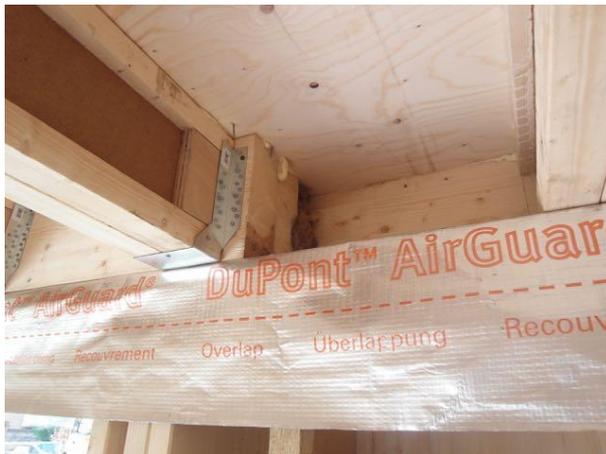
- 6.1 The first challenge was that the contractor had never built to an airtightness standard before. The details had to be simple to execute. The airtight junctions were drawn carefully, and airtight layers shown on the timber frame companies drawing.

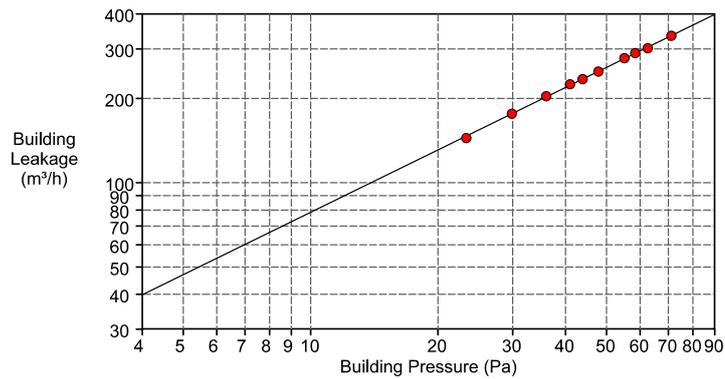
Airflow at 50 Pascals: 258 m<sup>3</sup>/h ( +/- 0.2 % )  
 (50 Pa = 0.2 w.c.) 0.59 ACH (1/h)

Leakage Areas: 87.5 cm<sup>2</sup> ( +/- 1.1 % ) Canadian EqLA @ 10 Pa  
 42.8 cm<sup>2</sup> ( +/- 1.8 % ) LBL ELA @ 4 Pa

Building Leakage Curve: Flow Coefficient (C) = 14.3 ( +/- 2.7 % )  
 Exponent (n) = 0.740 ( +/- 0.007 )  
 Correlation Coefficient = 0.99965

Test Standard: EN 13829	Test Mode: Depressurization
Type of Test Method: B	Regulation complied with: ADL1A
Equipment: Model 3 Minneapolis Blower Door, S/N 12455

- 6.6 Preliminary air testing showed that the contractor had left some areas to improve such as service entries, and corners where the airtight membrane was wrapped around the floor cassettes. The final results came in just about on target, 0.58 and 0.59 ach under pressurisation and depressurisation respectively. The test was carried out by JTec Environmental Ltd, Dorset, BINDT test ref 68104.
- 6.7 Copies of the pressurisation test and depressurisation test is attached from JTec Environmental Ltd.

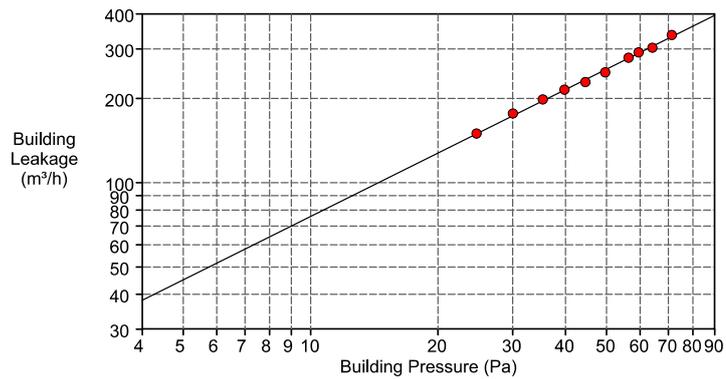
Airflow at 50 Pascals: 254 m<sup>3</sup>/h ( +/- 0.5 % )  
 (50 Pa = 0.2 w.c.) 0.58 ACH (1/h)

Leakage Areas: 84.7 cm<sup>2</sup> ( +/- 2.7 % ) Canadian EqLA @ 10 Pa  
 41.1 cm<sup>2</sup> ( +/- 4.1 % ) LBL ELA @ 4 Pa

Building Leakage Curve: Flow Coefficient (C) = 13.5 ( +/- 6.3 % )  
 Exponent (n) = 0.751 ( +/- 0.016 )  
 Correlation Coefficient = 0.99822

Test Standard: EN 13829	Test Mode: Pressurization
Type of Test Method: B	Regulation complied with: ADL1A
Equipment: Model 3 Minneapolis Blower Door, S/N 12455

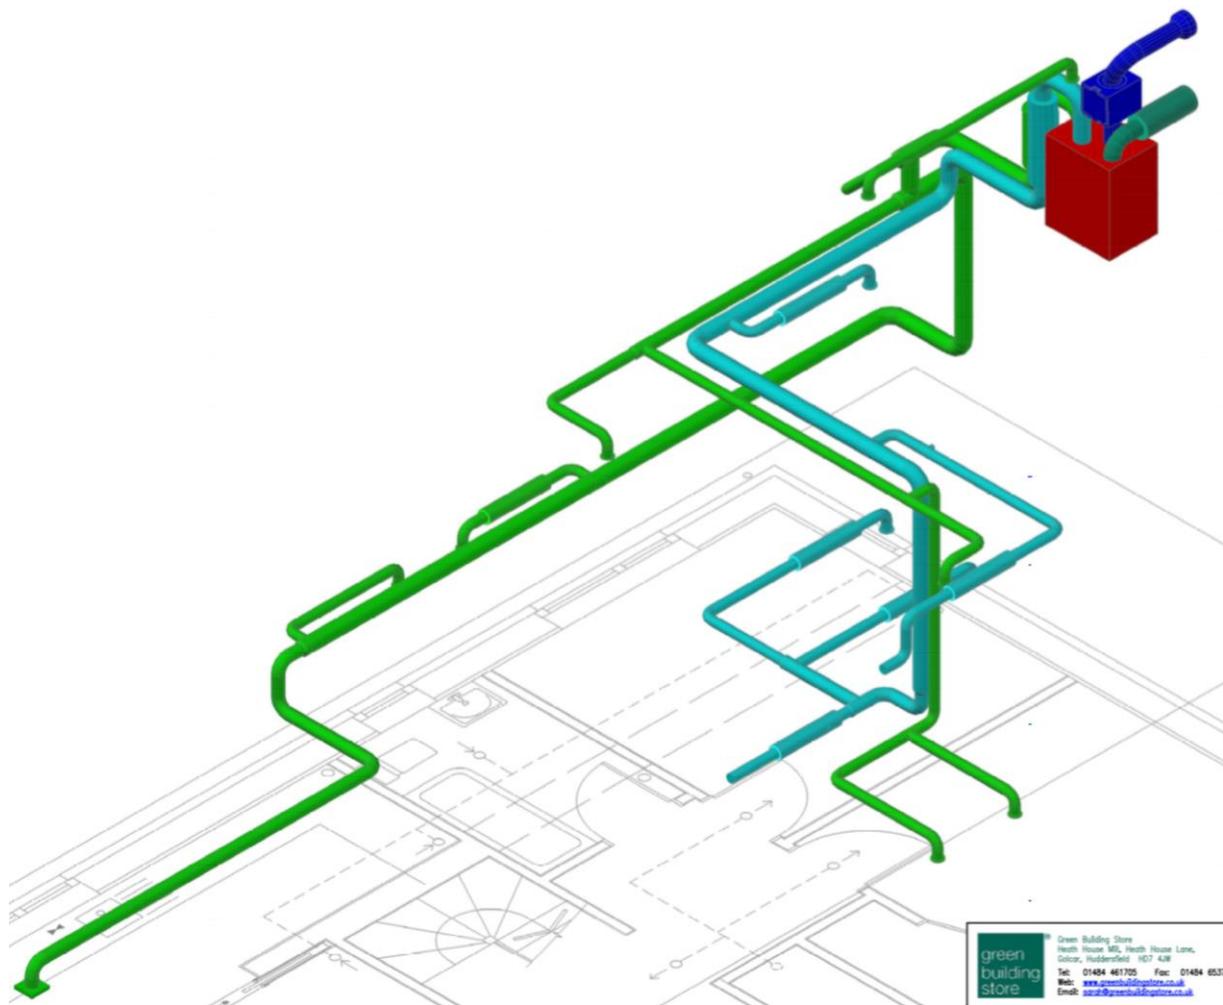
7.1.1 The MVHR intake is at second floor level on the east elevation directly in to the plant room. Ductwork is mostly run through the I joist floors, but at second floor level it runs in the low level space at the eaves. Fresh air supply to each bedroom and living space, and extract from bathroom, kitchen, ensuites and utility room. The routing proved to be quite complex, even though much work was done to keep it simple and short.

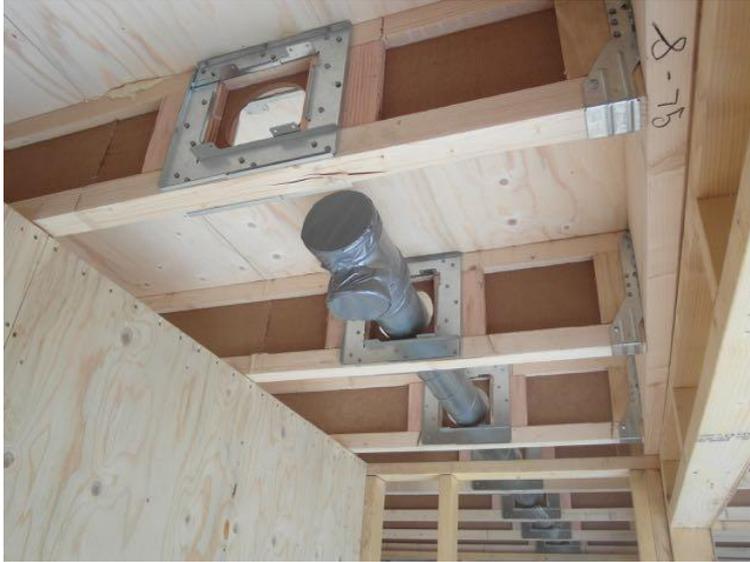
7.1.2 Rigid galvanised steel circular duct was used with ready made joints containing an EPDM gasket. Although this material is expensive it allows for very good quality installations by skilled carpenters, without needing to use specialist duct installers. Some joists needed to be reinforced where large diameter ducts were run, exceeding the cut out limits for the joist. Ducts were kept taped closed during construction to keep them clean.

- 7.1.3 Joist reinforced to accept large diameter duct. Duct taped closed to keep out dust.

- 7.1.4 Silencers were used to prevent noise from the MVHR unit and prevent cross talk. Some ducts needed to be installed at a very early stage in the build to allow them to be fitted through the joists, as shown in photo above.
