# Submission for renewal of CEPH Designer qualification by Paul Mallion, BSc(Hons) MSc(Arch) FRICS

**The Den, Ansty, Dorset.**

**Detached three bedroom house in Dorset, England**

### The Den, Ansty, Dorset

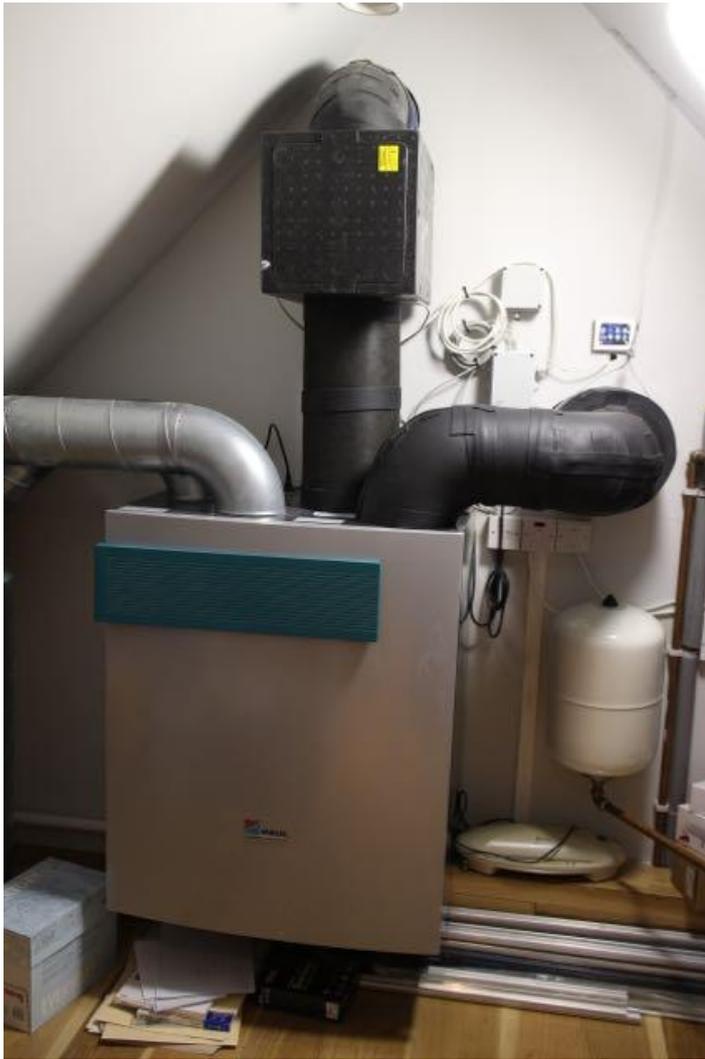
- 7.2.1 A Paul Novus 300F unit was located in the top floor plant room on the external wall. It was a tight fit, as the ceiling height is limited and the unit is very large. However, it is easy to access for cleaning the filters and maintenance. The contractor did a very neat job of insulating the exterior ducts with closed cell foam and taping the joints, not an easy task.

- 7.2.2 The unit has a heat recovery rate of 93%, and a SFP of  $0.23\text{W}/\text{m}^3\text{h}$  at  $200\text{m}^3/\text{h}$ . The system efficiency is 89%.<sup>3</sup>

- 7.2.5 The MVHR unit in the plant room

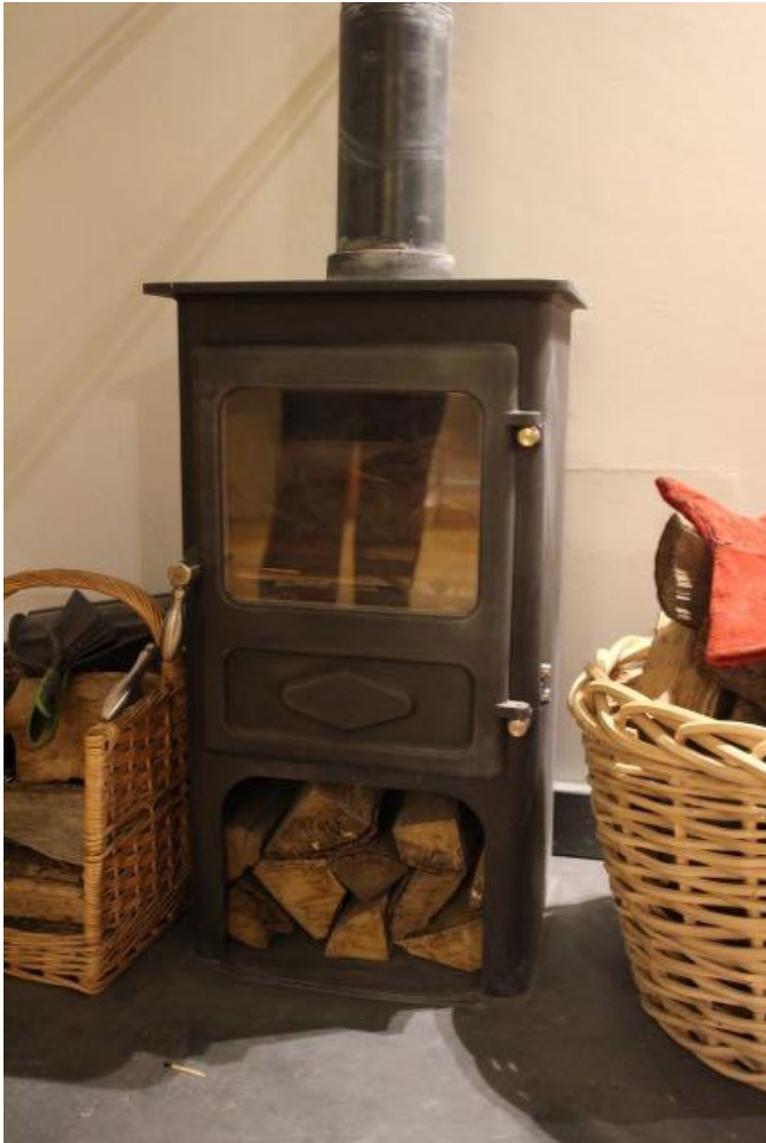
4kW Woodwarm Fox stove.

- 8.1 Heating was evaluated at great length. As with most rural houses there was no mains gas supply, leaving wood, electricity, or bottled gas as options. Ground source and air sourced heat pumps were considered, but the cost relative to the heat load were ridiculously expensive. A small condensing gas boiler was considered, running on propane, this would have quite simple, but the boilers available are either much too large or very expensive.
- 8.2 Underfloor heating was considered for the ground floor, but excluded as an unnecessary expense.
- 8.3 A small efficient wood stove was finally agreed upon for the main source of heating on the first floor, which being partly open to the second floor would heat both spaces. A 4kW 'Fox' unit by Woodwarm was chosen. In each bathroom, WC and ensuite an electric towel rail is provided, allowing timed

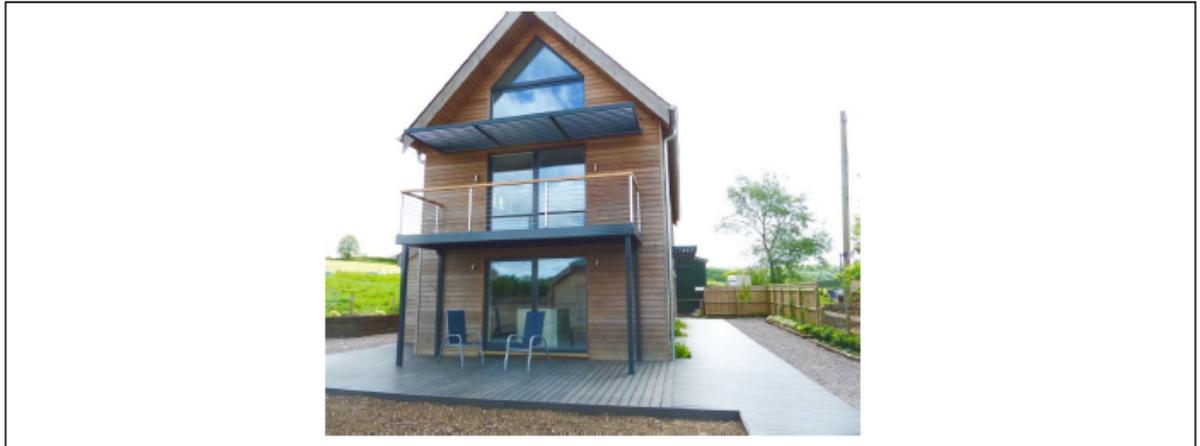
### Passive House Verification

Building:	The Den		
Location and Climate:	Dorset	4 South England	
Street:	Hartfoot Lane		
Postcode/City:	DT2 7PN	Anstey	
Country:	UK		
Building Type:	Detached House		
Home Owner(s) / Client(s):	Dennis Merrigan		
Street:	The Den, Hartfoot Lane		
Postcode/City:	DT2 7PN	Anstey	
Architect:	Conker Conservation Ltd		
Street:	6, The Stour Centre, 2-24 Stour Street		
Postcode/City:	CT1 2NZ	Canterbury	
Mechanical System:	Green Building Store		
Street:	Heath House Mill, Heath House Lane, Golcar		
Postcode/City:	BD7 4JW	Huddersfield	
Year of Construction:	2014		
Number of Dwelling Units:	1	Interior Temperature:	20.0 °C
Enclosed Volume $V_e$ :	528.2 m <sup>3</sup>	Internal Heat Gains:	2.1 W/m <sup>2</sup>
Number of Occupants:	4.6

Specific Demands with Reference to the Treated Floor Area					
	Treated Floor Area:	Applied:	Monthly method	PH Certificate:	Fulfilled?
Specific Space Heating Demand:	161.4 m <sup>2</sup>	11	kWh/(m <sup>2</sup> a)	15 kWh/(m <sup>2</sup> a)	Yes
Heating Load:		11	W/m <sup>2</sup>	10 W/m <sup>2</sup>	
Pressurization Test Result:		0.6	h <sup>-1</sup>	0.6 h <sup>-1</sup>	Yes
Specific Primary Energy Demand (DHW, Heating, Cooling, Auxiliary and Household Electricity):		120	kWh/(m <sup>2</sup> a)	120 kWh/(m <sup>2</sup> a)	Yes
Specific Primary Energy Demand (DHW, Heating and Auxiliary Electricity):		89	kWh/(m <sup>2</sup> a)		
Frequency of Overheating:		2	%	over 25 °C	
Cooling Load:		5	W/m <sup>2</sup>
