Pedro Reyna Re-accreditation as Passivhaus Designer

Casa Biguá, Tigre

Abstract

A weekend home located deep in the Tigre Delta in Buenos Aires. The building is elevated over the ground to allow for the frequent flooding of the river to flow underneath.

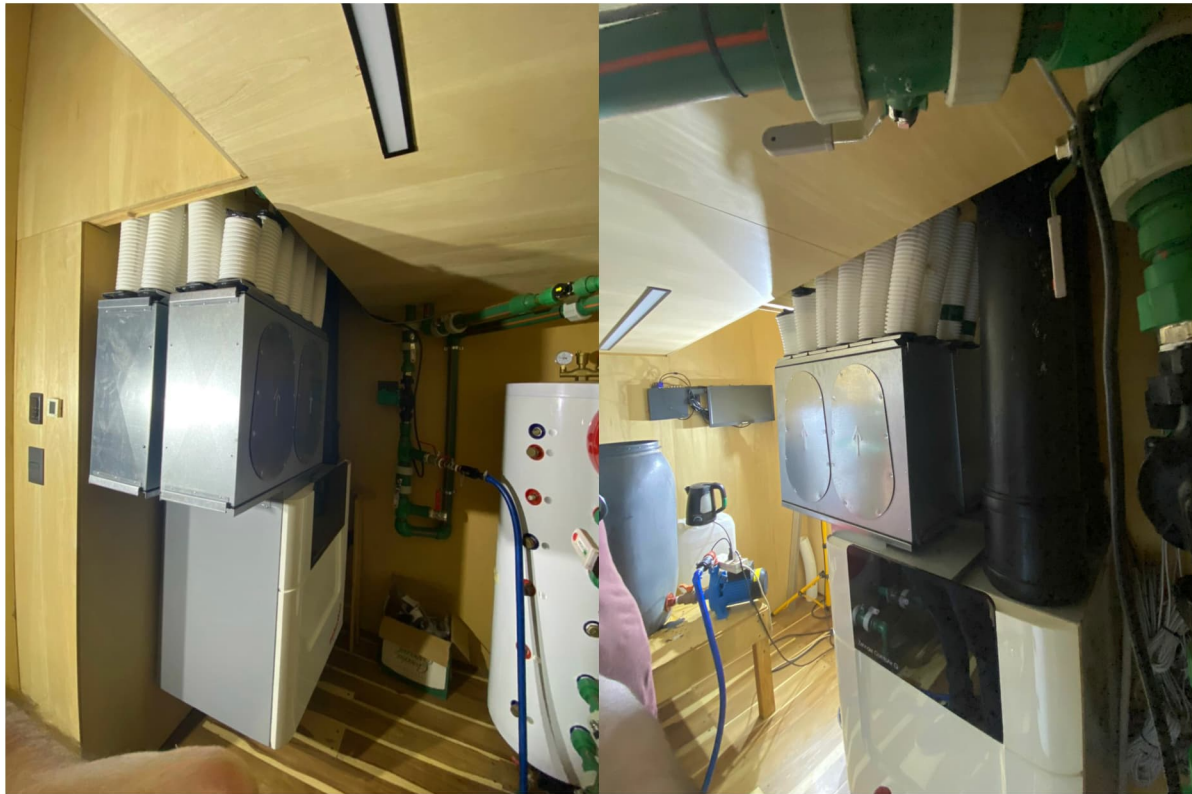
10. Ventilation Unit

A Zehnder Q600 Enthalpic unit was used. The climate in Tigre is fairly humid and this unit helps remove unwanted humidity in the air. See Spec sheet below for the Heat Recovery Ventilation Unit

Category: **Air handling unit with heat recovery**
 Manufacturer: **Zehnder Group Zwolle B.V. Netherlands**
 Product name: **ComfoAir Q600 ERV, Comfort Vent Q600 ERV**

Airflow range	70–460 m ³ /h
Heat recovery rate	$\eta_{HR} = 80\% \text{ 1)}$
Specific electric power	$P_{el,spec} = 0.22 \text{ Wh/m}^3$
Humidity recovery	$\eta_x = 68\%$
