# Project Documentation

**Apartment 03 in Nafplio, Argolis, Greece**

### Passive House in Nafplio, Argolis

The project concerns the renovation of an existing house from the 60s to which an addition by extension and in height was made. The residence is located at the base of the Acronafplia Castle walls in Nafplio, Greece.

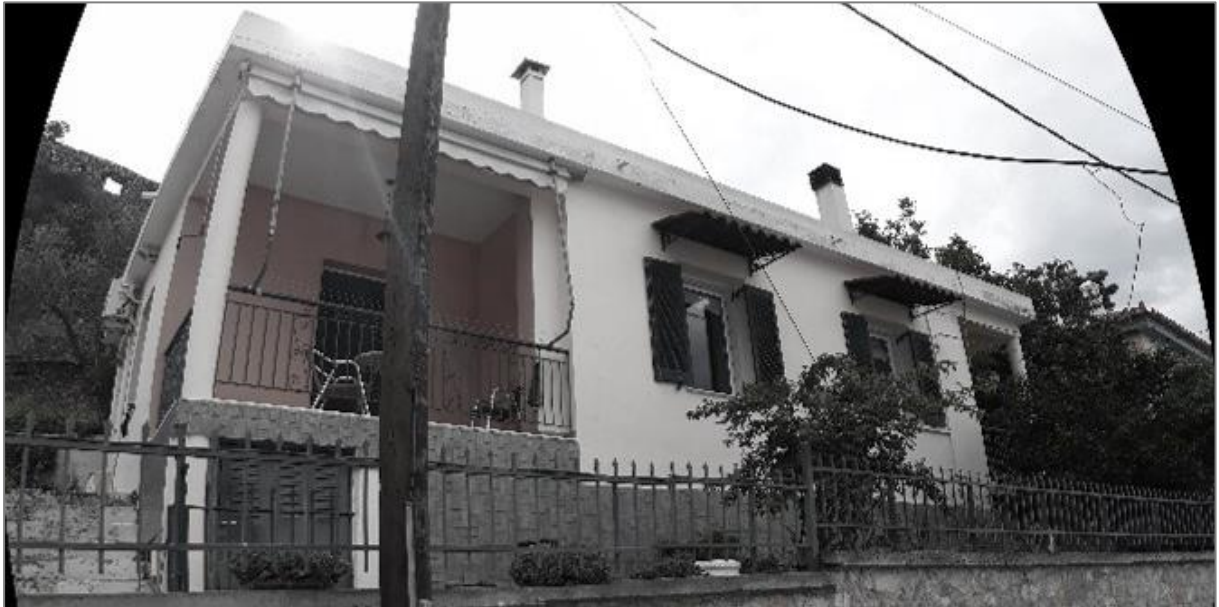
*Picture 1: North view of the existing building.*

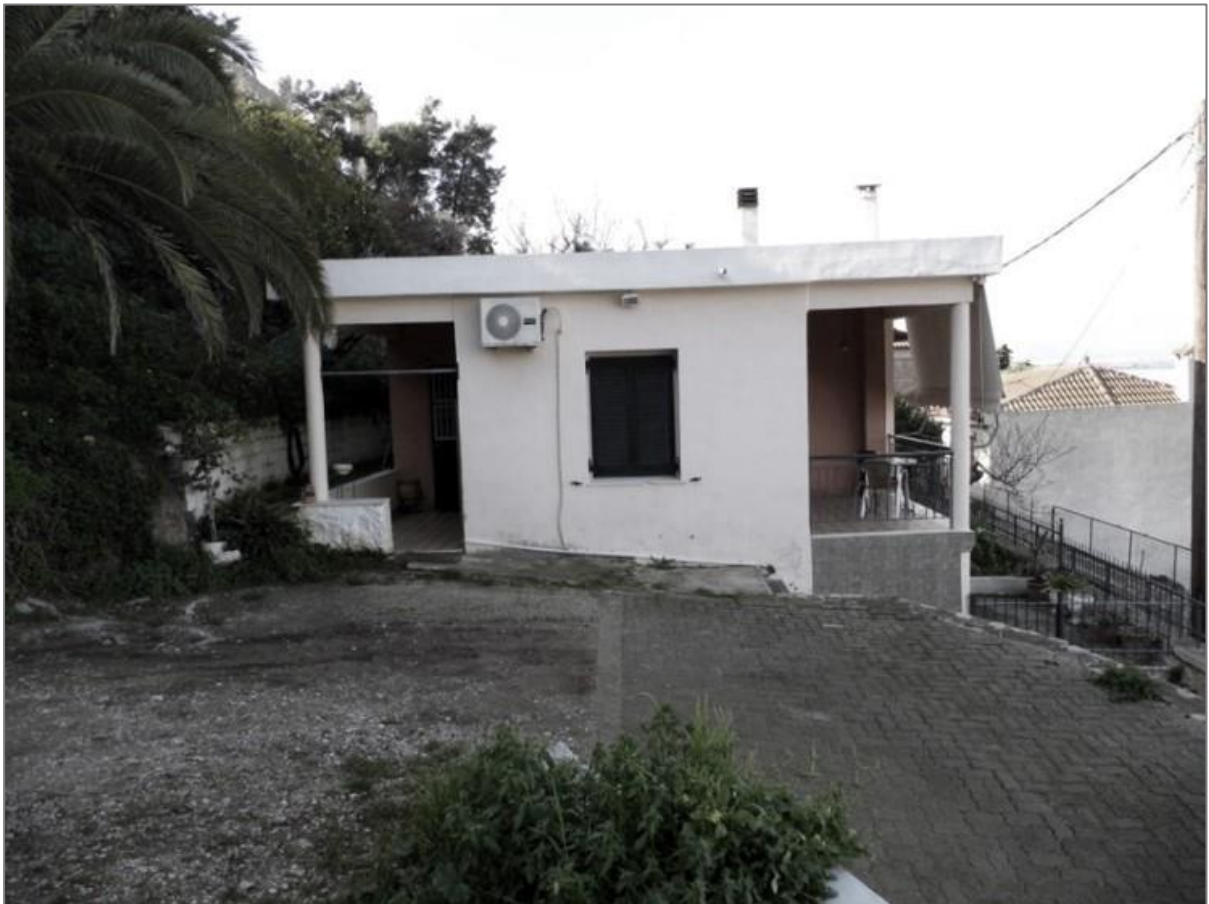
*Picture 2: East view of the existing building.*

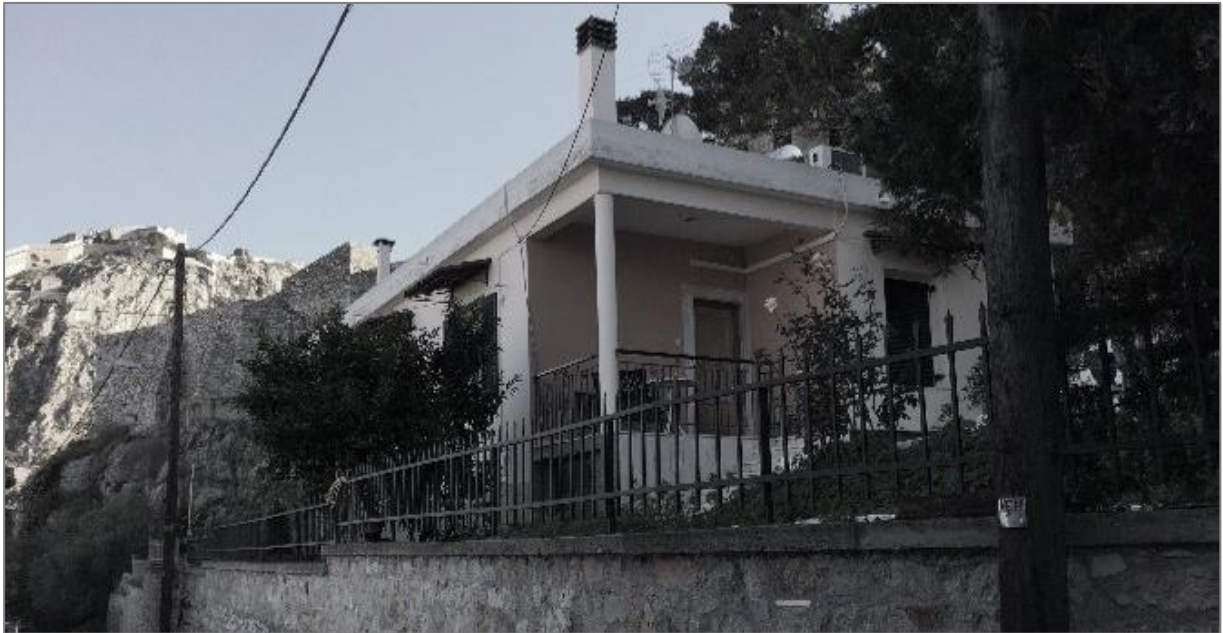
*Picture 3: West view of the existing building.*

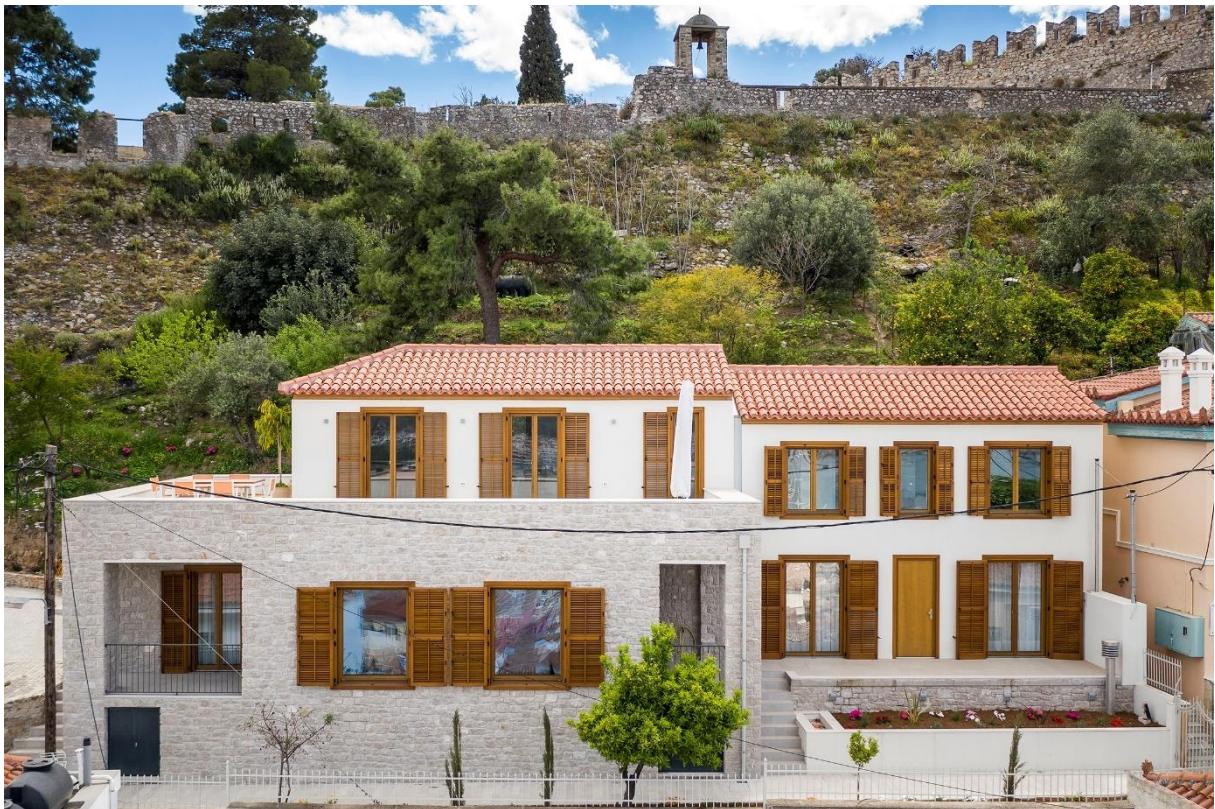
*Picture 4: North view of the new construction.*

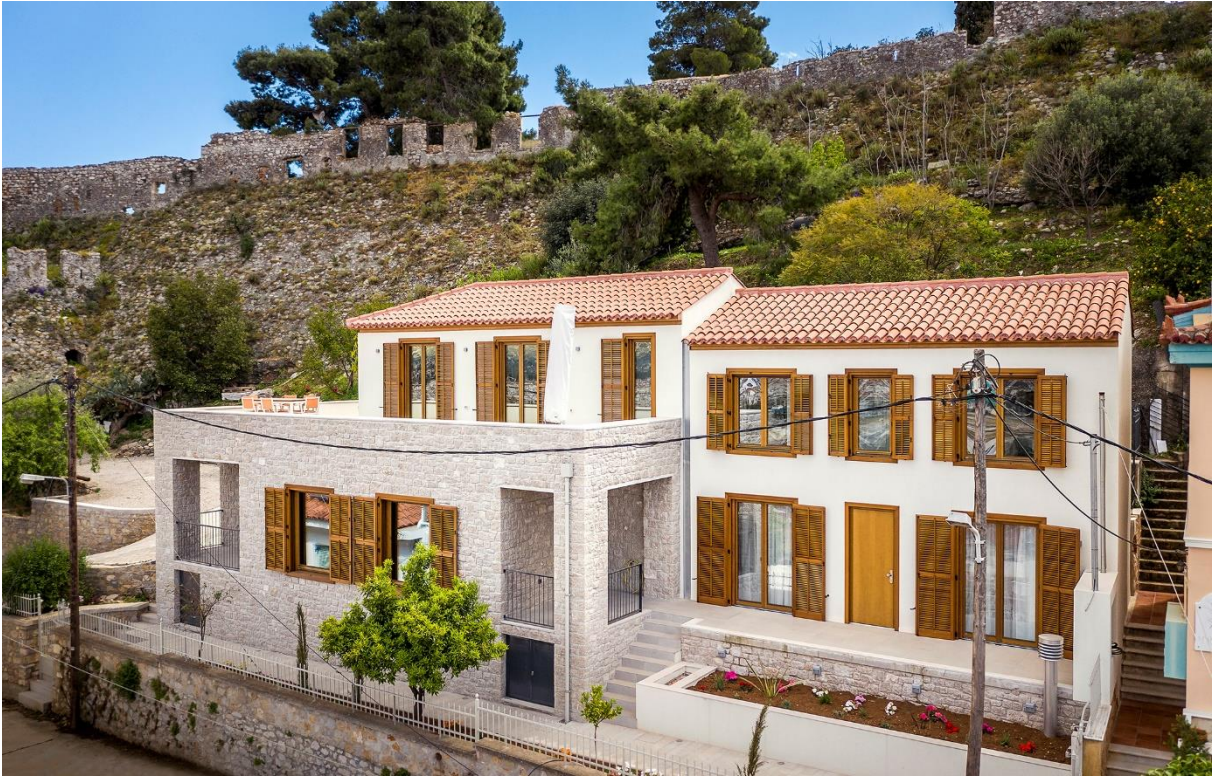
*Picture 5: North - West view of the new construction.*

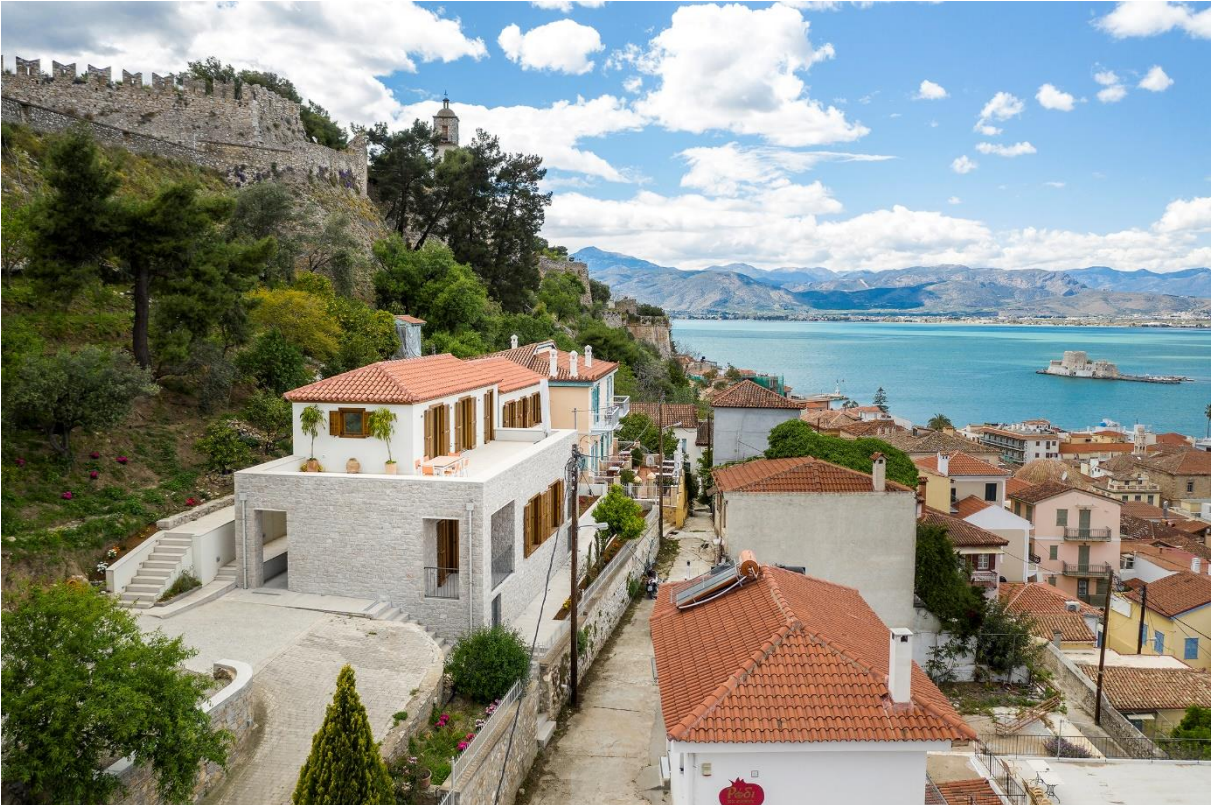
*Picture 6: North - East view of the new construction.*

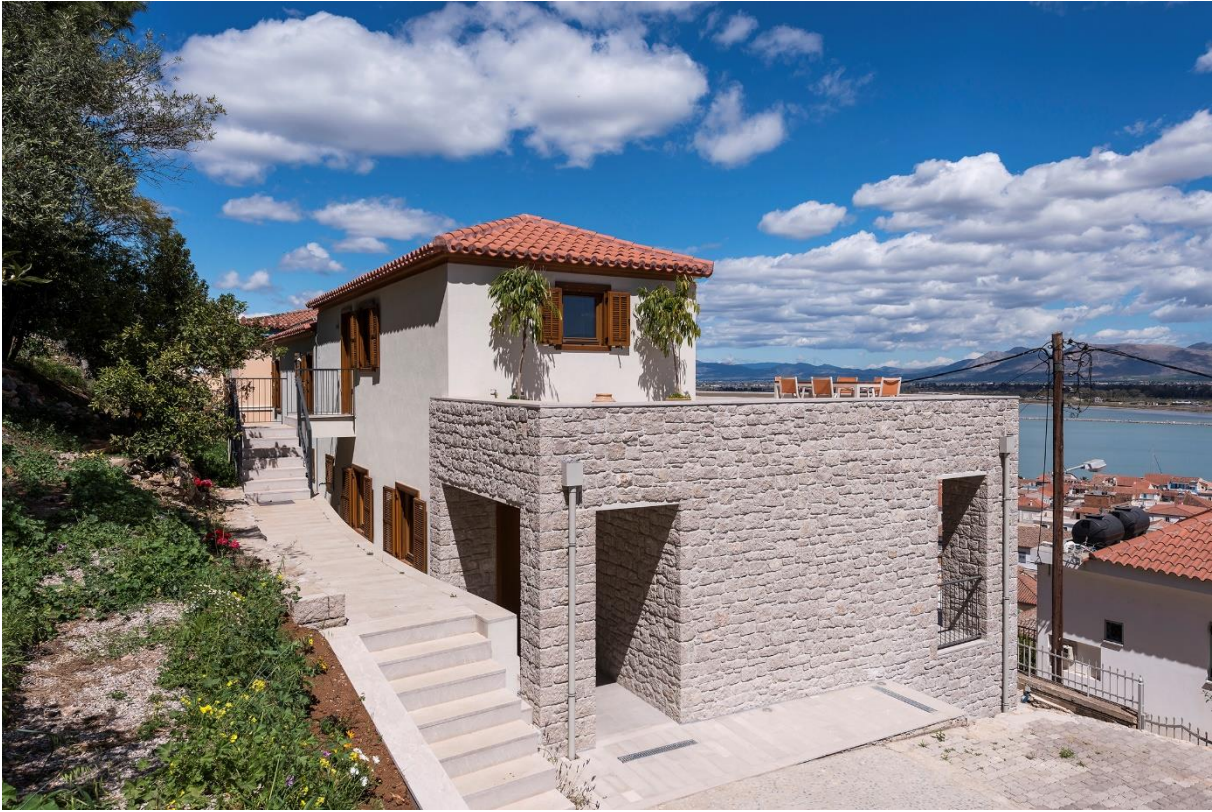
Picture 7: South - East view of the new construction.

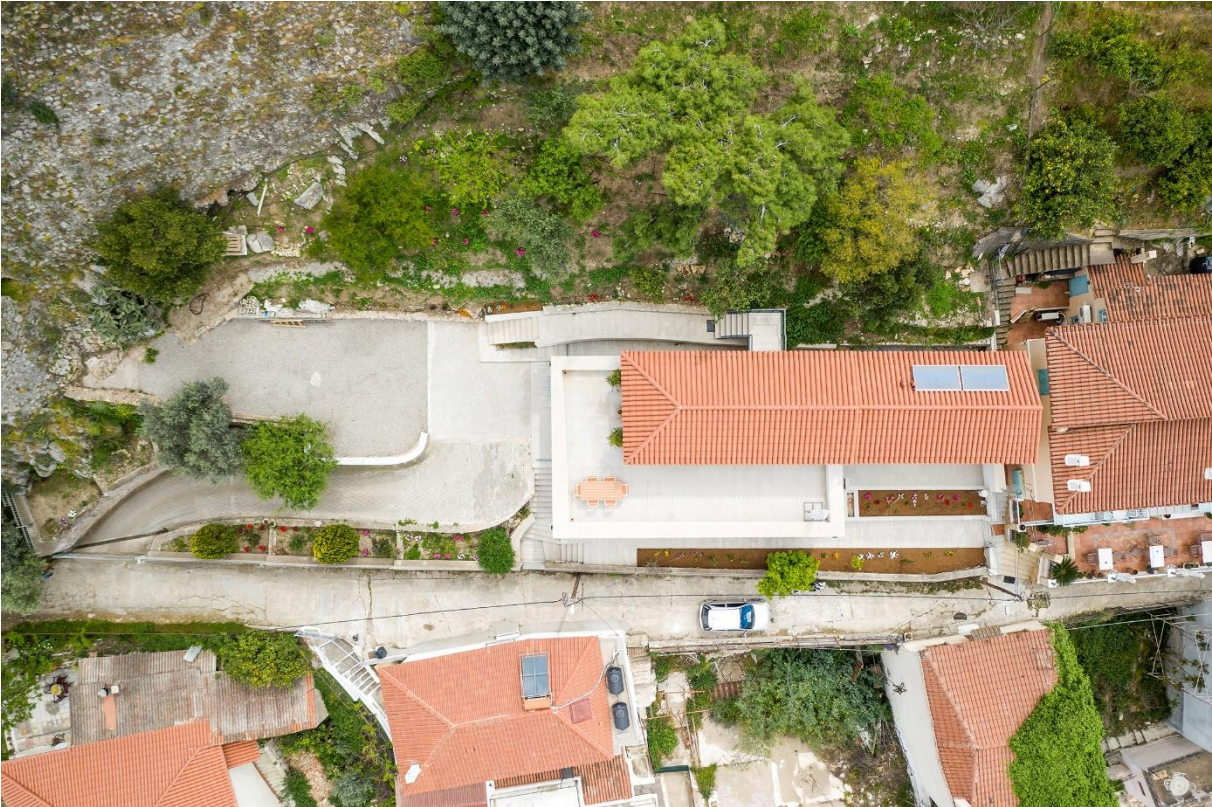
Picture 8: Top view of the new construction.

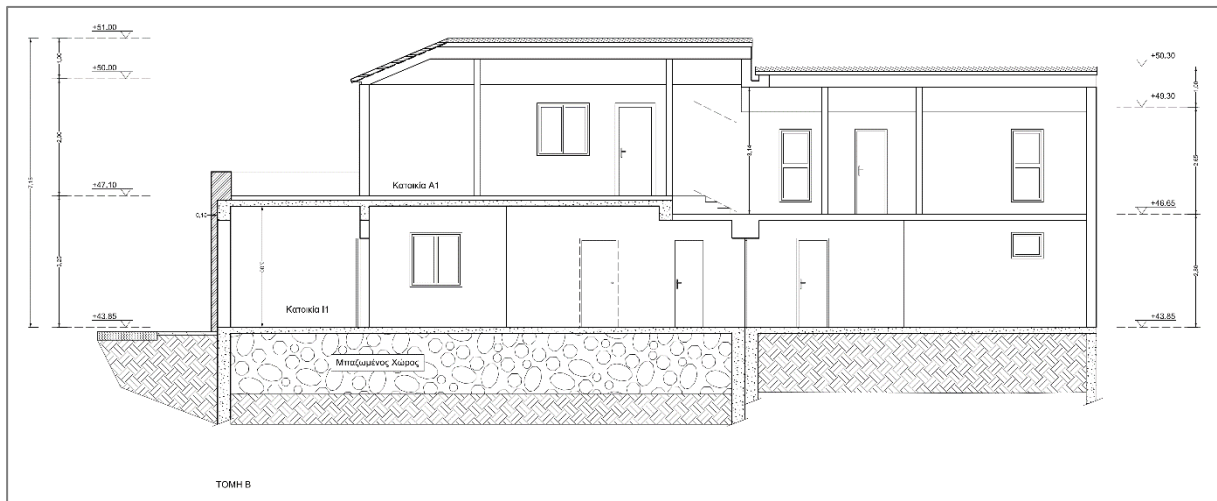
Picture 13: Section B.

The renovated existing part of the building and the new construction are shown in section B (Picture 13). The insulation was implemented on the walls and roofs externally without any interruption. On the other hand, the insulation of the ground floor slab is placed above the slab due to the existing status. Measures have been taken to minimize thermal bridges.

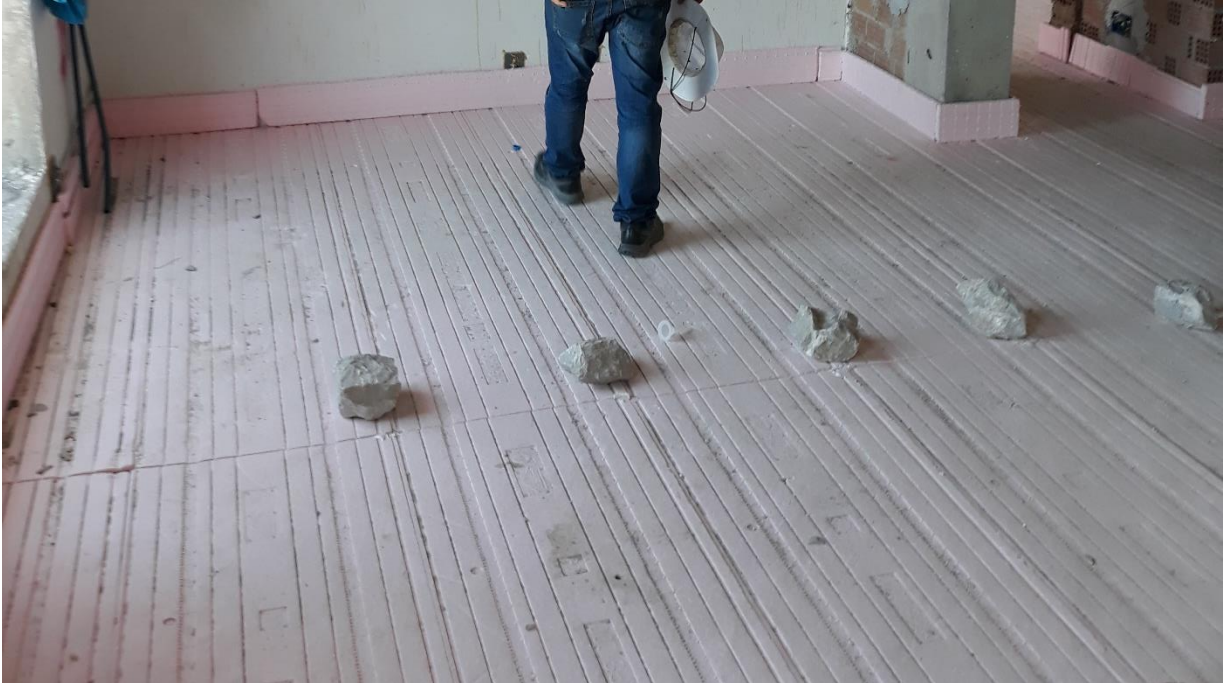
Internal insulation of 3 cm thick eps 250 ( $\lambda=0.033$  W/mK) has been applied to the ground floor of the building due to the existing construction. The final U-value of the ground floor is 0.833 [W/m<sup>2</sup>K].

Picture 16: Ground floor insulation, existing building.

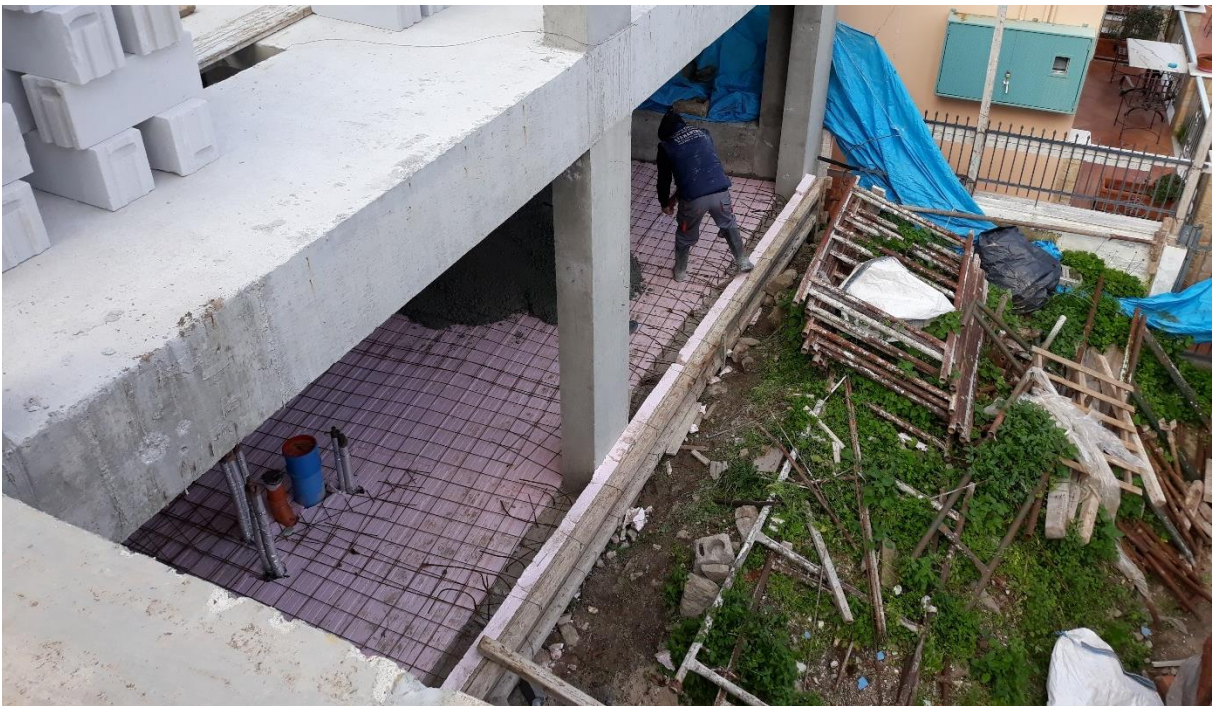
Picture 17: Ground floor insulation, new construction.

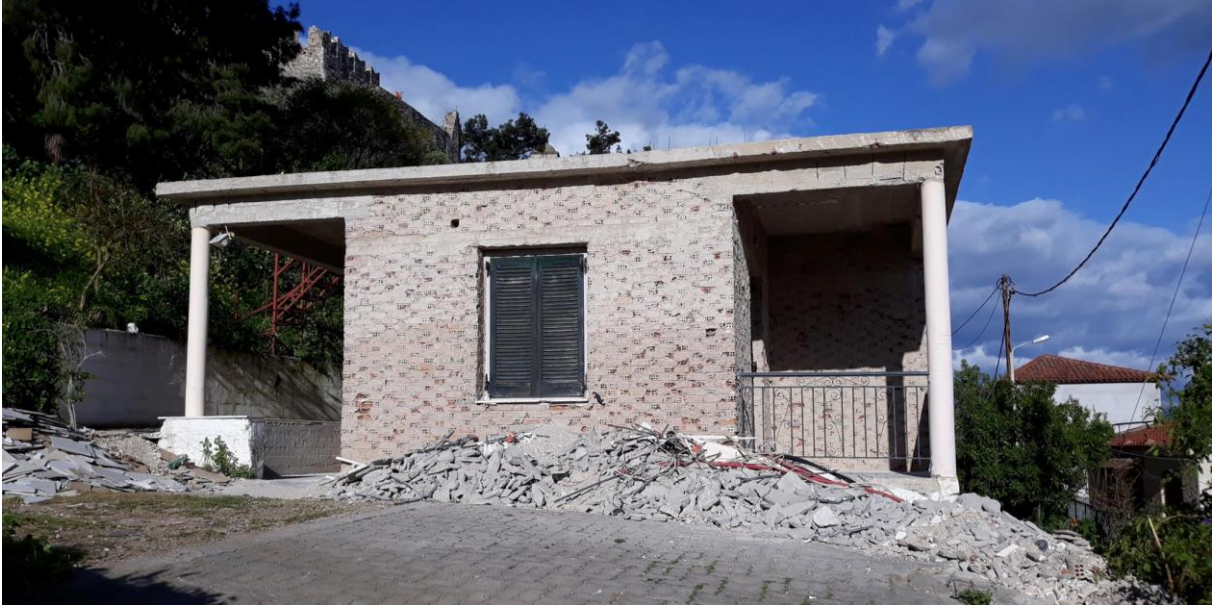
The existing construction had a typical exterior wall assembly consisting of 25 cm thick uninsulated brick walls plastered on each side with an estimated U-value at 2.20 [W/m<sup>2</sup>K]. The existing walls were renovated and insulated externally with 10 cm eps graphite insulation ( $\lambda=0.030$  W/m<sup>2</sup>K) and cladded with 20 cm stone, giving a final U-value of 0.233 [W/m<sup>2</sup>K]. Insulation also applied to the reinforced concrete structure of the building, giving a final U-value of 0.283 [W/m<sup>2</sup>K] for beams and columns.

Picture 20: External brick walls renovation.

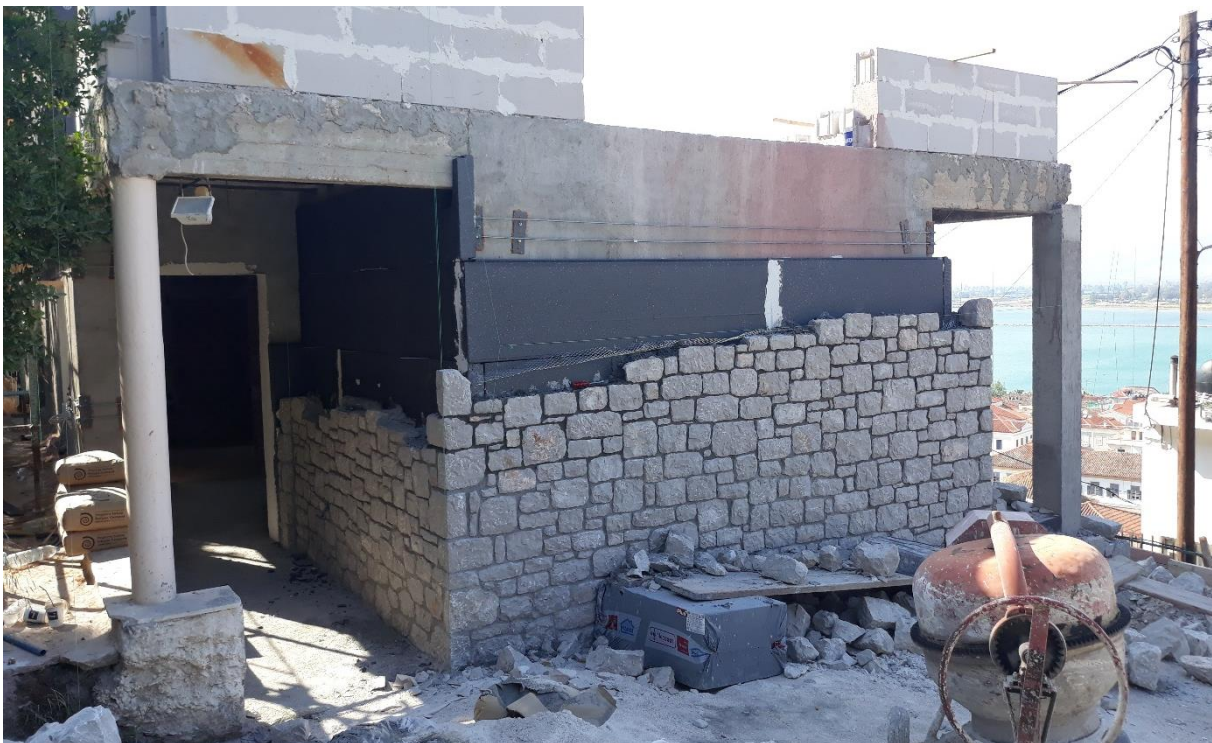
Picture 21: External brick walls.

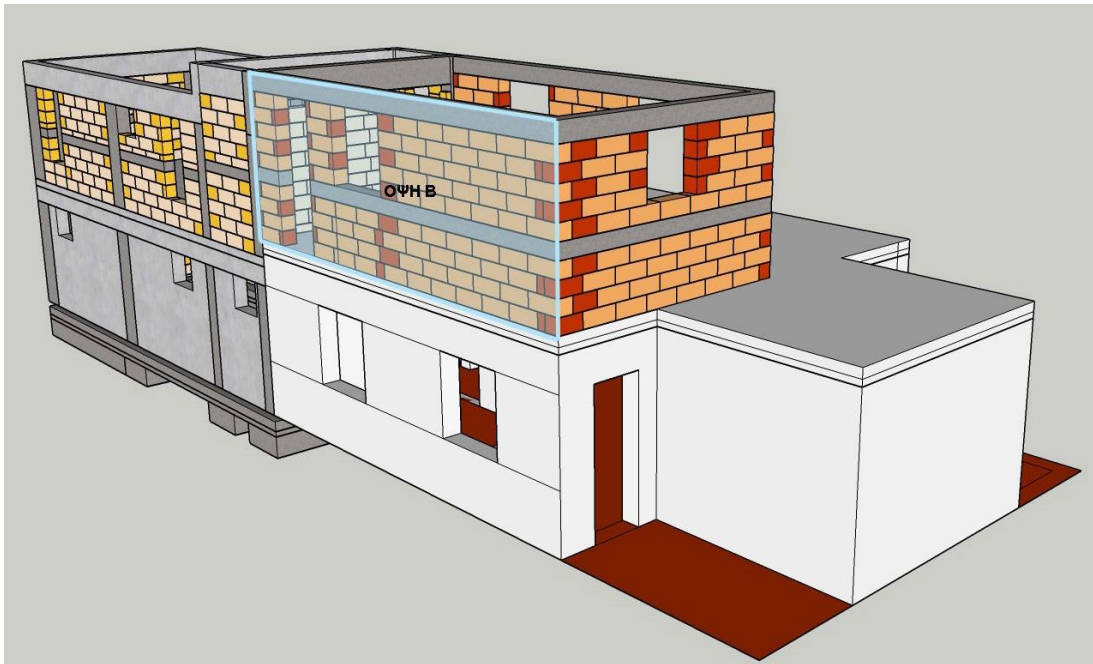
The wall assemblies of the new construction vary as shown on the picture below:

*Picture 22: Wall assemblies of both existing and new construction, south view.*

Thermal blocks (YTONG) 25 cm thick used for the extension in height above the existing building, and 10 cm eps graphite applied externally, giving a U-value of 0.180 [W/m<sup>2</sup>K].

Thermal blocks 20 cm thick are filling the walls of the two-story extension and 10 cm eps graphite applied externally, giving a U-value of 0.181 [W/m<sup>2</sup>K]. The new construction has a reinforced concrete frame as well as a concrete wall to the south view of the ground floor where 10 cm eps graphite applied externally, giving a U-value of 0.261 [W/m<sup>2</sup>K].

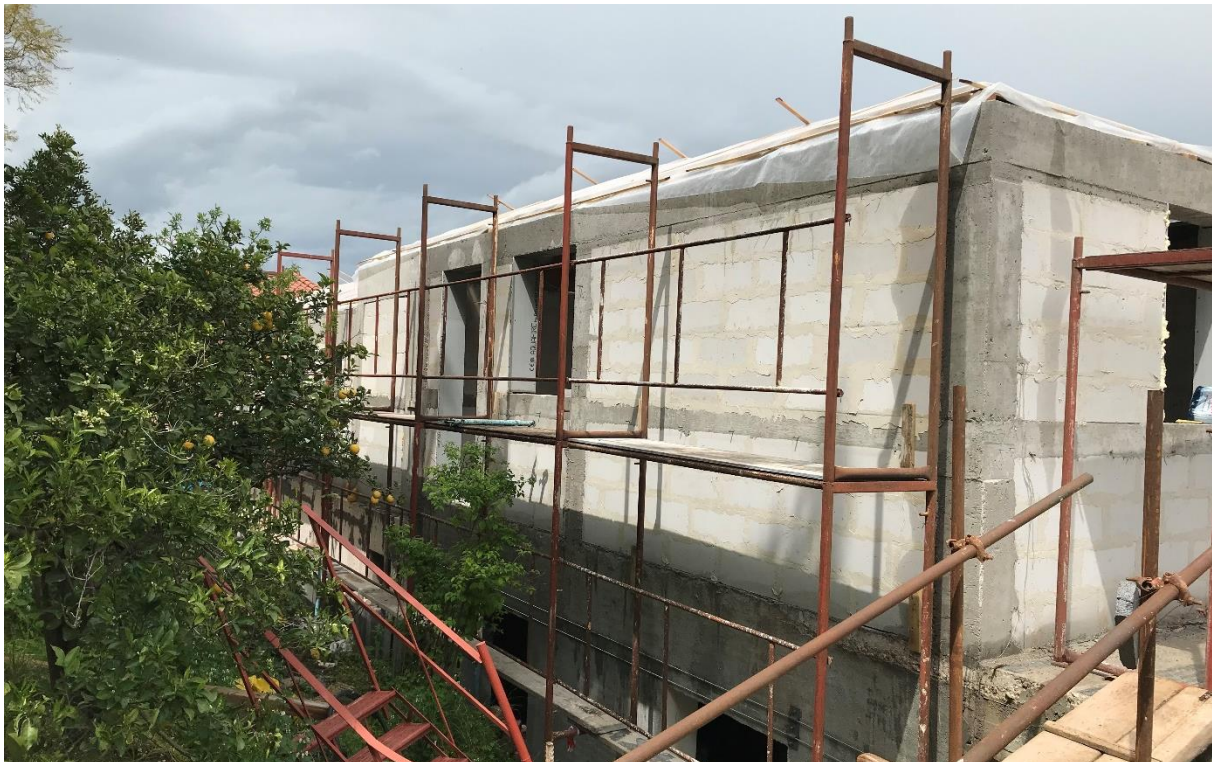
*Picture 23: Thermal blocks extension in height, south view.*

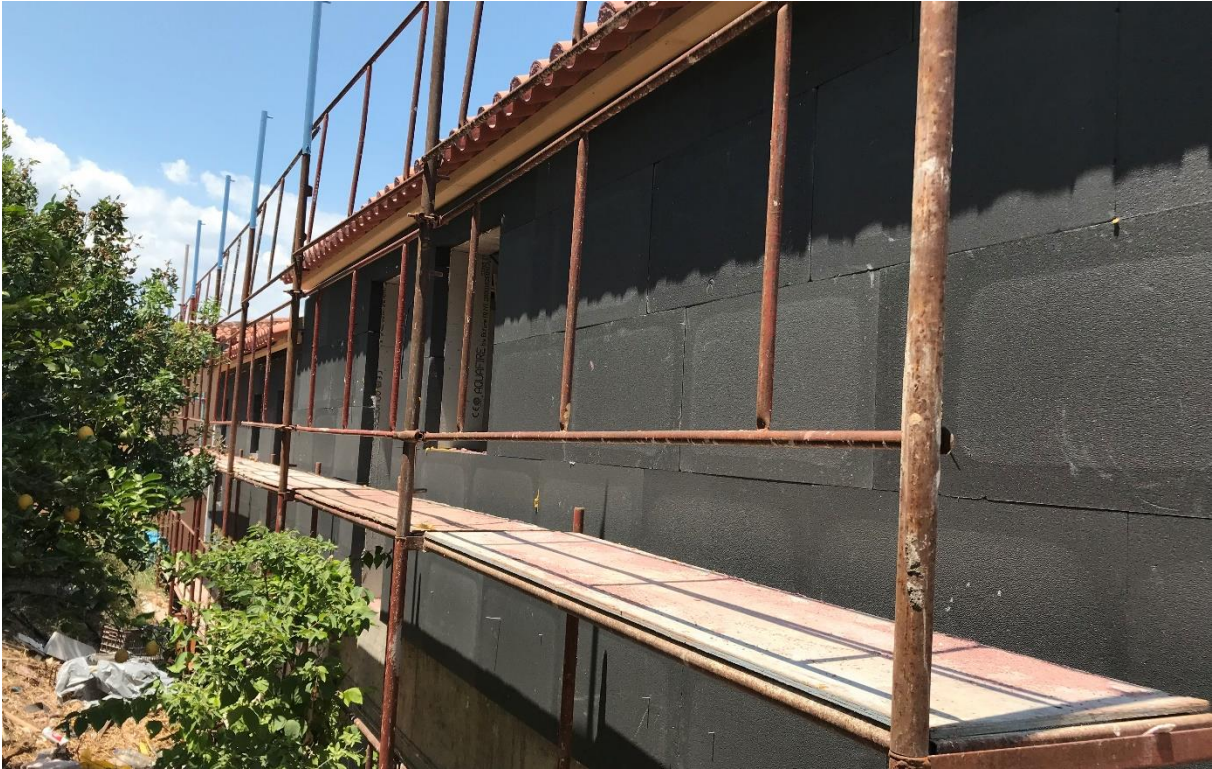
*Picture 24: Wall insulation, south view.*

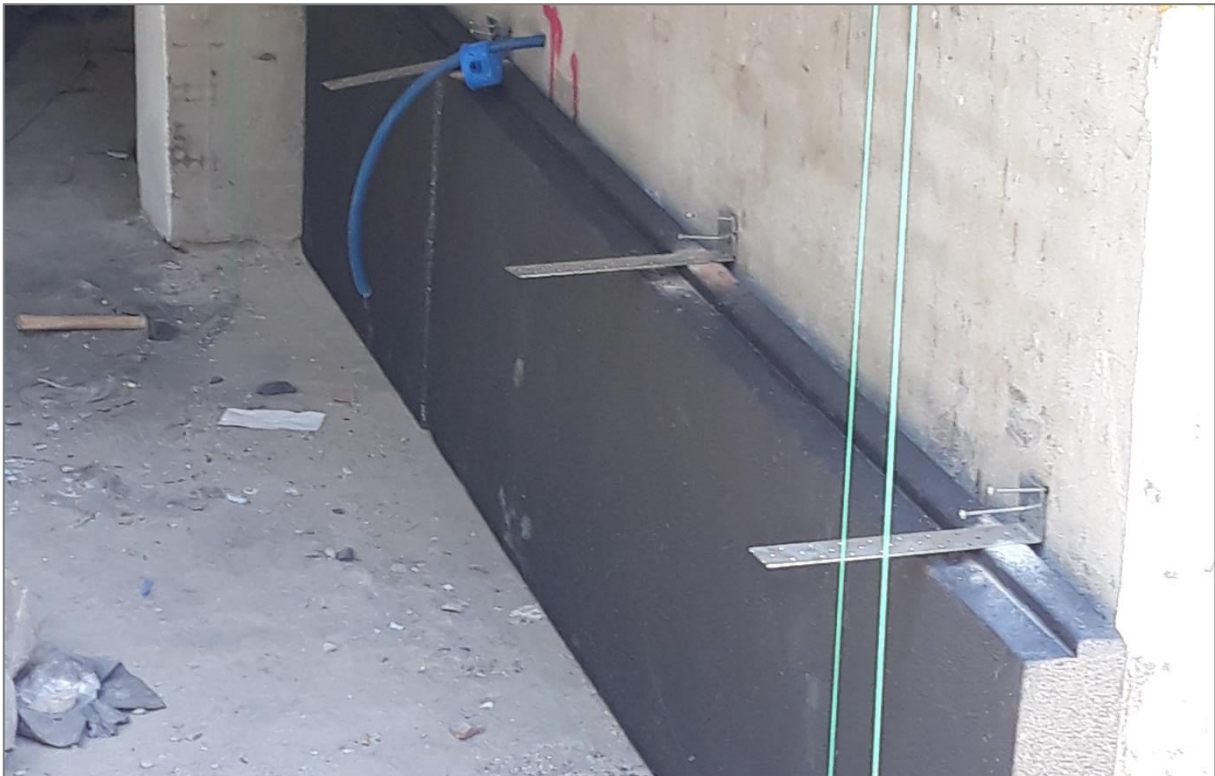
Internal insulation has been applied to the part of the south wall of the existing building which is attached to the ground. The insulation has been expanded 70 cm above the ground level to minimize thermal bridges. The final U-value of the assembly is 0.248 [W/m<sup>2</sup>K].

*Picture 25: Basement wall insulation, internal insulation existing construction.*

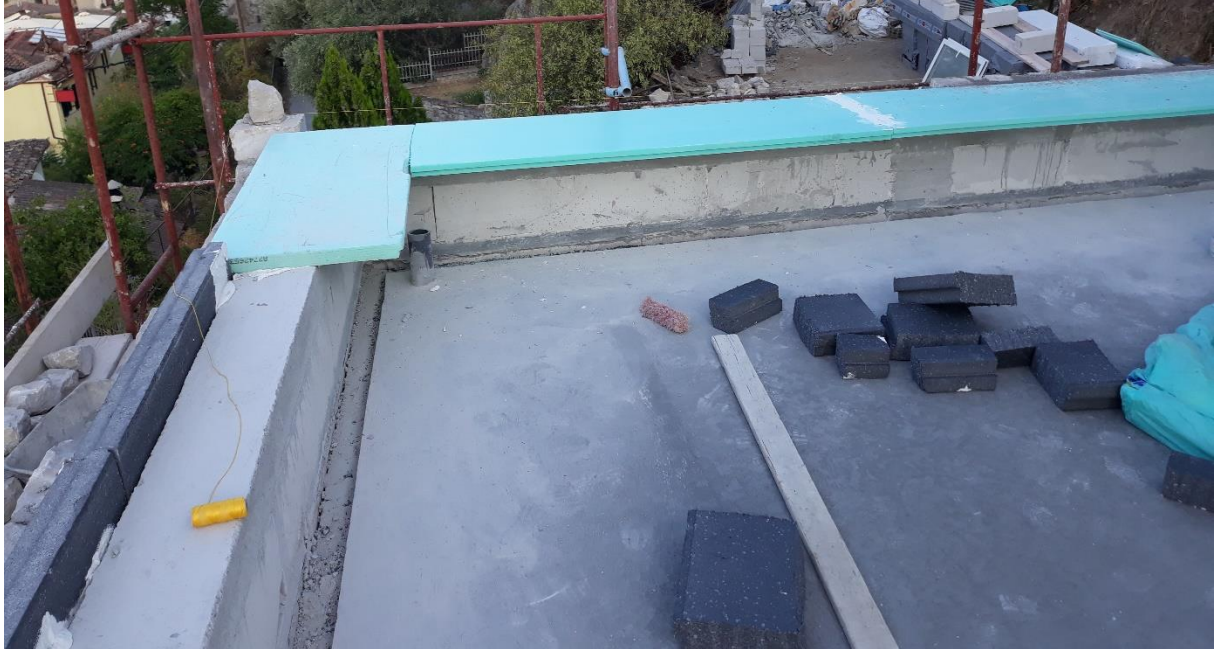
Thermal insulation 15 cm thick eps graphite ( $\lambda=0.030$  W/mK) has been applied to the exposed ceiling of the ground floor apartment, giving a U-value of  $0.187$  [W/m<sup>2</sup>K]. The projected elements of the building have been covered with 5 cm xps insulation ( $\lambda=0.035$  W/mK) to minize thermal bridges.

Picture 26: Ceiling, ground floor, existing building.

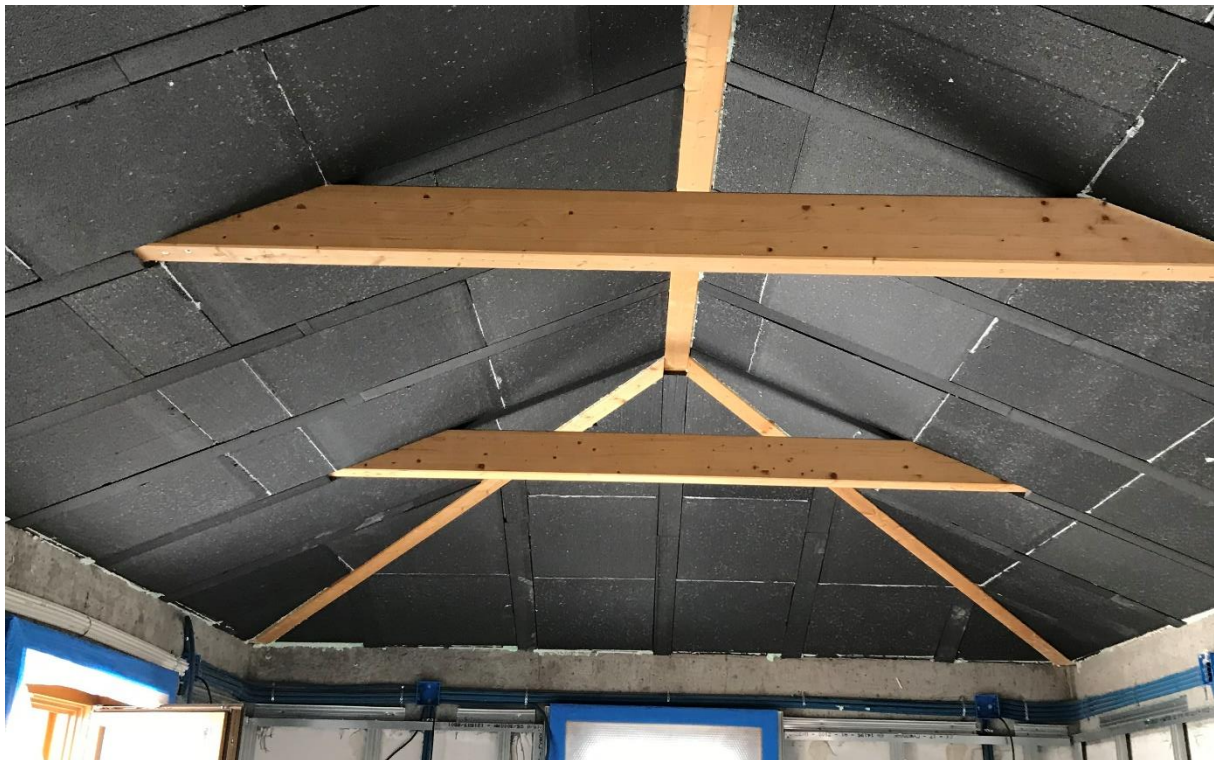
Thermal insulation of 25 cm thick eps graphite ( $\lambda=0.030$  W/mK) has been applied to the roof of the first floor apartment, giving a U-value of  $0.111$  [W/m<sup>2</sup>K].

Picture 27: Roof, first floor apartment.

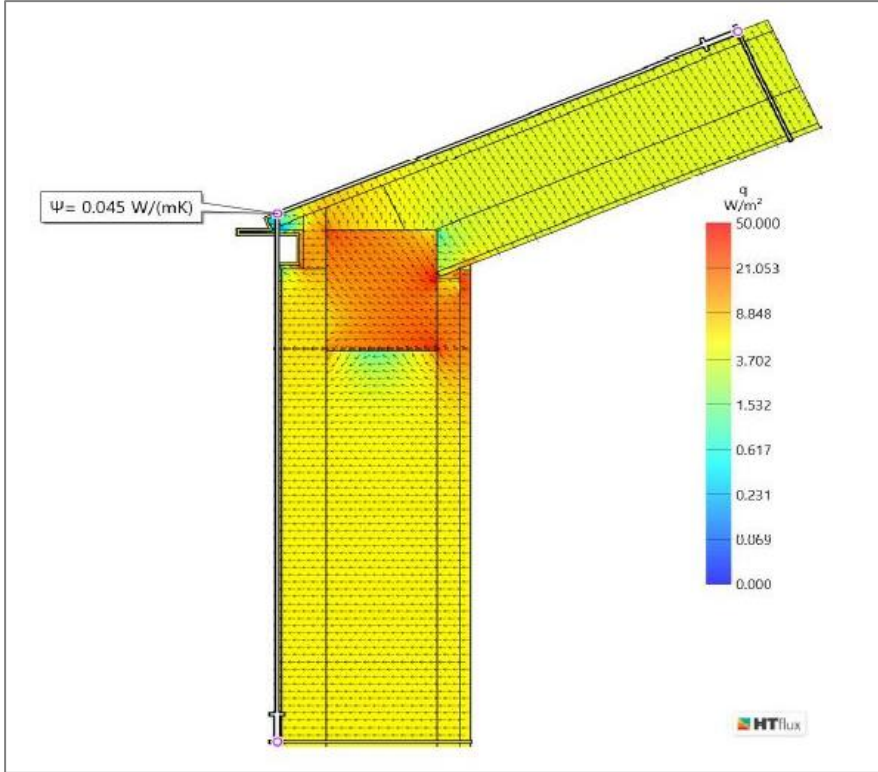
Picture 29: Thermal bridge calculation, roof.

A reduction of insulation thickness at the upper part of the external wall is shown on the section detail drawing below. The thermal bridge has been calculated (Picture 30) and has been considered during phpp calculations.

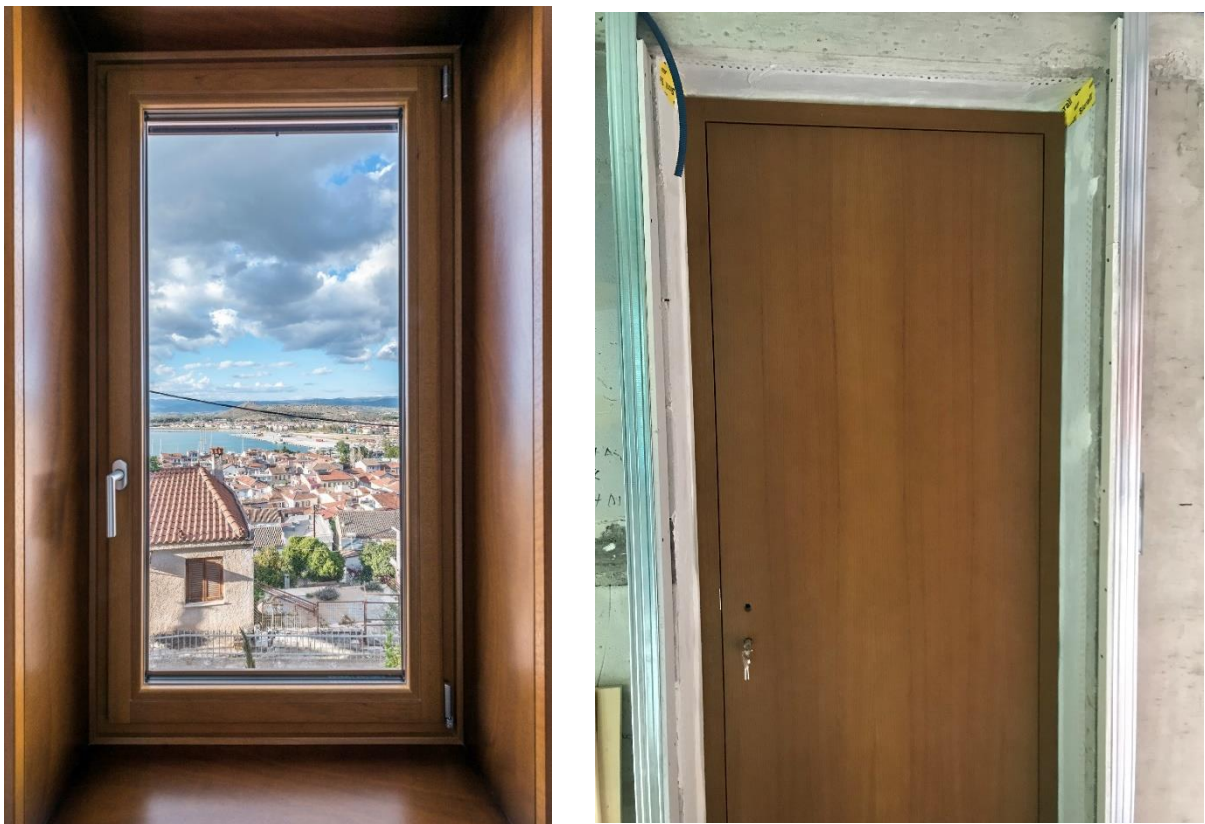
Wooden framed, triple glazed, single or double opening windows ISARHOLZ FENSTER INO-80 (4/14/4/14/4) have been chosen due to the historical location of the building. The windows technical specifications are as follows:  $U_f=1.20$  [W/m<sup>2</sup>K],  $U_g=0.60$  [W/m<sup>2</sup>K]. The total window surface of the building is 23.64 m<sup>2</sup> where more than 75% of the windows surface is facing the north, leading to unwanted heat losses during the winter period. Hence, to increase the solar radiation, the highest available g-value in the market for three glazed windows has been chosen (i.e.  $g=0.60$ ).

Wooden opaque doors INO-80 have been installed with a U-value of 0.865 [W/m<sup>2</sup>K].

*Picture 30: Triple glazed, wooden framed windows and opaque wooden door.*

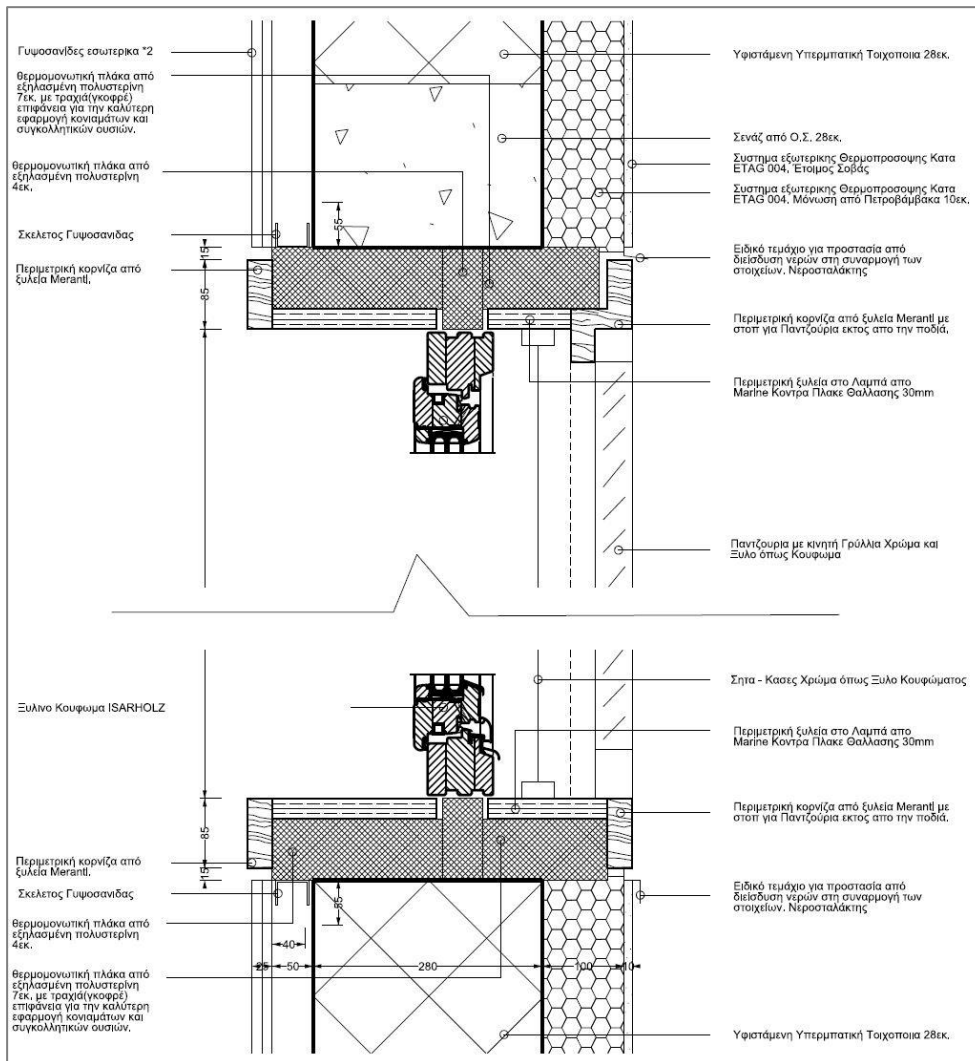
A section detail of the windows installation is shown below. The thermal bridges have been calculated and are included in the phpp calculations.

Picture 31: Section detail of windows installation.

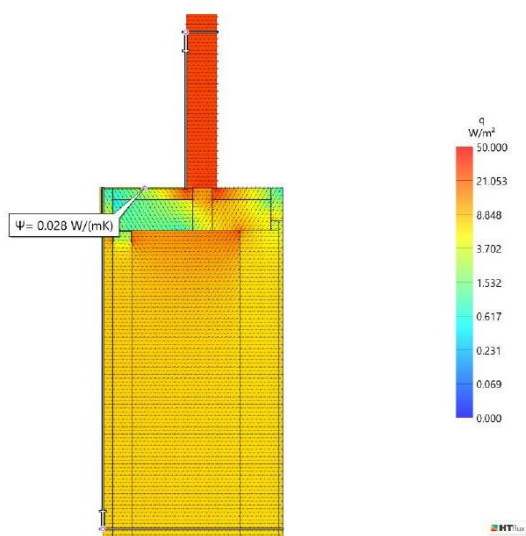
Picture 32: Windows thermal bridge calculation.

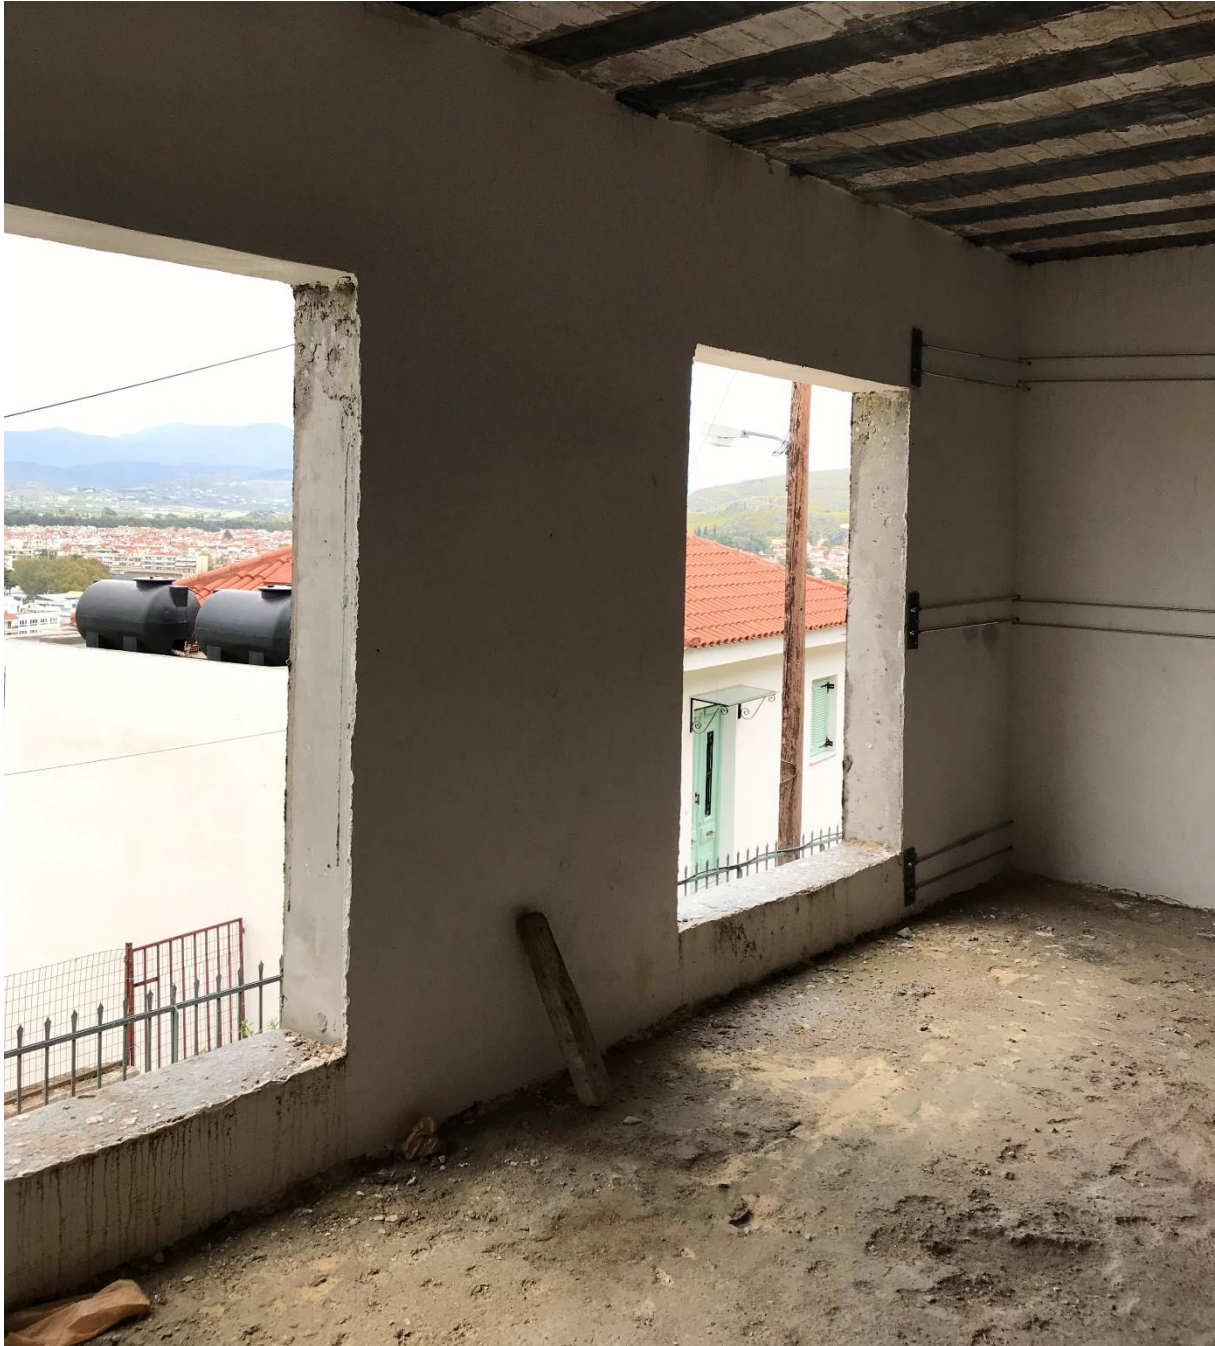
*Picture 33: Plaster applied on the brick walls as an airtight layer.*

Airtightness in a passive house is crucial to minimize infiltration and therefore to avoid unexpected heat losses. The reinforced concrete frame is considered airtight construction. Plaster applied to the existing building brick walls internally as airtight material. A special material named Aerosana applied on all the walls of the new construction, and a membrane applied on the wooden roof to achieve the desirable airtightness. Tapes are used for windows and doors, and for any other leak caused by penetration.
