# Project Documentation

**Apartment 03 in Nafplio, Argolis, Greece**

### Passive House in Nafplio, Argolis

The project concerns the renovation of an existing house from the 60s to which an addition by extension and in height was made. The residence is located at the base of the Acronafplia Castle walls in Nafplio, Greece.

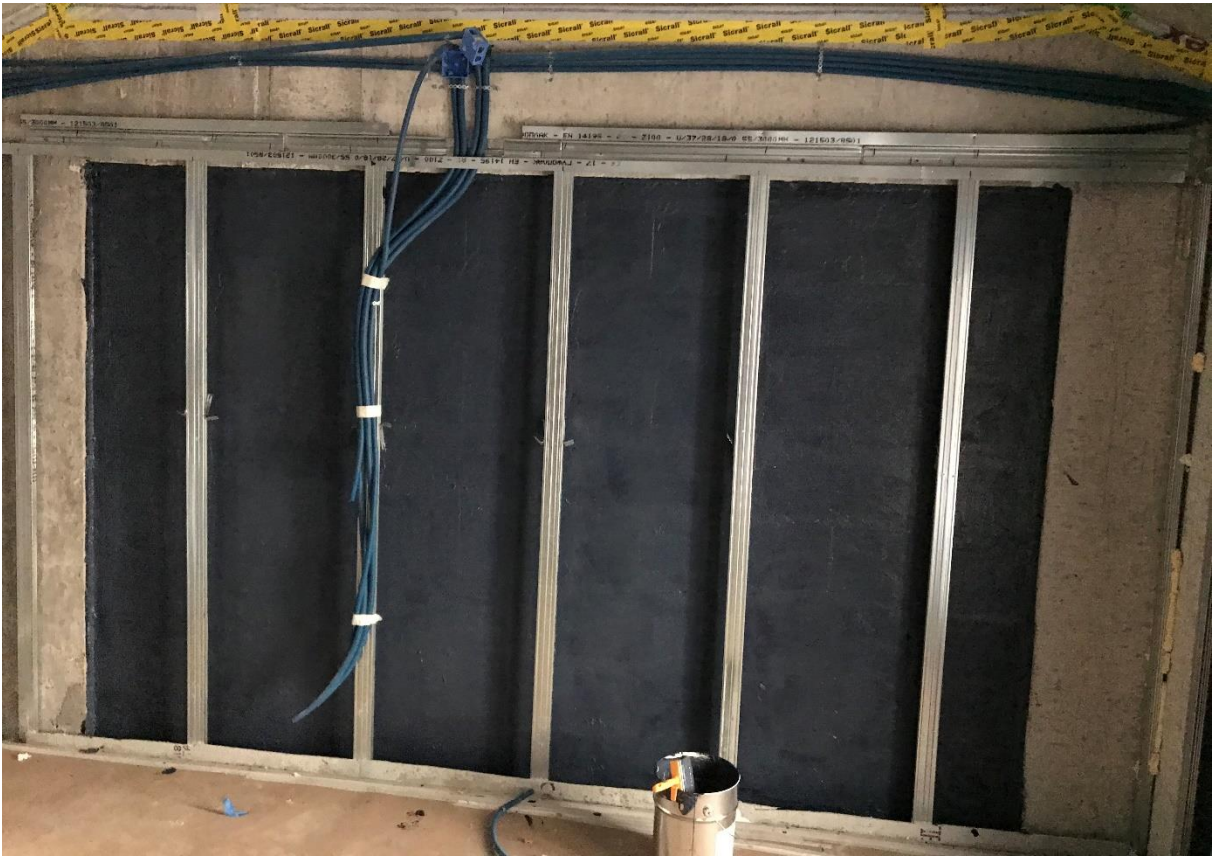
Picture 34: Aerosana, airtight material used on thermal block walls.

Airtightness in a passive house is crucial to minimize infiltration and therefore to avoid unexpected heat losses. The reinforced concrete frame is considered airtight construction. Plaster applied to the existing building brick walls internally as airtight material. A special material named Aerosana applied on all the walls of the new construction, and a membrane applied on the wooden roof to achieve the desirable airtightness. Tapes are used for windows and doors, and for any other leak caused by penetration.

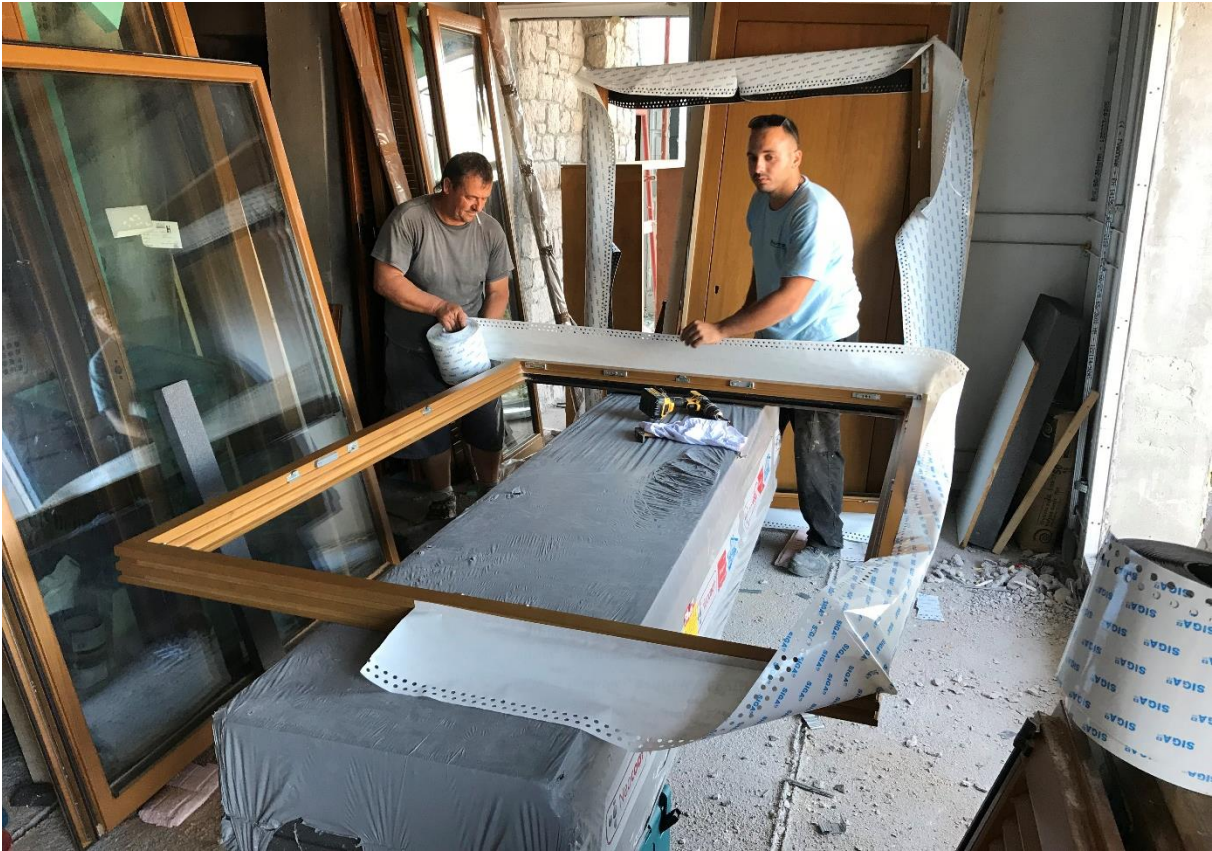
Picture 35: Special tapes applied around the window frame before installation.

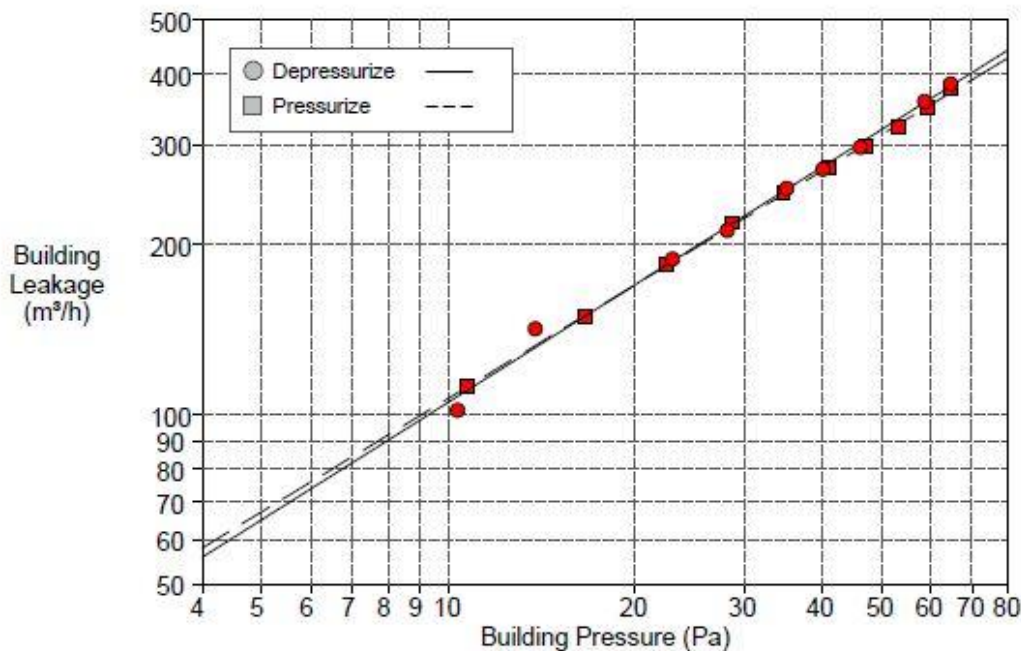
An average value of 0.64 1/h at n50 has been achieved. The blow door test results are shown below.

Picture 37: Blow door test results, Hellenic Passive House Institute.

Depressurization	Pressurization	Average
<b>Test Results at 50 Pascals:</b>			
V50: m <sup>3</sup> /h Airflow	320 (+/- 3.8 %)	313 (+/- 0.9 %)	316
n50: 1/h (Air Change Rate)	0.65	0.63	0.64
w50: m <sup>3</sup> /(h·m <sup>2</sup> Floor Area)	2.02	1.98	2.00
q50: m <sup>3</sup> /(h·m <sup>2</sup> Envelope Area)	0.70	0.68	0.69
<b>Leakage Areas:</b>			
Canadian EqLA @ 10 Pa (cm <sup>2</sup> )	117.4 (+/- 6.3 %)	119.2 (+/- 1.8 %)	118.3
cm <sup>2</sup> /m <sup>2</sup> Surface Area	0.26	0.26	0.26
LBL ELA @ 4 Pa (cm <sup>2</sup> )	60.3 (+/- 10.6 %)	62.5 (+/- 2.9 %)	61.4
cm <sup>2</sup> /m <sup>2</sup> Surface Area	0.13	0.14	0.13
<b>Building Leakage Curve:</b>			
Air Flow Coefficient (Cenv) m <sup>3</sup> /(h·Pa <sup>n</sup> )	21.4 (+/- 17.3 %)	23.0 (+/- 4.8 %)	
Air Leakage Coefficient (CL) m <sup>3</sup> /(h·Pa <sup>n</sup> )	21.5 (+/- 17.3 %)	23.0 (+/- 4.8 %)	
Exponent (n)	0.690 (+/- 0.050 )	0.667 (+/- 0.013 )	
Correlation Coefficient	0.99675	0.99969

Test Standard:	EN 13829		
Test Mode:	Depressurization and Pressurization		
Type of Test Method:	B		
Regulation complied with:	passive house standard n50 ≤ 0.6 1/h

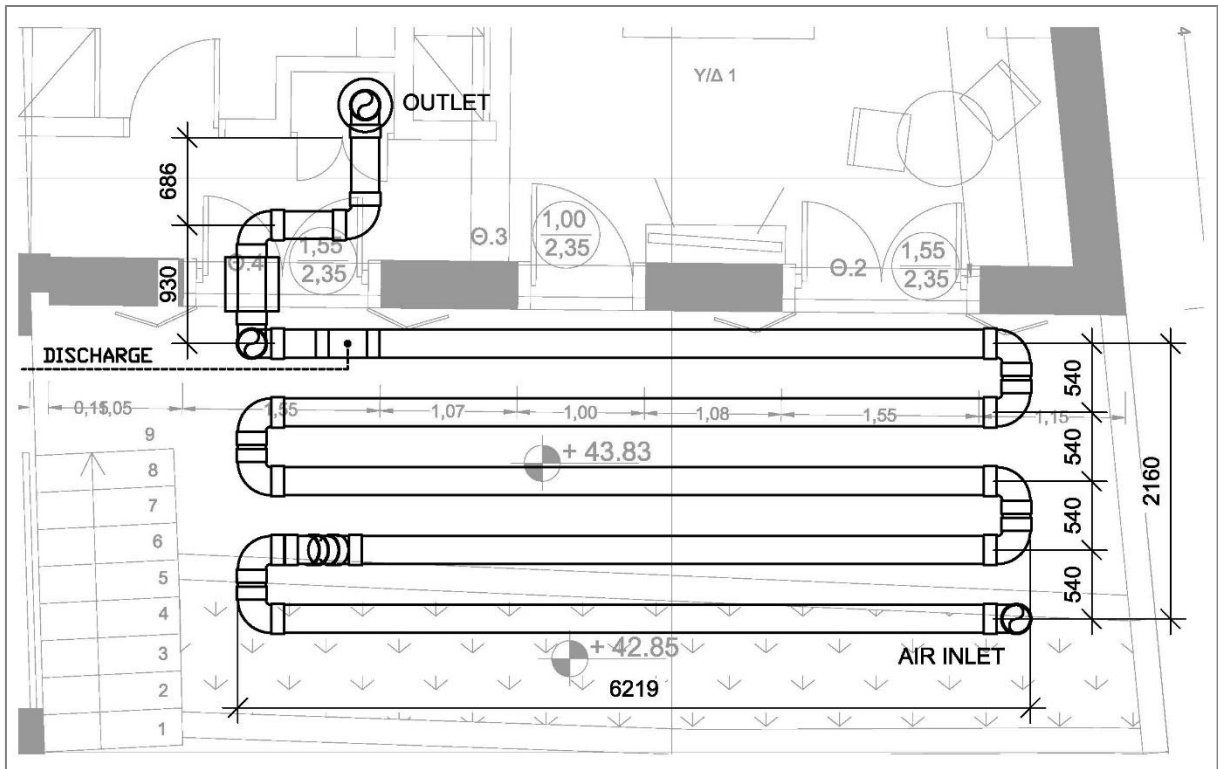
As mentioned, the windows g-value increased to improve the solar gains during heating period. As a result, the solar gains during the summer period also increased. Therefore, a subsoil heat exchanger was introduced to meet the passive house standards. An efficiency of 65% was estimated for an installation length of 34.0 m in an installation depth between 1.50 and 1.80 m. The overall efficiency is estimated at 80 and 78% for the ground floor and first floor respectively. The cooling demand decreased significantly from 17 [Wh/m<sup>2</sup>a] to 12 [Wh/m<sup>2</sup>a].

Picture 40: Subsoil heat exchanger layout.

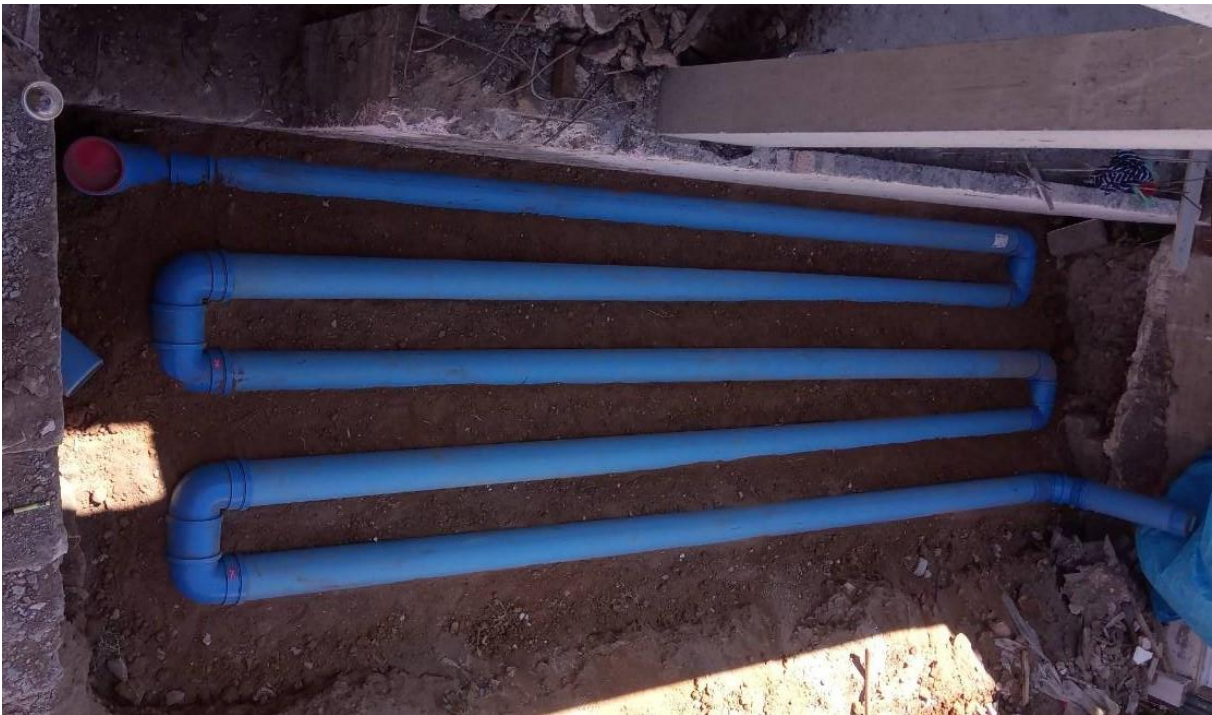
Picture 41: Subsoil heat exchanger during installation.

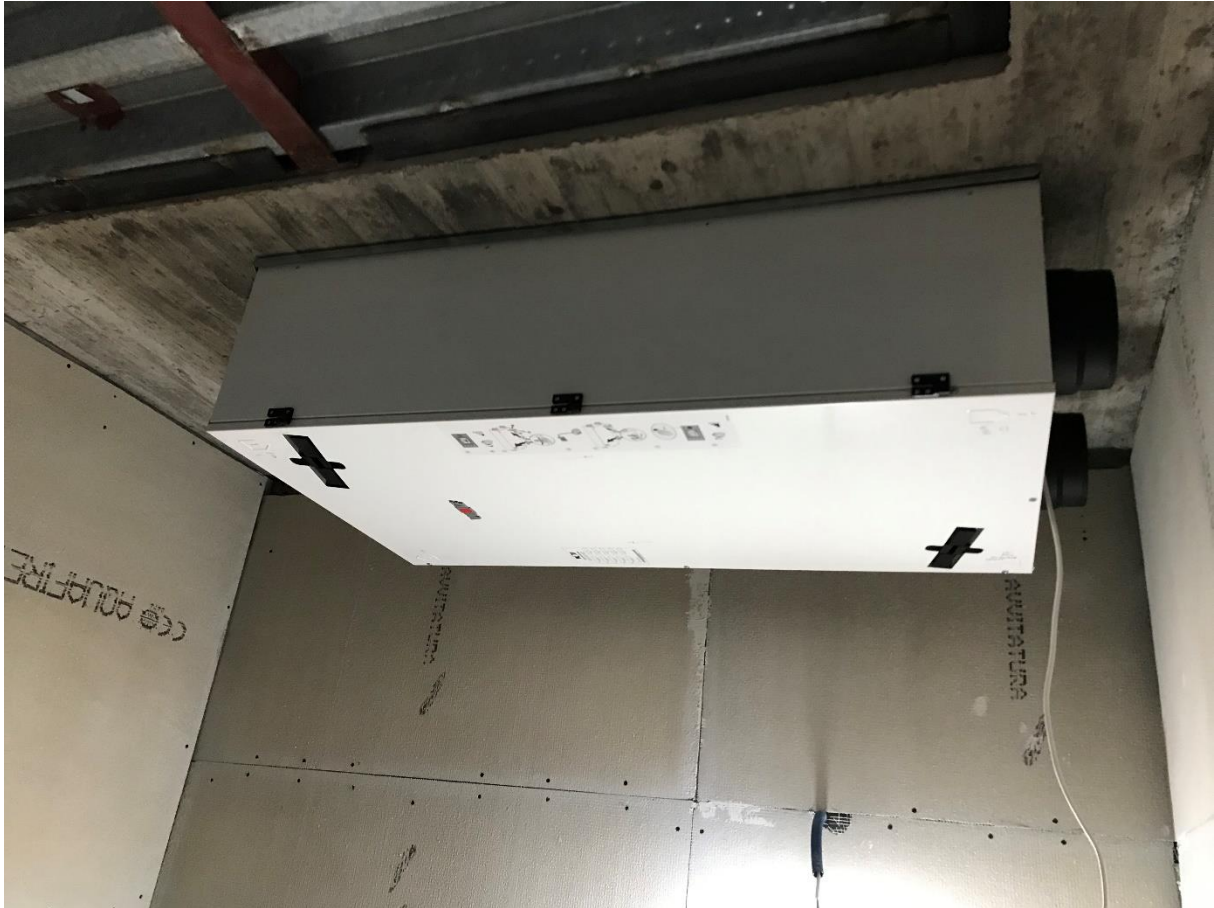
A mention two ventilation units have been installed in the bathroom false ceiling of each apartment. The design proposed the Wolf - CWL-F-300 Excellent model with an effective heat recovery efficiency at 85%, an electrical efficiency at  $0.31 \text{ Wh/m}^3$ , and finally an effective range of  $66 - 226 \text{ m}^3/\text{h}$ .

Picture 42: Ventilation unit, ground floor

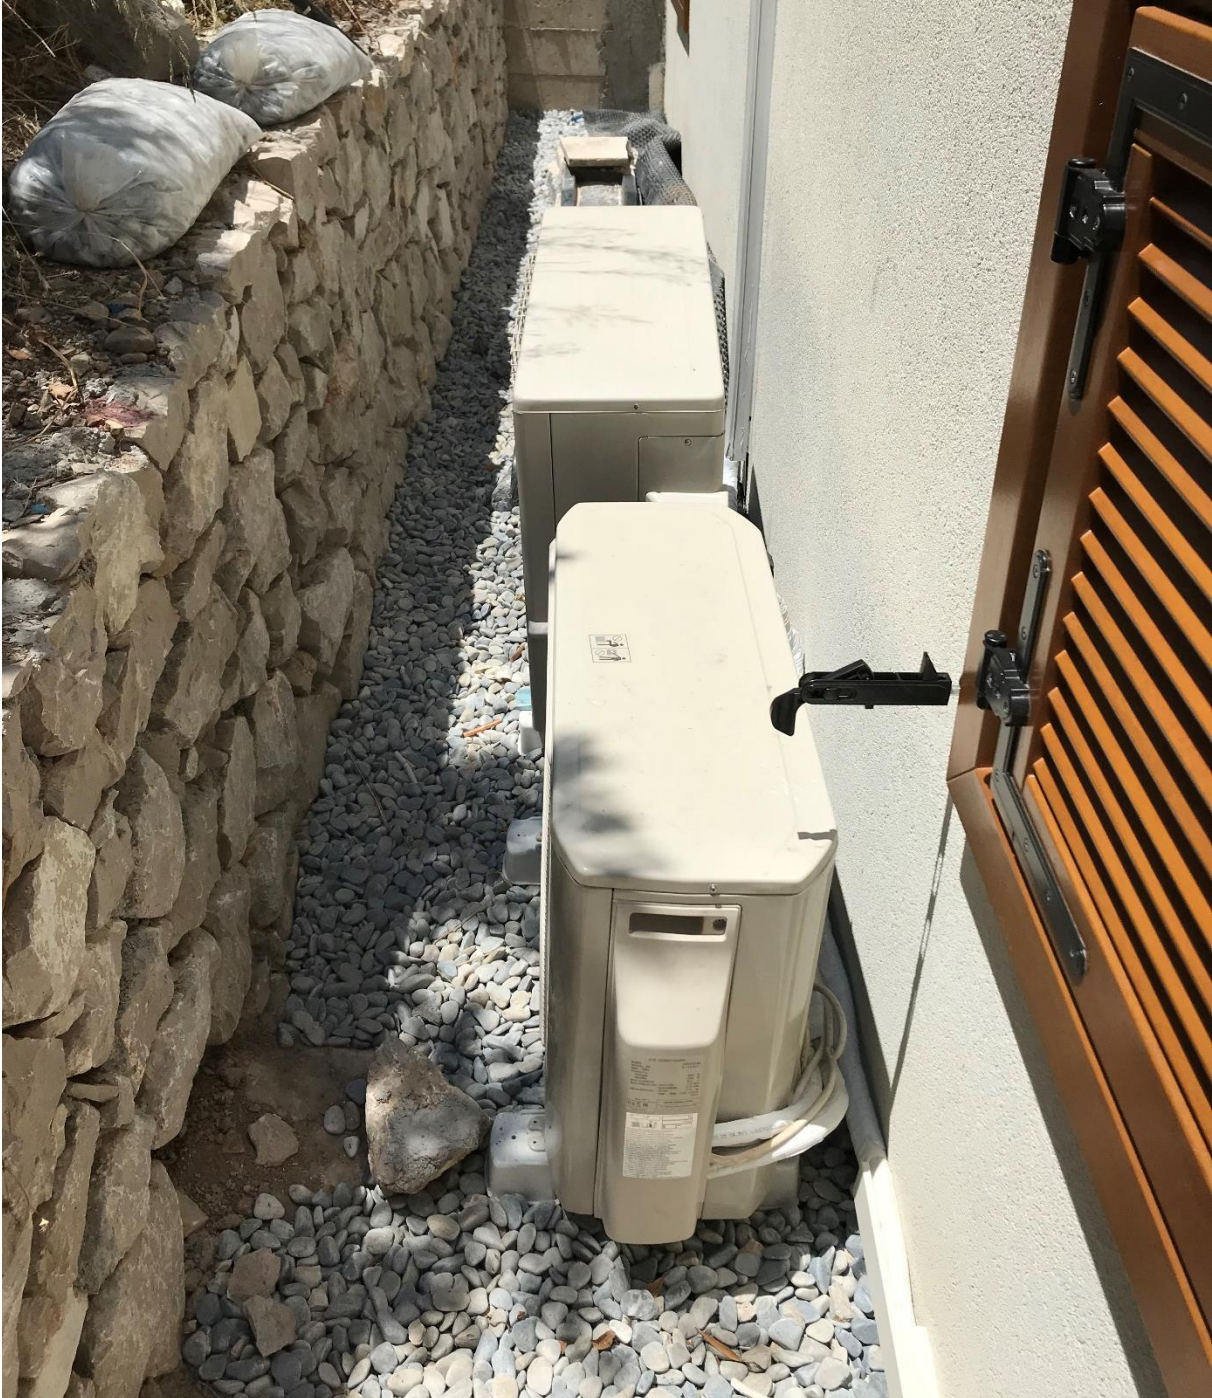
The heating and cooling demands of the building are met by the installation of two air to air heat pumps, one for each apartment. The heat pump of the ground floor has a nominal heating and cooling capacity of 6.80 and 5.40 kW respectively. The heat pump of the first floor has a nominal heating and cooling capacity of 4.10 and 3.50 kW respectively. Ceiling concealed ducted units have been installed as terminal units, one for the first floor and two for the ground floor.

*Picture 43: Air to air heat pumps outdoor units for heating and cooling.*

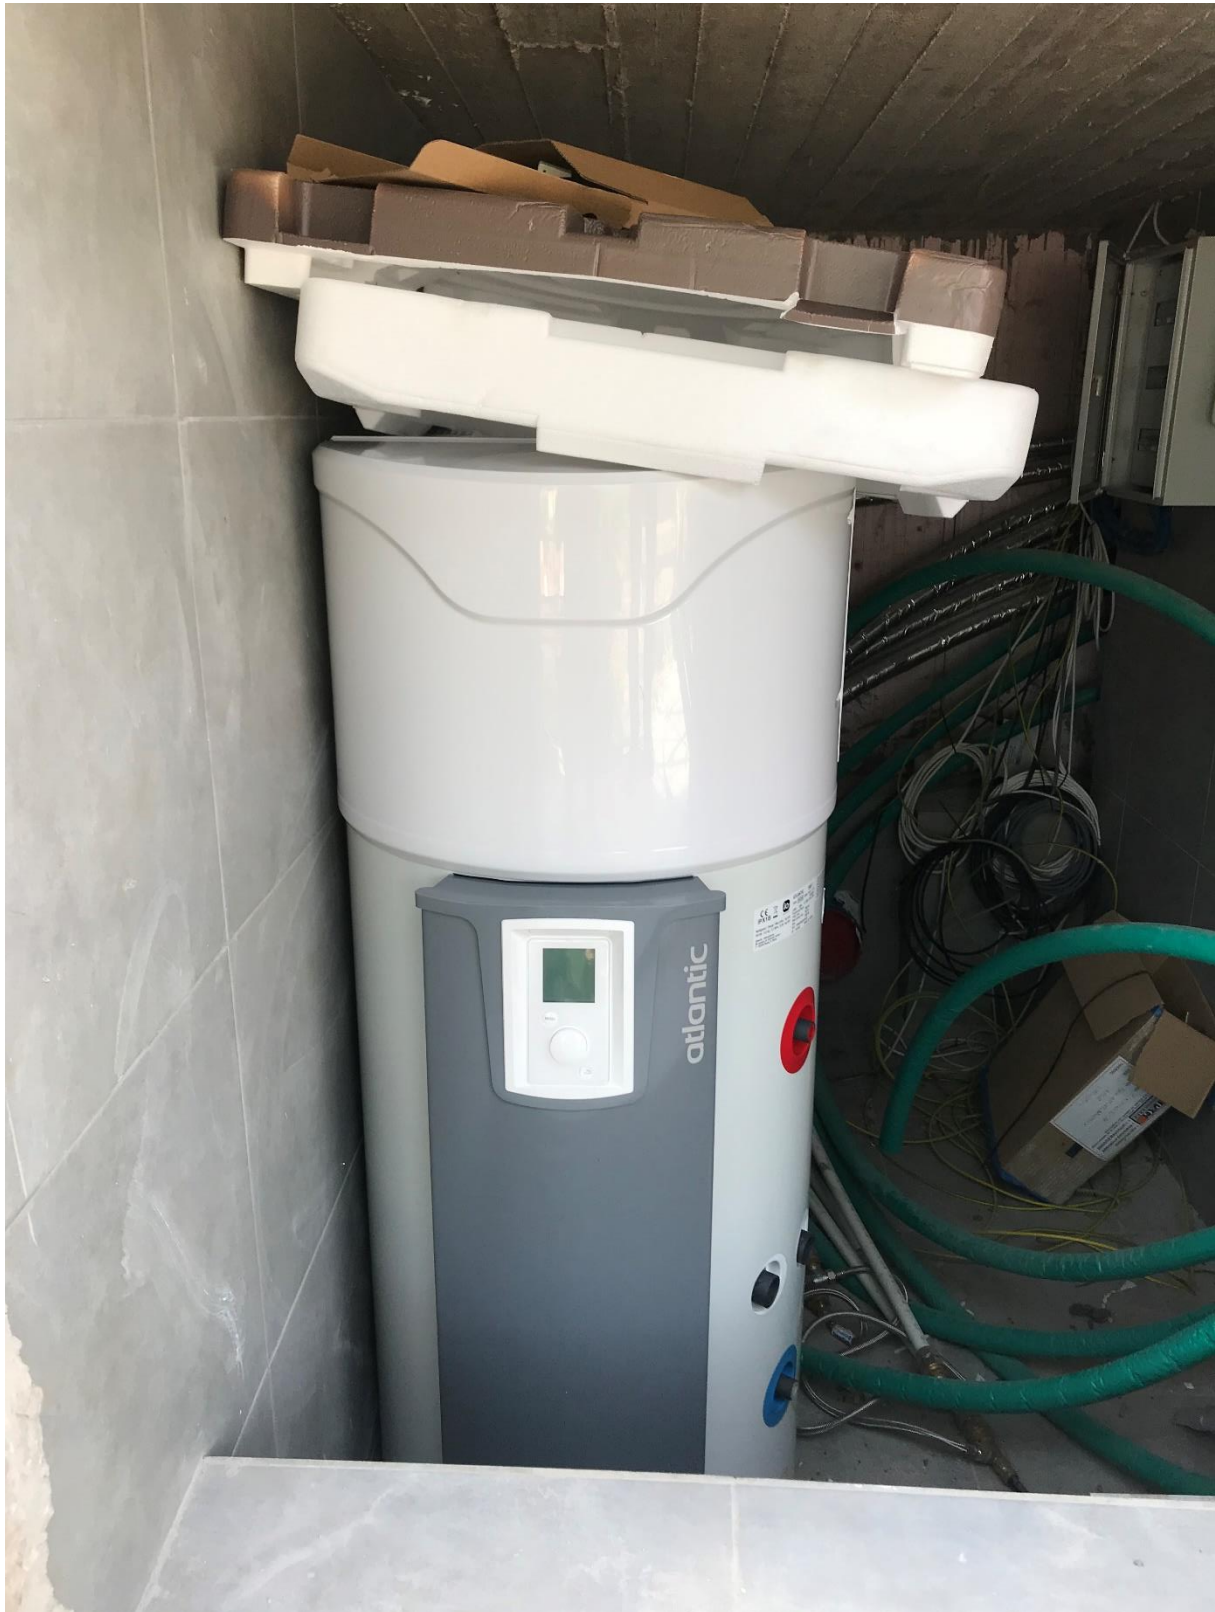
*Picture 44: DHW heat pump during installation.*

The design proposed a heat pump for the production of DHW with a maximum heating output of 2.5 kW. The storage tank has a capacity of 195l. Two selective solar collectors of a total surface area of 4.58 m<sup>2</sup> have been installed. The solar contribution for the production of DHW reaches 66% during the year. An electrical resistance of 1.80 kW is used as an auxiliary power.

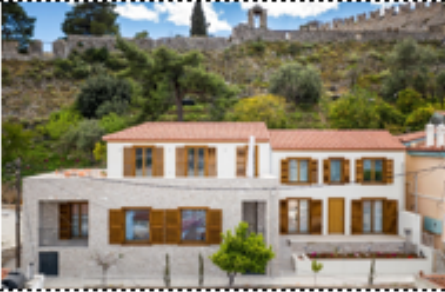
Picture 47: PHPP Verification results.

Specific building characteristics with reference to the treated floor area				Alternative criteria		Fulfilled? <sup>2</sup>
	Treated floor area m²			Criteria	Alternative criteria	
<b>Space heating</b>	Heating demand kWh/(m²a)	13	≤	15	-	yes
	Heating load W/m²	12	≤	-	10	
<b>Space cooling</b>	Cooling & dehum. demand kWh/(m²a)	12	≤	17	17	yes
	Cooling load W/m²	10	≤	-	11	
	Frequency of overheating (> 25 °C) %	-	≤	-	-	-
	Frequency of excessively high humidity (> 12 g/kg) %	1	≤	10	-	yes
<b>Airtightness</b>	Pressurization test result n <sub>50</sub> 1/h	0,6	≤	0,6	-	yes
<b>Non-renewable Primary Energy (PE)</b>	PE demand kWh/(m²a)	91	≤	-	-	-
<b>Primary Energy Renewable (PER)</b>	PER demand kWh/(m²a)	47	≤	60	60	yes
	Generation of renewable energy (in relation to projected building footprint)	4	≥	-	-

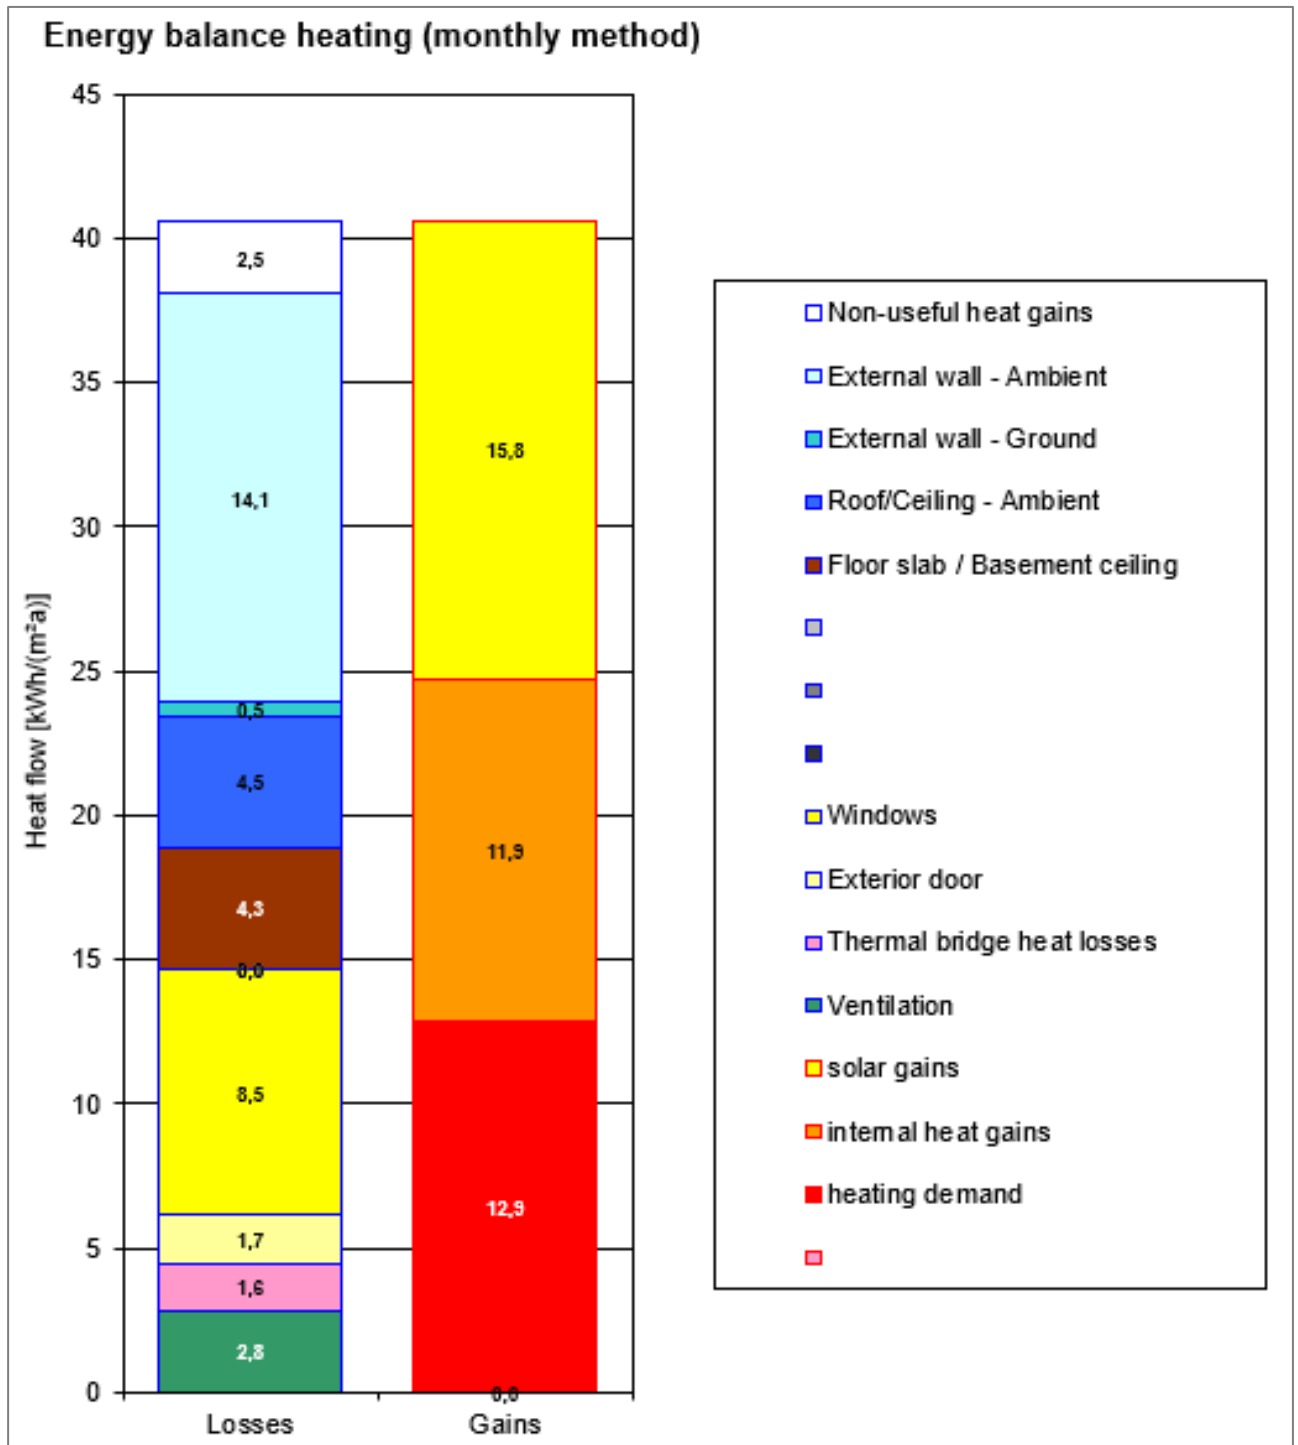
Picture 48: PHPP results, energy balance (monthly method).

The results show that most of the heat losses take place through the walls and windows. On the other hand, the solar and the internal gains are 15.8 and 11.3 kWh/m²a respectively, while the remaining heating demand reaches 12.9 kWh/m²a.
