Wonga park Drive, Waldara in Victoria Australia

Building data			
Year of construction Baujahr	2022	Space heating Heizwärmebedarf	14 kWh/(m²a)
U-value external wall U-Wert Außenwand	0,267 W/(m ² K)		
U-value floor slab U-Wert Bodenplatte	0,479 W/(m ² K)	Primary Energy Renewable (PER) Erneuerbare Primärenergie (PER)	38 kWh/(m ² a)
U-value roof U-Wert Dach	0,149 W/(m ² K)	Generation of renewable Energy Erzeugung erneuerb. Energie	0 kWh/(m ² a)
U-value window U-Wert Fenster	1,30 W/(m ² K)	Non-renewable Primary Energy (PE) Nicht erneuerbare Primärenergie (PE)	82 kWh/(m ² a)
Heat recovery Wärmerückgewinnung	84 %	Pressurization test n ₅₀ Drucktest n ₅₀	0,6 h ⁻¹
Special features Besonderheiten	Exterior blinds to prevent overheating in Summer

Passive House Waldara Victoria

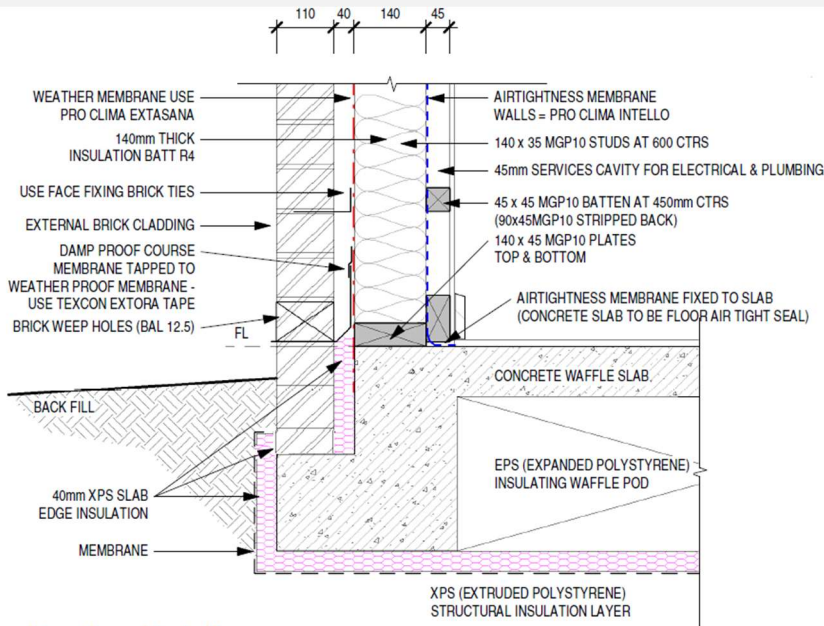
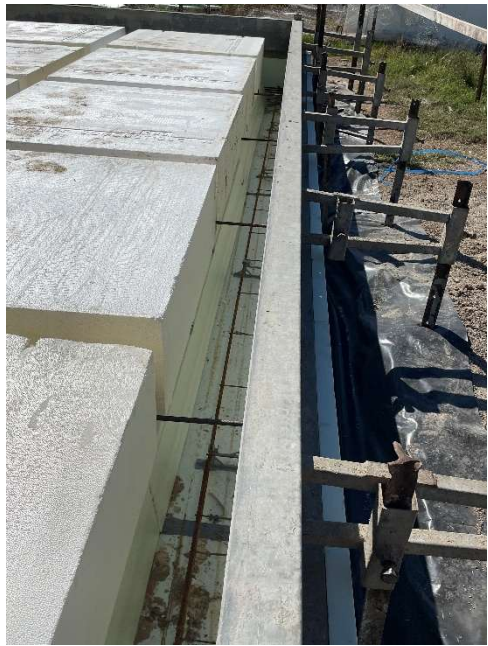
Footing Detail

To minimize the thermal bridge caused during construction due to bricks connected directly to the concrete slab, it was determined that if at least 2 brick courses were in ground (below grade), this would minimize the thermal bridge.

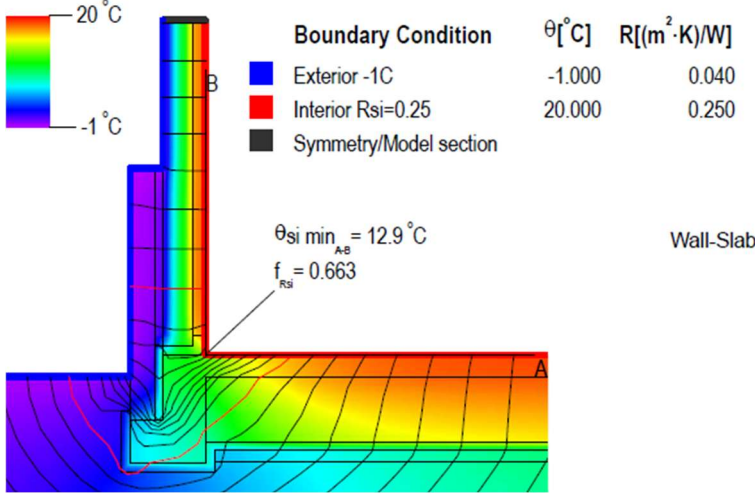
Assembly no.	03ud Warfe Floor 1			Interior insulation?		
Heat transmission resistance [m ² K/W]						
Orientation of building element	0.17	interior R _{si}	0.17			
Adjacent to	2-Ground	exterior R _{se}	0.00			
Area section 1	$\lambda [W/(mK)]$	Area section 2 (optional)	$\lambda [W/(mK)]$	Area section 3 (optional)	$\lambda [W/(mK)]$	Thickness [mm]
Slab	2.100					100
EPS80% Concrete20%	0.451					50
Air 50% EPS 30%	0.562	Concrete ribs	2.100			250
XPS LOADBEARING	0.028					40
Percentage of sec. 1	80%	Percentage of sec. 2	20.0%	Percentage of sec. 3		Total
						44.0 cm
U-value supplement		U-value:	0.479	W/(m ² K)

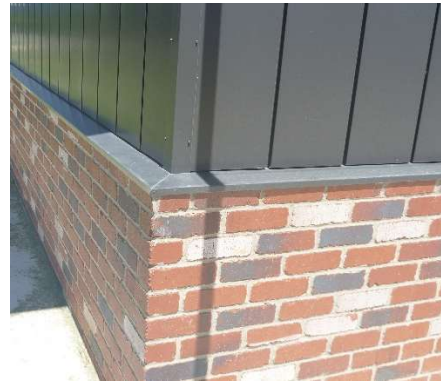
Assembly no.		02ud Warfe Wall 1				Interior insulation?
Orientation of building element		2-Wall				
Adjacent to		1-Outdoor air				
Heat transmission resistance [m ² K/W]						
		interior R _{se}		0.13		
		exterior R _{se}		0.04		
Area section 1	λ [W/(mK)]	Area section 2 (optional)	λ [W/(mK)]	Area section 3 (optional)	λ [W/(mK)]	Thickness [mm]
Sheet metal	50.000					0
Air	0.190	Batten	0.130	Ventilated		0
R4 Batts	0.035	Stud	0.130			140
Air	0.190	Batten	0.130			45
Plasterboard	0.250					10
Percentage of sec. 1		Percentage of sec. 2		Percentage of sec. 3		Total
91%		9.3%				19.5 cm
U-value supplement						U-value: 0.267 W/(m ² K)

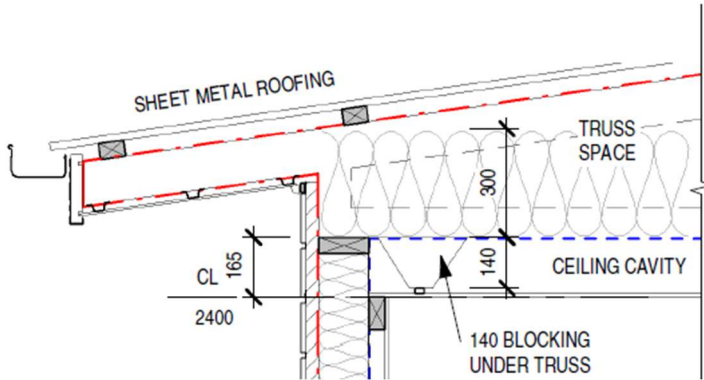
7. Construction of the roof

Sheet metal roofing on battens above weatherproof membrane fixed to top of timber truss structure. R7 bulk insulation between roof trusses. Airtight membrane fixed to bottom of roof trusses. Dropped ceiling for ventilation ducts and electrical lighting etc.

Assembly no.	Building assembly description				Heat transmission resistance [$\text{m}^2\text{K/W}$]		Interior insulation?
01ud	Warfe Roof 1						<input type="checkbox"/>
Orientation of building element	0.1	interior R_{se}		0.10			
Adjacent to	1-Outdoor air	exterior R_{se}		0.04			
Area section 1	λ [W/(mK)]	Area section 2 (optional)	λ [W/(mK)]	Area section 3 (optional)	λ [W/(mK)]	Thickness [mm]	
R7 Batt Hi Performance	0.041	Truss bottomchord	0.130			290	
Service Cavity Air	0.860					140	
Service Cavity Air	0.860			Ceiling Furring Channel	40.000	15	
Plasterboard	0.250					10	
Percentage of sec. 1	91%	Percentage of sec. 2	5.0%	Percentage of sec. 3	4.0%	Total	
						45.5 cm	
U-value supplement	<input type="text"/>	U-value:		0.149	W/(m ² K)

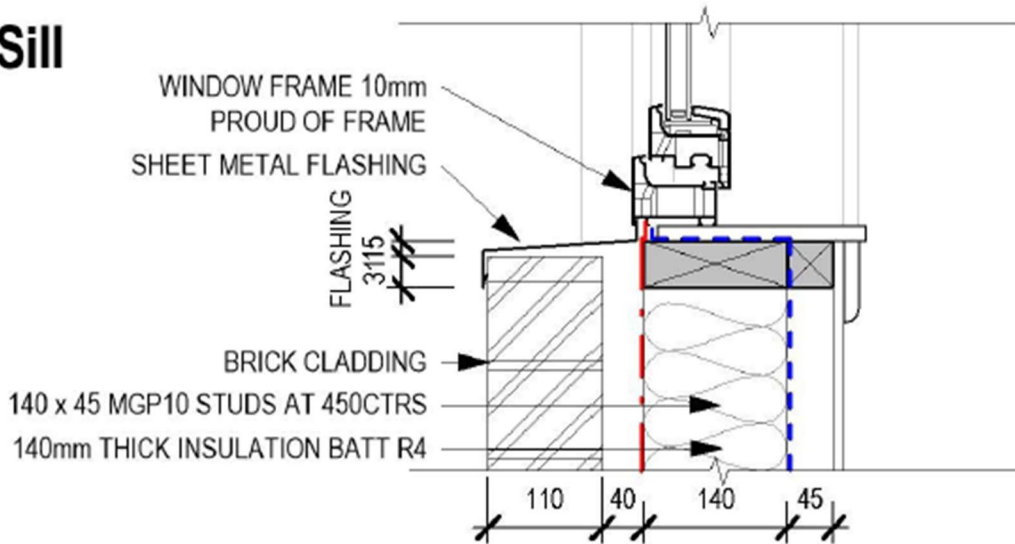
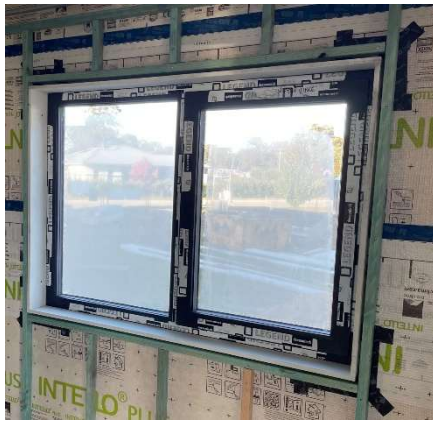
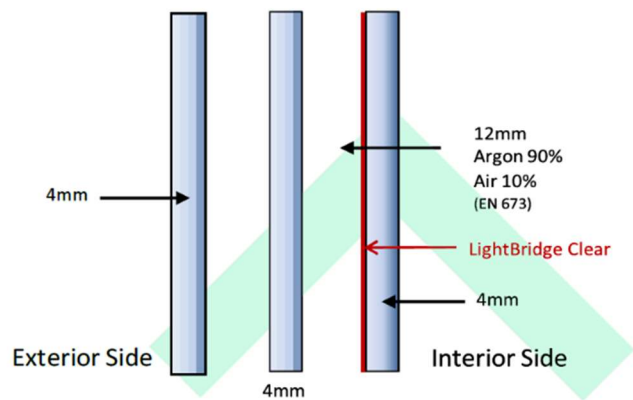
Sill

Description of the window frame, construction, manufacturer	Deceuninck, uPVC
Window make (frame, product name)	Legend
Frame-U-value U_f	1.02 W/(m ² K)
Type of glazing	4 12 4 12 4 – Argon filled with lightbridge film
Glass-U-value U_g	1.02 W/(m ² K)
g-Value of the glass unit	0.57

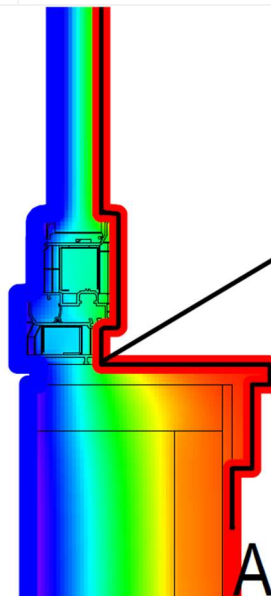
A-B

$$\theta_{si \min} = 11.6^{\circ} \text{C}$$

$$f = 0.600$$

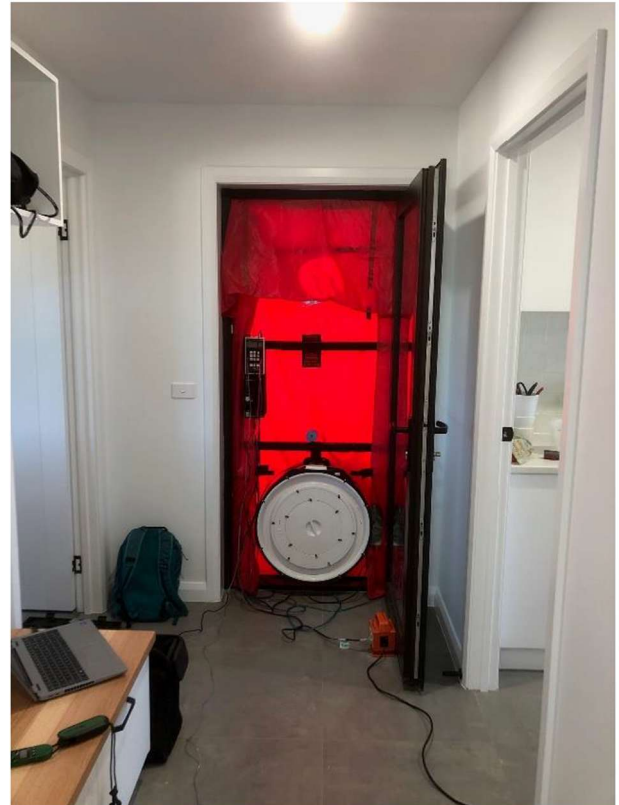
- Walls: Pro clima Intello airtight membrane fixed between stud and interior batten. Membrane fixed to concrete slab via ORCON joint sealant. Top of membrane to continue over ceiling.
- Floor slab: Concrete
- Window connection: Pro clima Intello membrane taped to PVC window frame with TESCON EXTONSEAL sill tape under timber window reveals.
- Roof: Pro clima Intello airtight membrane fixed between roof truss and dropped ceiling. Membrane to continue from exterior walls across ceiling to opposing exterior wall.

The pressure test was carried out by Detail Green on the 17th of November 2022. There was a temporary seal of the HRV outdoor and exhaust air ducts, the test equipment was setup in the garage doorway.

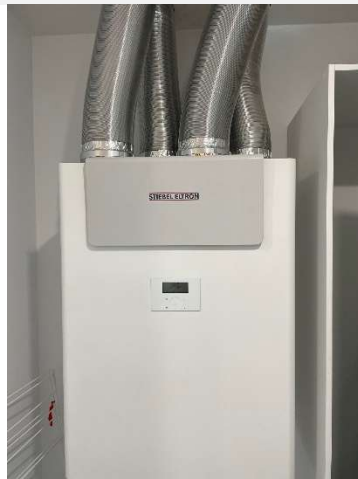
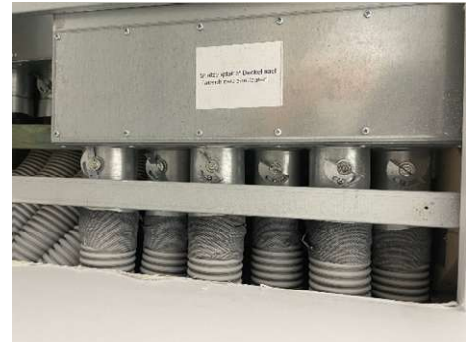
In order to significantly reduce ventilation losses, a balanced supply/exhaust air system with a highly efficient counterflow air-to-air heat exchanger was used. The Stiebel Eltron LWZ 280 heat recovery ventilation unit is a highly efficient appliance, importantly in this climate it has summer bypass function and is passive house certified.

Ventilation system Brand	Stiebel Eltron LWZ 280
Heat recovery efficiency	84 %
Electric efficiency	0.27 Wh/m ³

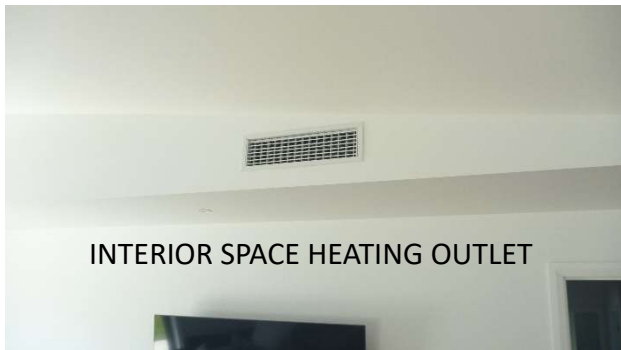
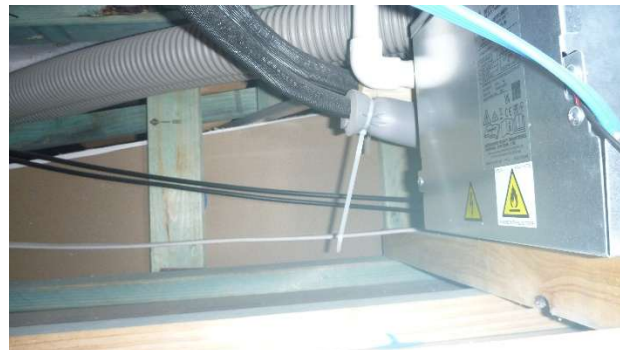
INTERIOR SPACE HEATING UNIT IN CEILING BULKHEAD

Hot water supply is via a heatpump insulated storage system located in the garage. Space heating and cooling is supplied via a heat pump air to air system. The exterior condenser unit is located outside of the East wall. The interior unit is located within the open living area dropped ceiling with a bulkhead grill, located centrally to help distribution throughout the house.
