Project Documentation

Private residence in St. Andreu de Llavaneres, Spain

Passive House Llavaneres

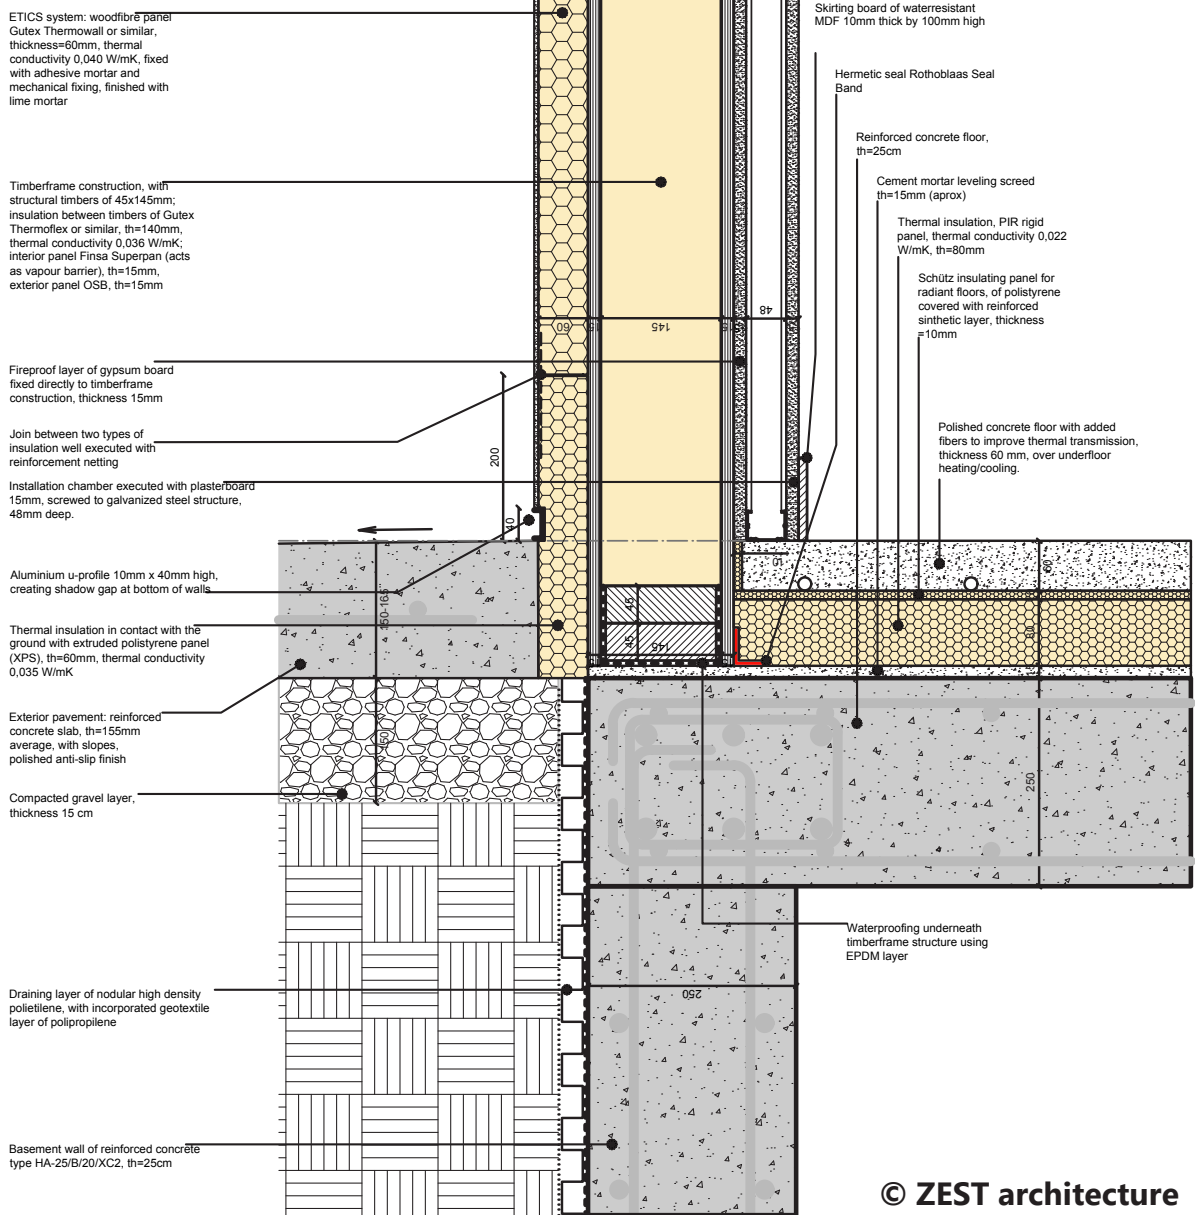
5a. Ground floor above unheated basement

Description of building assembly		Assembly no.					
Ground floor above unheated basement		09ud					
Orientation of building assembly (or R _{si})		3-Floor	Interior insulation?				
Adjacent to (or R _{se})		3-Ventilated	U-value supplement [W/(m²K)]				
Area section 1	λ [W/(mK)]	Area section 2 (optional)	λ [W/(mK)]	Area section 3 (optional)	λ [W/(mK)]	Thickness [mm]	
Polished concrete with fibers	2.000					43	
Schutz underfloor heating panels with polished concrete with fibers	0.039	Concrete floor	2.000			17	
Schutz underfloor heating panels	0.034					28	
PIR Rigid insulation panel	0.028					80	
Leveling screed (cement mortar)	1.800					10	
Reinforced concrete slab	2.500					250	
Percentage of sec. 1:	40%	Percentage of sec. 2:	60.0%	Percentage of sec. 3:			
Heat transmission resistance coefficients						Total thickness [cm]:	42.8
Interior R _{si} :						0.17	m²KW
Exterior R _{se} :						0.17	m²KW
U-value [W/(m²K)]:						0.233

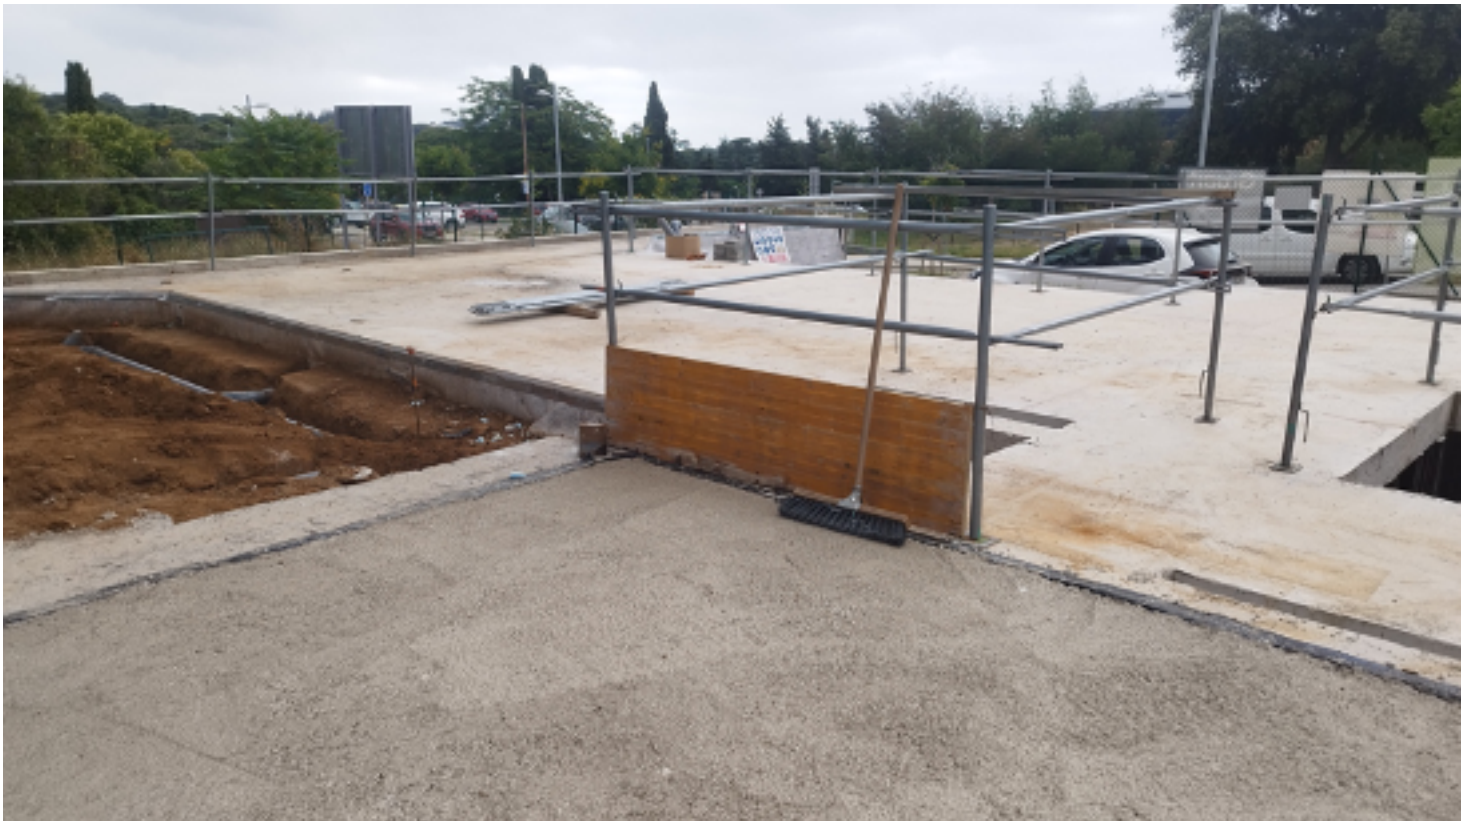
Below a photograph of the build, with in the second plane the ground floor above the basement, and in the foreground the separate construction of the floor of the living room, where there is no basement underneath.

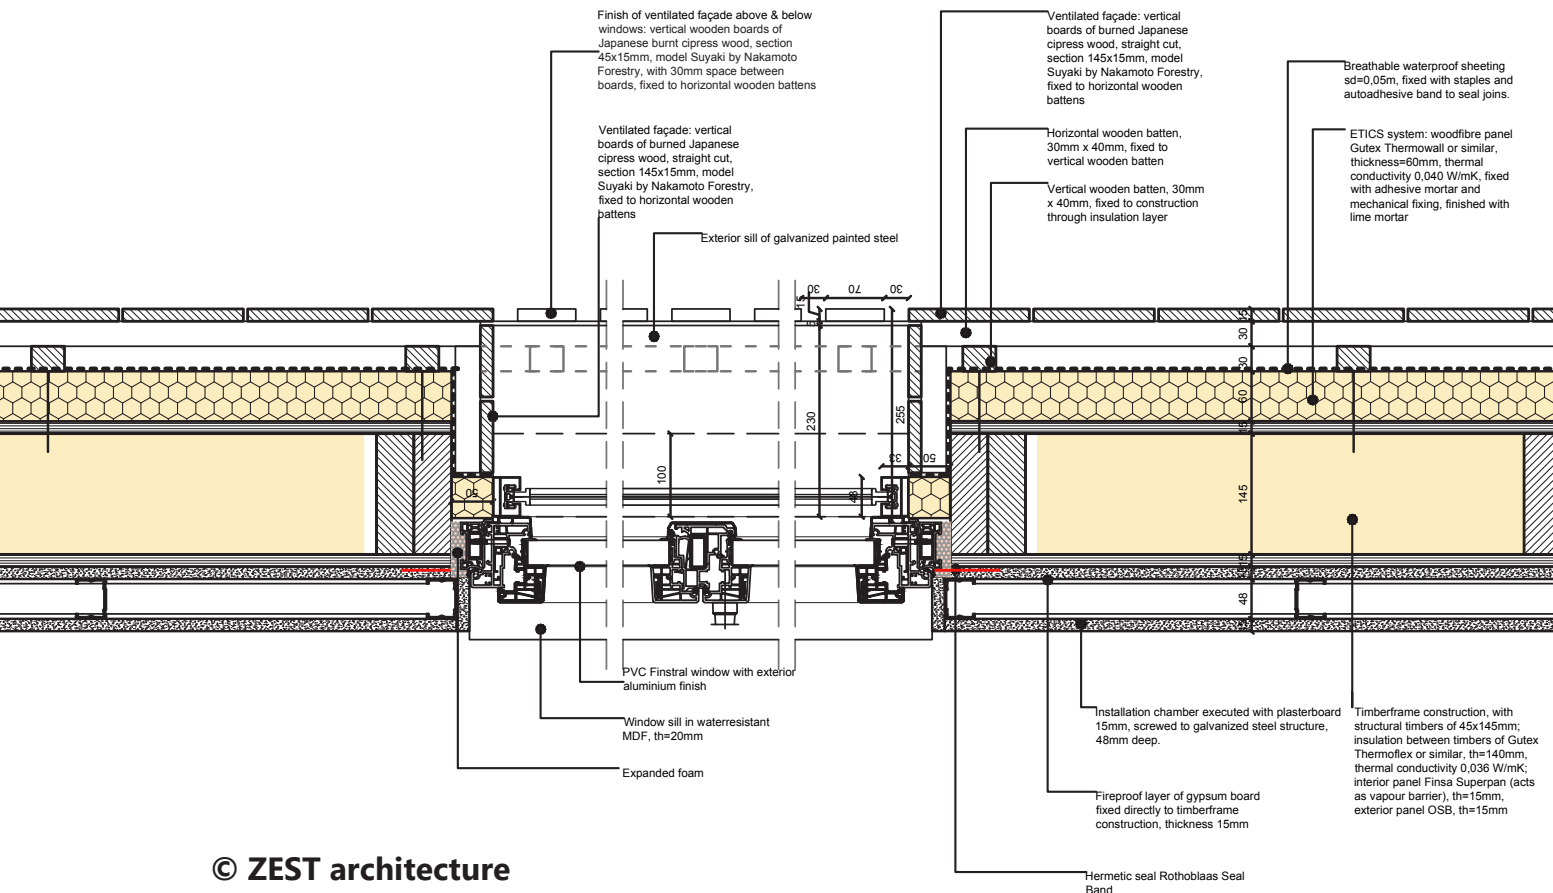
6. Façade construction

The façade has two different types of finish; the day-spaces are finished with lime mortar, the bedrooms are finished with a ventilated façade of vertical boards of charred Japanese cypress wood. However, in terms of thermal behavior these façades are the same, except for the additional thermal bridges introduced by the fixings of the ventilated façade. For this reason we only show the detail for the ventilated façade here.

Description of building assembly						Assembly no.	
Wall with ETICS system						02ud	
Orientation of building assembly (or R_{si})			2-Wall		Interior insulation?		
Adjacent to (or R_{se})			1-Outdoor air		U-value supplement [W/(m ² K)]		
Area section 1	λ [W/(mK)]	Area section 2 (optional)	λ [W/(mK)]	Area section 3 (optional)	λ [W/(mK)]	Thickness [mm]	
ETICS mortar finish	1.800					3	
Gutex Thermowall Insulation	0.040					60	
OSB 3	0.130					15	
Gutex Thermoflex insulation	0.036	Structural timbers	0.130			140	
Superpan Fintech	0.140					15	
Plasterboard	0.250	Screws to structure				15	
Air chamber	0.260			Galvanized steel structure	17.000	48	
Plasterboard	0.250					15	
Percentage of sec. 1:	92%	Percentage of sec. 2:	7.5%	Percentage of sec. 3:	0.2%		
Heat transmission resistance coefficients						Total thickness [cm]:	
Interior R_{si} :	0.13	m ² K/W					31.1
Exterior R_{se} :	0.04	m ² K/W					U-value [W/(m ² K)]:

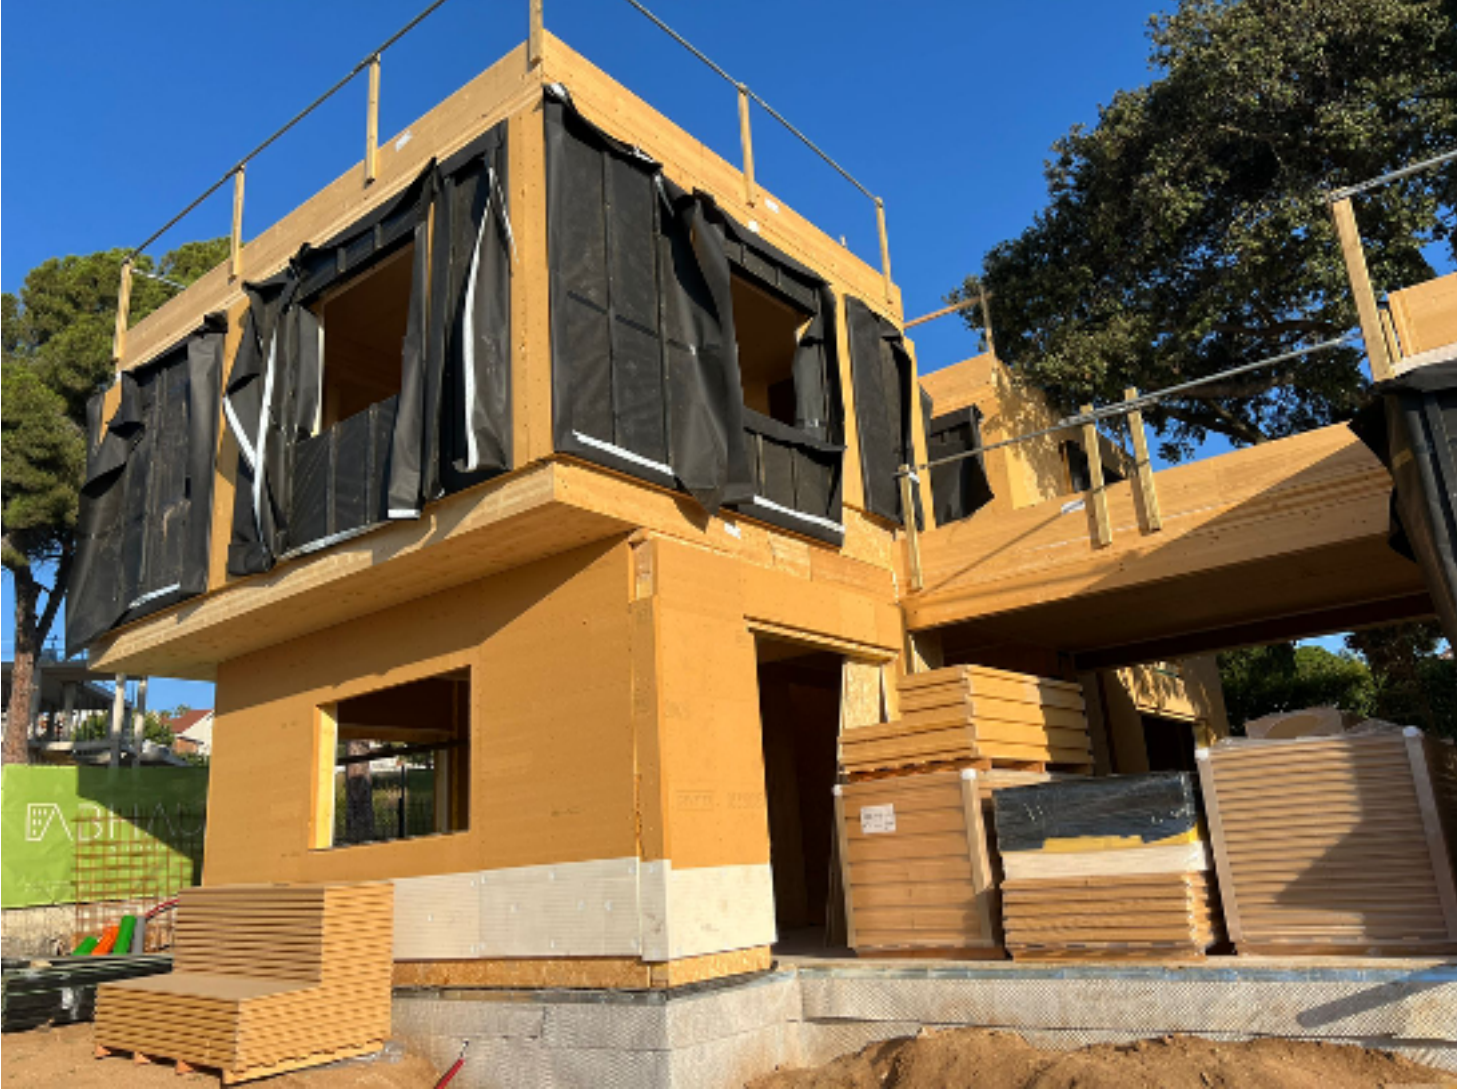
Below a picture after the timberframe construction of the ground floor and first floor were finished. On the ground floor the façade has already been covered with additional exterior insulation, in the porch the material for covering the rest of the façade.

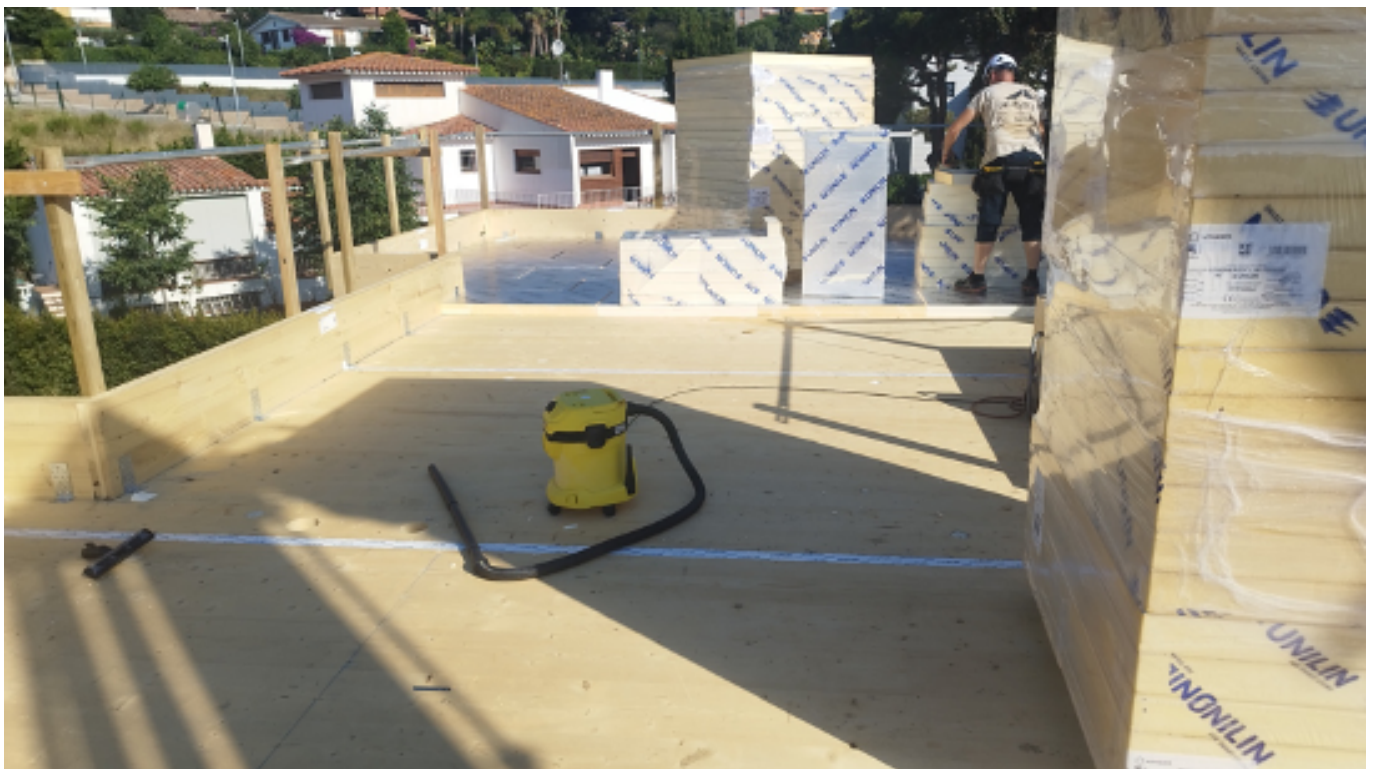
Above a picture of the roof during the process of insulation. In the rear of the photo the roof has received the first layer of 8cm PIR insulation. In the foreground the material stand-ing ready.

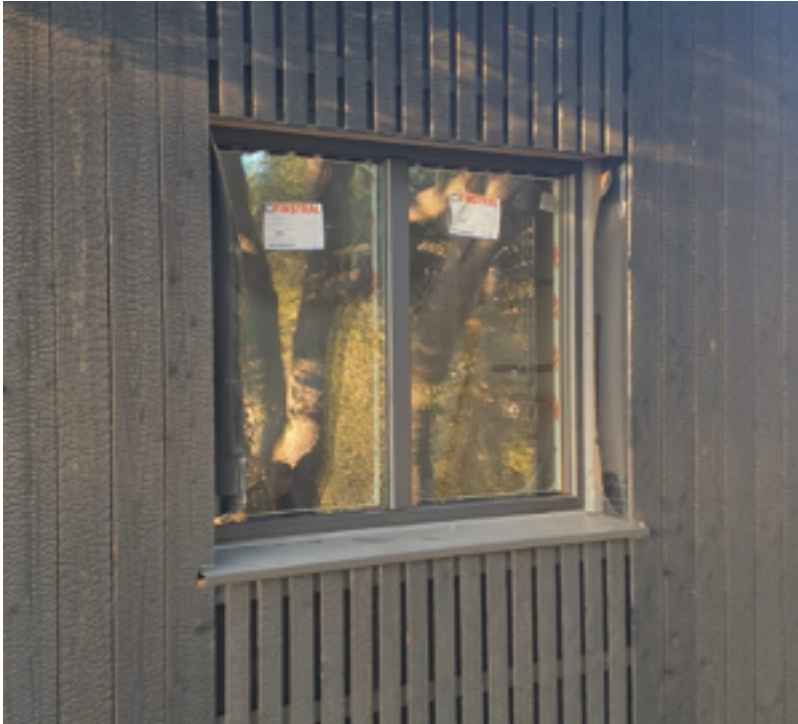
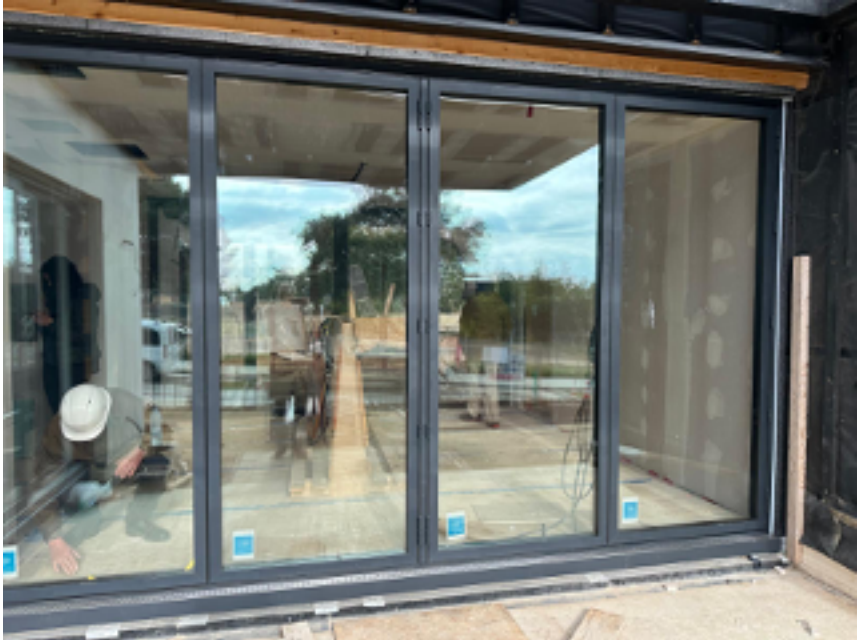
Below the PVC windows installed, and underneath the folding sliding doors of the dining room.

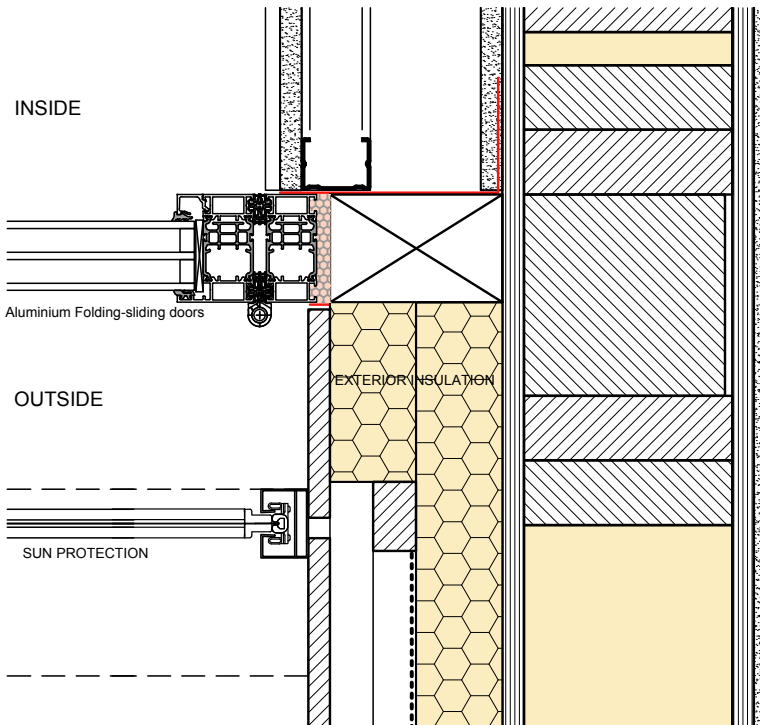
Aluminium folding sliding frames:

Window manufacturer	Sunflex
Window frame materials	Aluminium window frames
Window-U-Value Uf	1,74 W/(m ² K)
Glass composition	4+4 12ar 6 13ar 6
Glass U-Value Ug	1,04 W/(m ² K)
Glass g-Value	0,43

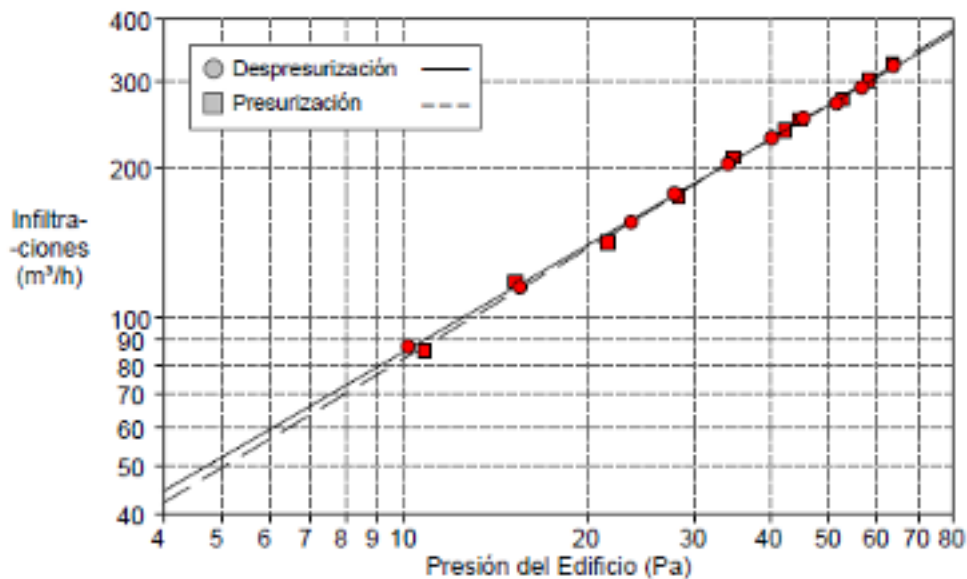
A first blowerdoor test was done on 17.9.2024 after the airtight envelope was finished, which was not sufficient. After locating a number of issues, a second test was done on 19.9.2024, which was more than compliant.

Resultados del test a 50 Pa:	Despresurización	Presurización	Media
q ₅₀ : m³/h (Caudal de Aire)	268 (+/- 0.9 %)	269 (+/- 2.2 %)	268
n ₅₀ : 1/h (Tasa de Renovación de Aire)	0.54	0.54	0.54
qF50 : m³/(h·m² Área del Suelo)	1.56	1.56	1.56
qE50 : m³/(h·m² Área de la Envolvente)	0.36	0.37	0.37

Norma del Test:	ISO 9972
Modo del Test:	Despresurización y Presurización
Método del Test:	Método 1 - Test para el edificio en uso
Objetivo del test:	Passivhaus n50 ≤ 0.64 1/h

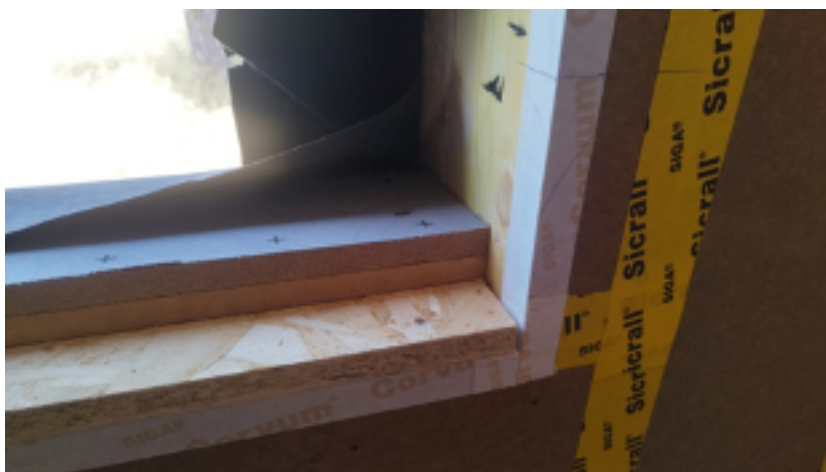
Façade: Fintech Superpan board (functions both as airtightness layer and vapor barrier, with the joints between panels taped with Siga Sikrall seal band)

Joint between Fintech panels and with window mounting frame

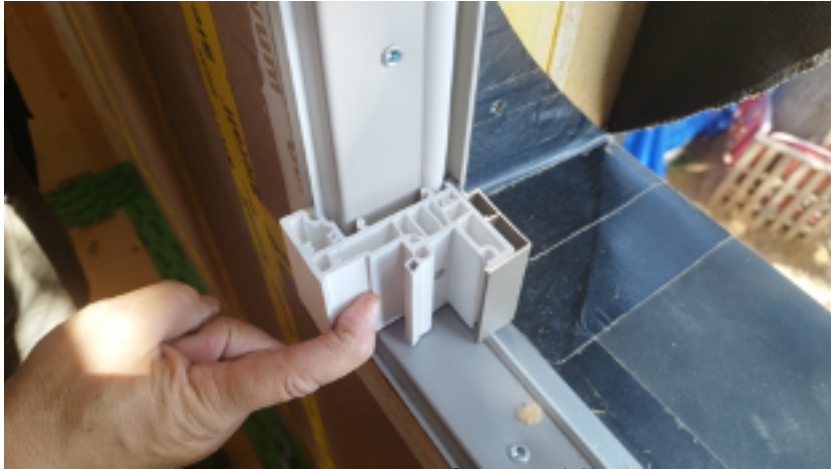
Demonstration of fit Casement frame with Mounting frame

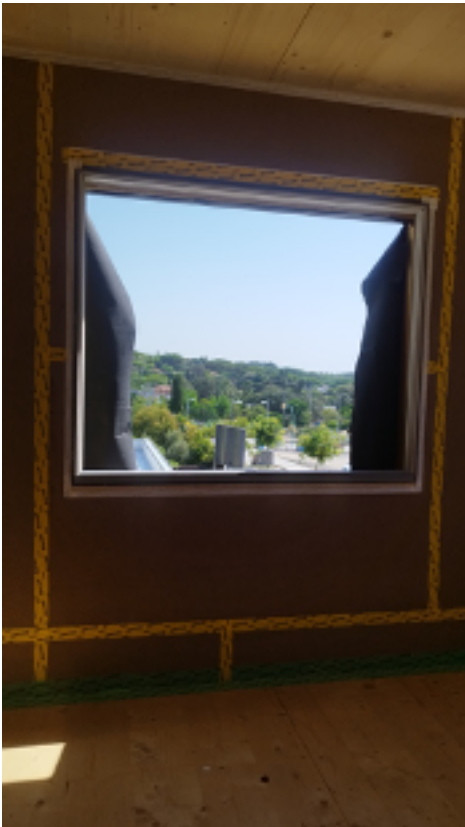
View of 3 types of Siga seal band installed

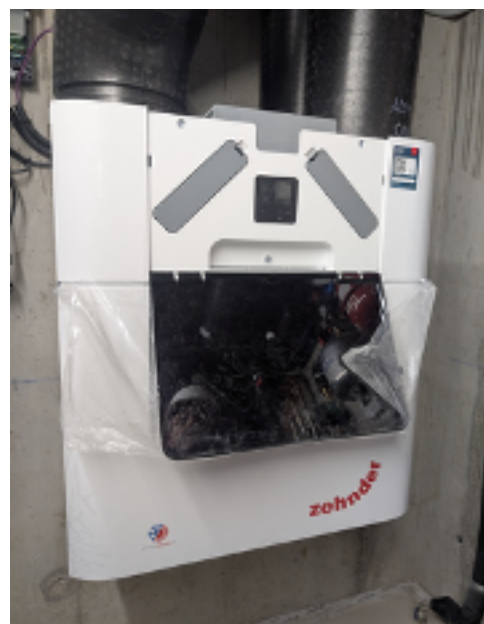
Zehnder ComfoAir Q600
Photo ZEST architecture

Manufacturer	Zehnder
Heat recovery efficiency	87%
Power input	0,24 Wh/m ³

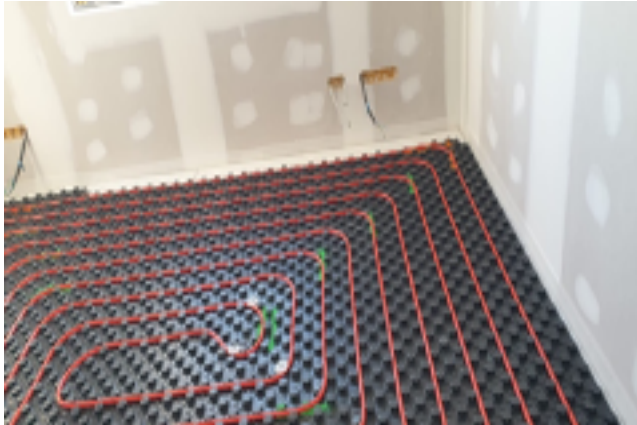
Radiant floor installed

Although heating/cooling would have been sufficient using air based systems, the sensitivity to air movements of the owner of the house led us to opt for a radiant system. A polished concrete screed covers a radiant floor which can be run both in heating and cooling setting. This floor is fed by a Panasonic air-to-water heat pump. The system includes dehumidifiers which control the dew point when the underfloor system is in cooling mode, ensuring sufficient cooling power is achieved at all times.

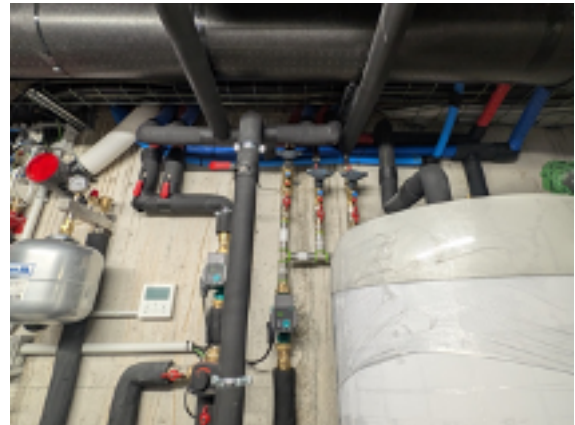
Panasonic heat pump

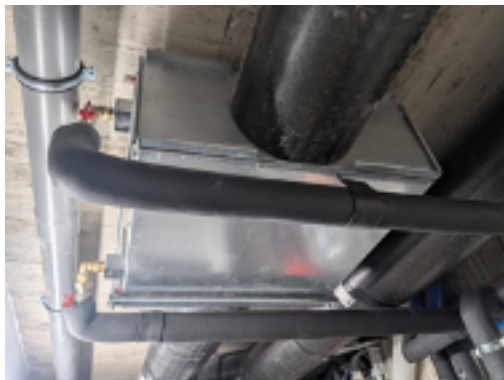
Zehnder dehumidifier

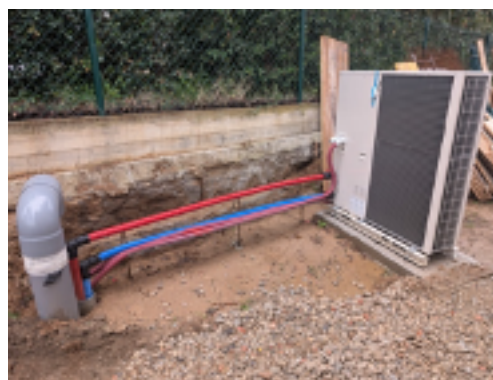
Exterior unit of the Panasonic heat pump

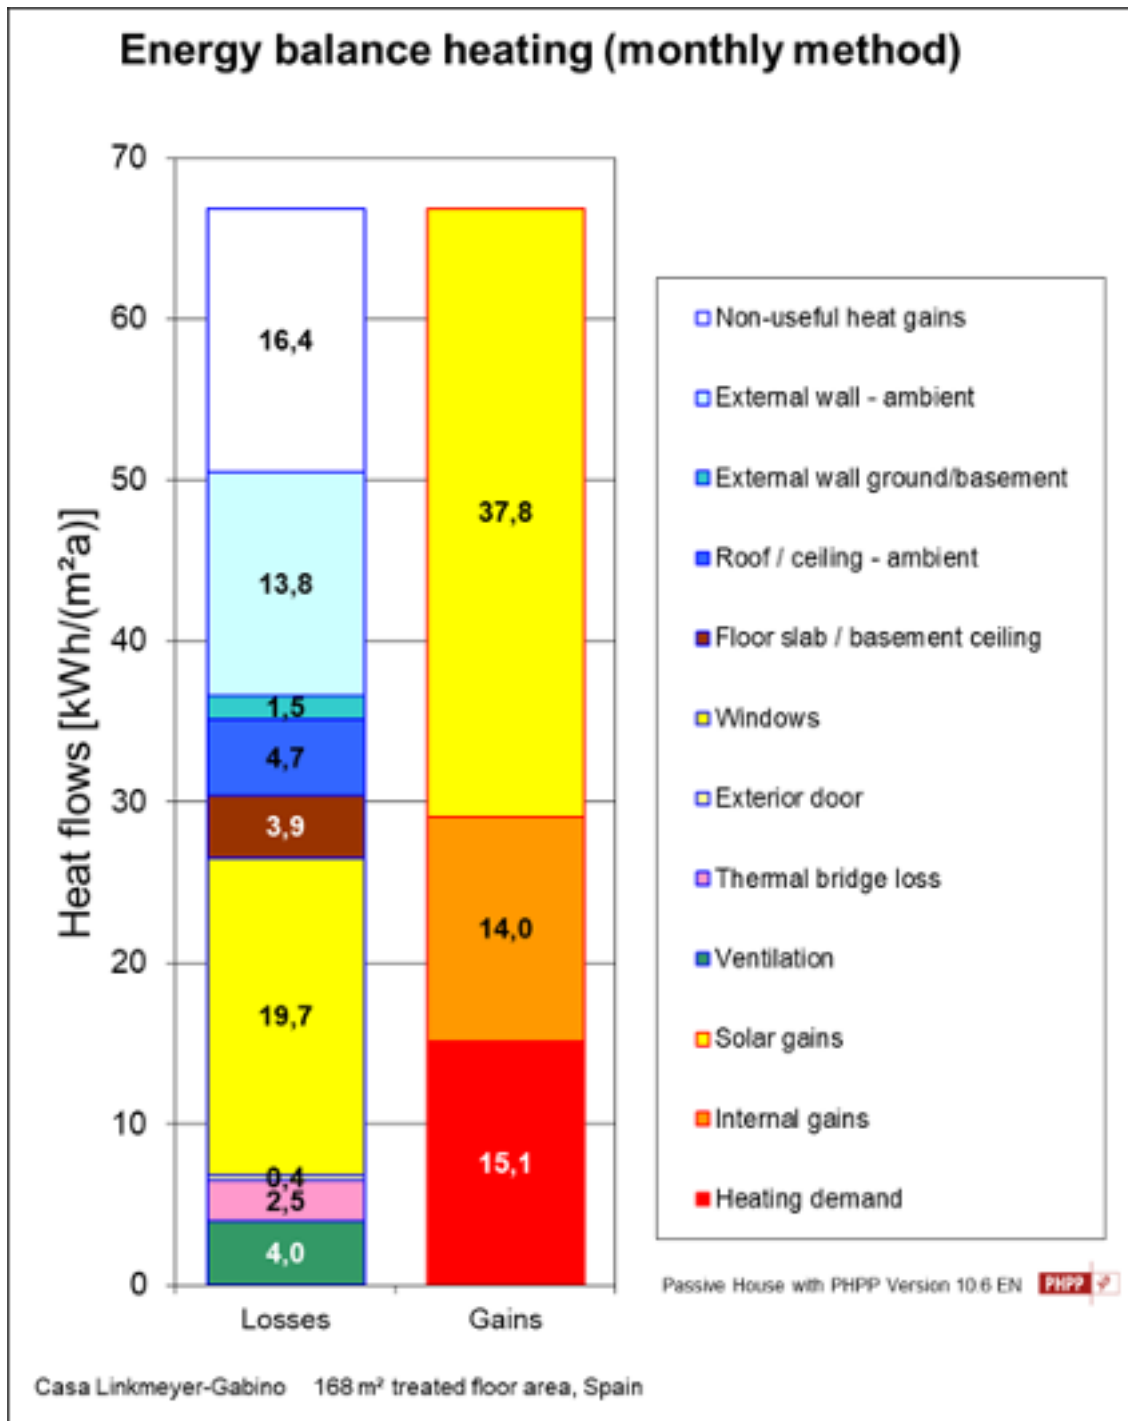
First factor complicating matters was the orientation, which was far from ideal. As a result, we could not follow the rule of few openings that face North, and most openings facing South. As visible in the energy balance on the next page, although the windows facing South-East, South and South-West give us a lot of solar gains, these are offset with the heat losses of North-East, North and North-West facing windows, of which there are quite a few, including large glazed elements in the dining room.
