# Project Documentation Gebäude-Dokumentation

### Single-family dwelling in a densely populated urban area, Bucharest

### Detached single-family house in Bucharest

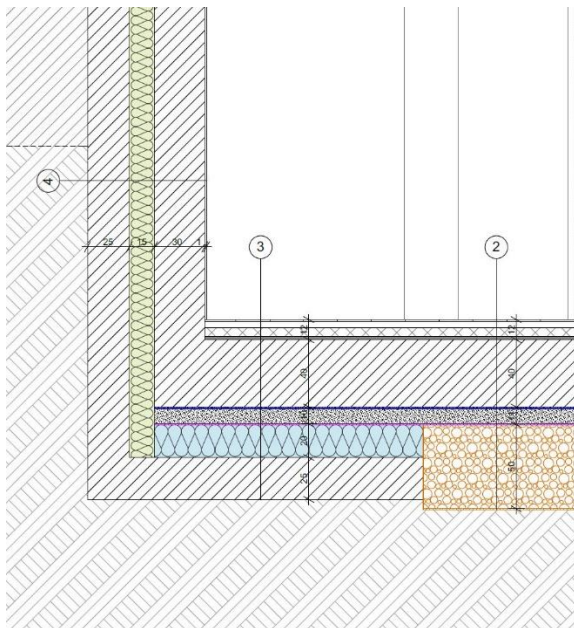
## 5. Konstruktion der Bodenplatte

- STRAT 4 CALCAN**
- panare
  - sprijinire tip pircin de beton armat
  - termoizolație polistiren extrudat XPS30 15 cm
  - diafragma de beton armat 30 cm
  - tencuială pe baza de ipsos 1 cm
  - glet
  - vopsea lavabila
- STRAT 5 CALCAN**
- zid de sprijin din caramida plina 15cm
  - termoizolație vata minerala Rockwool 25cm
  - adeziv
  - caramida porotherm 25 cm
  - gips-carton + profile metal 6,5 cm
  - glet la rosarii
  - vopsea lavabila

Due to the structural support for the neighboring building, the infrastructure consists of two structural layers and a thermally insulated core.

On the side facing the courtyard, it was sufficient to insulate only with glass foam gravel.

The structural stability of the existing northern building required the design team to use underpinning infrastructure. Consequently, the underground insulation is a mixture of XPS and glass foam gravel.

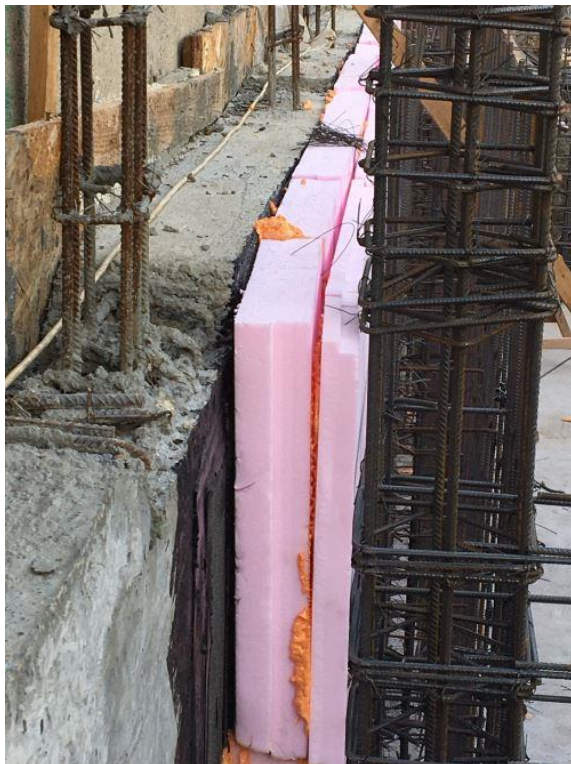
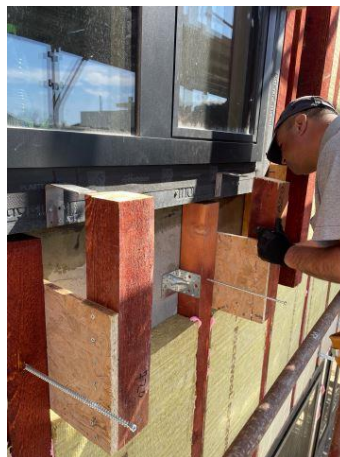
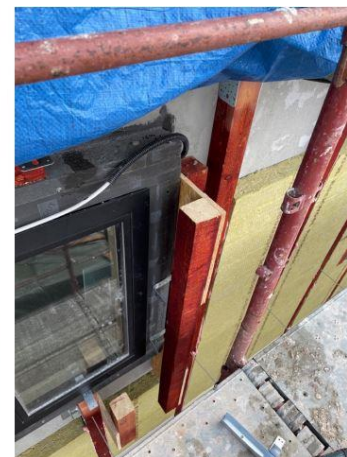
## 6. Konstruktion der Außenwände

The rear wall consists of an outer structural layer, a thermally insulated core, and the wall itself, which is made of concrete or ceramic blocks.

The exterior walls facing the courtyard are made of confined masonry and are insulated with 30 cm of mineral wool. A ventilated shingle-covered façade is mounted over the insulation.

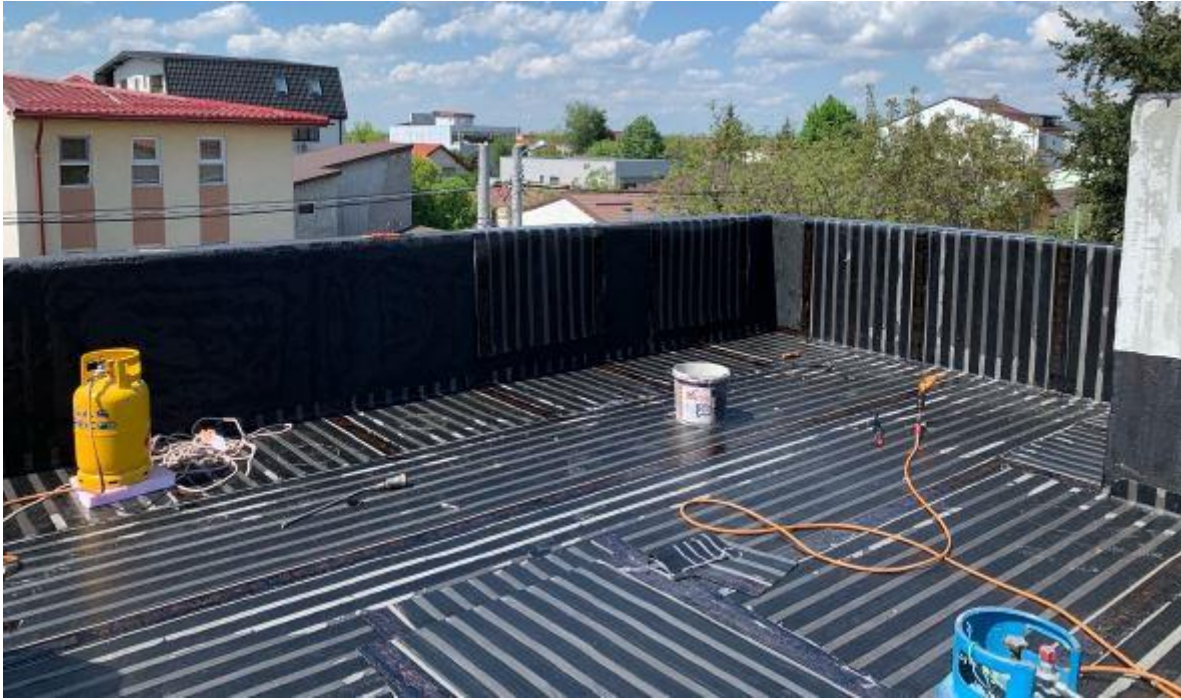
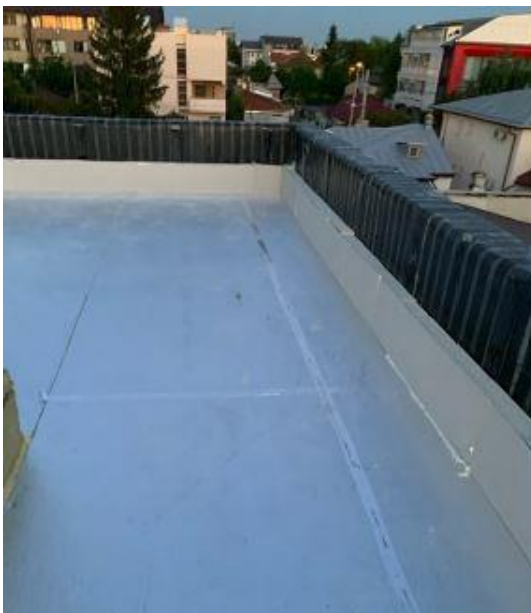
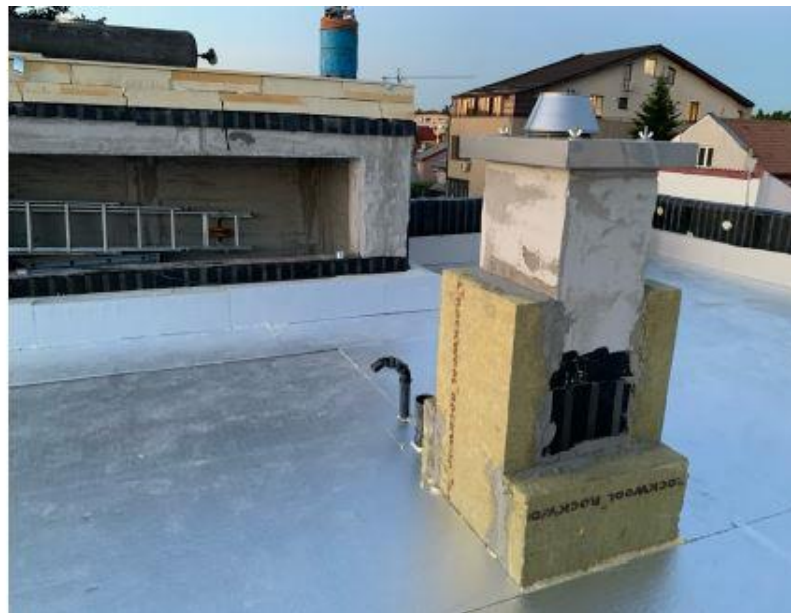
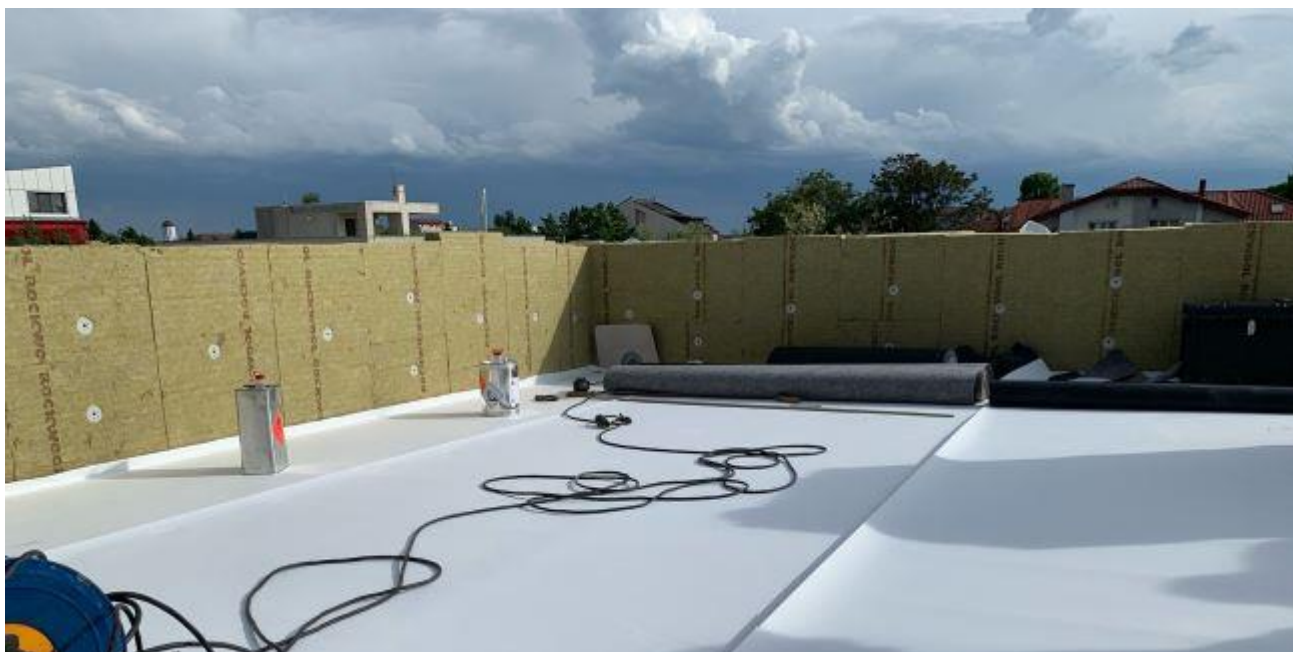
## 7. Konstruktion des Daches

The terrace roof consists of a concrete slab, bituminous vapor barrier, 28 cm of PIR, and TPO membrane for waterproofing.

Component nr.		08ud				07_Terasa		Izolatie la interior?
Orientarea elementului de clădire		1-Acoperiș		Rezistență la transfer termic [m²KW]		R <sub>si</sub> (interior): 0.13		
Adiacent la		1-Aer exterior		R <sub>se</sub> (exterior): 0.04				
Aria secțiunii 1	λ [W/(mK)]	Aria secțiunii 2 (opțional)	λ [W/(mK)]	Aria secțiunii 3 (opțional)	λ [W/(mK)]	Grosime [mm]		
Gipscarton + ST	0.240					150		
Placa beton armat	2.500					130		
Bariera vapori	0.200					2		
PIR	0.022					280		
Membrana FPO	0.700					2		
Procentaj sect. 1		Procentaj sect. 2		Procentaj sect. 3		Total		
100%						56.4 cm		
supliment la valoarea-U:				Valoare-U:		0.074 W/(m²K)

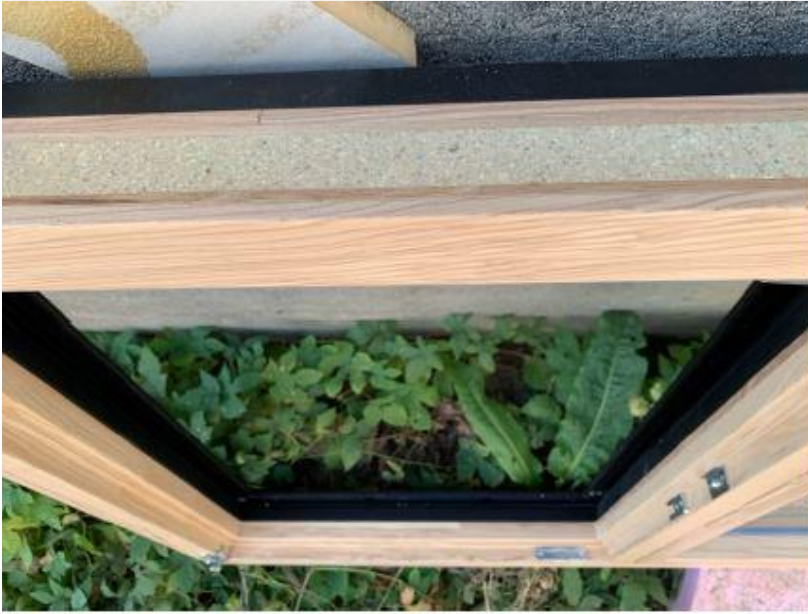
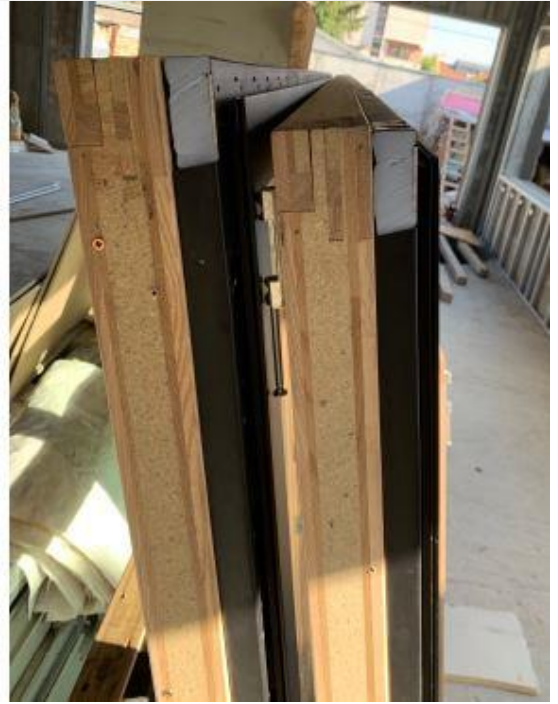
## 8. Fenster und Fenster-Einbau

<b>Beschreibung der Fenster (rahmen)-Konstruktion, Hersteller</b>	<b>Termoscudo Easy Flat</b>
<b>Fabrikat Fenster (rahmen; Produktname)</b>	Wooden frame with aluminum cladding and PU thermal insulation module
<b>Rahmen-U-Wert <math>U_f</math></b>	0,75 W/(m <sup>2</sup> K)
<b>Bauart der Verglasung</b>	Triple glazing Saint Gobain 442SIXN_4F_6XN_56
<b>Glas-U-Wert <math>U_g</math></b>	0,5 W/(m <sup>2</sup> K)
<b>g-Wert der Verglasung</b>	0,50

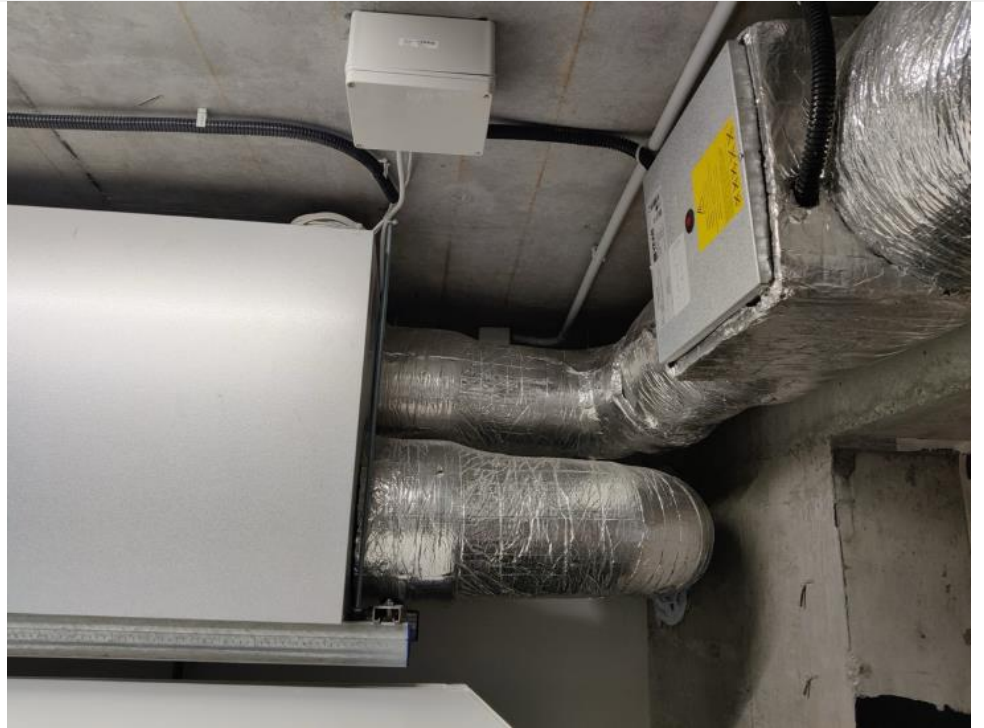
## 10. Lüftungsgerät

Fresh air is supplied by a Dantherm HCH 8 ventilation system with a heat recovery rate of 83%.

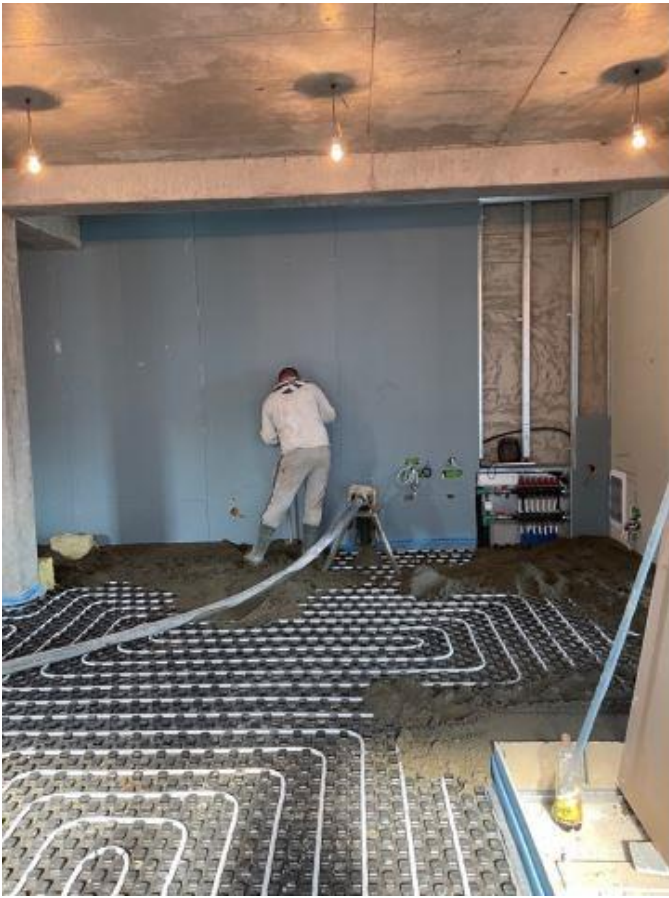
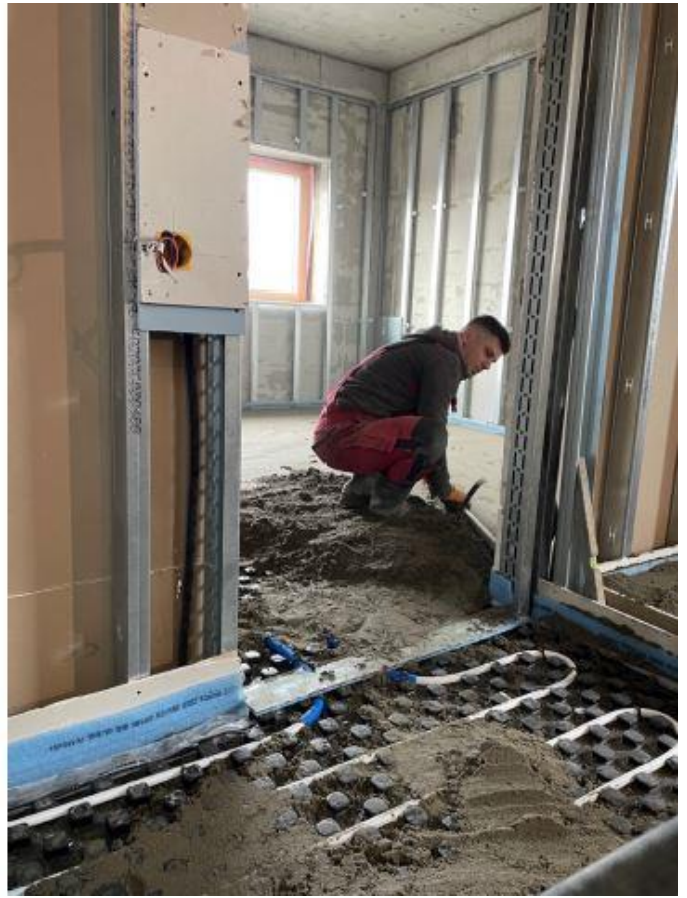
## 12. Wärmeversorgung

The heating system consists of underfloor heating, which is supplied with thermal agent from an air-water heat pump.

In addition to it, the owners requested a fireplace. To avoid overheating, we've chosen a model that is a certified PHI Component.

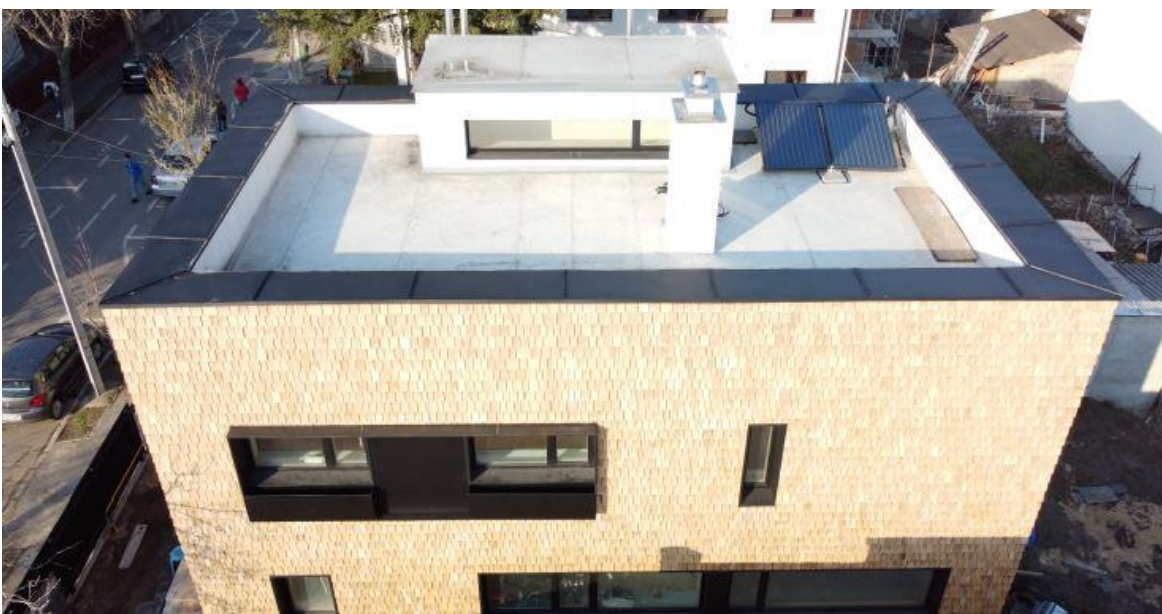
The heat pump and the two solar panels mounted on the terrace roof provide domestic hot water.

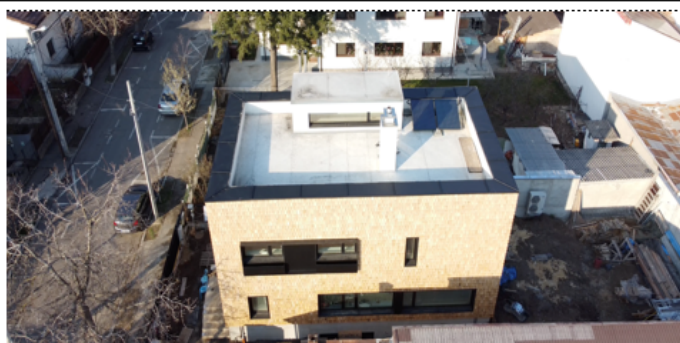
### Casa Pasivă - Verificare

Arhitectură:	Birou proiectare metropolitana srl			Clădire:	Casa Baltagi		
Strada:	Pălăniș, nr. 18			Strada:	Fortunei, nr 56		
Cod poștal/Localitate:	200127	Craiova		Cod poștal/Localitate:	12877	București	
Provincia/Țara:	Dolj	RO-România		Provincia/Țara:	Ro-Romania	RO-România	
Tip de clădire:	Clădire locuință unifamilială S+P+E			Set de date climatice:	ud-02-RO0004a-Bucharest		
Consultanță energetică:	Inginerie Cretivă Birou de Proiectare SRL			Zonă climatică:	4: Temperată caldă	Altitudine:	90 m
Strada:	Constantin Caraaș nr 4			Proprietar / Client:	Baltagi Vlad și Florina		
Cod poștal/Localitate:	11154	București		Strada:	Fortunei, nr 56		
Provincia/Țara:	București	RO-România		Cod poștal/Localitate:	12877	București	
Anul de construcție:	2023	Temperatură interioară de iarnă [°C]:		20.0	Temp. Int. de vară [°C]:	25.0	
Nr. de unități de locuit:	1	Aporturi interne de căldură (IHG) pentru încălzire [W/m²]:		2.3	IHG caz răcire [W/m²]:	3.1
