ID 5849 - Swan Residence

1.2 Brief Description

This project is a single detached dwelling for private clients. The site is located in the existing village of Paengaroa, near Te Puke in the Bay of Plenty. The 2-storey house faces true north and has a separate double garage accessed via a carport to the south of the house.

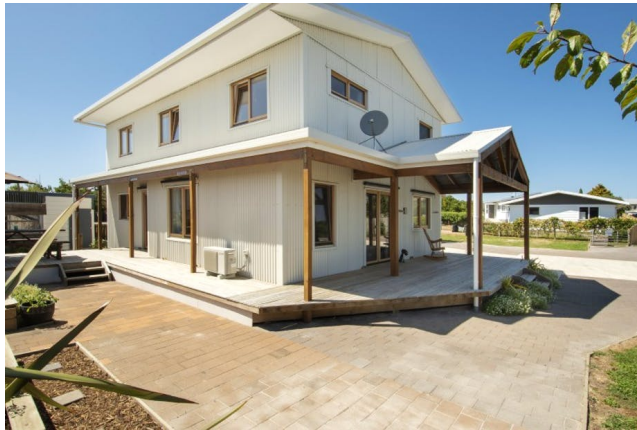
Figure 1 North and West Elevations of Dwelling,
Nord und Westansichten der Wohnung

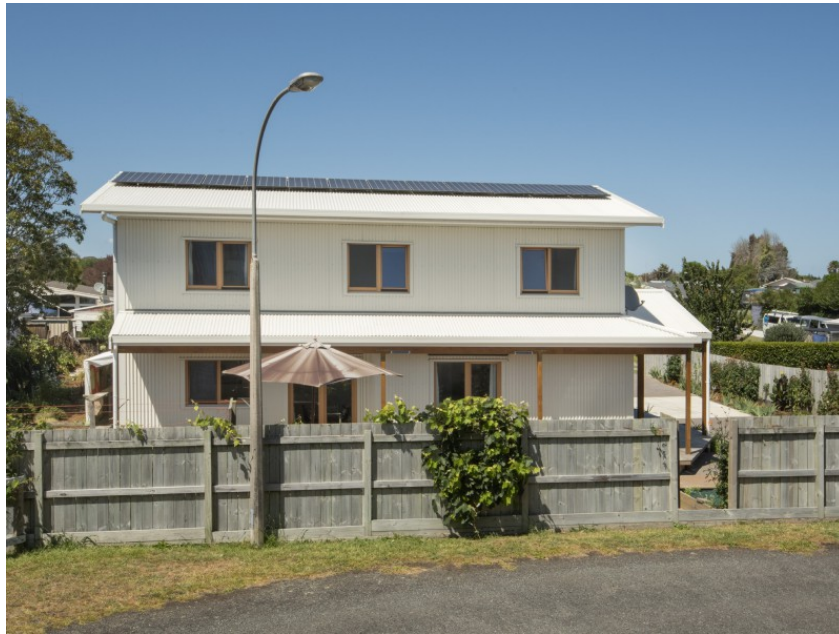
Figure 2 North elevation of dwelling

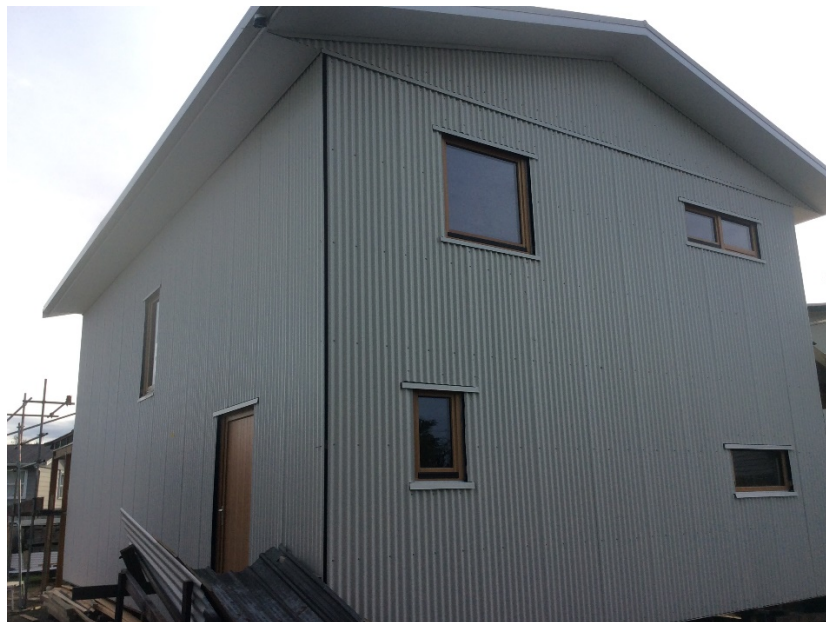
Figure 3 South and East elevations of dwelling (prior to completion and construction of carport)

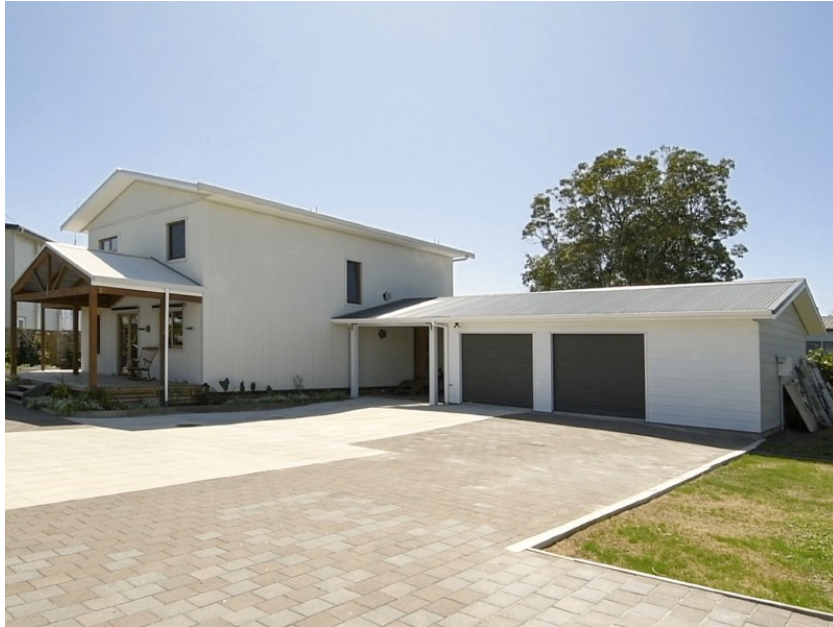
Figure 4 West and South elevations of dwelling, carport and garage

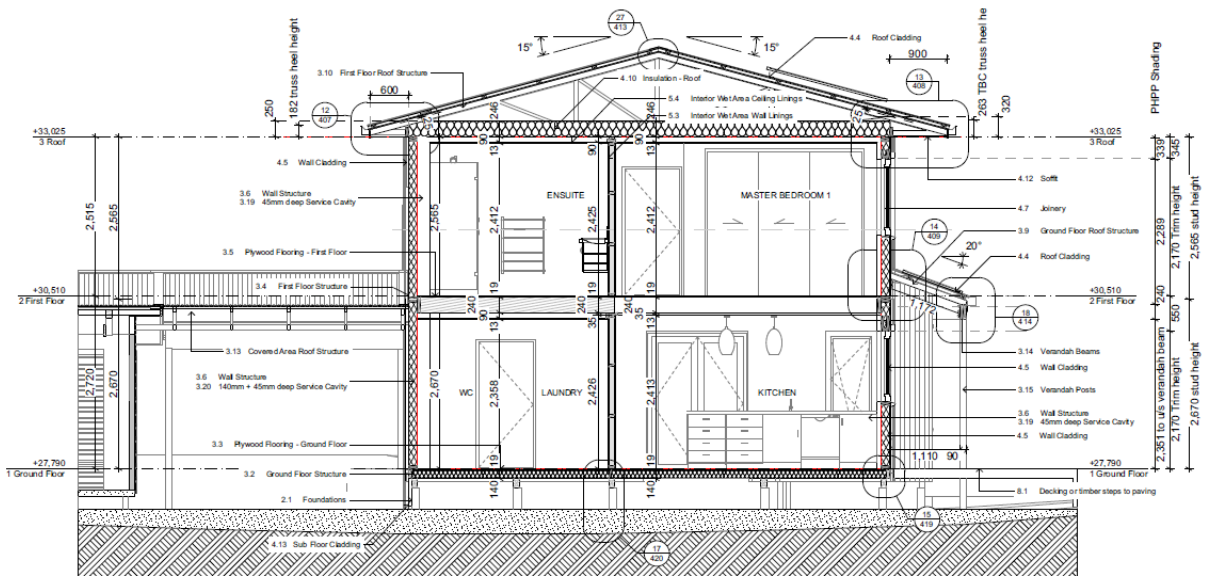
Figure 6 Typical Section

The thermal envelope is a fairly simple rectangular box, with a small area of ground floor in the living area protruding beyond the 2-storey rectangle. The carport is a self supporting, engineered design adjacent to the dwelling outside of the thermal & weathertight envelope and adjacent to the garage.

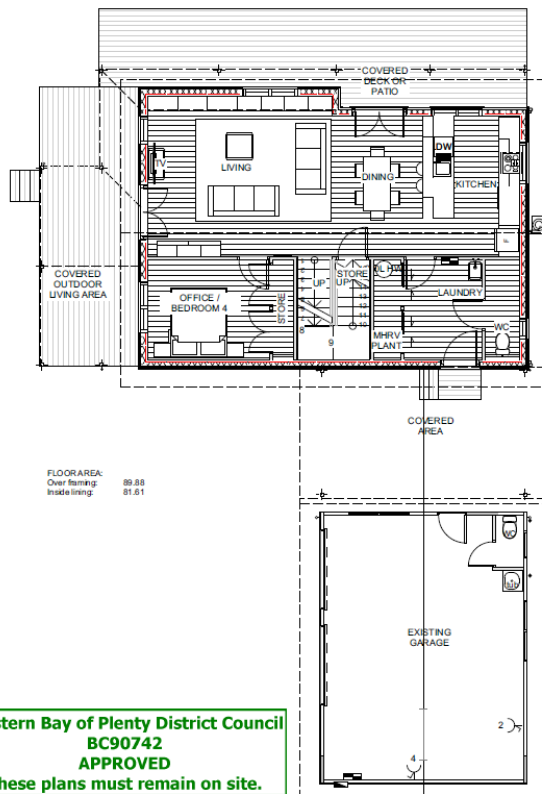
1 Ground Floor Overview 1:100

The ground floor contains the living area, dining area, kitchen, multipurpose room – bedroom / office / media room, downstairs toilet with space for an additional shower, laundry and plant cupboard which houses the MHRV unit and hot water cylinder.

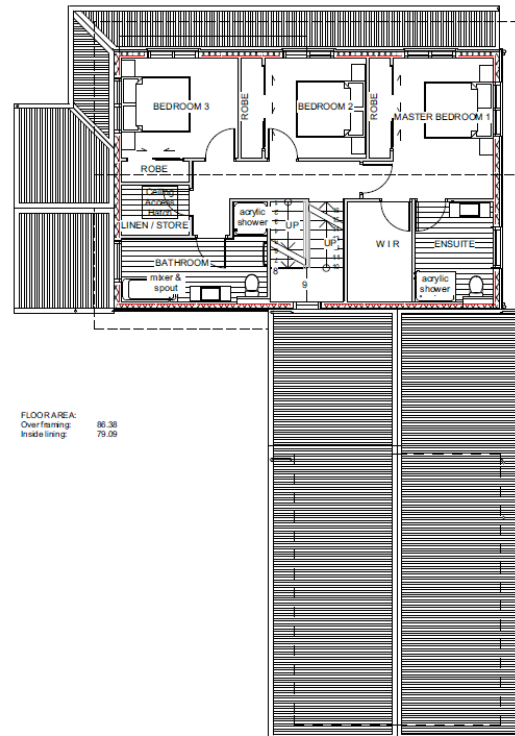
2 First Floor Overview 1:100

The first floor contains 3 double bedrooms, family bathroom, line cupboard, master ensuite and walk-in wardrobe.

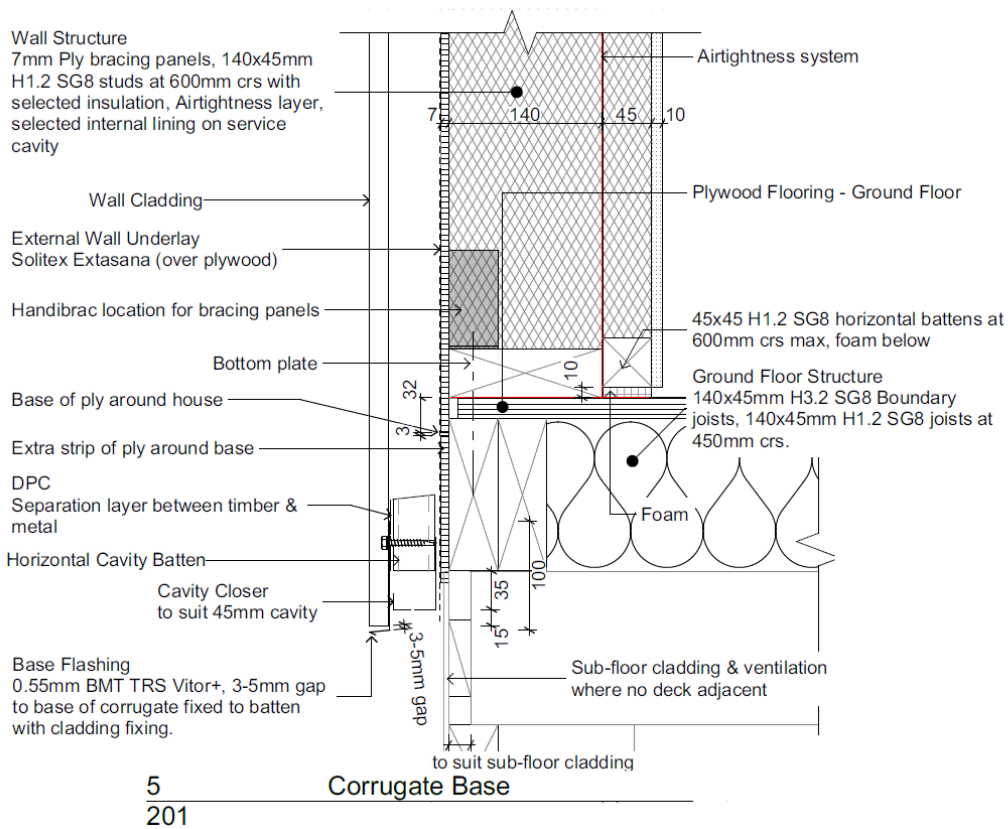
Figure 7 Typical floor slab edge and base of wall cladding

The ground floor is a timber construction: 140x45mm joists at 450mm centres with 2 layers of insulation between the joists, (either 2 x layers of R1.8, 75mm thick glasswool batts with wind wash in areas of plumbing and drainage pipes, U-value 0.342 W/(m²K) or 2 layers of semi-rigid Polyester sections, 90mm & 55mm thick, between the joists with an additional layer of R1.8, 75mm thick glasswool batts with wind wash perpendicular to and under the joists (not shown in above detail), U-value 0.221 W/(m²K)).

The airtight layer is indicated by the red line in the previous details.

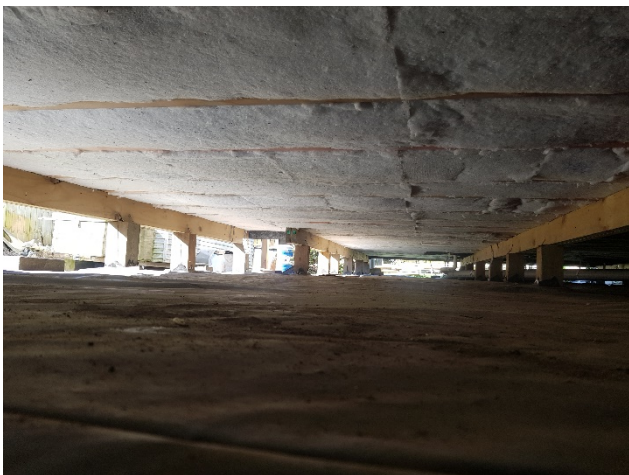
Figure 9 2 layers of Polyester underfloor sections between joists

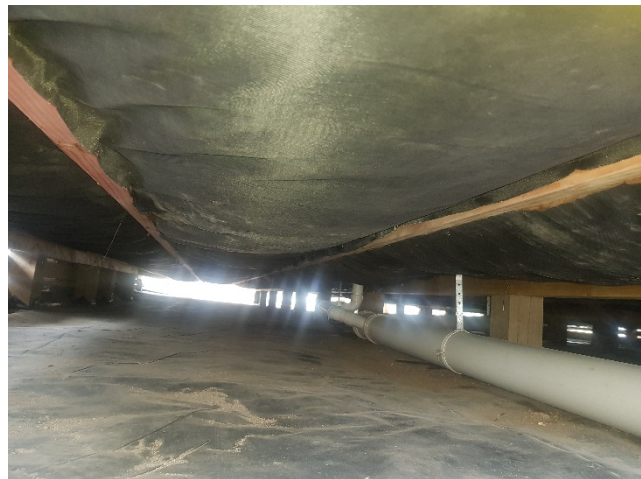
Figure 8 Additional layer of glasswool insulation with windwash, perpendicular to and under the joists

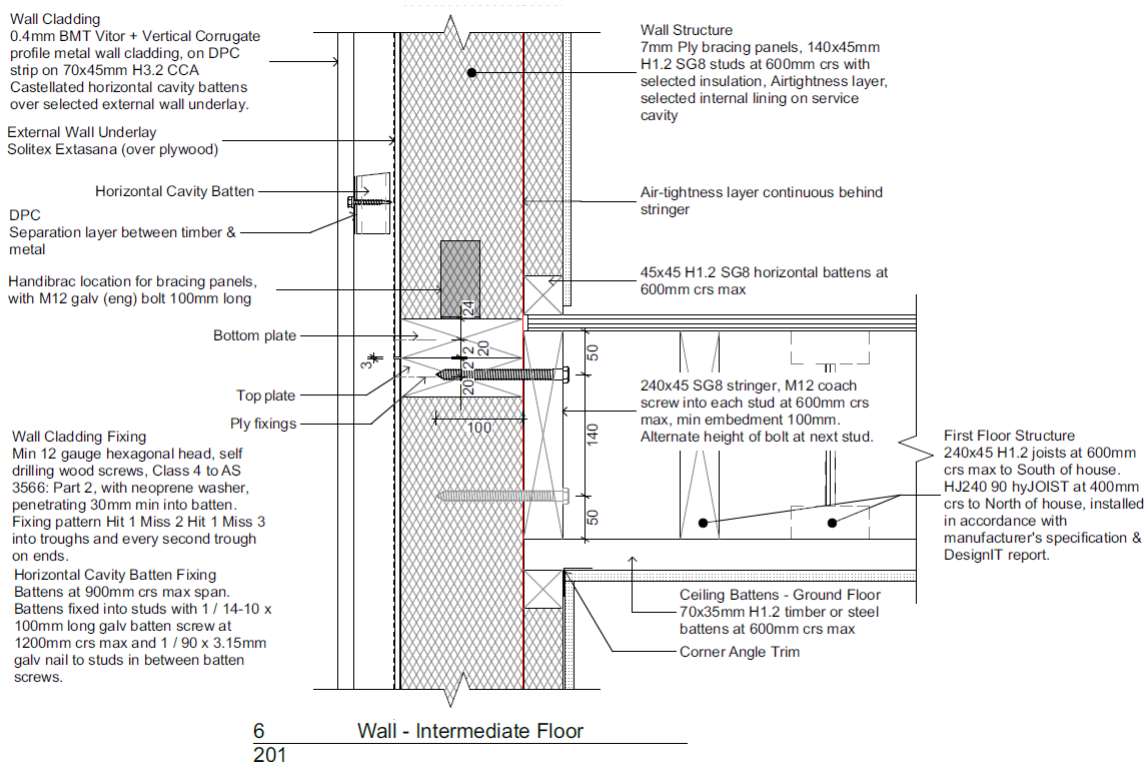
Figure 10 Typical external wall and mid-floor detail

The external walls were constructed with 7mm plywood for bracing on 140x45mm studs at 600mm centres, no nogs, filled with 140mm thick glasswool batt segments. Inside this is an Intello airtightness layer and 45x45mm horizontal battens at 600mm centres filled with 45mm thick glasswool batts. Inside this is the plasterboard lining. The external cladding is 0.4mm BMT profiled metal corrugate cladding on castellated horizontal structurally fixed battens over the wall underlay on the 7mm plywood. U-value 0.221 W/(m²K).

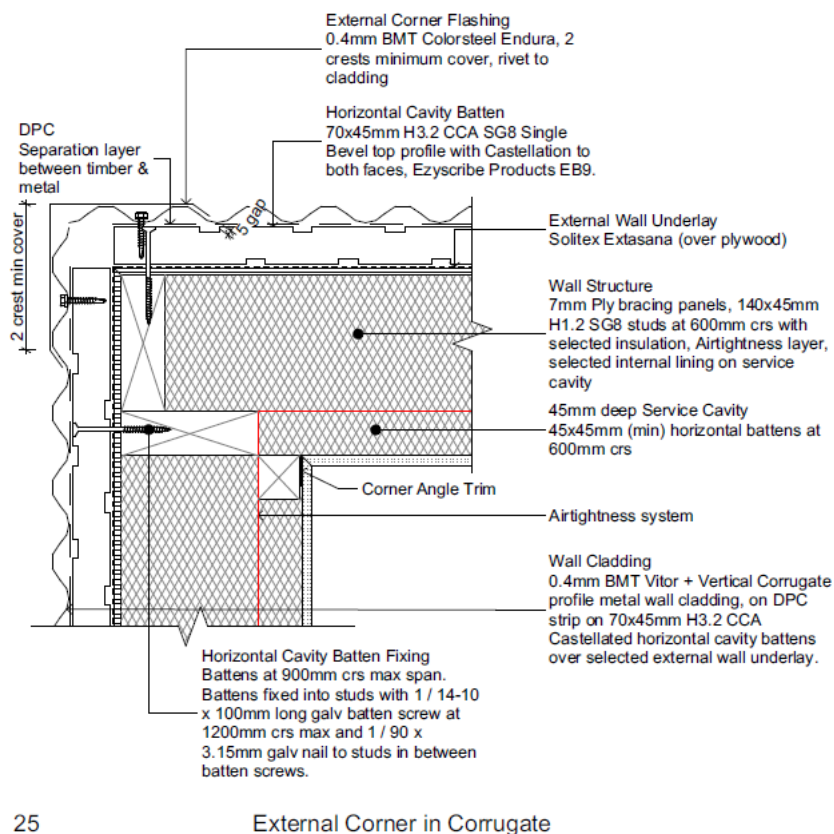
Figure 11 External corner detail

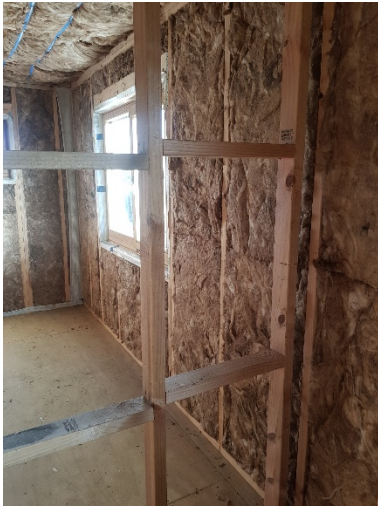
Figure 13 Insulation to the wall studs

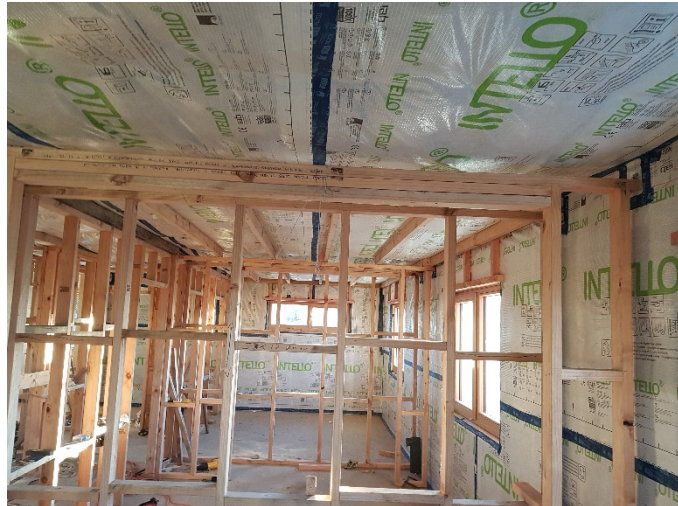
Figure 12 Typical Intello airtightness layer installed to the wall studs and first floor ceiling, with joints taped

The main airtightness layer is Pro-Clima Intello attached to the inside of the structural wall framing and roof trusses / ceiling framing. This is taped around the windows and doors. All joints in the Intello are taped. There is a 45mm deep service cavity inside the Intello and any services penetrating the airtight layer use proprietary sealing grommets. The ground floor plywood flooring is also part of the airtight layer, with all joints tape sealed. The Intello on the walls is tape sealed to plywood floor.

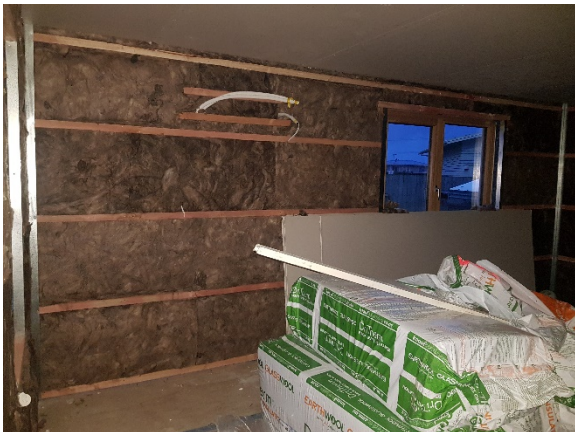
Figure 14 Insulation to the horizontal service cavity inside the airtightness layer

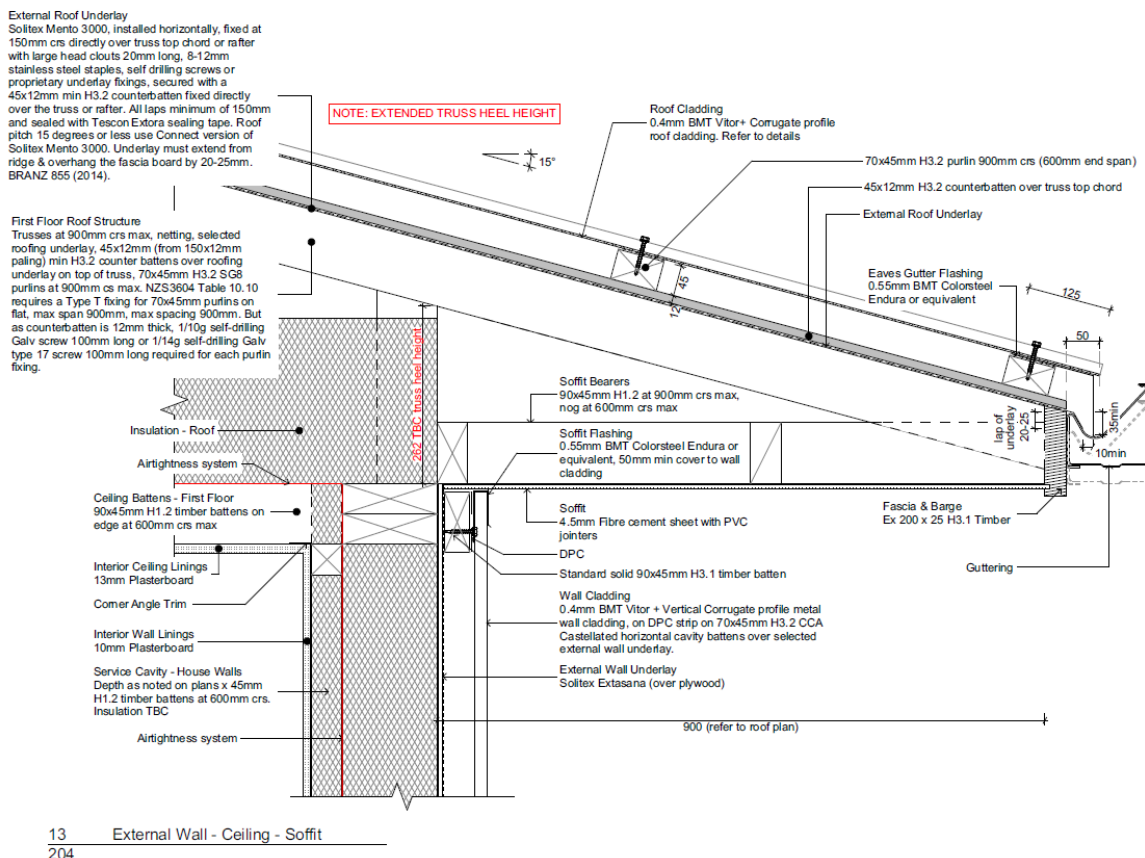
Figure 15 Typical roof to external wall detail

The roof structure has timber trusses at 900mm centres, with 2 layers of insulation; 130mm thick glasswool batt segments between the truss bottom chords (and taken over the wall top plate) and a 150mm layer of glasswool blanket above this running perpendicular to the truss bottom chords. The ceiling batten space between the Intello airtightness layer and ceiling plasterboard is not insulated. The external roof cladding is 0.4mm BMT profiled metal corrugate cladding on purlins on a counterbatten over the roofing underlay on the truss top chords. U-value 0.158 W/(m²K).

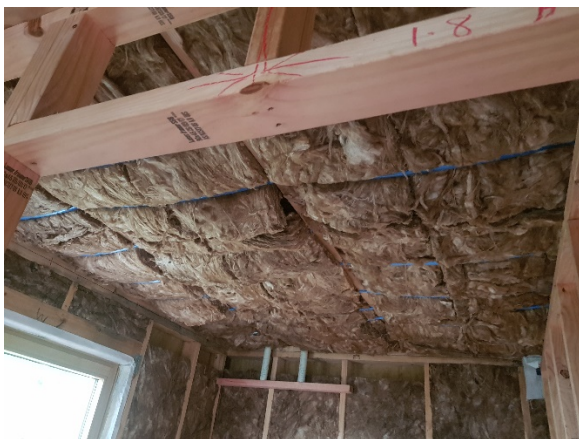
Figure 17 Roof / ceiling insulation

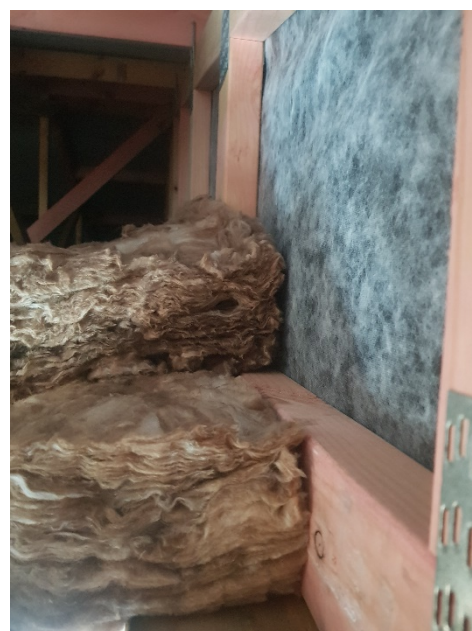
Figure 16 2 layers of insulation to roof space

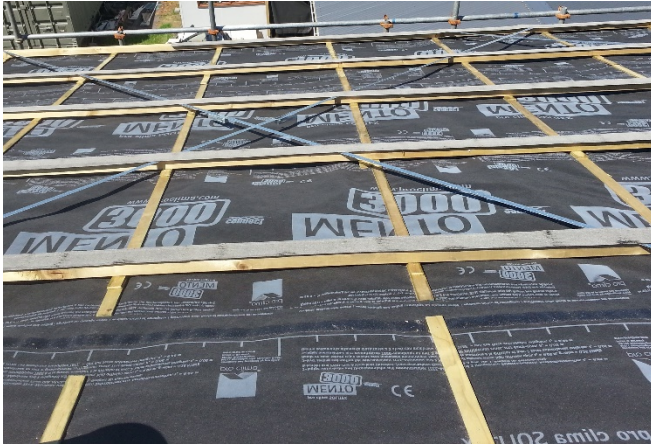
Figure 18 Roof purlins on counterbattens on roofing underlay

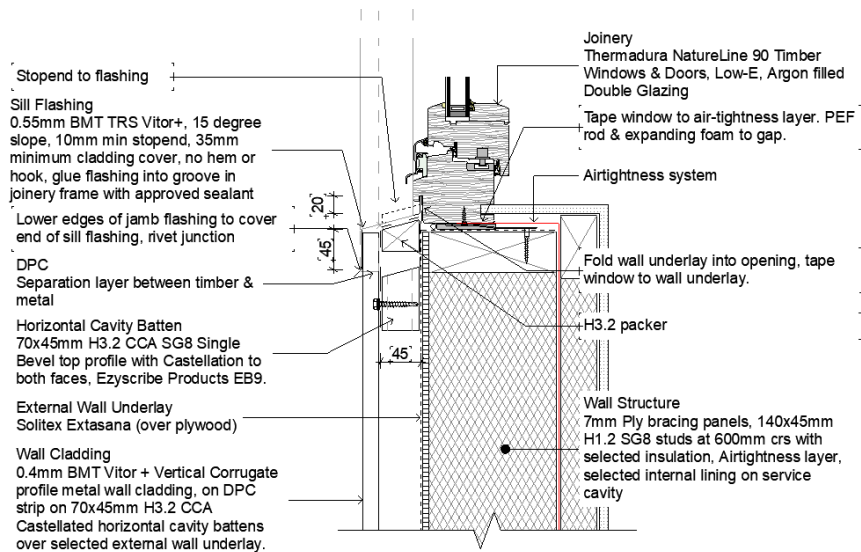
Figure 19 Typical Window Sill Detail

The windows are Thermadura Natureline 90, Siberian Larch timber frames, $U_f = 1.1 \text{ W/(m}^2\text{K)}$, double glazed 4/18/4, with Argon and low-e glazing with thermal spacer $U_g = 1.14 \text{ W/(m}^2\text{K)}$, g-Value 0.64. These windows also have continuous double air seals.

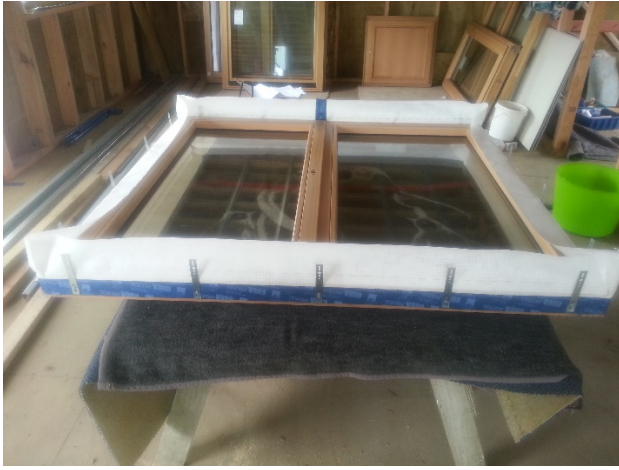
Figure 21 Window taped & fixing brackets attached

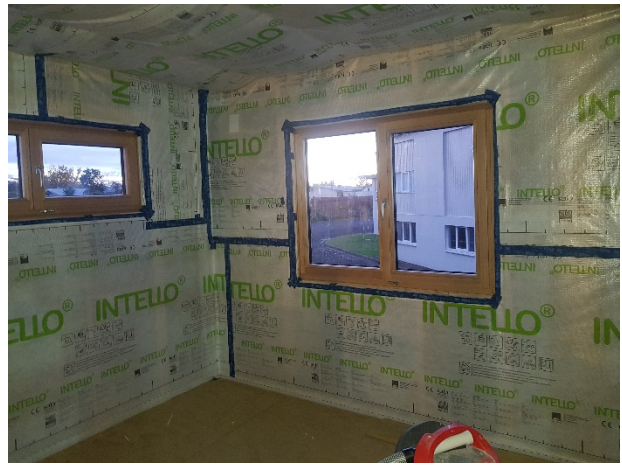
Figure 20 Window installed and taped to Intello airtight layer on wall framing

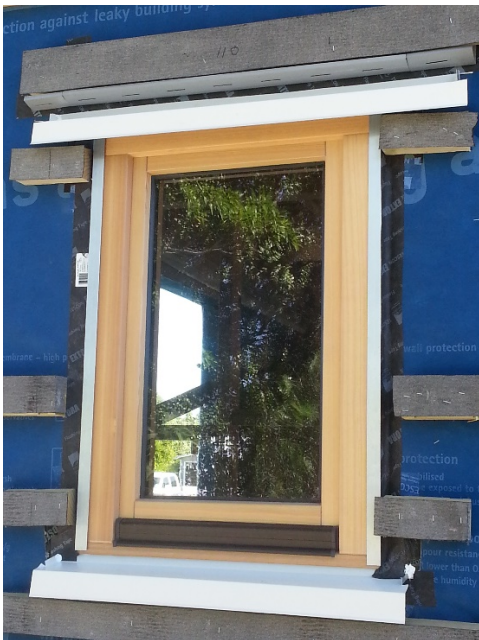
Figure 22 External view of window taped in place

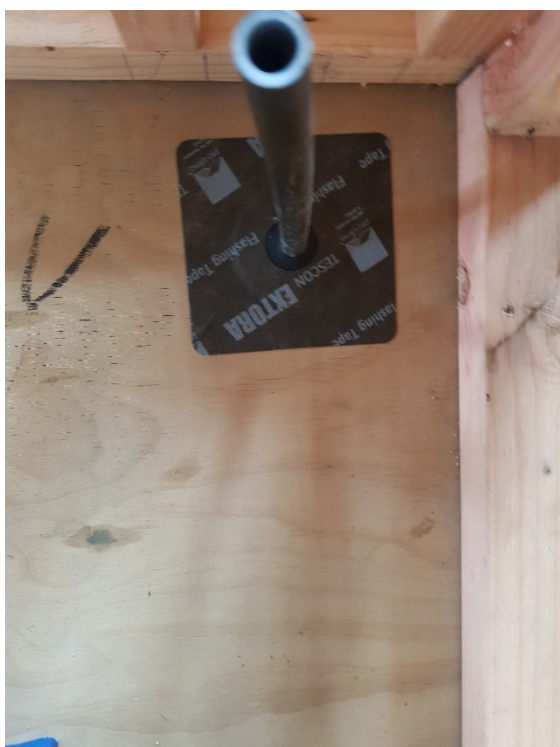
Figure 24 Typical Air Seal – Pipe to plywood floor

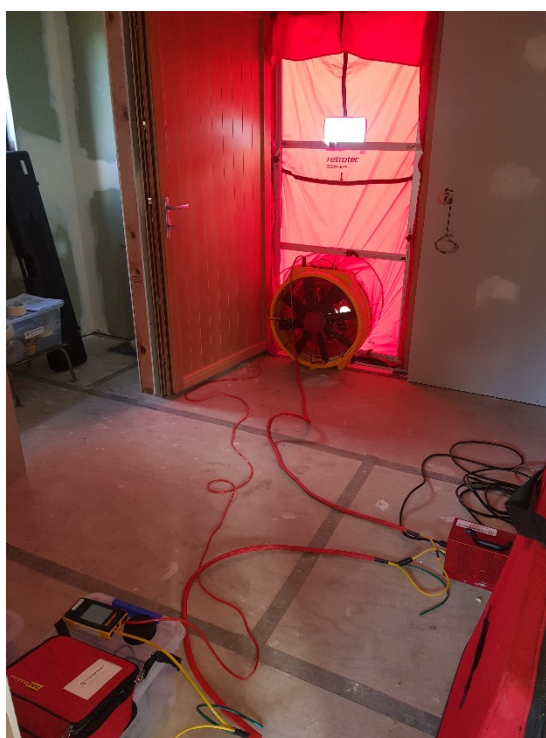
Figure 23 Blower Door Test in progress

Pressure test n50 result was 0.52 h^{-1} . This was carried out by Alexander & Co Ltd.

Pressure	Depressurisation	Pressurisation	Average
50 Pa	0.47 ACH	0.57 ACH	0.52

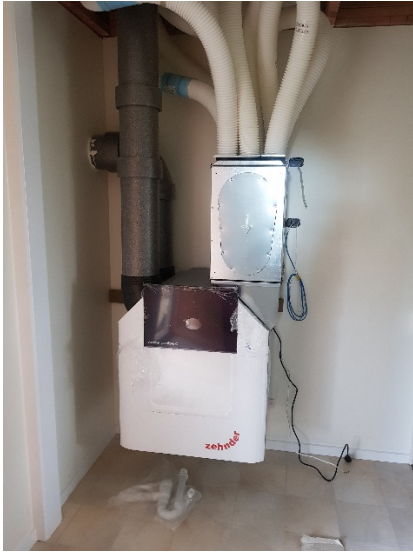
Figure 26 Zehnder ComfoAir Q350 during installation

A Zehnder ComfoAir Q350 heat recovery ventilation unit was installed, with ComfoWell attenuators and 90mm ComfoTube ducting to ceiling grilles.

The effective heat recovery efficiency was 81.1%.

The electrical efficiency is 0.29 Wh/m³.

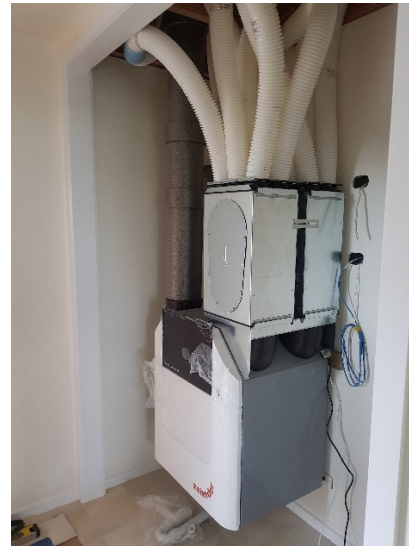
Figure 25 Zehnder ComfoWell attenuators above central unit

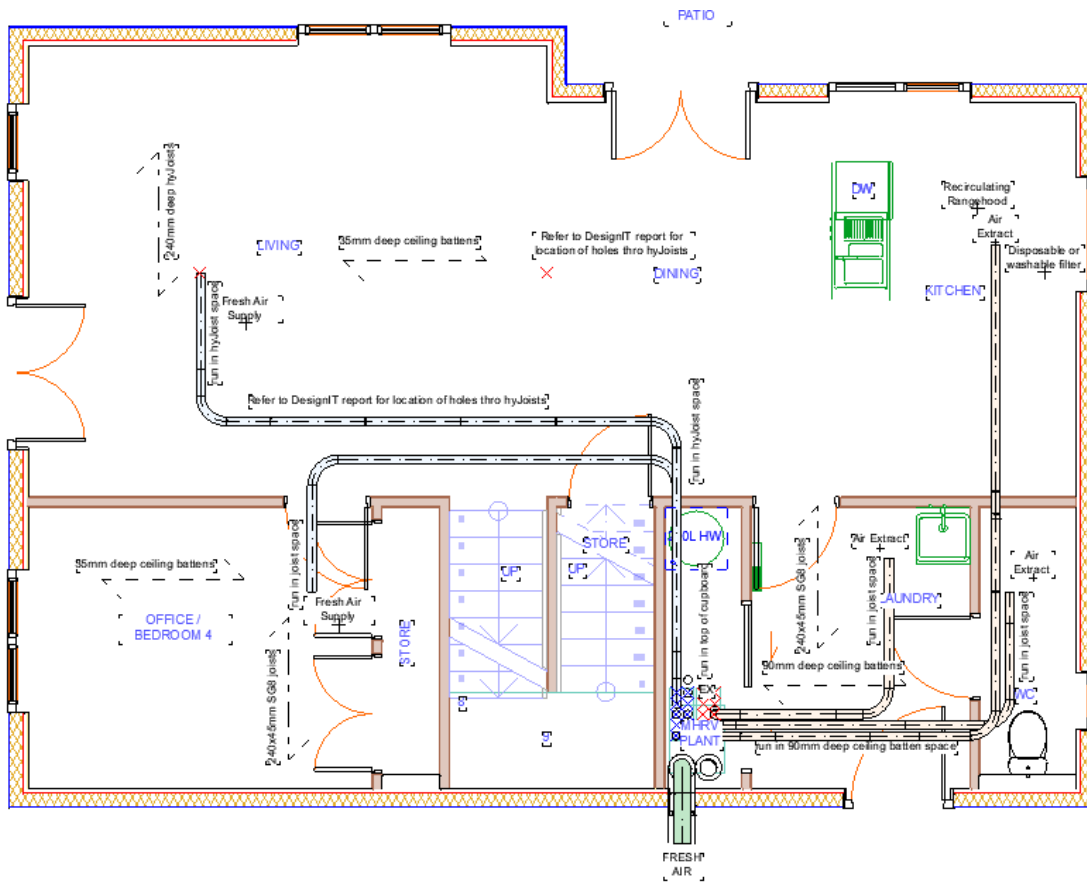
Figure 27 Ground floor HRVU duct layout

The ground floor MVHR ductwork (and water supplies to the first floor) were installed in the intermediate floor, which were hyJoists with allowable holes designed into the floor structure. The first floor MVHR ductwork were installed in a deep first floor ceiling cavity within the airtight layer.

The MVHR unit was located on the ground floor adjacent to the South external wall. Exhaust air was expelled above the Fresh Air Intake to the unit on the South Elevation.

Grilles / valves, in the ceilings, were used to set the required level of air supply to the bedrooms and living rooms and extract air was taken from the kitchen, laundry and bathrooms.

Air is returned / circulates via undercut doors to bedrooms and above bathroom / ensuite door lintels.

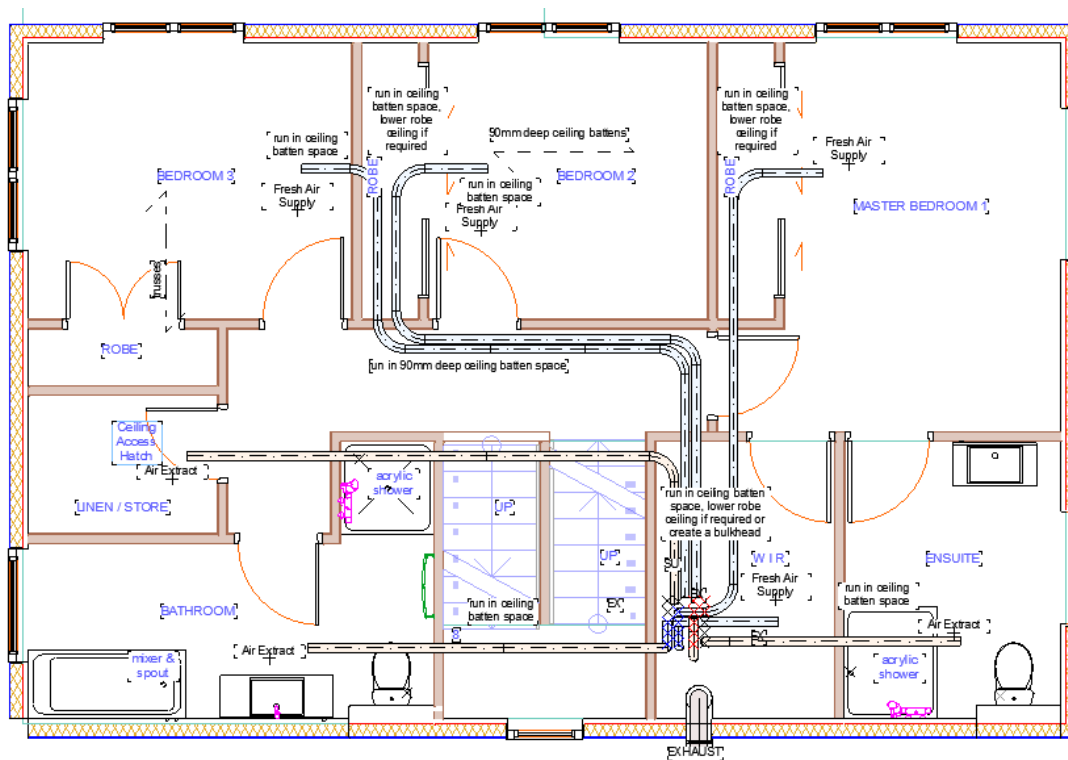
Figure 28 First floor HRVU duct layout

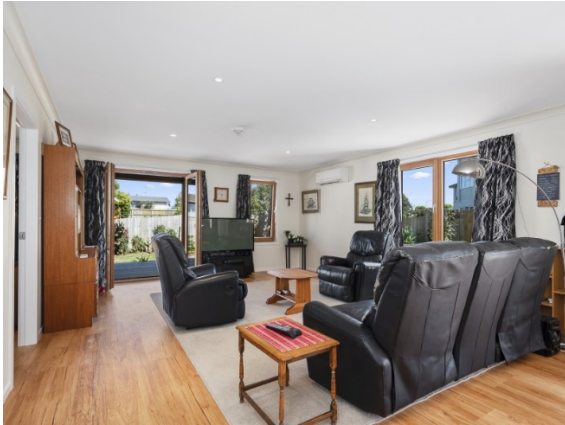
There is a Mitsubishi MSZ-GL35VGD-A1 - DC Inverter R32 Wall Mount Heat Pump in the living room to provide heating and cooling.

Figure 30 Living room heat pump (wall mount)

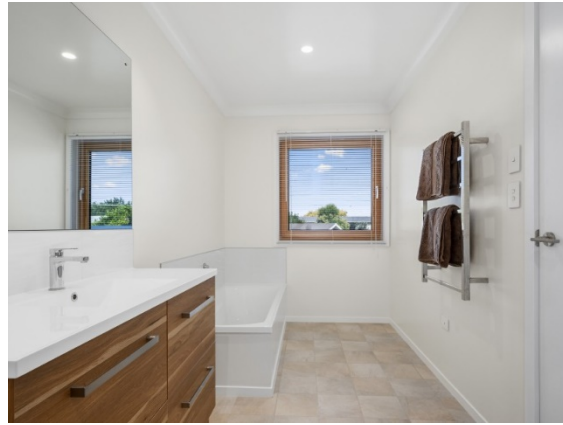
Figure 29 Main bathroom heated towel rail

There are also (direct electric) heated towel rails in the main bathroom and master ensuite to provide heating if required during winter.

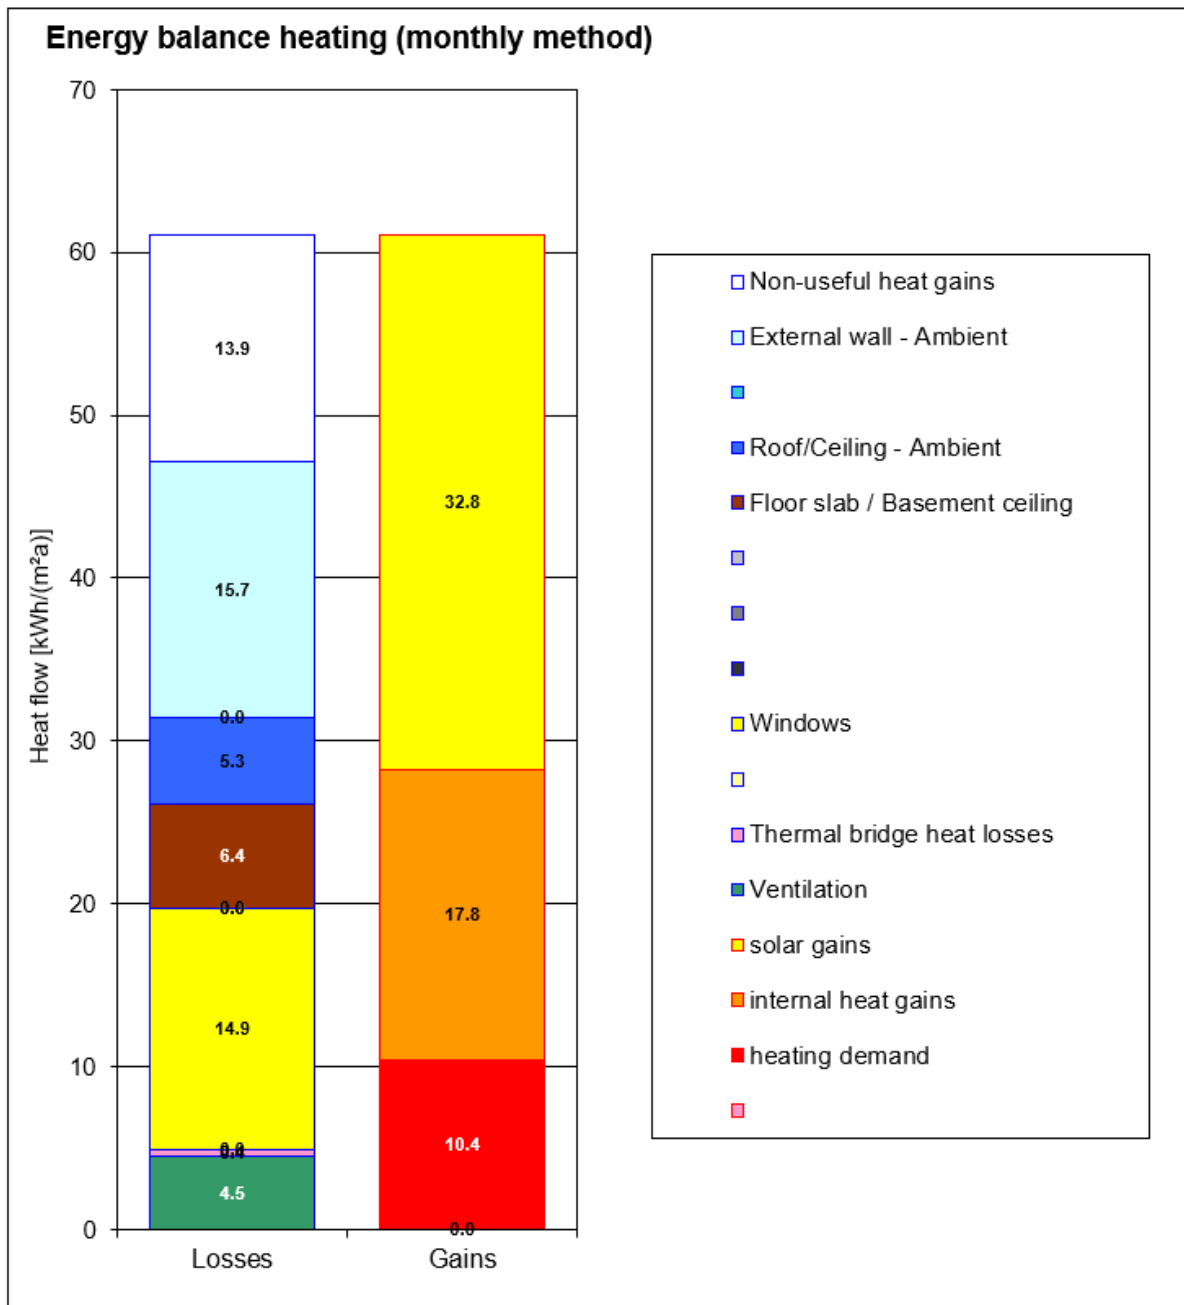
Figure 32 PHPP Heating Tab

The majority of the heat gain is from solar gains. With a predicated frequency of overheating of 3.69% and having lived in the home for 18 months or so, additional external shading has been added post certification to help control the amount of solar gain in summer months in particular to the west facing windows and French doors.
