# Project documentation: CASA EL PILAR

Single family House in Madrid, Spain.

Semi-detached single family home built by conventional construction system in the city of Madrid (Spain). The house has two floors above ground and one below ground, with an SRE of 198 m<sup>2</sup>. Part of the semi-basement belongs to the SRE, being conditioned. Construction ended in 2019. The main façade of the building is south facing.

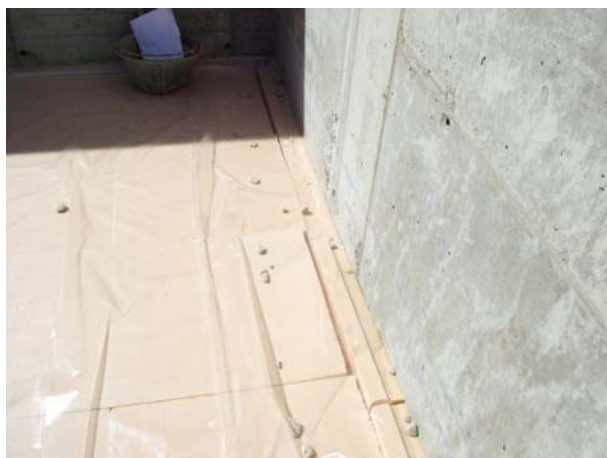
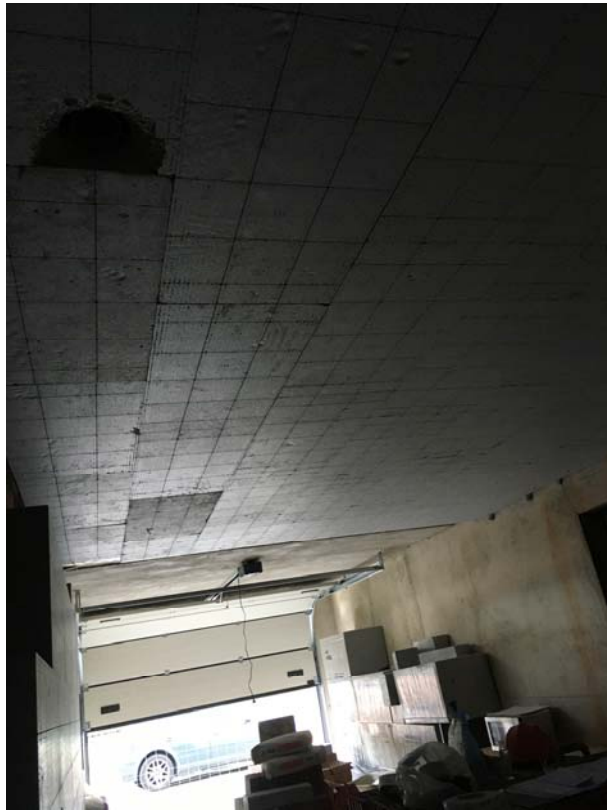
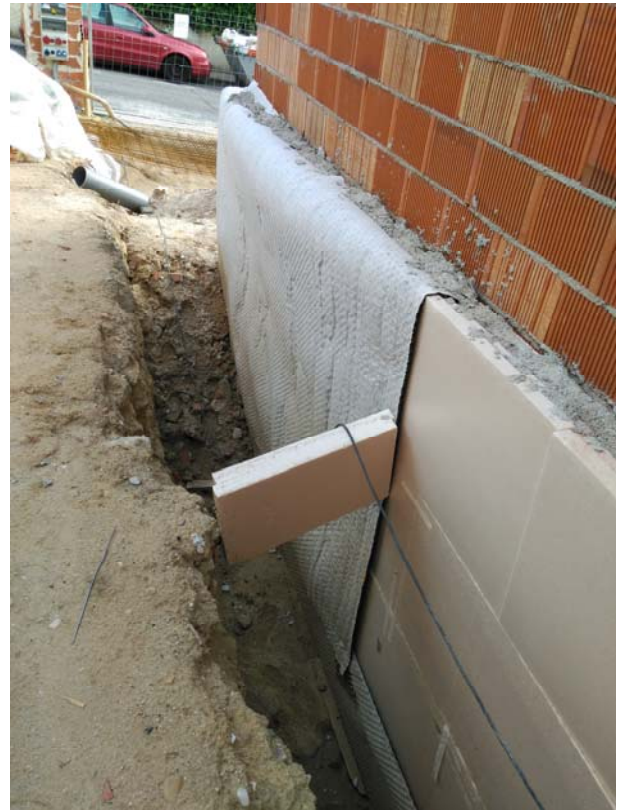
### 5.1 Construction including insulation of the floor slab or basement ceiling with connection points of exterior and interior walls

In the meeting between the thermal envelope and the foundation, an interruption in the continuity of the thermal insulation occurs. This thermal bridge is reduced by extending the thermal insulation (both of the floor slab and of the external wall or the conditioned part of the semi-basement) up to the upper face of the foundation footing.

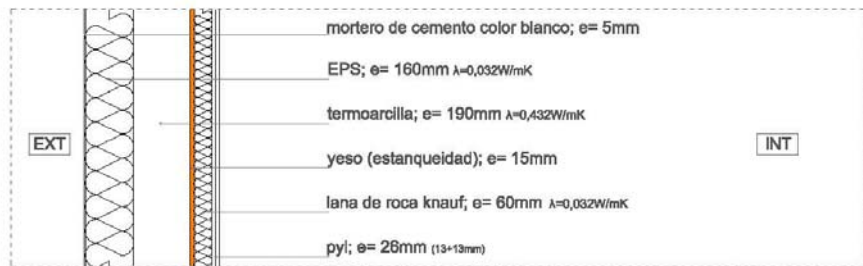
FACHADA TIPO 1  
(F1\_fachada en el PHPP)

Deck and terrace parapets are completely covered with thermal insulation, in order to guarantee the continuity of the insulation layer.

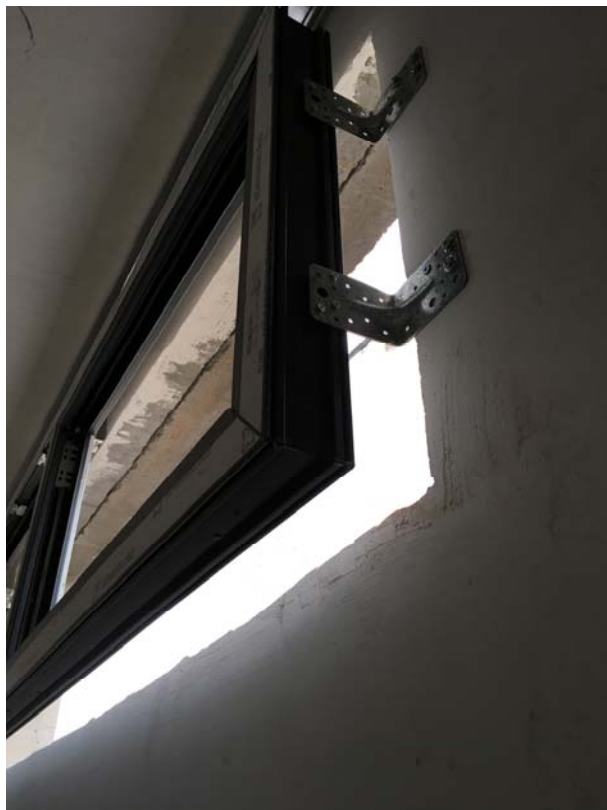
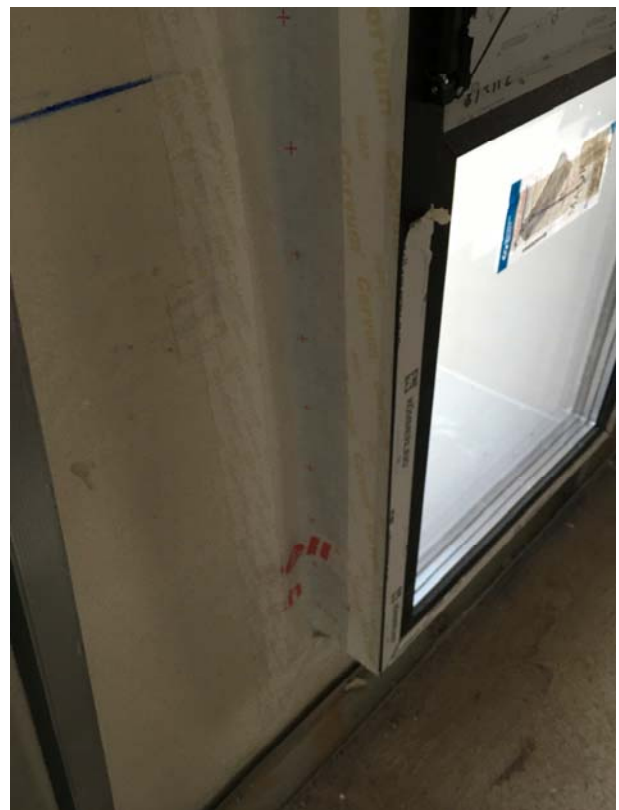
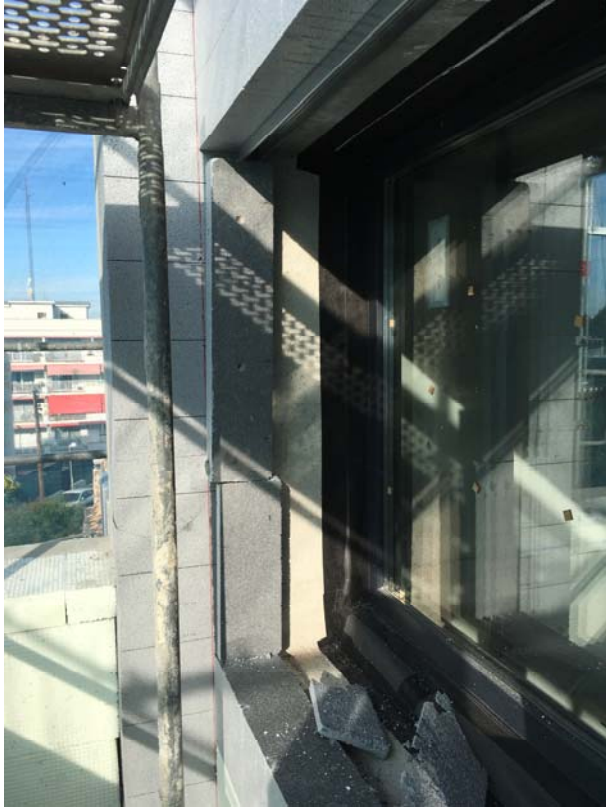
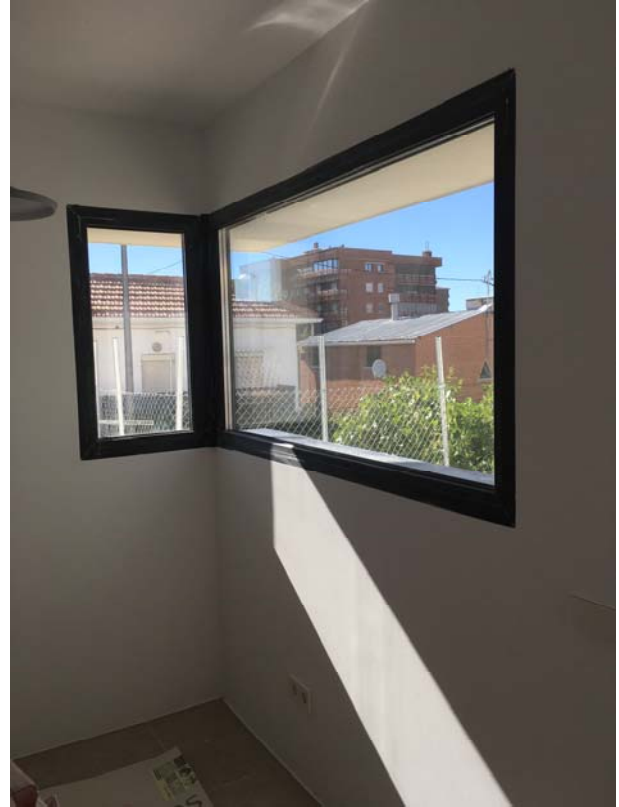
## 5.4 Description of the window sections including installation drawing

Three types of glazing with three panes were used and two chambers filled with argon gas. The glazing used on the north, west and east façades (triple Low-E glazing) has the following characteristics:

The intercalary in the edge of the glazing is a warm edge type, being the  $\Psi$  value  $0,038 \text{ W/mK}$ .

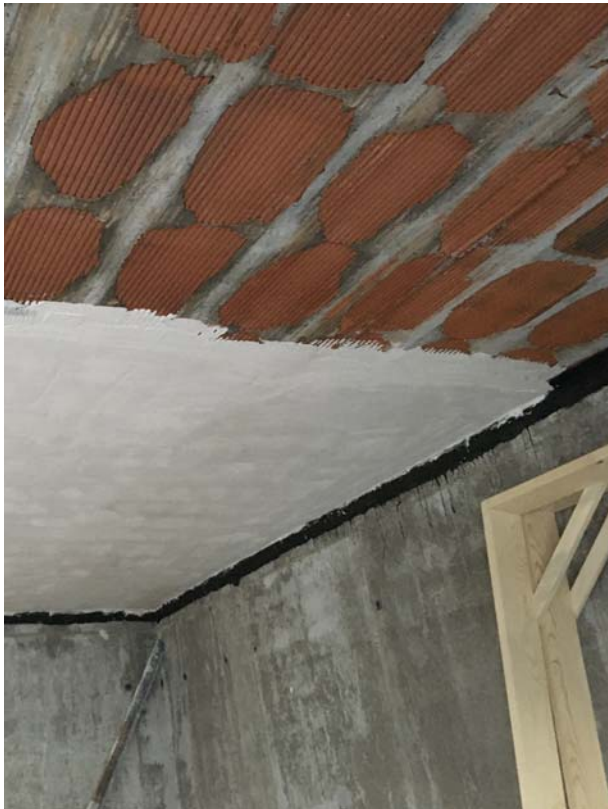
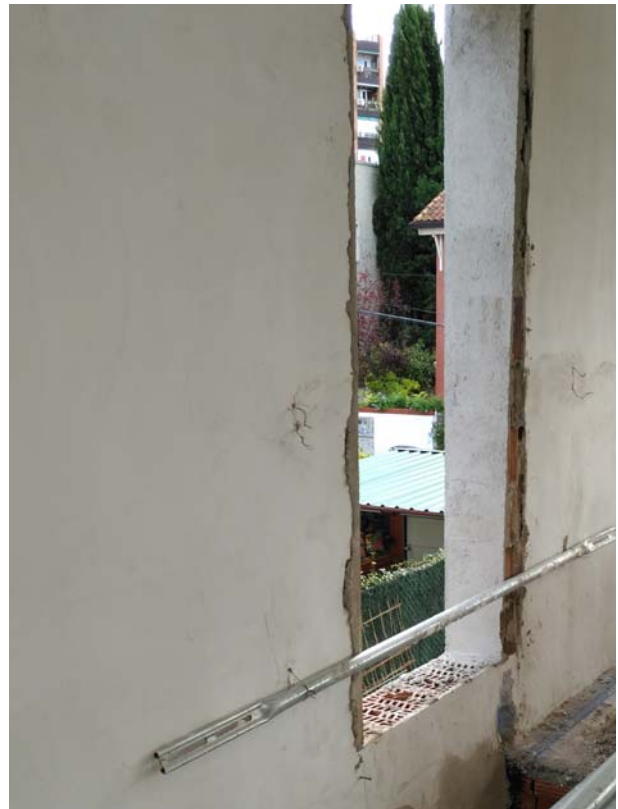
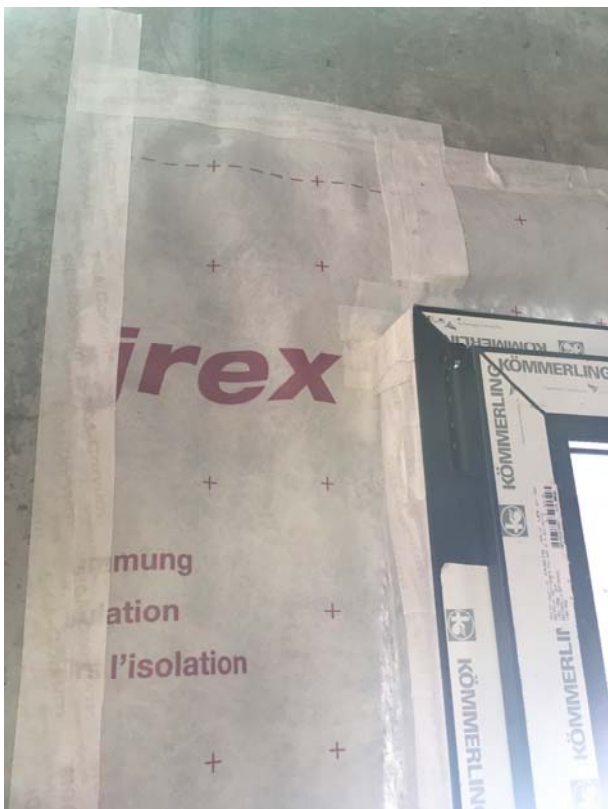
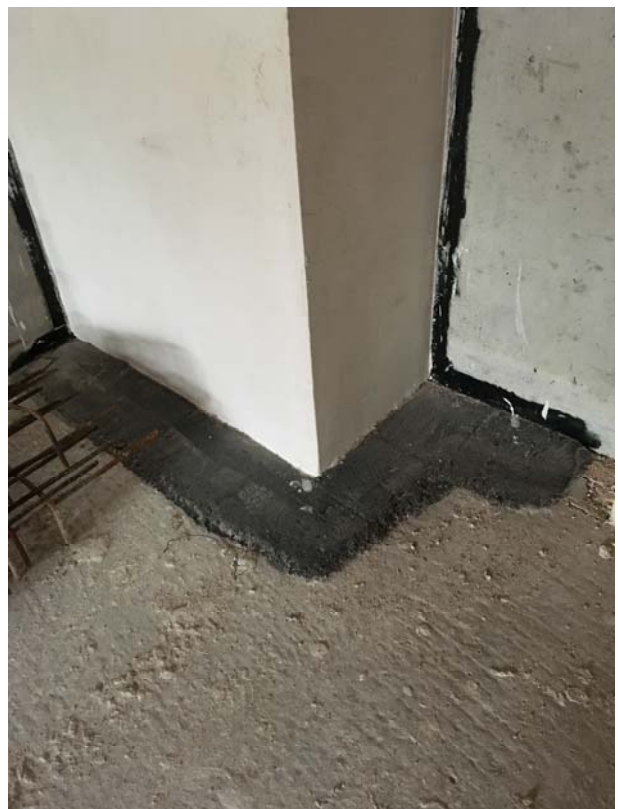
## 6 Description of the airtight envelope; documentation of the pressure test result

Basement floor: The in-situ concrete slab in itself is airtight. Any penetrations and joints are treated using airtight liquid membrane.

Basement ceiling: The in-situ concrete compression layer in itself is airtight. Any penetrations and joints are treated using airtight liquid membrane.

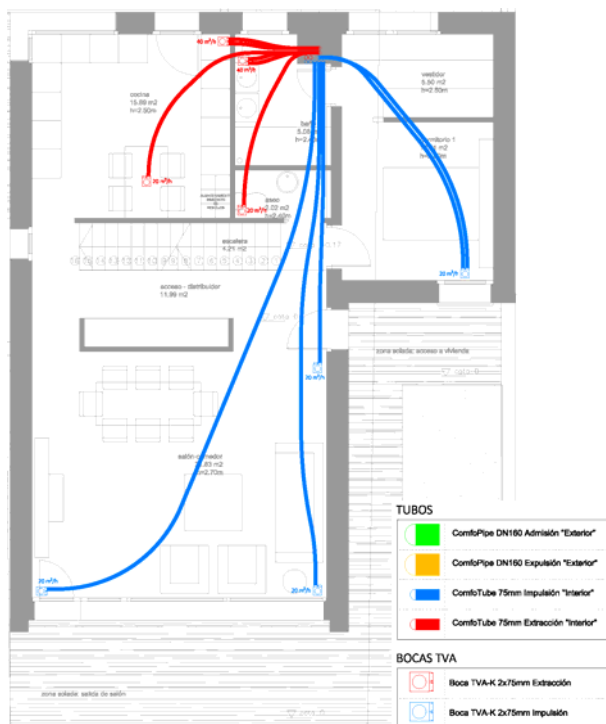
## 7.1 Description of the planning of the ventilation ductwork

Fresh air is intaken near the entrance to the plot. Fresh air is supplied in rooms "despacho profesional" (basement floor); "dormitorio 1" and "salon-comedor" (ground floor); and "zona de juegos", "dormitorio 2" and "dormitorio 3" (first floor). Air is transferred in the next areas: "escalera", "acceso distribuidor", "vestidor" and "distribuidor". Air is extracted from "baño 1" (basement floor); "cocina", "aseo" and "baño 2" (ground floor); and baño 3" and "zona de juegos" (first floor). There is a geothermal heat exchange present: a conduit about 40 meters long, buried in the south and east of the plot.

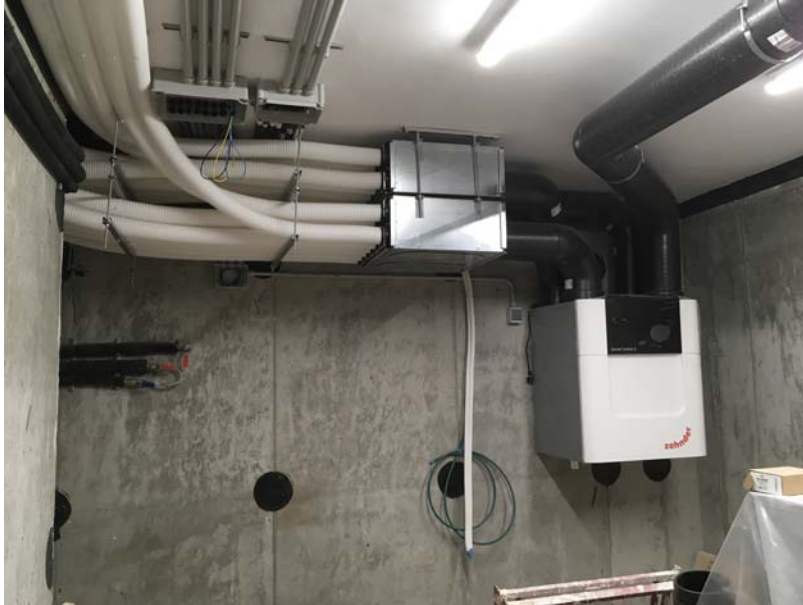
## 7.2 Description of the planning for the central unit (of the ventilation system) / the ventilation device

The heat recovery used in the ventilation system is ComfoAir Q350 ERV, Comfort Vent Q50 ERV (Zehnder).

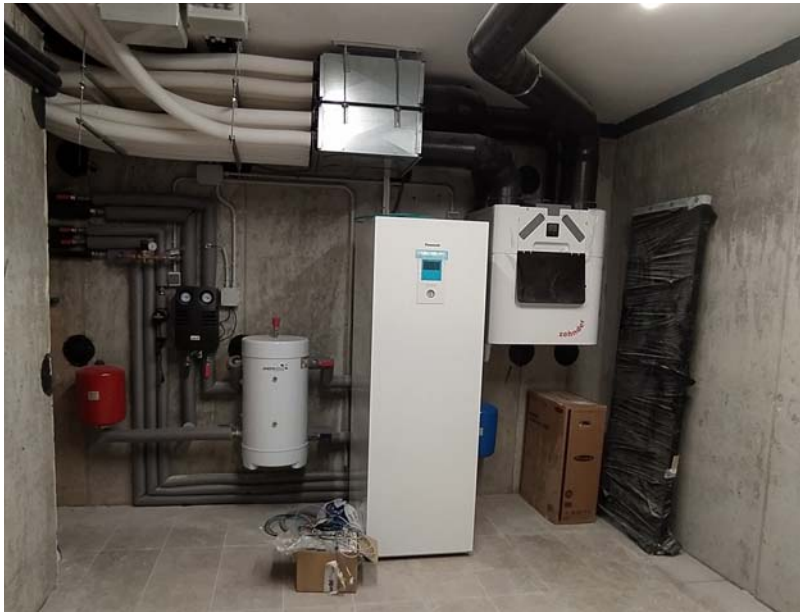
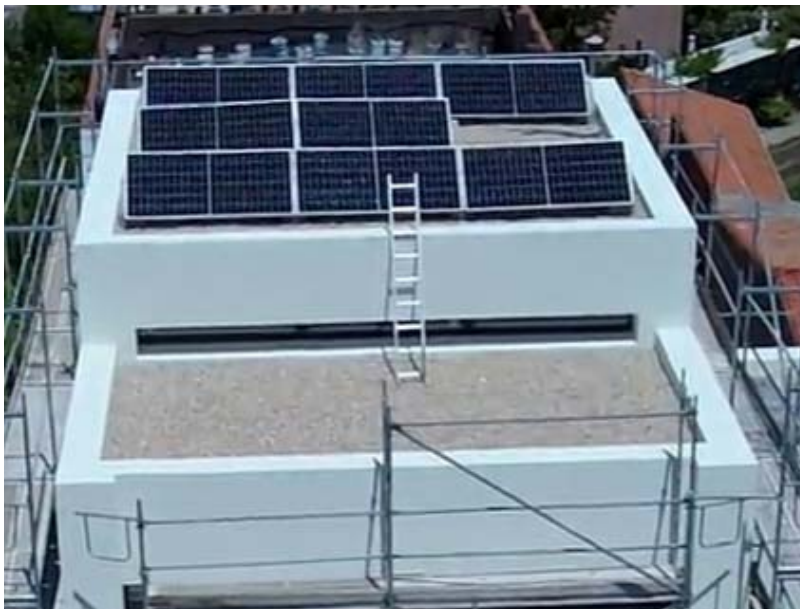
## 8 Description of the heat supply system

The hot water generation and space heating and cooling takes place through an aerothermal heat pump. The indoor unit is located in the facilities room. The outdoor unit is located on the deck of the master bedroom.

Spaces are heated and cooled by radiant ceiling panels, located in every room, except in the basement rooms, in the bathroom and toilet and in the dressing room.
