Project Documentation (ID 6558)

Gebäude-Dokumentation

5-Storey College Campus Building in Etobicoke, Canada

Located in Toronto, at Humber College's North Campus, Building NX has been transformed thanks to a retrofit that took the building from one of the campus' most inefficient and worst performing buildings to one of the best. Originally built in 1989, the five-story, 4,487 m² building was notorious for being cold in the winter, and hot in the summer—not a great atmosphere for the administrative staff whose offices are located there.

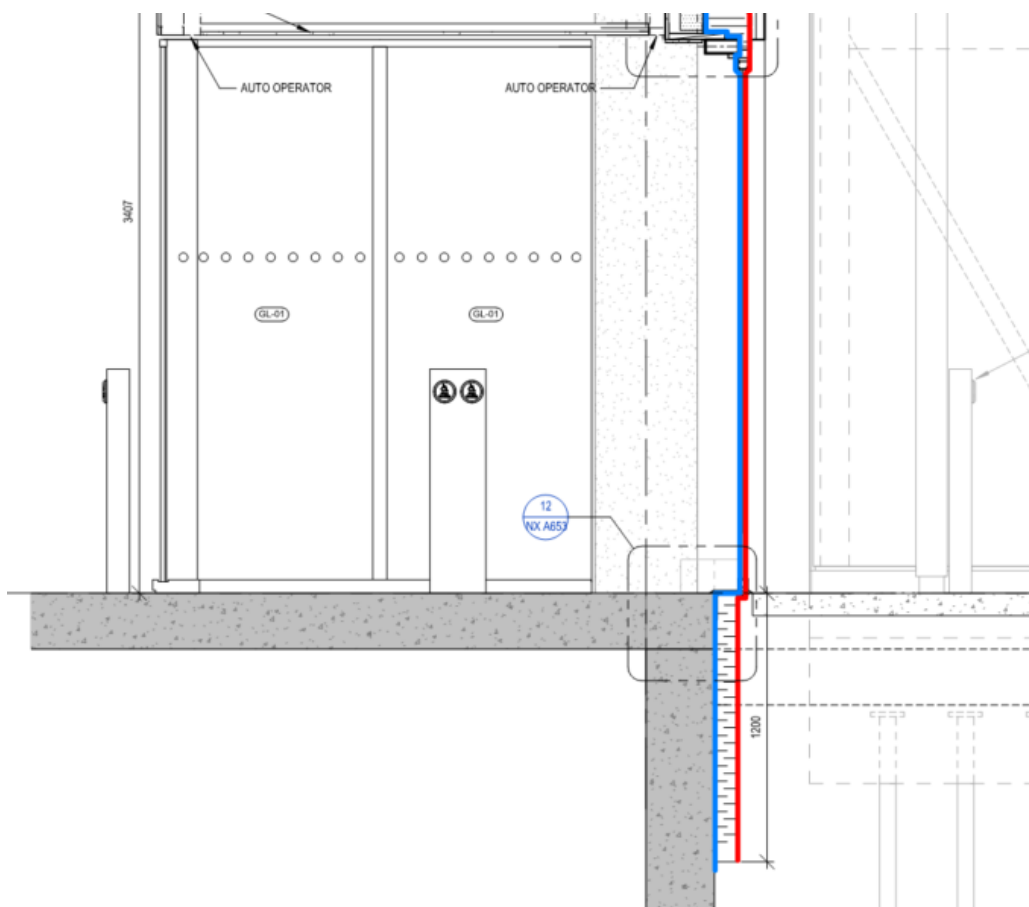
5. Konstruktion der Bodenplatte

Due to the nature of the retrofit, the floor slab could not be insulated. Assembly only consists of concrete slab. 4" XPS of insulation added to exterior foundation wall.

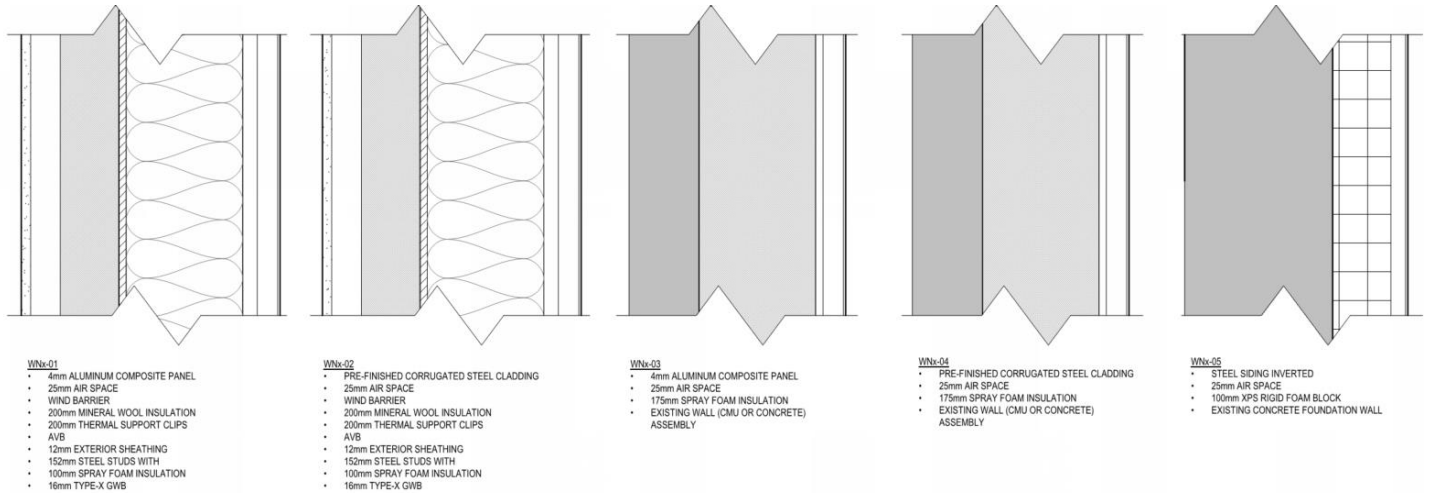
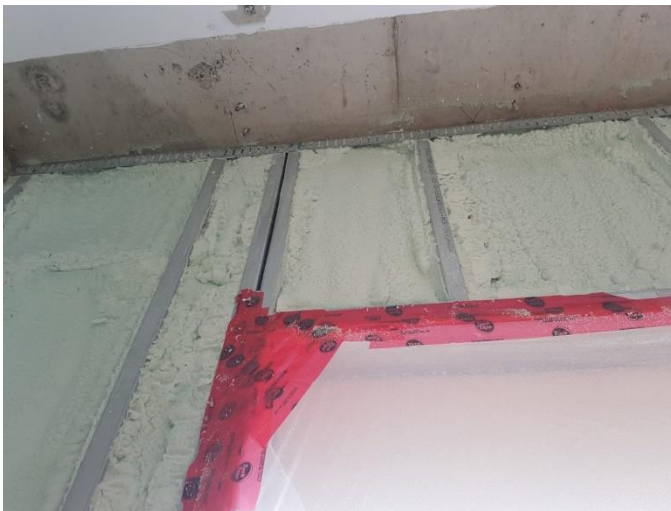
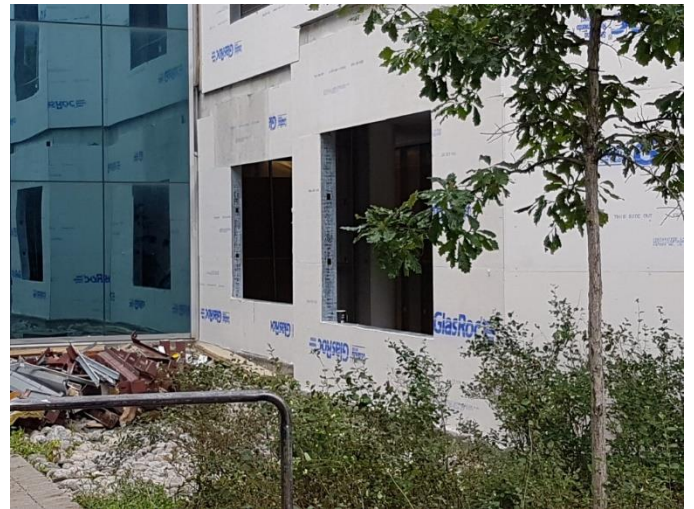
6. Konstruktion der Außenwände

All wall types have either a concrete or concrete masonry unit backup wall. Insulation ranges from 100mm to 300mm, consisting of either spray foam or mineral wool. See graphic for specific description of wall assemblies.

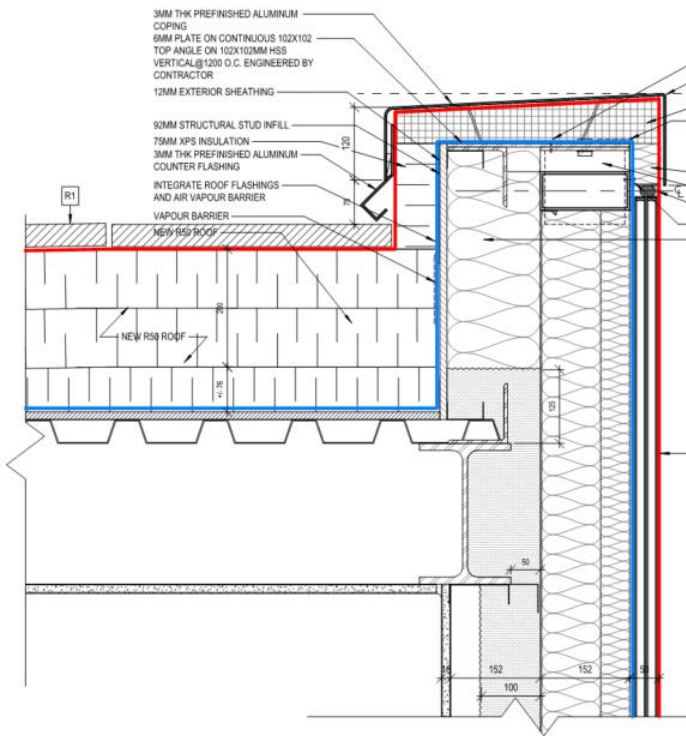
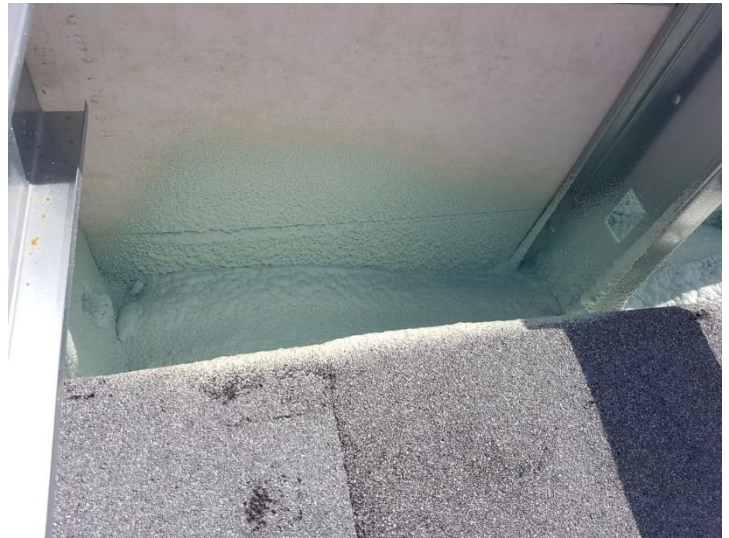
7. Konstruktion des Daches

XPS insulation outboard of concrete slab plus integrated roofing membrane. Exterior sheathing is mechanically fastened through to the roof infill.

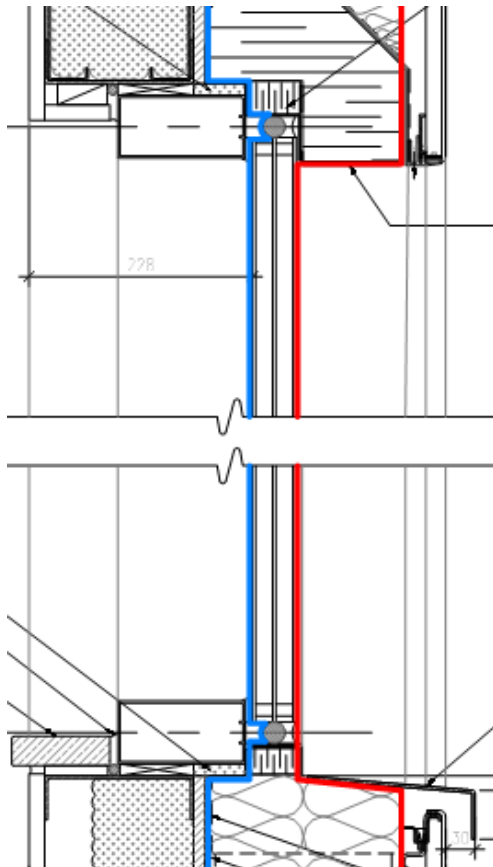
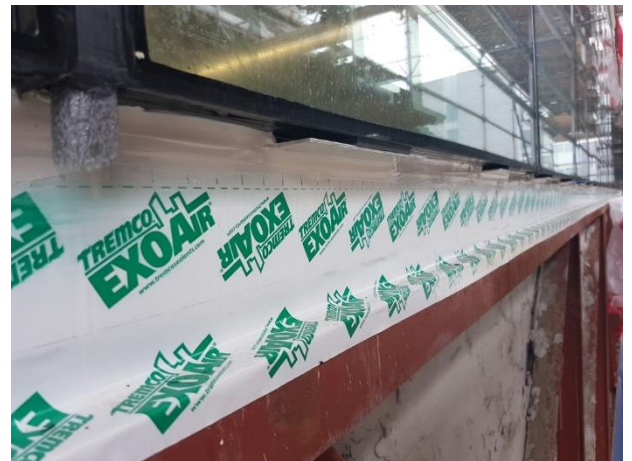
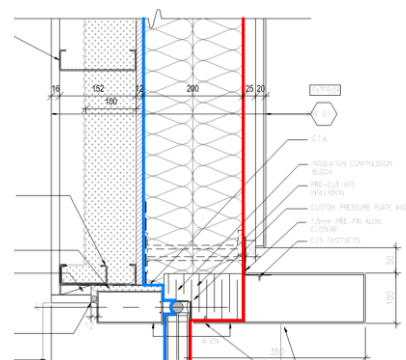
8. Fenster und Fenster-Einbau

Beschreibung der Fenster (rahmen)-Konstruktion, Hersteller	Schuco AWS 90.SI (Windows) Schuco FW 50+ SI (Curtain Wall)
Fabrikat Fenster (rahmen; Produktname)	Aluminum frames with foam composite insulating bars and a co-extruded middle sealare added to the insulation zones.
Rahmen-U-Wert U_f	0,80 W/(m ² K)
Bauart der Verglasung	Tripled glazed, Argon filled
Glas-U-Wert U_g	0,68 W/(m ² K)
g-Wert der Verglasung	0,68

GLASS 1	Clear (NA) Thickness = 1/4" = 6mm	#1 ---- #2 SunGuard® SNX 62/27 (NA)
	GAP 1	10% Air, 90% Argon, 1/2" = 12.7 mm
GLASS 2	Clear (NA) Thickness = 1/4" = 6mm	#3 ---- #4 SunGuard® SN 68 (NA)
	GAP 2	10% Air, 90% Argon, 1/2" = 12.7 mm
GLASS 3	Clear (NA) Thickness = 1/4" = 6mm	#5 ---- #6 ----

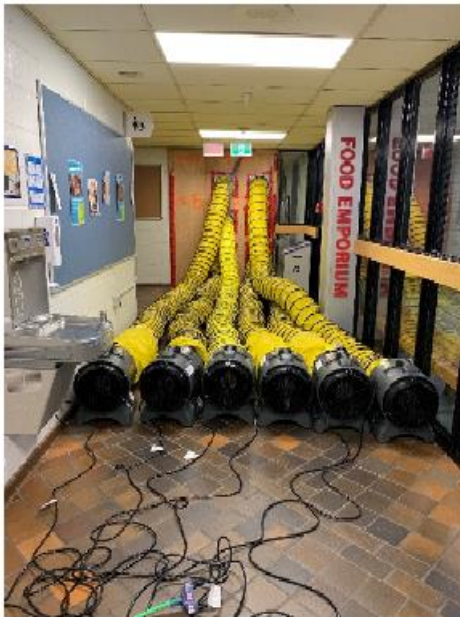
The final air tightness test was completed by Morrison Hershfield on December 19, 2019 after it was understood that all envelope and penetrations had been completed.

Building Envelope Airtightness Results³

Test Phase	ACH50	Result
Pressurization	0.55	PASS
Depressurization	0.51	PASS
Combined, Average	0.53	PASS

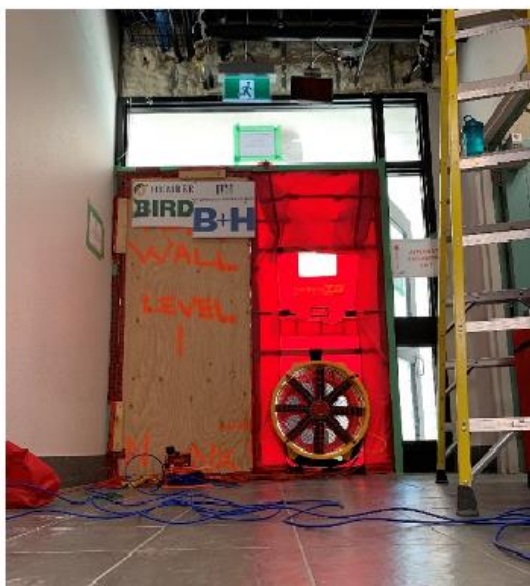
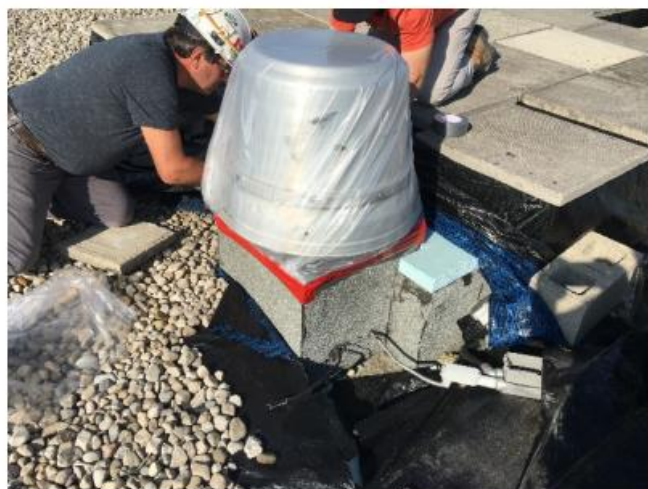
The building envelope consists of two basic wall types WNx-01 and WNx-03. Firstly, WNx-01 uses BlueSkin modified bitumen self-adhered membrane (SAM) applied to the exterior surface of exterior sheathing, supported on a structural steel stud wall assembly.

WNx-03 relies on spray foam insulation applied to the exterior surface of concrete or concrete block masonry. The transitions from WNx-01 to WNx-03 is facilitated by SAM membrane.

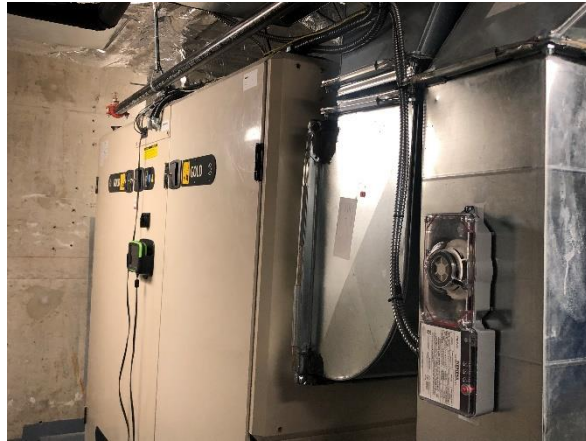
10. Lüftungsgerät

To greatly reduce ventilation heat losses, a balanced supply/exhaust air system with nominal 85% heat recovery was used.

Fabrikat Lüftungsanlage	Swgon GOLD RX 35
effektiver Wärmebereitstellungsgrad	85 %
Elektroeffizienz	0,45 Wh/m ³

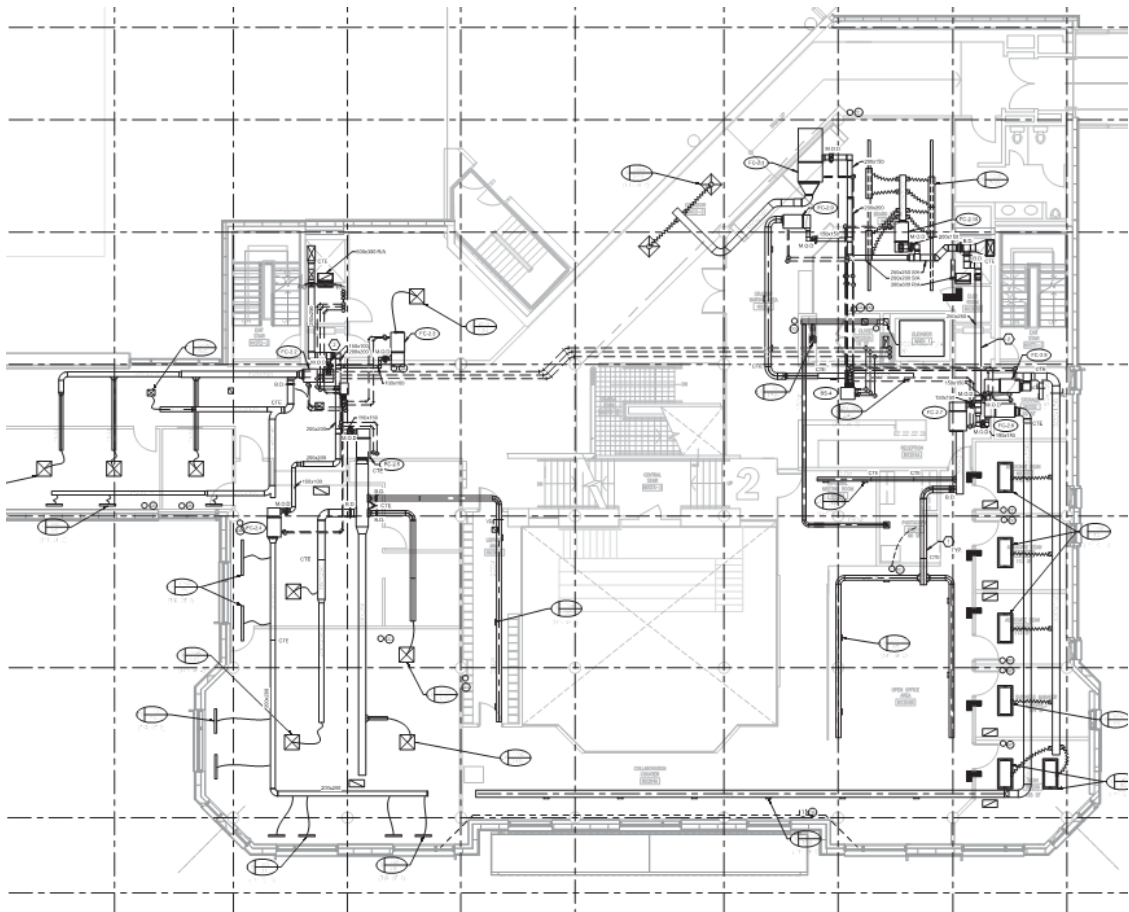
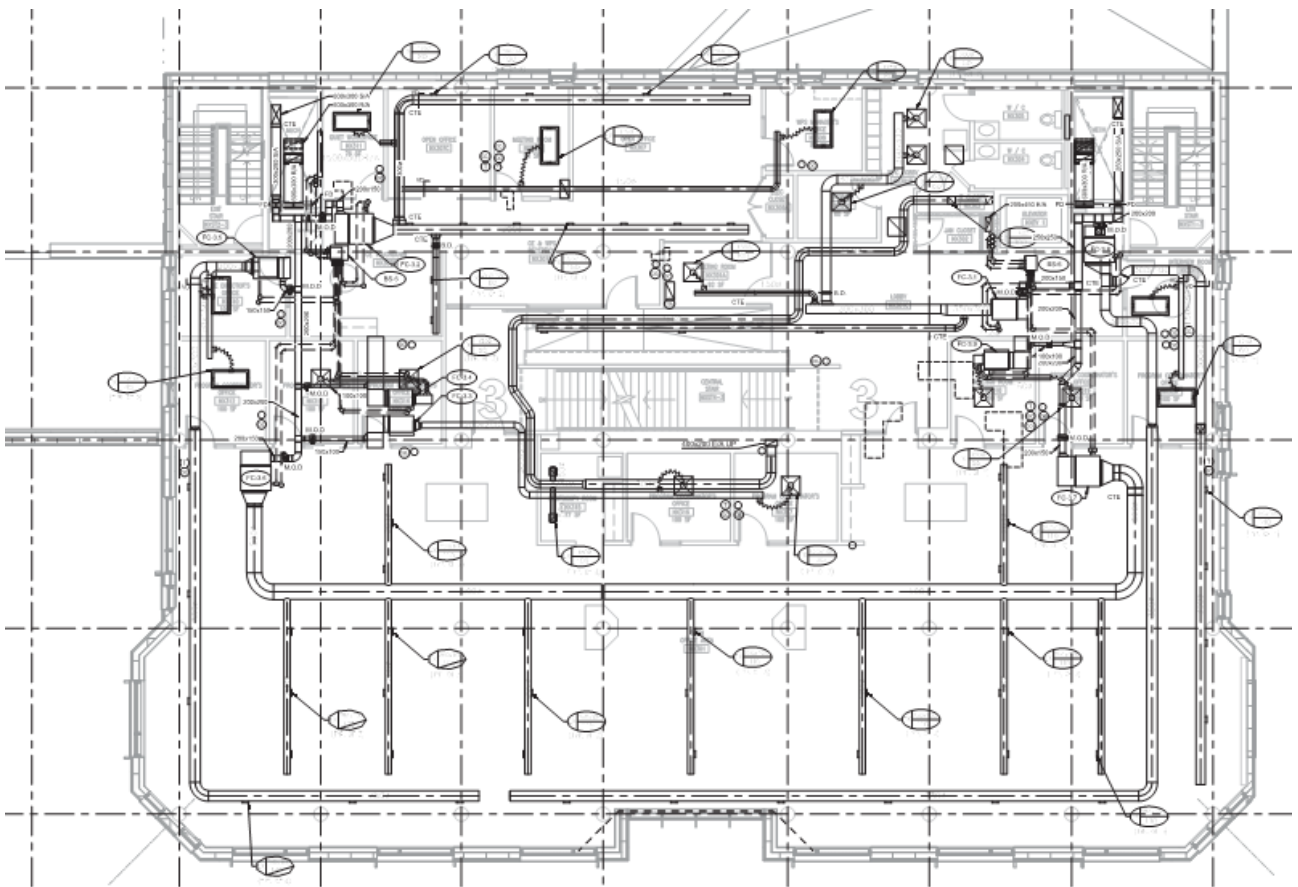
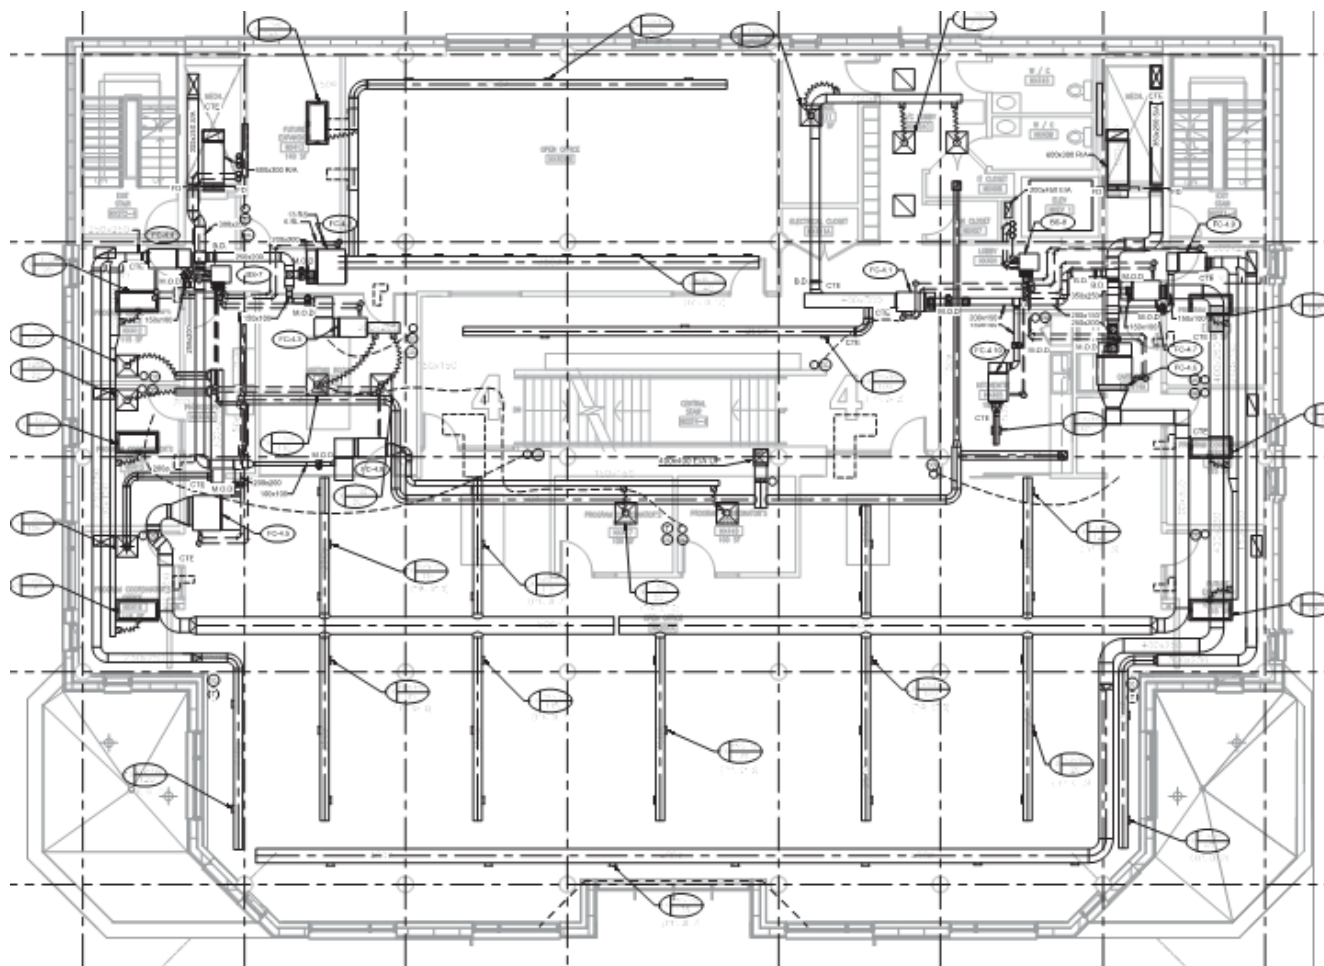
11. Lüftungsplanung Kanalnetz

One (1) Dedicated Outdoor Air system (DOAS) with 85% sensible heat recovery and 1900 l/s flow capacity. Refer to attached cut sheet. All existing sanitary and general exhaust ducting will be re-routed to the exhaust plenum of the proposed DOAS. New DOAS will be installed indoor on the 5th floor mechanical room.

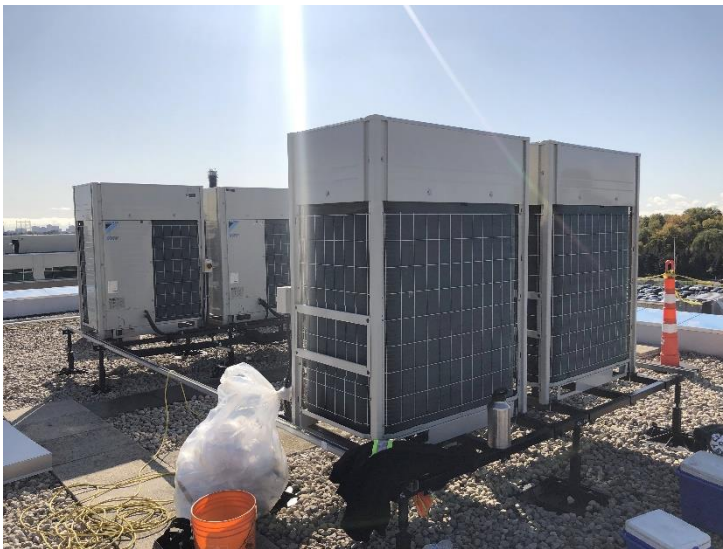
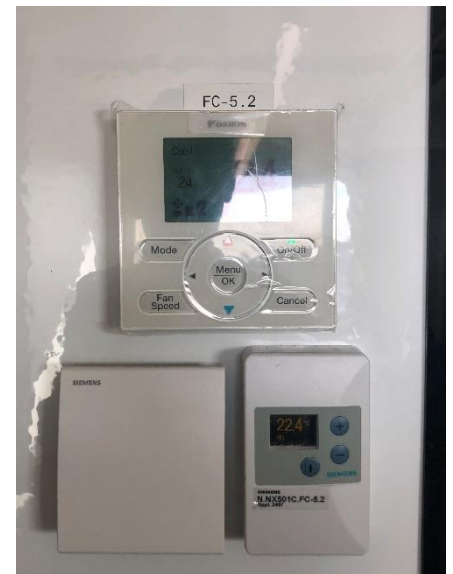
12. Wärmeversorgung

Two (2) new air cooled Variable Refrigerant Flow-Heat recovery Heat Pumps will be installed on the 5th floor mechanical room Roof. Refer to attached cut sheets
Fan-coil units will be installed for each thermal zone and the existing ductwork distribution within the floors will be re-used for each zone distribution. Refer to attached cut sheets.
One (1) Dedicated Outdoor Air system (DOAS) with 85% sensible heat recovery and 1900 l/s flow capacity. Refer to attached cut sheet. All existing sanitary and general exhaust ducting will be re-routed to the exhaust plenum of the proposed DOAS. New DOAS will be installed indoor on the 5th floor mechanical room.
For the new vestibule located on the North entrance of the ground floor an electric radiant infloor system will be installed separately in two areas to accommodate the proposed foot grille. A radiant system will account for the perimeter glazing heat losses in a more efficient manner than a forced air system
