Project Documentation Gebäude-Dokumentation

Dunedin City Council Community Housing - West

This building is half of a set of twin buildings that form the School Street community housing project. The project commenced on site in November 2019, was completed in July 2022 and achieved certification in December 2022.

The building is constructed of structural insulated panels walls on an insulated raft foundation with a traditional timber truss roof. The windows are timber/aluminium composite manufactured in NZ to a European design with triple glazing. All units in the building share a single heat pump hot water cylinder with an insulated ring main and metering system to measure proportion of hot water used and bill accordingly.

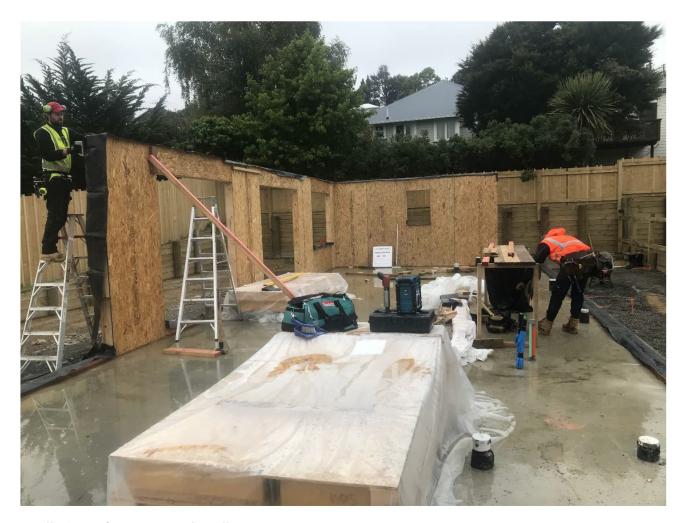
Installation of SIP External Walls

The SIP was taped to the concrete floor and formed an integral part of the air tightness strategy. These were lined internally with 10mm plasterboard and services were designed to be kept away from the external walls, limited to internal and intertenancy walls only.

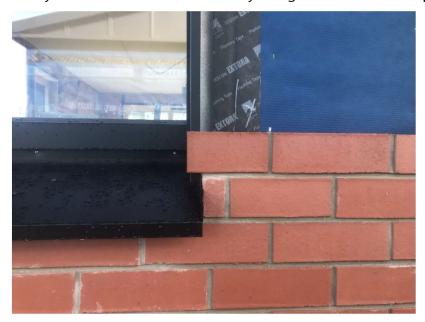
Photo of window installation from exterior

The depth of the frame almost matched that of the wall with the rear of the frame being located flush with the inside face of the wall lining to facilitate easy installation of air tightness tape. The brick cladding was dressed over the front of the insulated frame with an aluminium cavity closer installed to leave only the glass visible where possible.

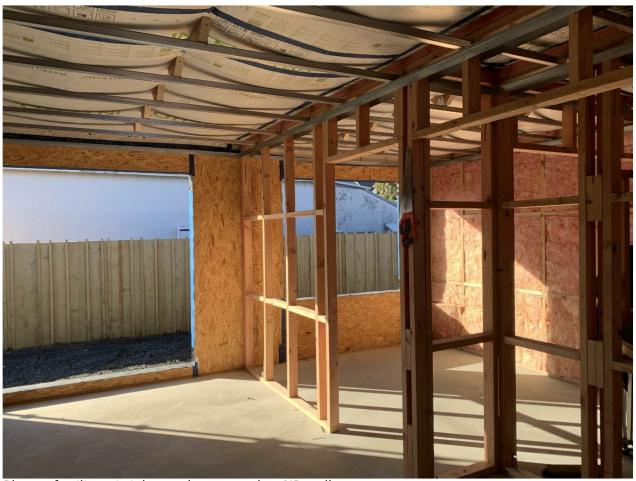
Photo of ceiling airtightness layer taped to SIP walls

The airtight envelope was formed by the concrete slab, the SIP external walls and a Prolcima Intello airtight membrane under the trusses. Additionally, the intertenancy wall for each unit was taped to the external walls to create individual airtight units for ease of testing.

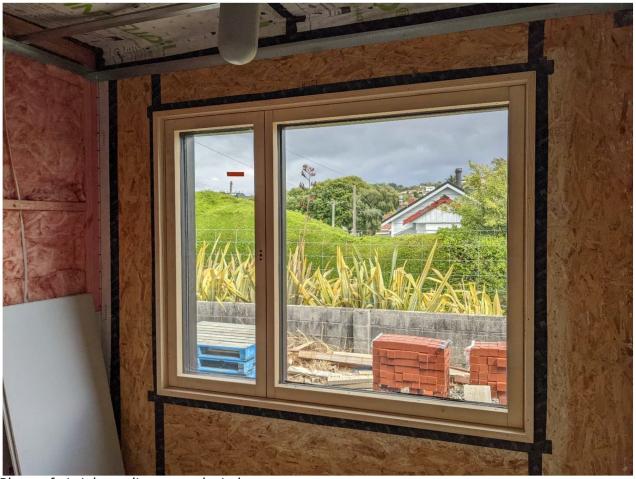
Photo of airtight sealing around windows

Sealing between elements was achieved using Proclima Tescon Vana tapes. The kitchen extract is a recirculating range hood reducing the required large penetrations through the air tight barrier to only that required for the MVHR system.

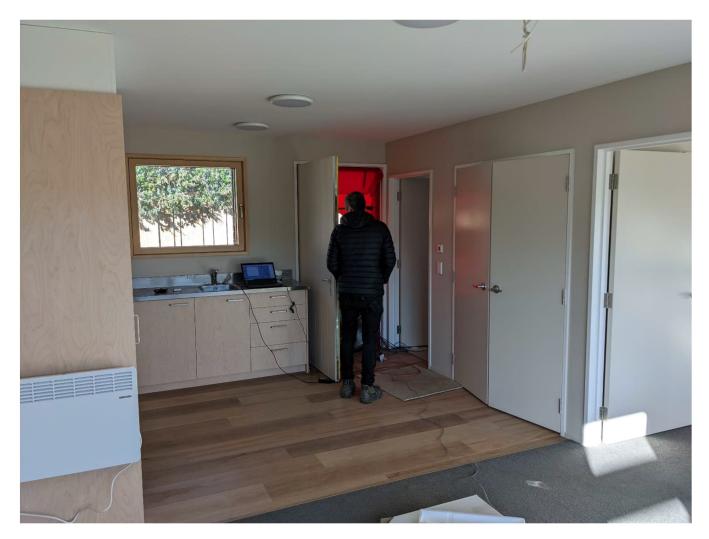
The heating for each unit is supplied via a thermostatically controlled 1.5kW direct electric heater fixed to the wall in the main living space which adequately covers the 358W Heating Load.

Heater installed in main living space.

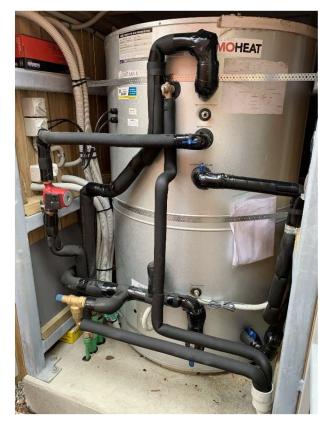
Photo of HWHP cylinder & ring main piping

The hot water cylinder is located outside at the West end of the North block. The insulated ring main is routed through the under-slab insulation to improve performance with only a small section between the North and West block in the ground. This provides the benefit of the efficiency that comes with a hot water heat pump but also reduces storage heat losses and space use of individual cylinders for each unit. As these are rental properties, it also limits the access requirements for maintenance.

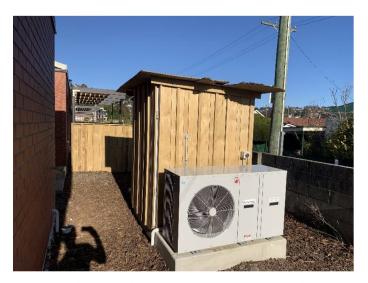
Photo of HWHP housing and external unit
