# PROJECT DOCUMENTATION GEBÄUDE- DOKUMENTATION

Bader Ventura 3C, Māngere, Auckland, New Auckland

## BRIEF DESCRIPTION

This 3-unit apartment block is one of 5 blocks within the Bader Ventura development which has a total of 18 units. The project is publicly funded social housing. The architecture is simple and modern with the predominate feature being vertically oriented bands of precast concrete Thermomass walls which span the full 3-storey building height. The development sits within the Māngere neighborhood located in South Auckland.

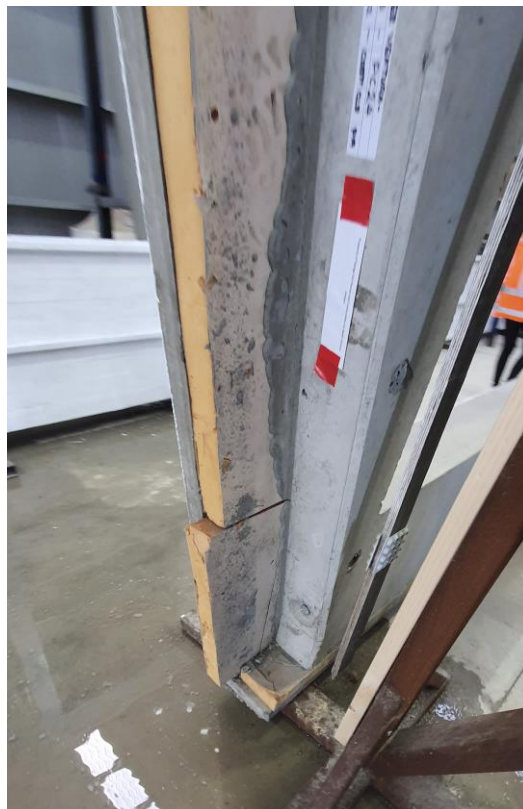
## 6. EXTERNAL WALL

Thermomass panel wall with a Farrat structural thermal break wherever a structural connect from the exterior needs to extend through the external layer of insulation. We also incorporated an additional layer of Kingspan K17 on the interior to boot the total U value. The joints between the precast panels were sealed with Proclima Tescon Tape for air barrier continuity.

Thermomass-Paneelwand mit einer strukturellen thermischen Trennung von Farrat überall dort, wo eine strukturelle Verbindung von außen durch die äußere Isolationsschicht verlaufen muss. Wir haben auch eine zusätzliche Schicht Kingspan K17 auf der Innenseite angebracht, um den Gesamt-U-Wert zu erhöhen. Die Fugen zwischen den Fertigteilplatten wurden mit Proclima Tescon Tape abgedichtet, um die Kontinuität der Luftbarriere zu gewährleisten.

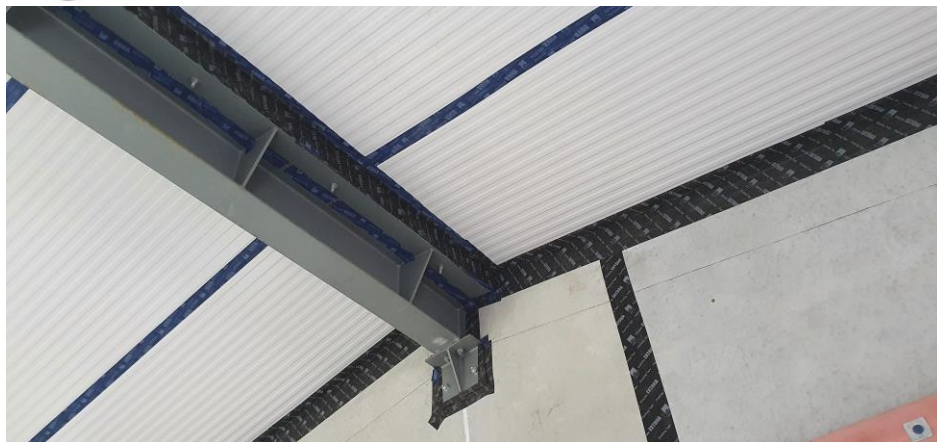
## 7. ROOF CONSTRUCTION

Kingspan Panel with joints taped with Proclima Tescon for vapour control layer continuity and air barrier continuity. The junctions with the walls were also taped (the interior structural layer of concrete was deemed as the main air barrier throughout the walls). Spray foam was used at the gaps between the roof and wall panels.

Kingspan-Paneel mit mit Proclima Tescon verklebten Fugen für die Kontinuität der Dampfsperrschicht und der Luftsperrre. Die Verbindungen mit den Wänden wurden ebenfalls abgeklebt (die innere Strukturschicht aus Beton galt als Hauptluftbarriere in den Wänden). In den Zwischenräumen zwischen Dach- und Wandpaneelen wurde Sprühschaum eingesetzt.

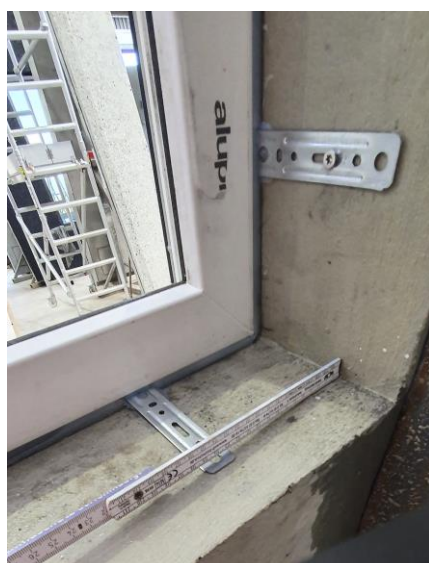
## 8. WINDOWS AND WINDOW INSTALLATION

The insulation was thinned around the window rough openings to allow for intermittent clip attachment. The rough opening was prepped with cementitious acrylic liquid applied flashing membrane, the air barrier seal at the windows was completed with a 100% silicone wet seal on backer rod which was detailed around each window attachment clip. Spray foam was then installed around the window cavity prior to metal flashings being installed to the exterior.

Die Isolierung wurde um die groben Fensteröffnungen herum ausgedünnt, um eine zeitweise Clipbefestigung zu ermöglichen. Die grobe Öffnung wurde mit einer zementären Acrylflüssigkeit vorbereitet, die mit einer Dichtungsmembran aufgetragen wurde. Die Luftsperrdichtung an den Fenstern wurde mit einer Nassdichtung aus 100 % Silikon auf einer Stützstange vervollständigt, die rund um jeden Fensterbefestigungsclip angebracht war. Anschließend wurde Sprühschaum um den Fensterhohlraum angebracht, bevor an der Außenseite Metalleinfassungen angebracht wurden.

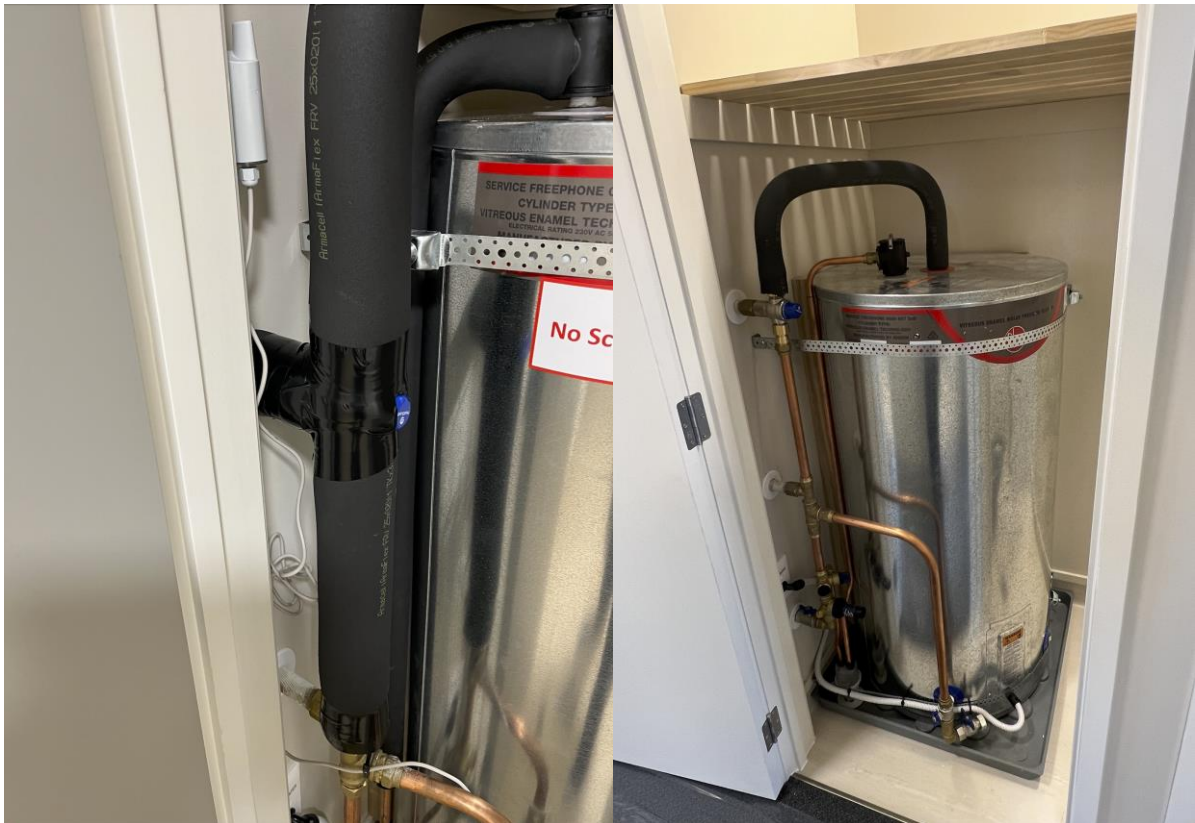
A Rheems Mains 180l hot water cylinder was used, Armaflex pipe insulation was used to limit storage heat losses. Insulation not fully installed in the right image below. Left image is finished install of insulation.

Es wurde ein 180-l-Warmwasserspeicher von Rheems Mains verwendet. Zur Begrenzung der Speicherwärmeverluste wurde eine Armaflex-Rohrisolierung verwendet. Im rechten Bild unten ist die Isolierung nicht vollständig installiert. Das linke Bild zeigt die fertige Installation der Isolierung.
