# Passive House Object Documentation

Single Family Home, Claverack, New York, USA  
(Passive House database 1893)

## 2.2 Short description of the construction task

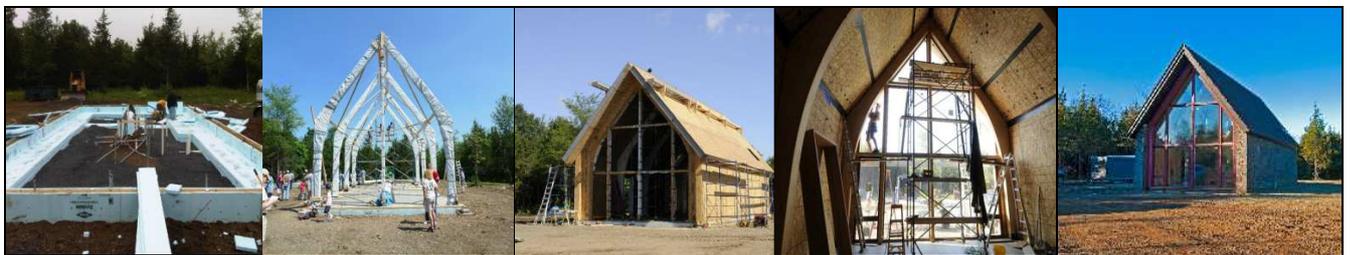
Construction commenced in May 2010 when the ground was broken and the site cleared. After the installation of the foundation and floor, the frame for the building was raised in June 2010. Wall and roof SIP installation continued through the following month. By September the envelope was complete with windows in place. Construction was essentially complete by the end of 2010 with interior finishing and landscaping. A timeline of the progress in pictures follows.

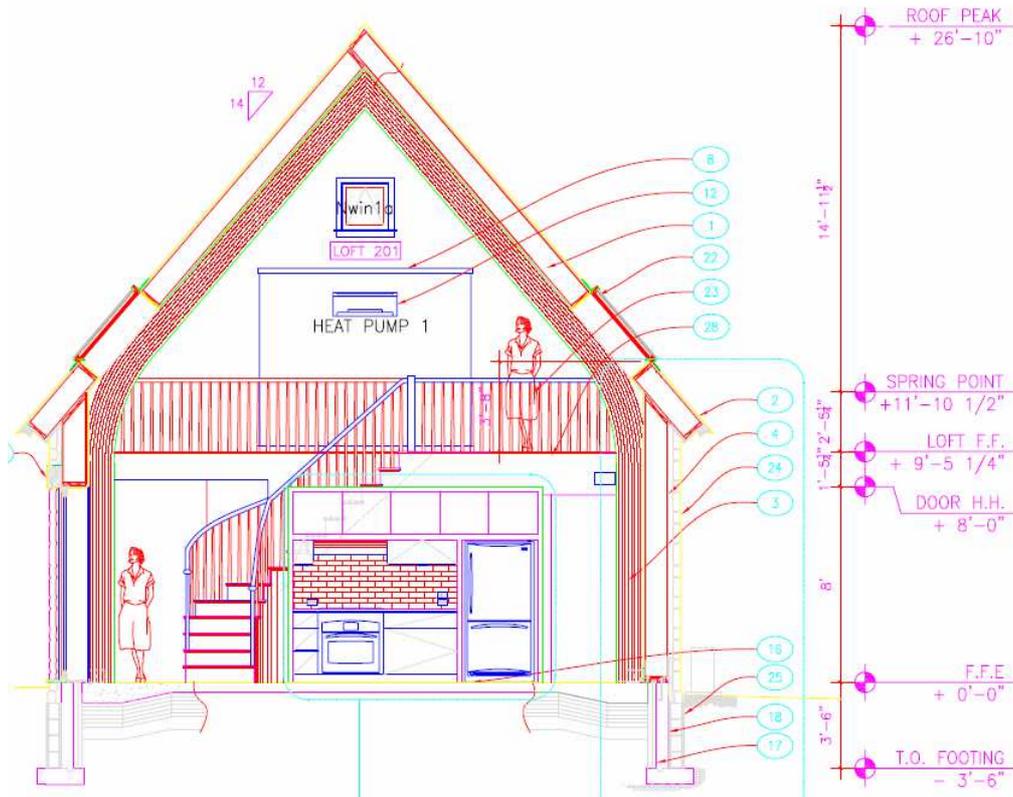
Figure 8 Cross section drawing

| 1 SIP roof panel | 12 Heat pump indoor unit | 23 Railing |
| 2 Asphalt roofing | 16 Polished concrete floor | 24 Stone cladding |
| 3 Timber frame column | 17 XPS insulation | 25 Concrete block foundation for stone cladding |
| 4 Drainage cavity behind stone cladding | 18 Poured concrete foundation wall | 28 Loft floor |
| 8 Top of partition wall | 22 Roof window | |

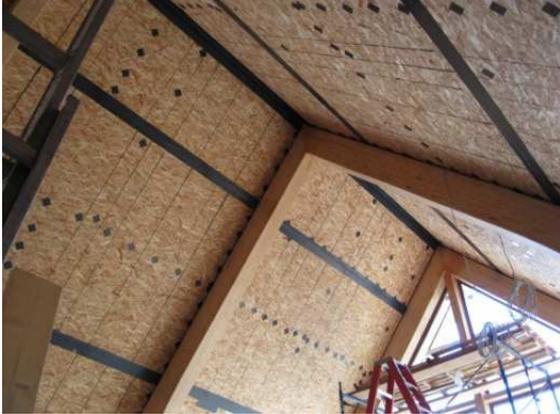
Figure 16 SIP flashing tape

A three-part strategy was used to achieve airtightness. First, caulk and adhesives were used to join SIP panels and between SIP panels and elements such as windows and the foundation. Second, two-part spray foam was applied in gaps between panels, around windows and to seal electrical penetrations. Finally, a SIP flashing tape (cured butyl-based adhesive with cross-laminated polyethylene membrane) was applied to all SIP seams, fastener penetrations and other joints.

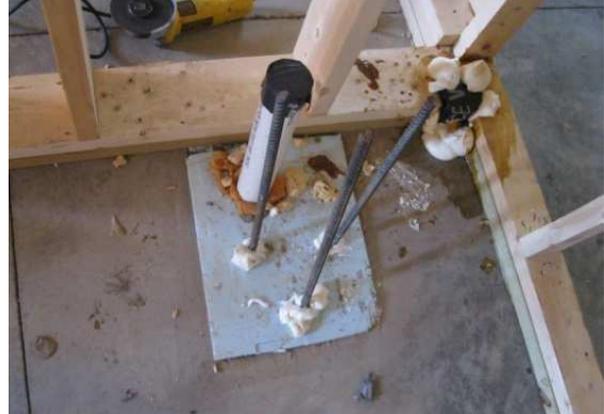
Figure 17 Spray foam at plumbing penetrations

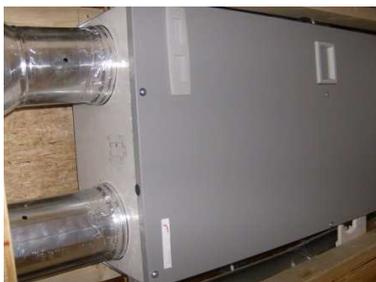
Figure 20 HRV in second floor cavity

For the Hudson Passive Project, a Zehnder ComfoAir 200 heat recovery ventilator was installed with soundproofing and filters. The unit was installed inside the loft ceiling cavity central to the house and within the thermal envelope. Rigid steel ductwork was installed to transfer air to designated spaces within the home and to the exterior intake and exhaust ports on the East facade. Ducts between HRV and exterior insulated with 10.2cm fibrous insulation. Adequate ventilation flow to each room is essential to maintain comfort and healthy indoor air, and proper balance must be achieved to avoid creating pressure differentials across the building envelope. Therefore the ventilation system was commissioned and flows were measured and adjusted in each room to the design requirements.

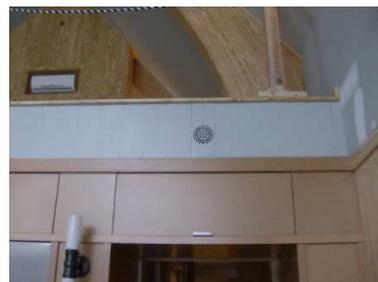
Figure 21 Supply air point in main room
