Case Sabin in Pieve di Soligo, Treviso, Italy – project ID 2194

Multifamily building with 11 residential flats, 3 offices and 2 shops.

Passive House Object Documentation - Case Sabin - 09.02.2012 (rev. 1)

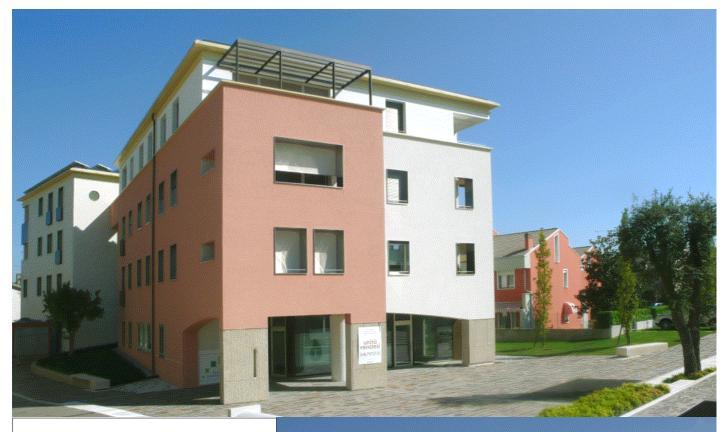
west and north prospect \uparrow south and west prospect \lor

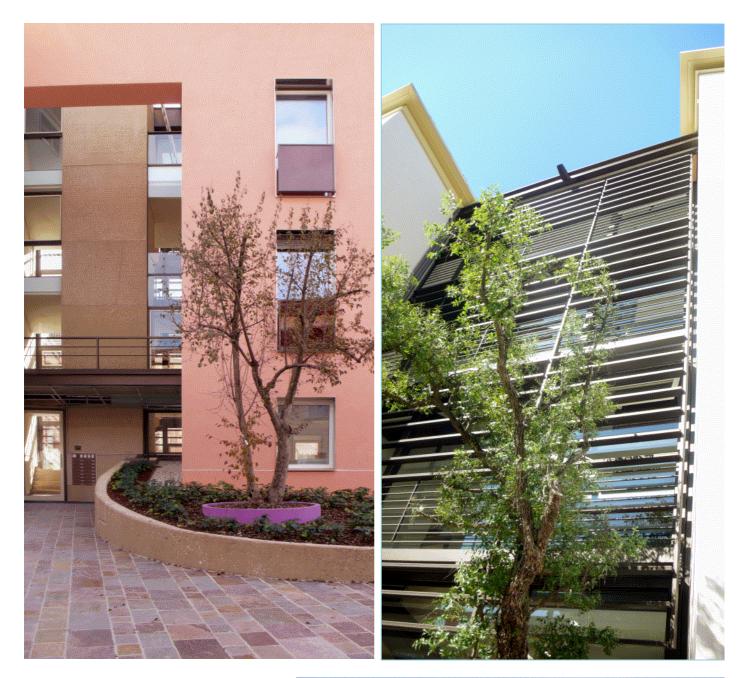
Non-heated stairwell, north prospect ↑ and south prospect **7** the photovoltaic field →

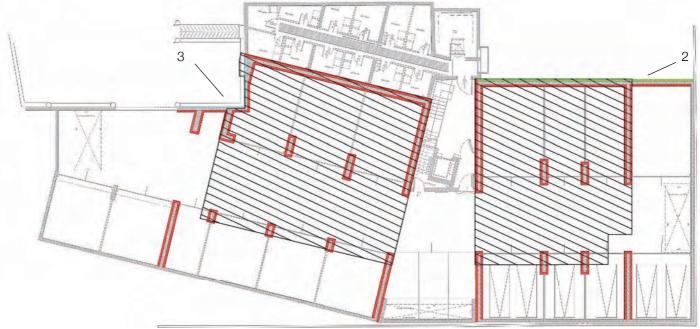
Vertical structures of the basement:

In red, septa and walls are insulated by graphite-added EPS (120 mm) fire protected by a double plasterboard layer (30 mm).

In green (number 2 in the sketch above), the wall against the ground is insulated by XPS (160 mm).

In cyan (number 3 in the sketch above), the interface with another existing basement is insulated with EPS (40 mm). This portion of the basement wall was an existing wall deriving from an abandoned previous project.

The dashed area represent the gross area of the two buildings.

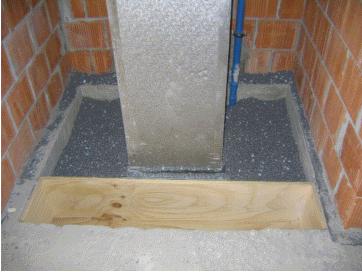
The common ducts are insulated with a minimum of 100 mm thick raw EPS, milled from the scraps of external insulation works, as in the following picture. Position of the common ducts is described on next page.
