# Project Documentation

### House for rural tourism in Ibero, Navarra, Spain

### 2 Views of the Passive House in Ibero

### 3 Sectional drawing of the house in Ibero

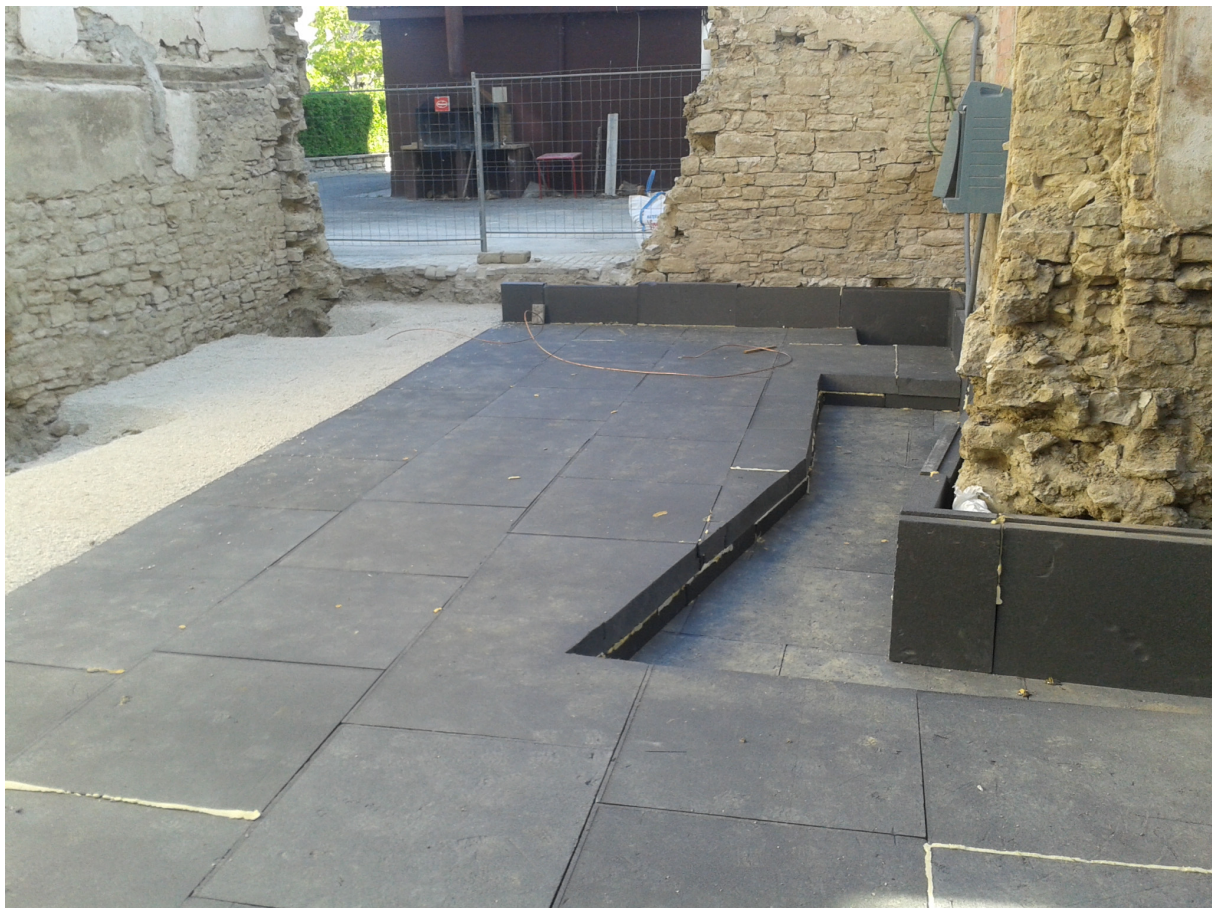
EPS under the concrete slab. The insulation advances under the floor of the garage to reduce the thermal bridge.

The structure of the building is formed with concrete pillar and beams supporting concrete slabs. The foundation of the building is a concrete slab. The isolation goes under the foundation slab.

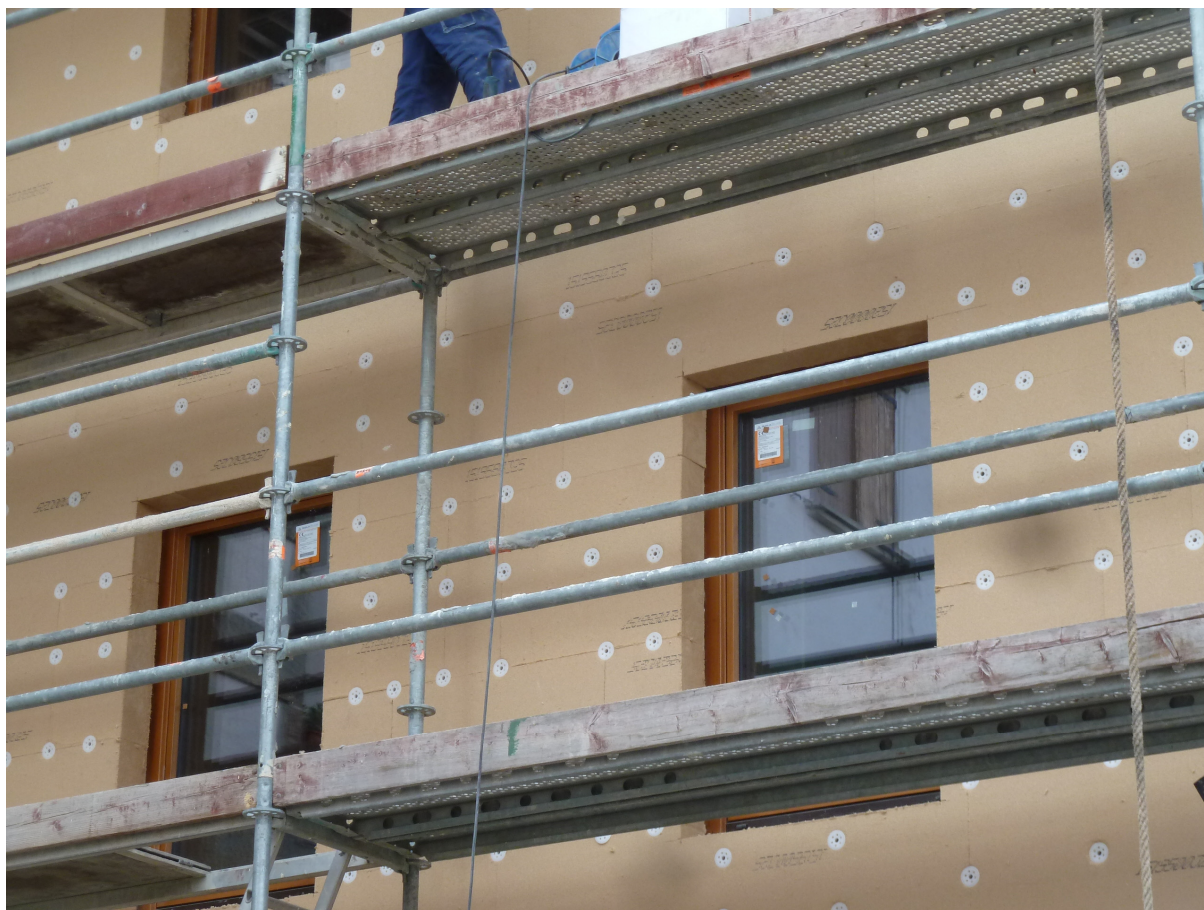
North façade with wood fiber insulation on the brick wall.

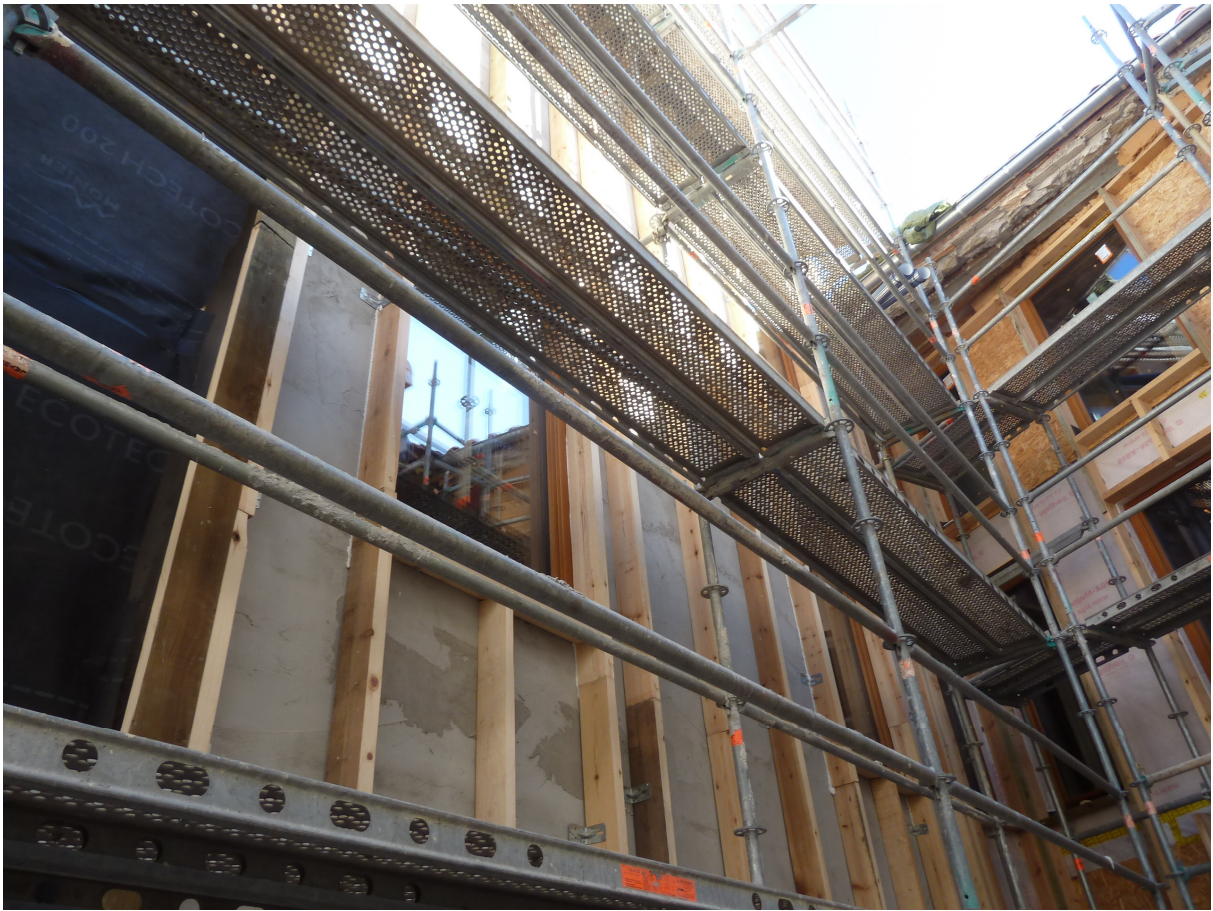
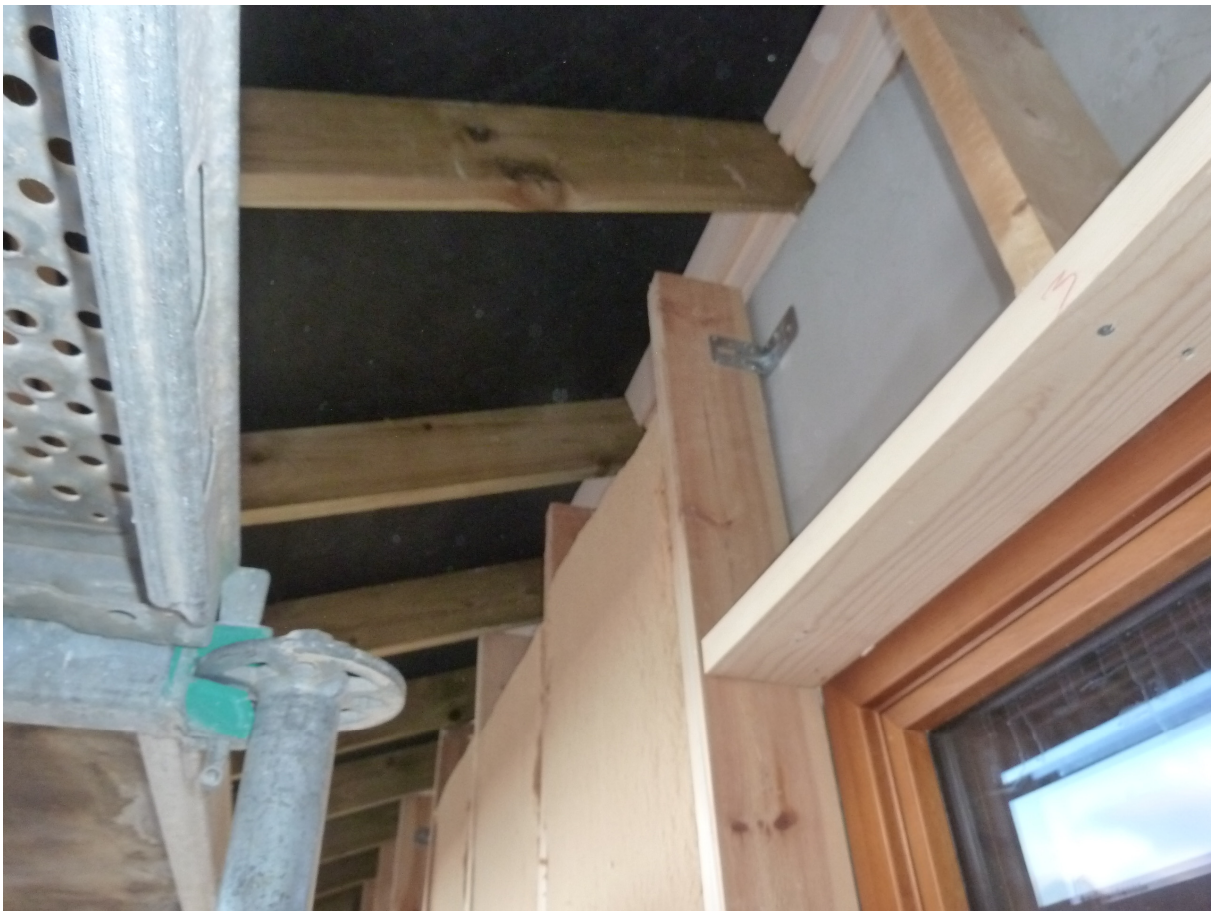
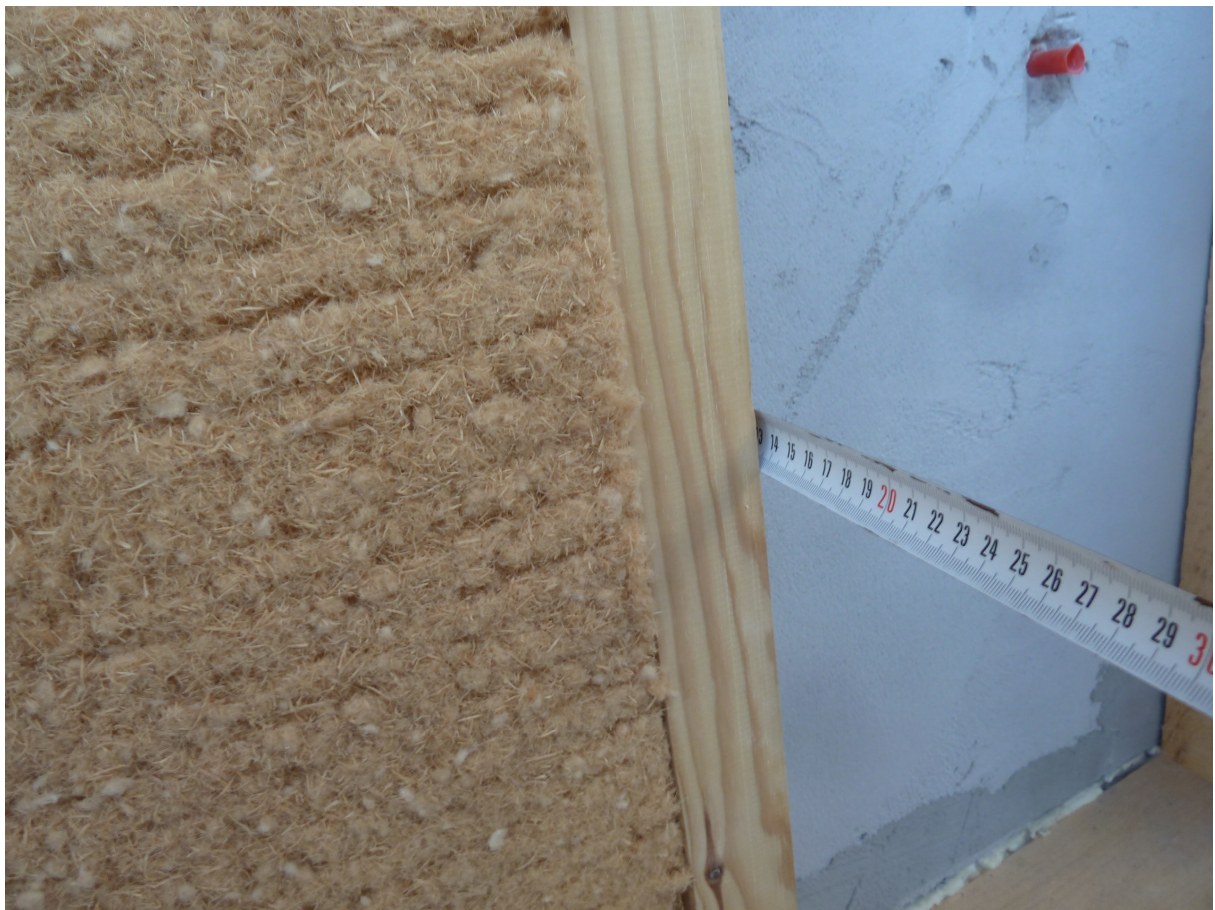
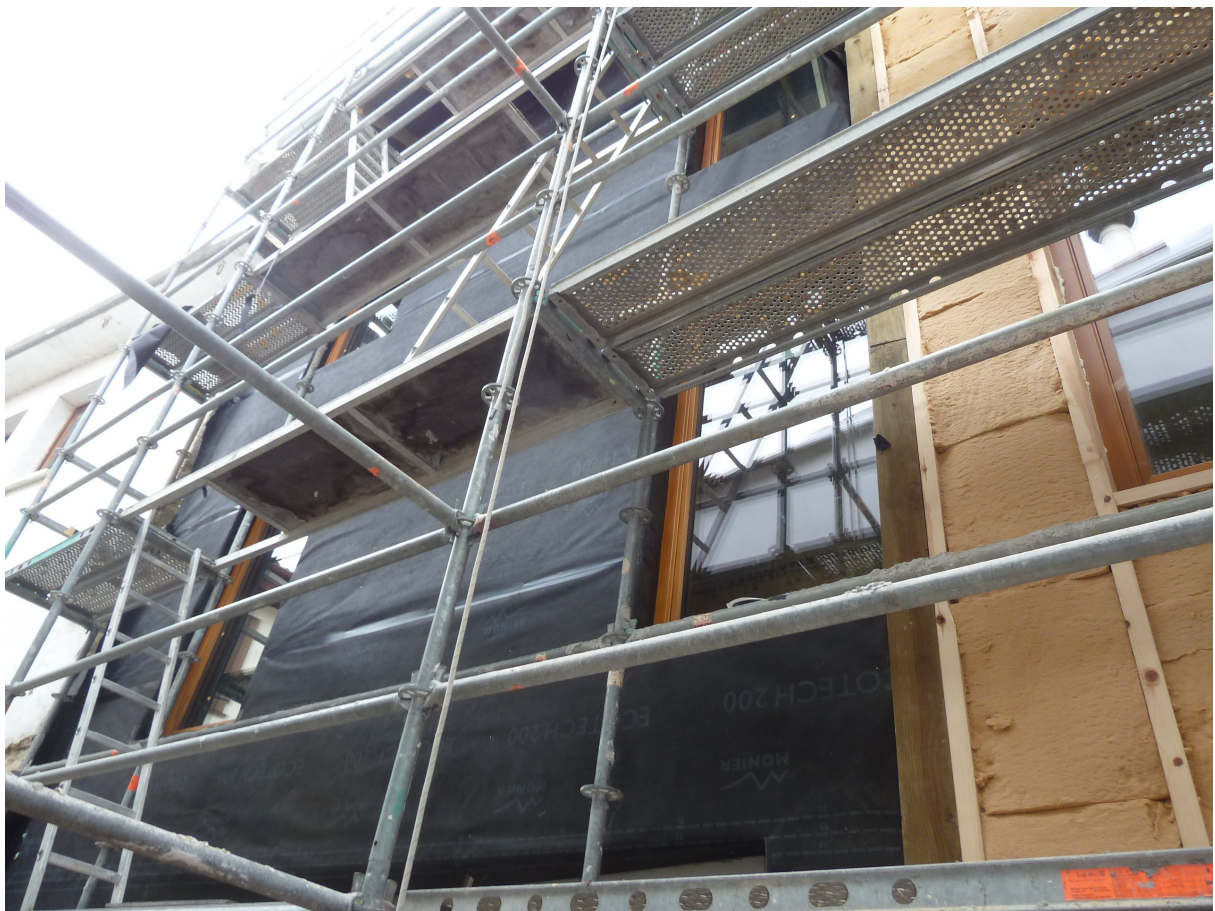
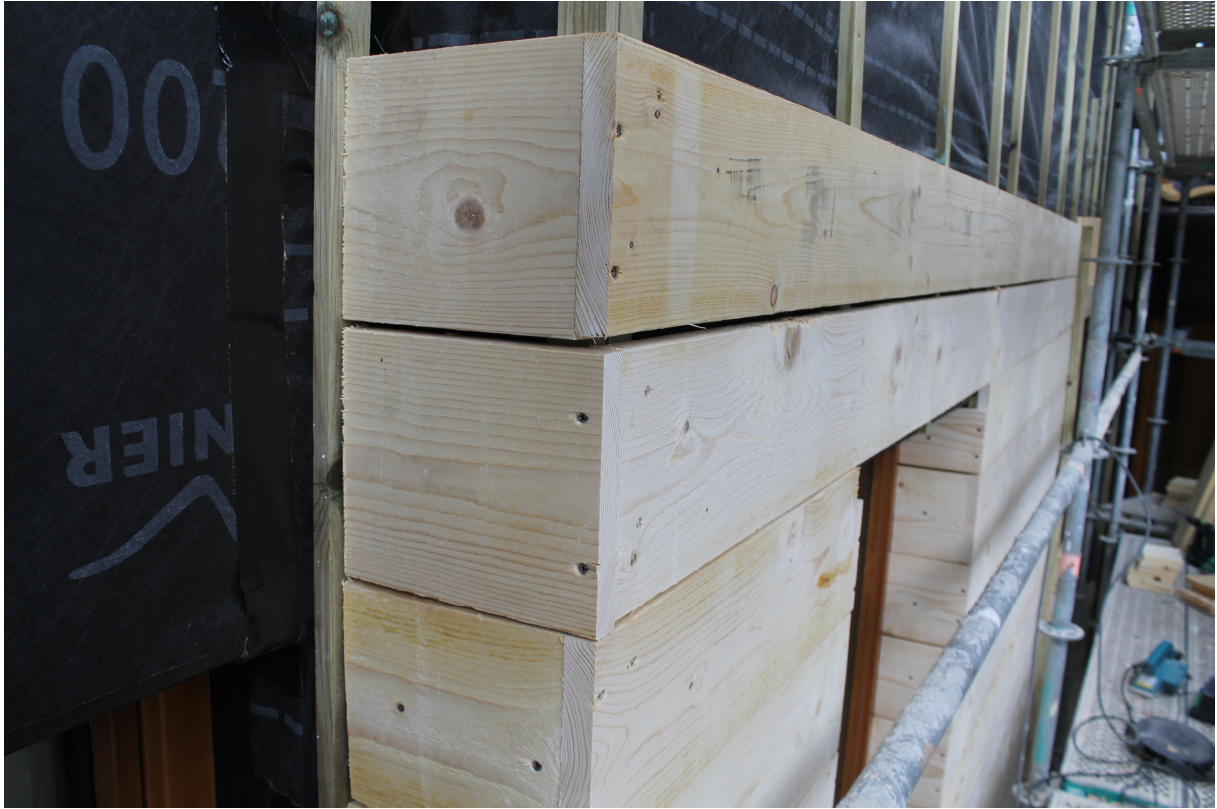
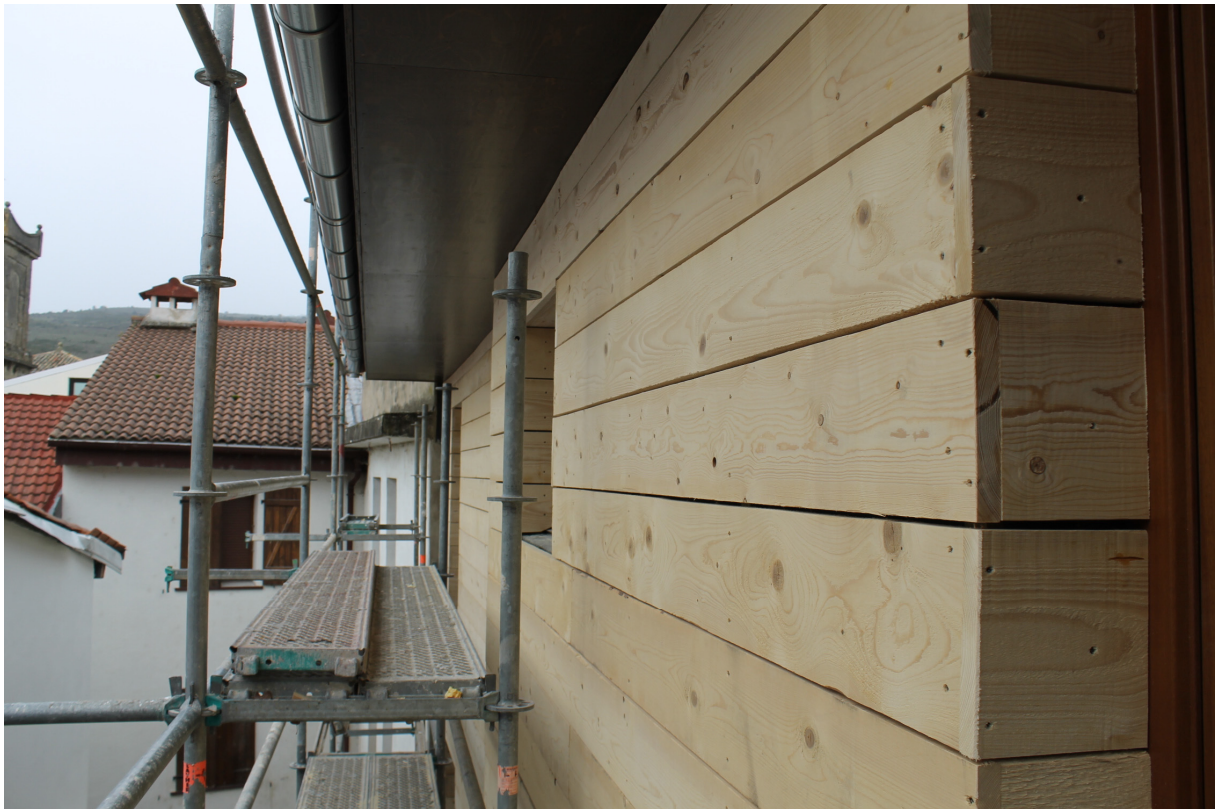
The south façade is solved as a ventilated façade: wood panels fixed to wooden strips. These wooden strips are nailed to other wooden strips fixed to the bricks wall. Between the main wooden strips there are wood-fiber panels, and over them a waterproof sheet.

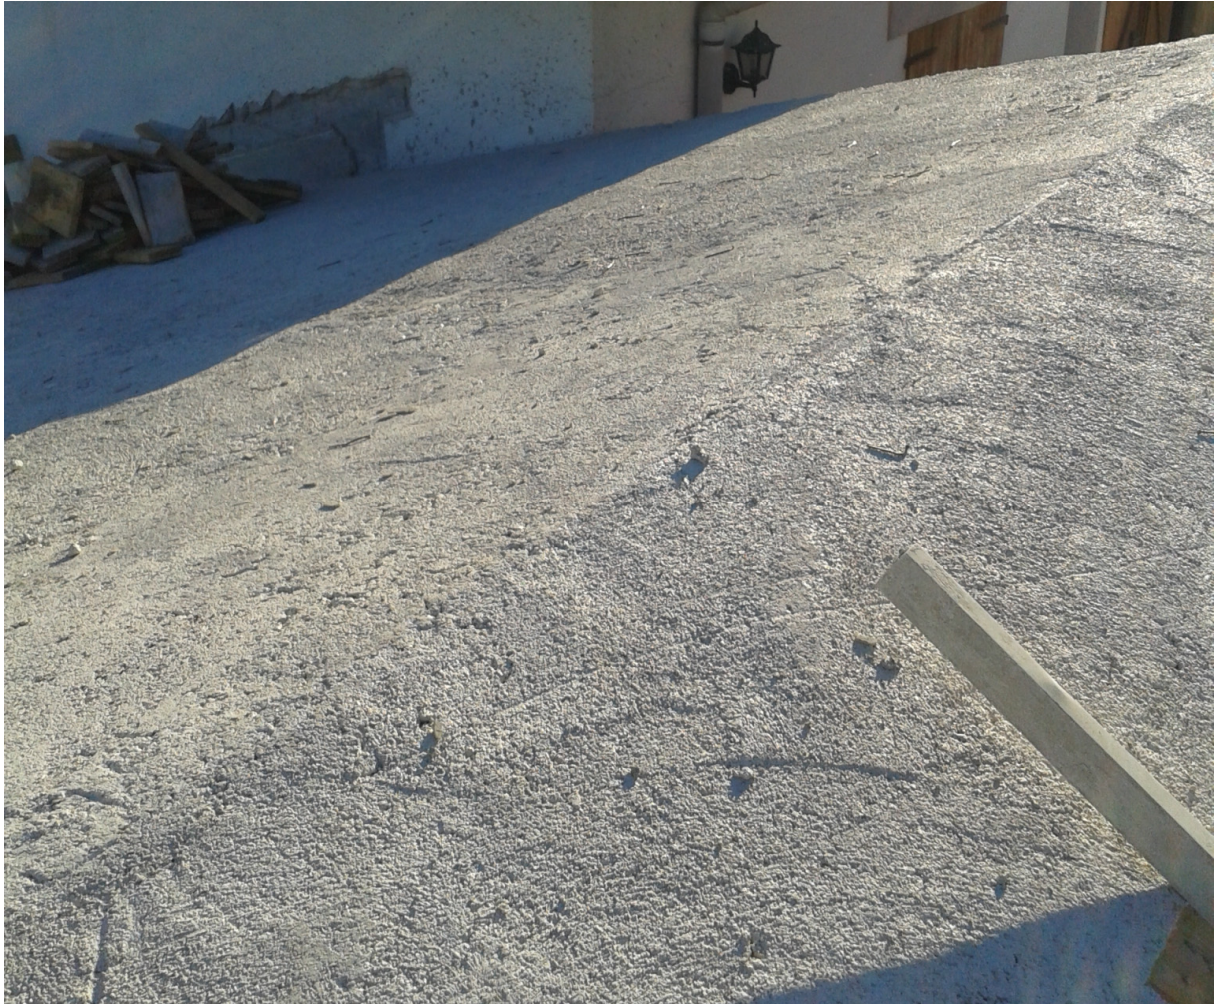
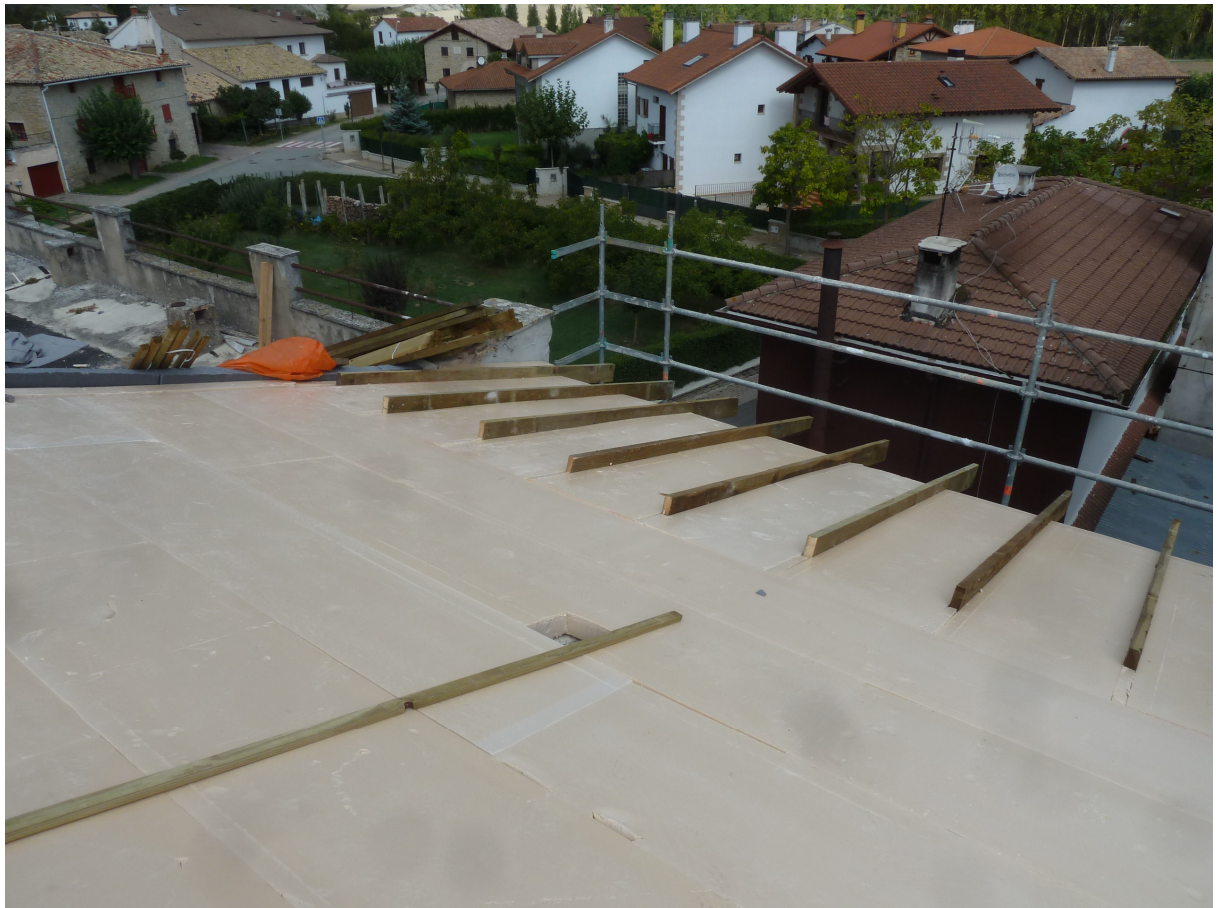
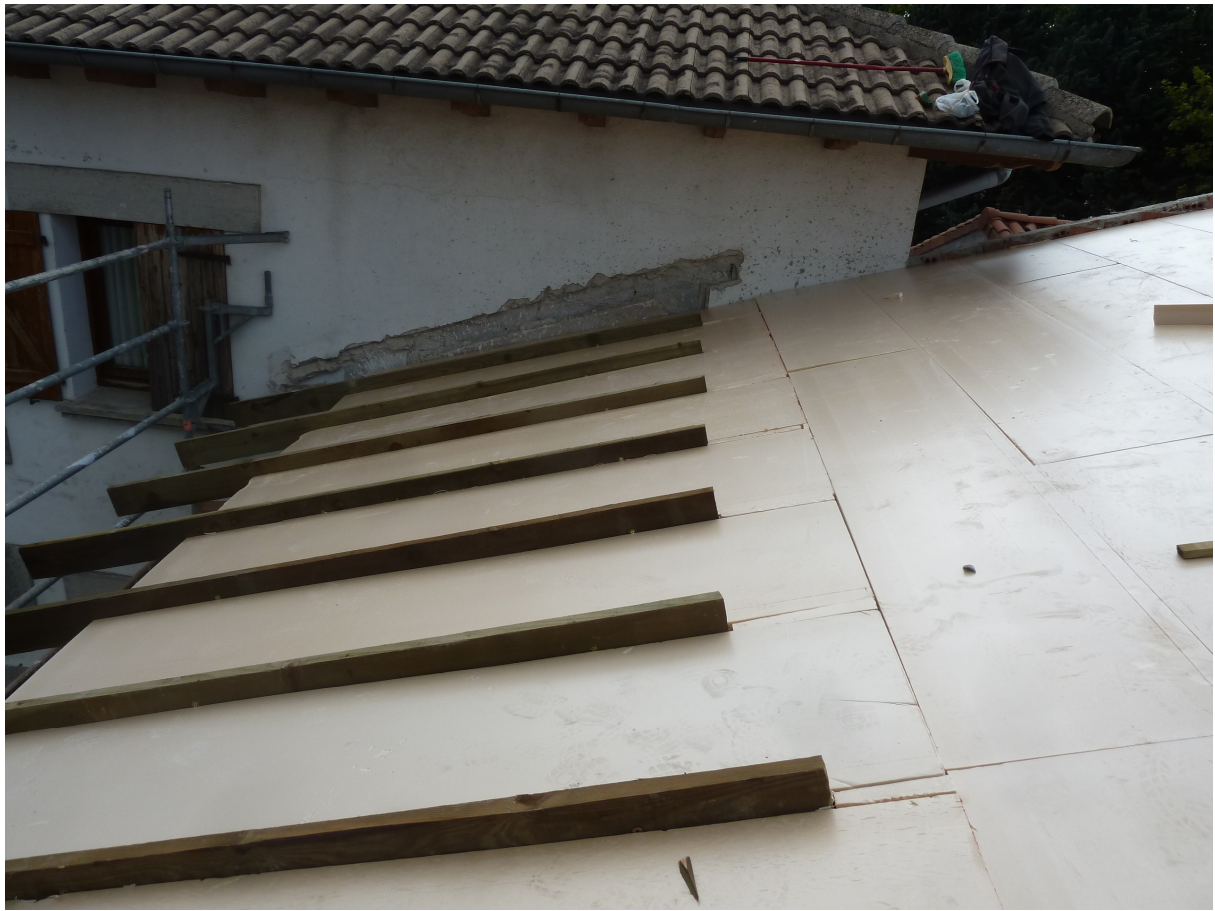
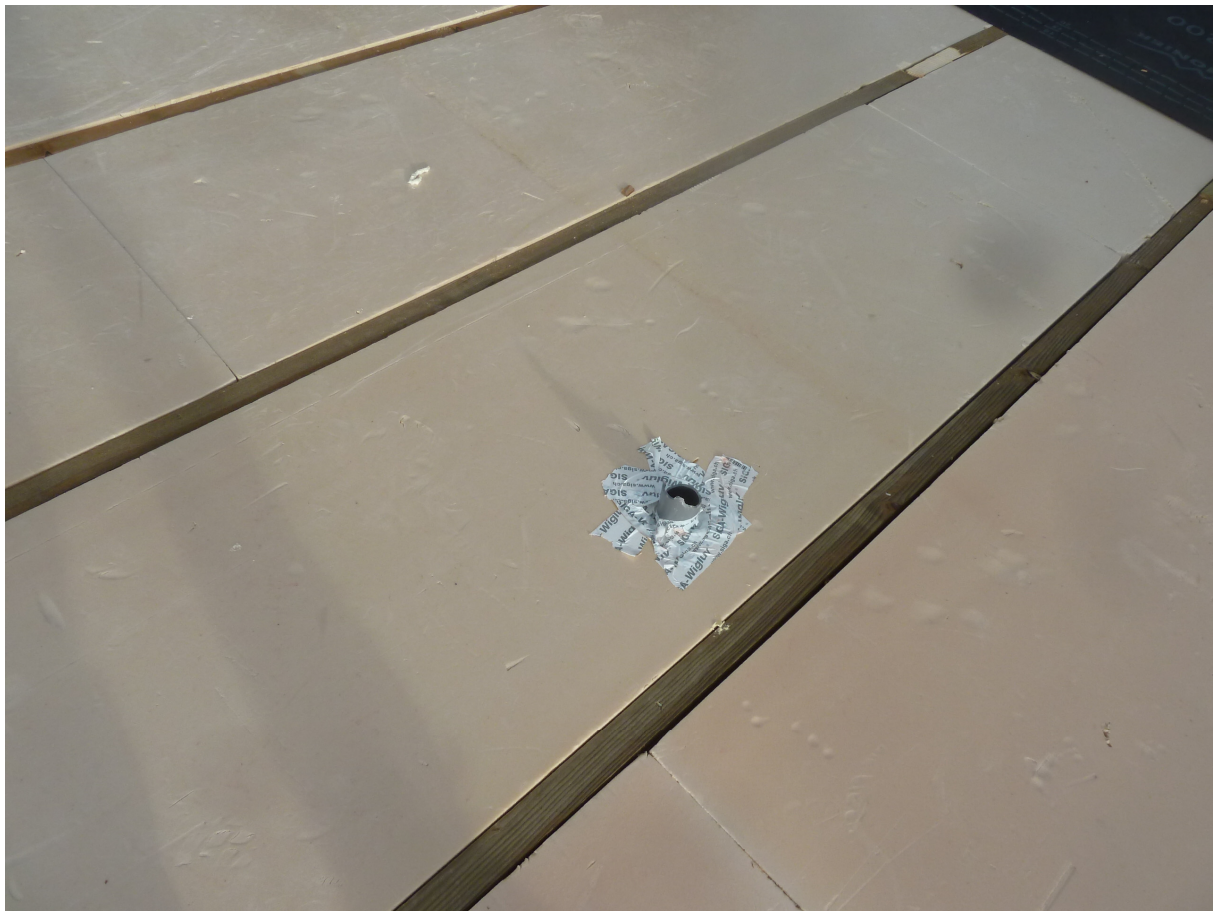
The roof is a tilted concrete slab and over it two XPS panels were fixed (with wooden strips between the slabs of the second level), and a waterproof screen. Over the last one there are wooden strips and ceramic tiles.

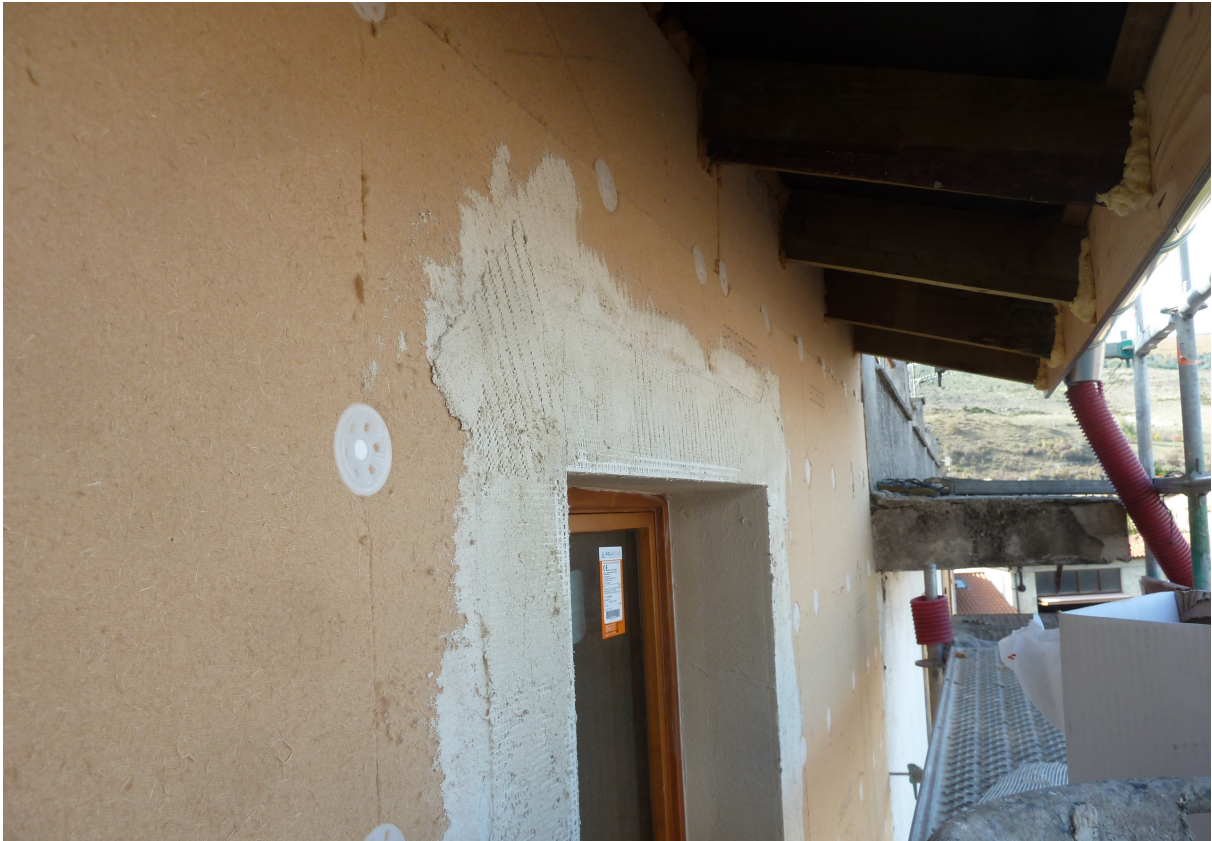
In the connection between the roof and the north façade the wood fiber insulation goes up to the wooden panels of the roof's eaver.

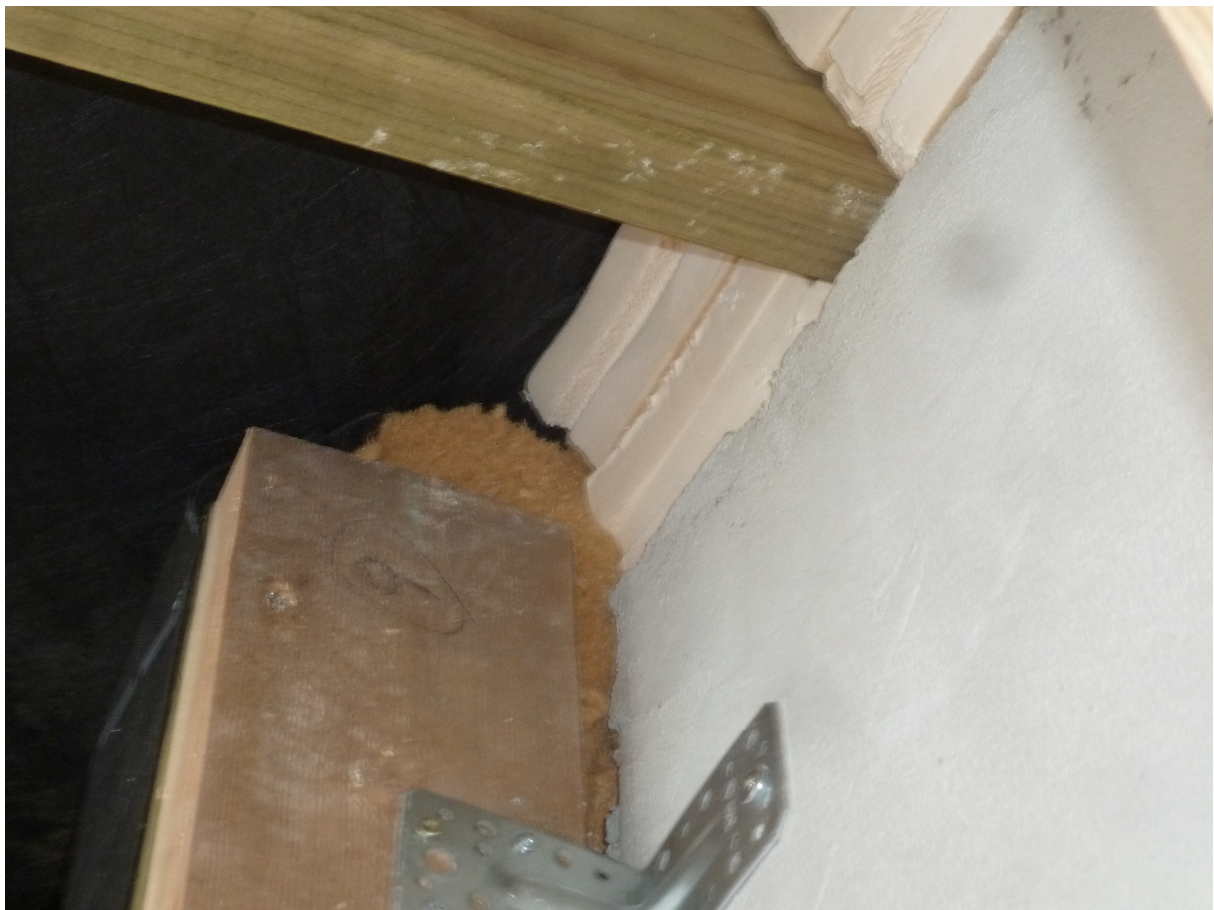
In the south façade the wood fiber panels of the façade go up to cover the front of the XPS panels of the roof.

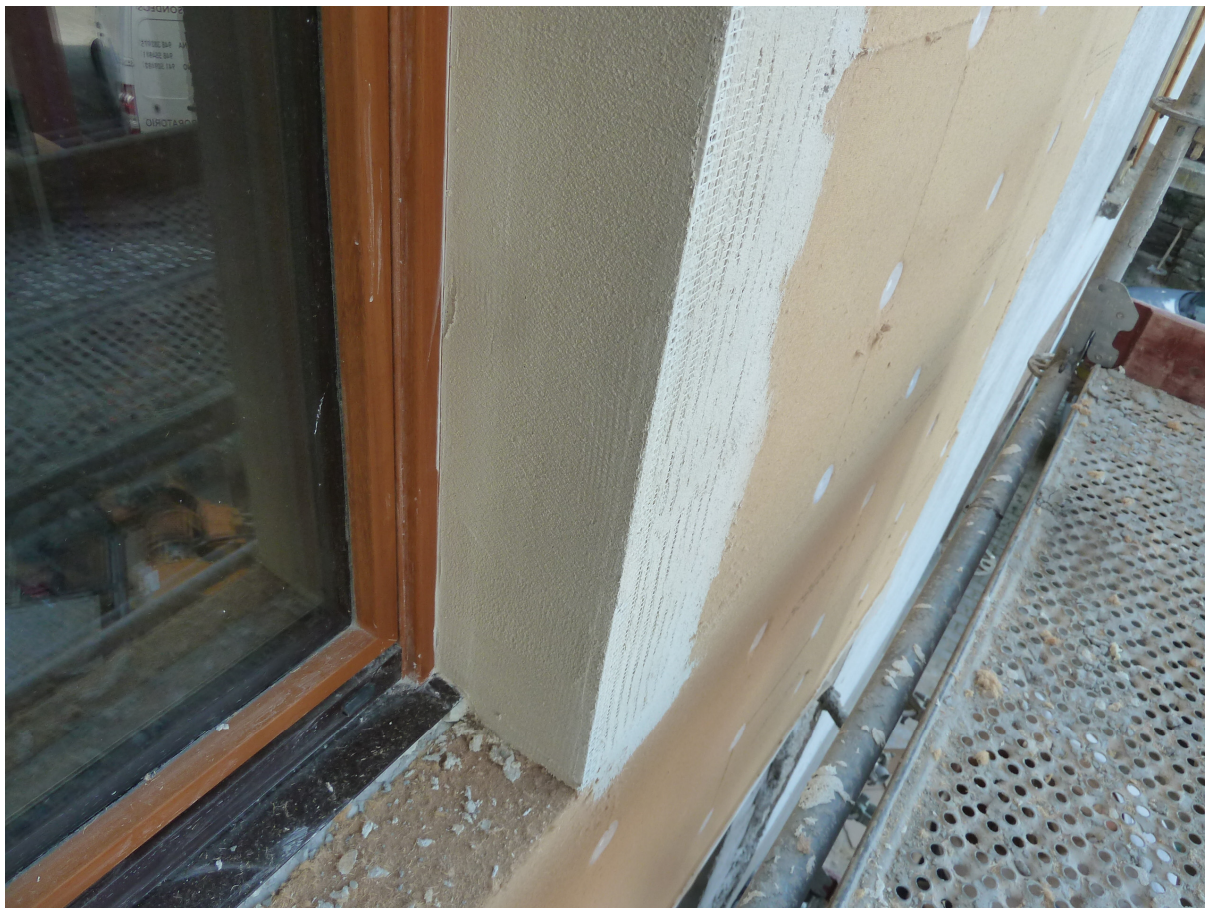
North façade windows are fixed to the brick wall. The exterior insulation overlaps the windows 'frame. In the inside the airtight is achieved with tapes fixed to the wooden frame and to the plaster of the wall.

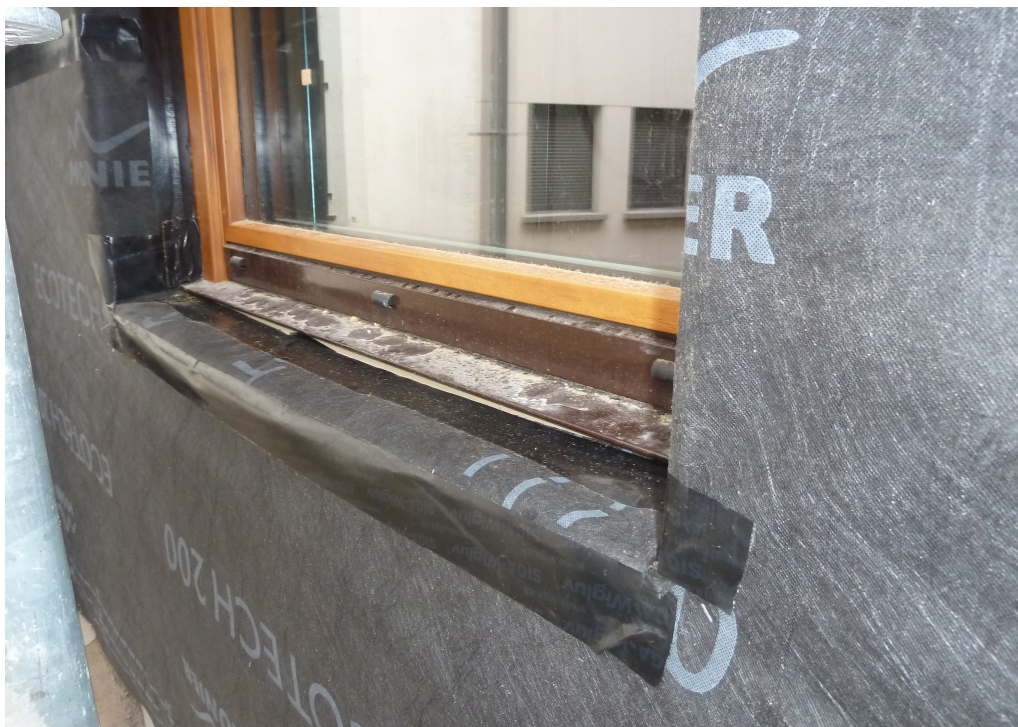
In the south façade the airtightness is solved in the same way, and outside the wooden strips of the ventilated façade overlap the windows frame and the waterproof sheet is fixed to the window frame.

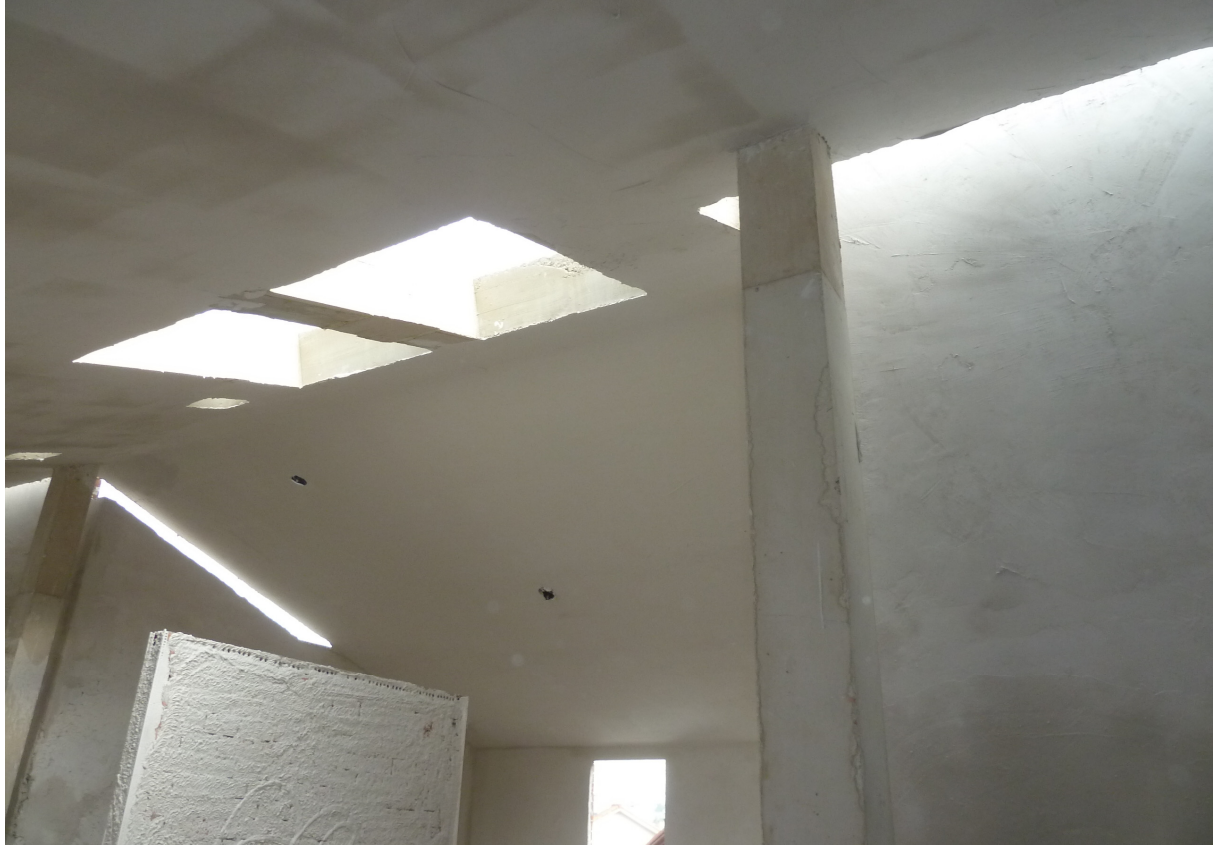
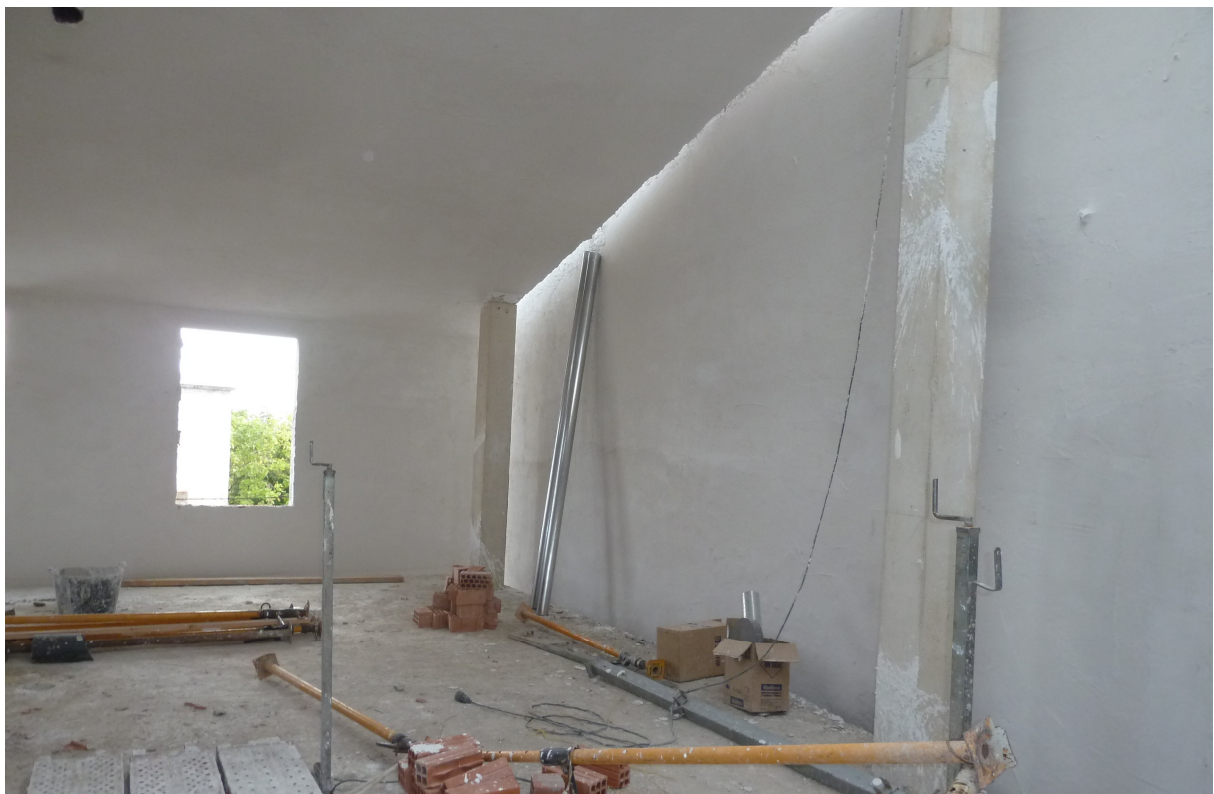
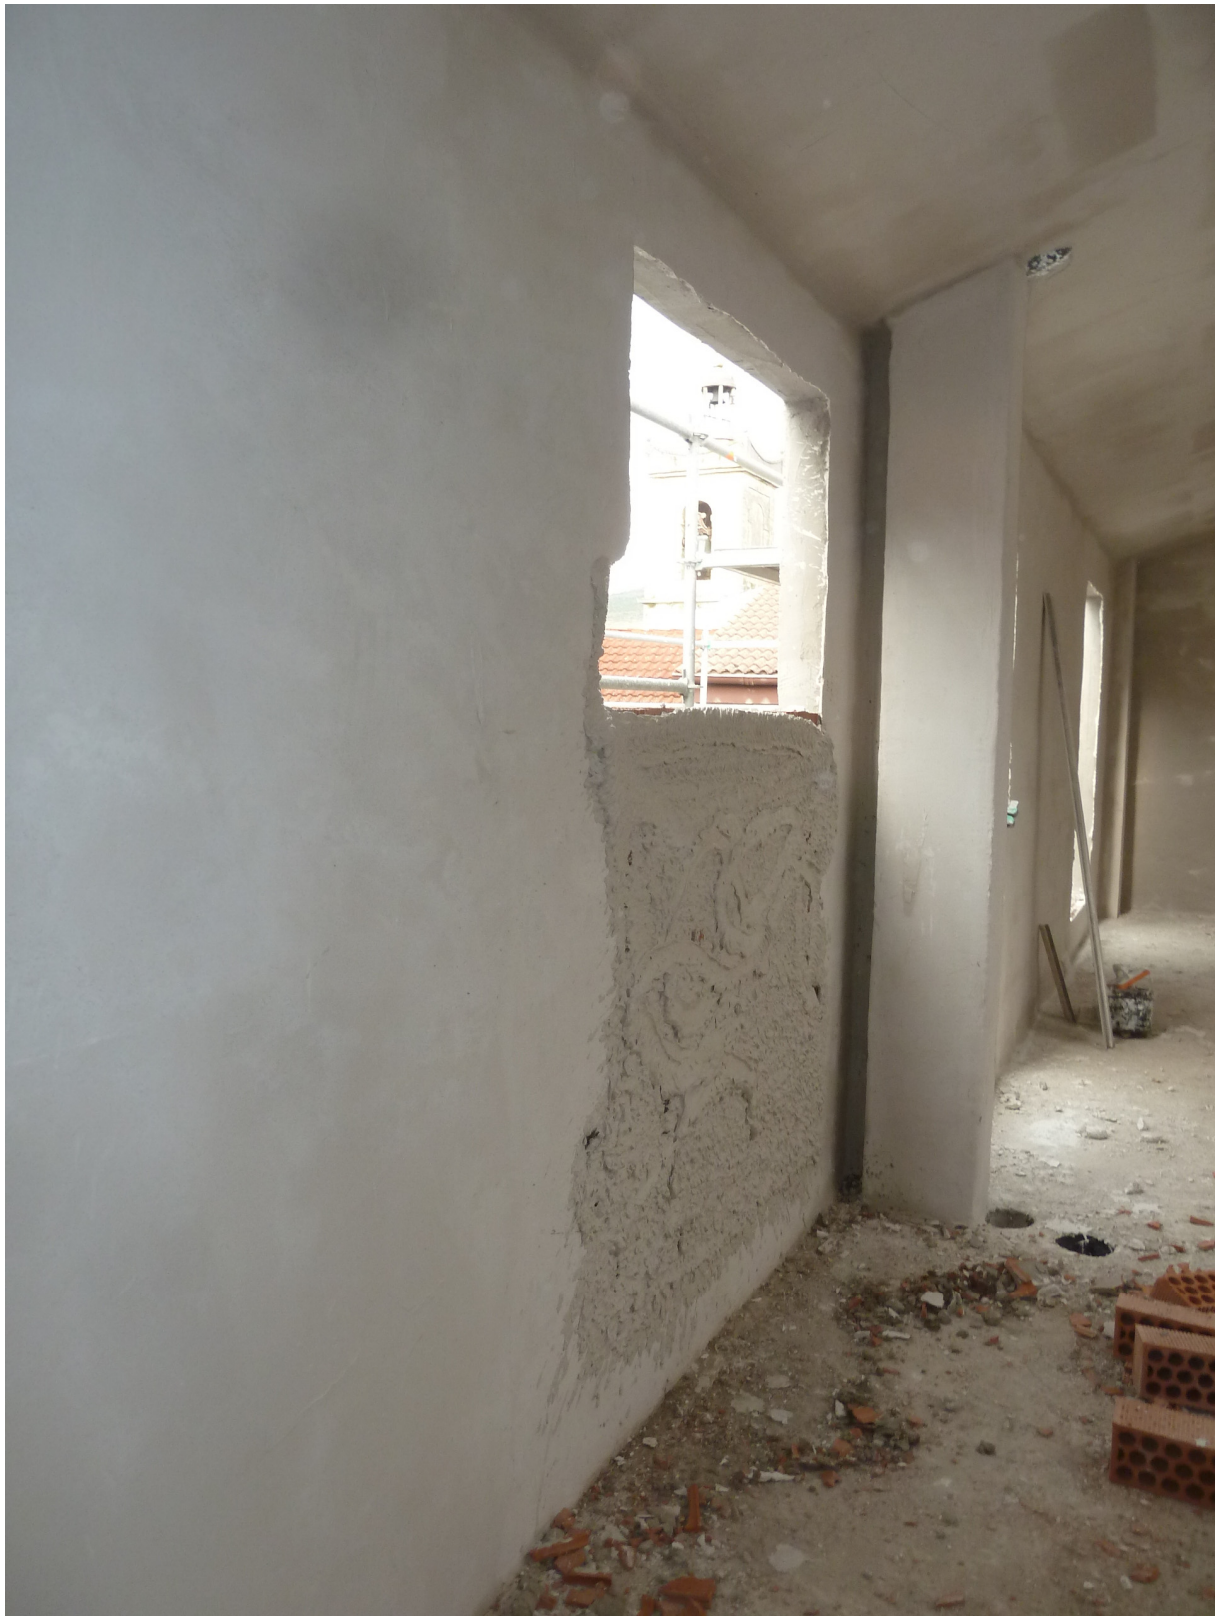
The airtightness is solved casting plaster over the brick walls and the concrete slabs of the roof and the basement ceiling. In the points where the continuity of the plaster is broken for the passing of the insulation special sheets are employed:

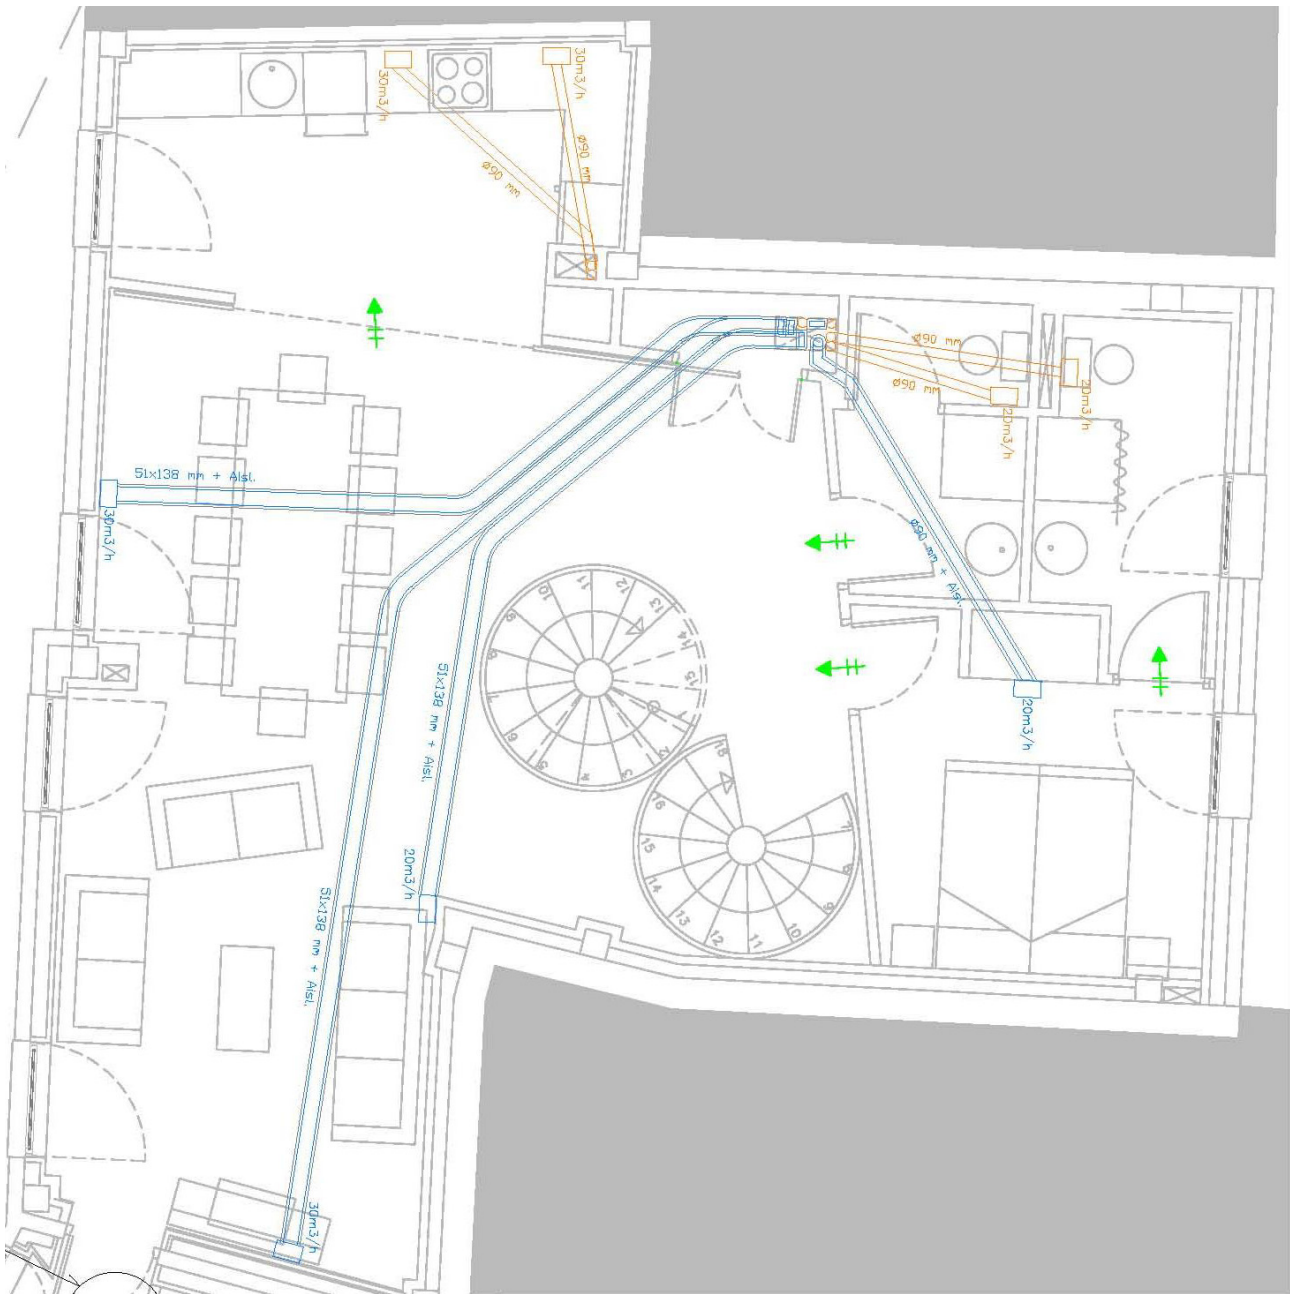
First floor plan. Supply ducts go through the ceiling of the floor to the living-room and bed-room. Extract ducts take air from bath-rooms and the kitchen.
