# Project Documentation

### House for rural tourism in Ibero, Navarra, Spain

### 2 Views of the Passive House in Ibero

### 3 Sectional drawing of the house in Ibero

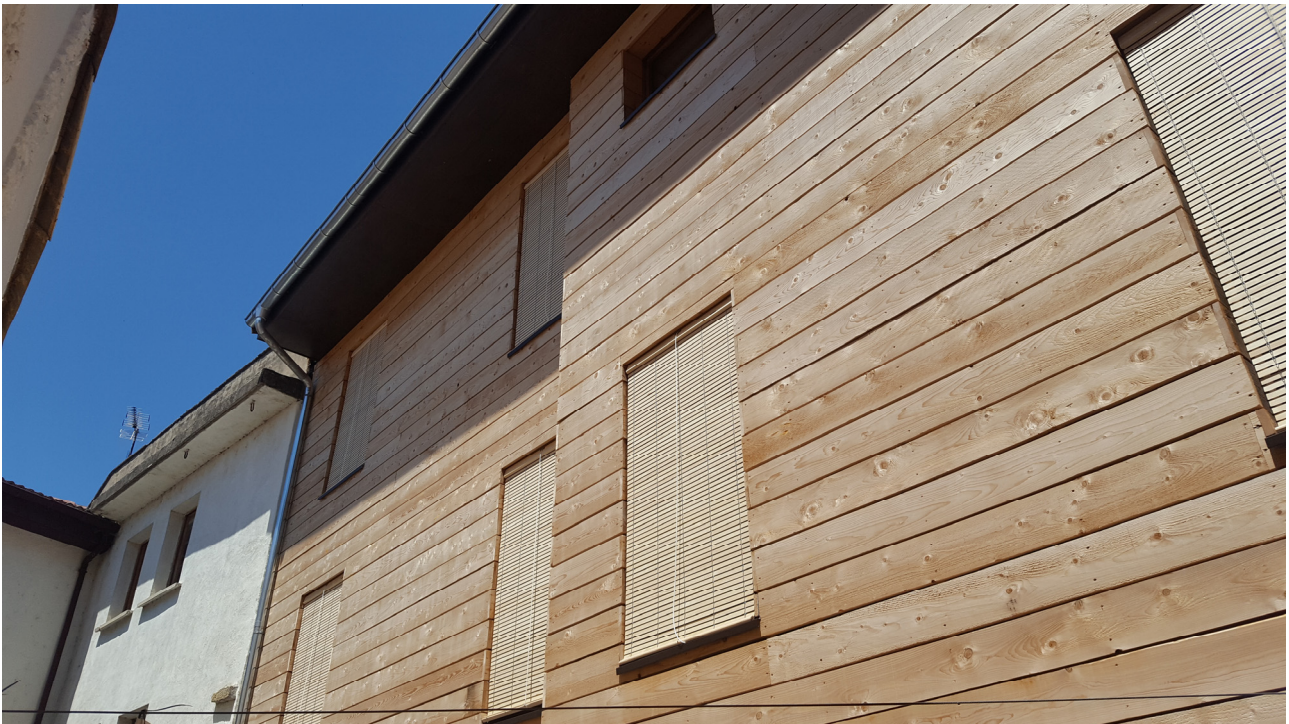
For the summer of 2017 exterior wood blinds were placed in the south windows of the north house:

This was enough to keep a low temperature inside the houses even though they were not occupied so windows were not opened during night time to do the free-cooling.

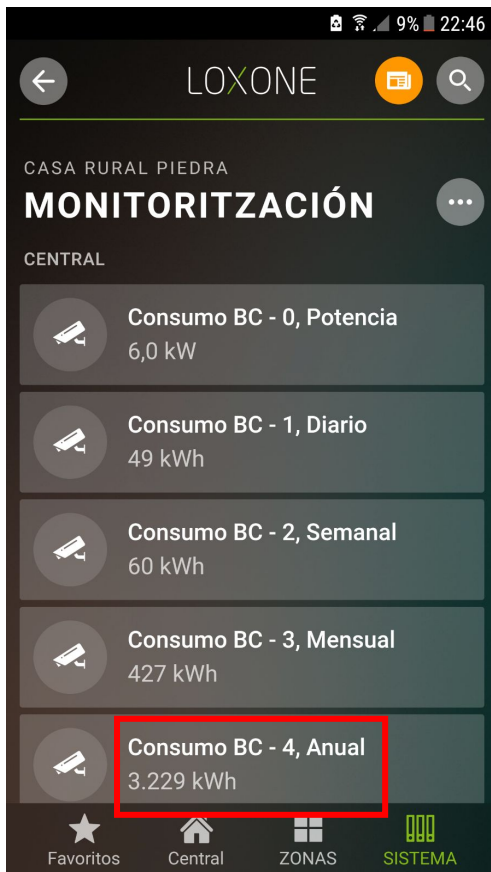
The electricity consumption of the air bomb (for hot water production) during one year was:

The reference surface of the house is 203,3 m<sup>2</sup>. So the annual consumption for square meter was:

$$3.229 \text{ kWh} / 203,3 \text{ m}^2 = 15,88 \text{ kWh} / \text{m}^2 \text{ per year}$$
