## Passive House Object Documentation

Project ID 4398

Two-family residence in Saanich, BC Canada

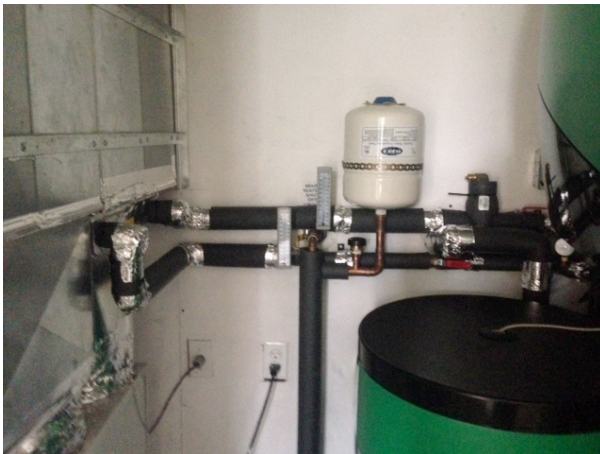
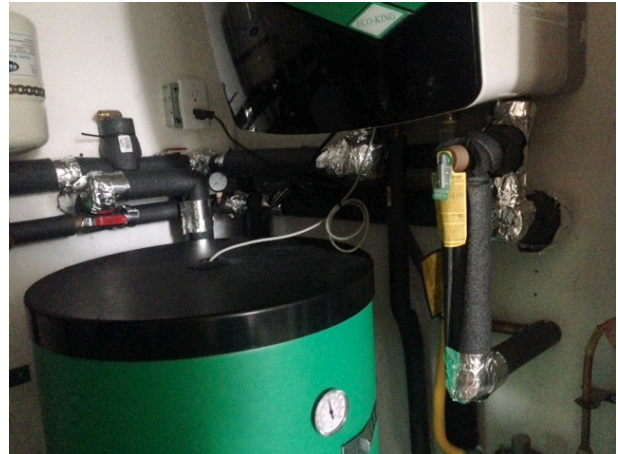
Hot water lines from boiler & storage tank to hydronic coils in HRV

The primary heat for the residence is a hydronic coil installed in the main HRV supply duct, upstream of the manifold. Hot water for the hydronic coil is supplied by the adjacent hot water storage tank, which is heated by a condensing gas boiler. The tiled bathroom floors have electric resistance heat mats under the tiles. There is no mechanical cooling. Exterior shade and a moderate climate make cooling unnecessary.
