Passive House Object Documentation

Project ID 4748

Six-Unit Condominium Victoria, BC Canada

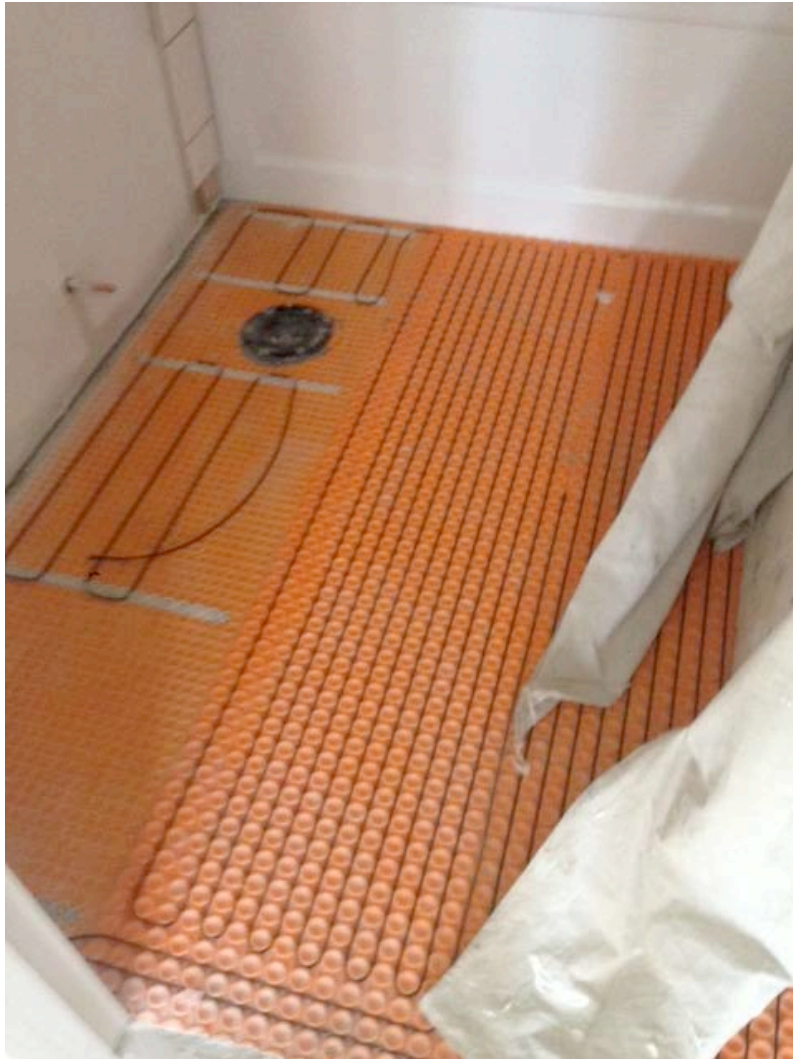
Heat Mat under Bathroom Floor Tile

The primary heat for the building is electric resistance heat mats under the tiled bathroom and entry floors. There is no mechanical cooling. Exterior shade and a moderate climate make cooling unnecessary.
