## 1.1 BUILDING DESCRIPTION:

Location: 2958 Princess Ave, North Vancouver, BC

Building Type: Single Family Residential - Retrofit

Certification Type: EnerPHit

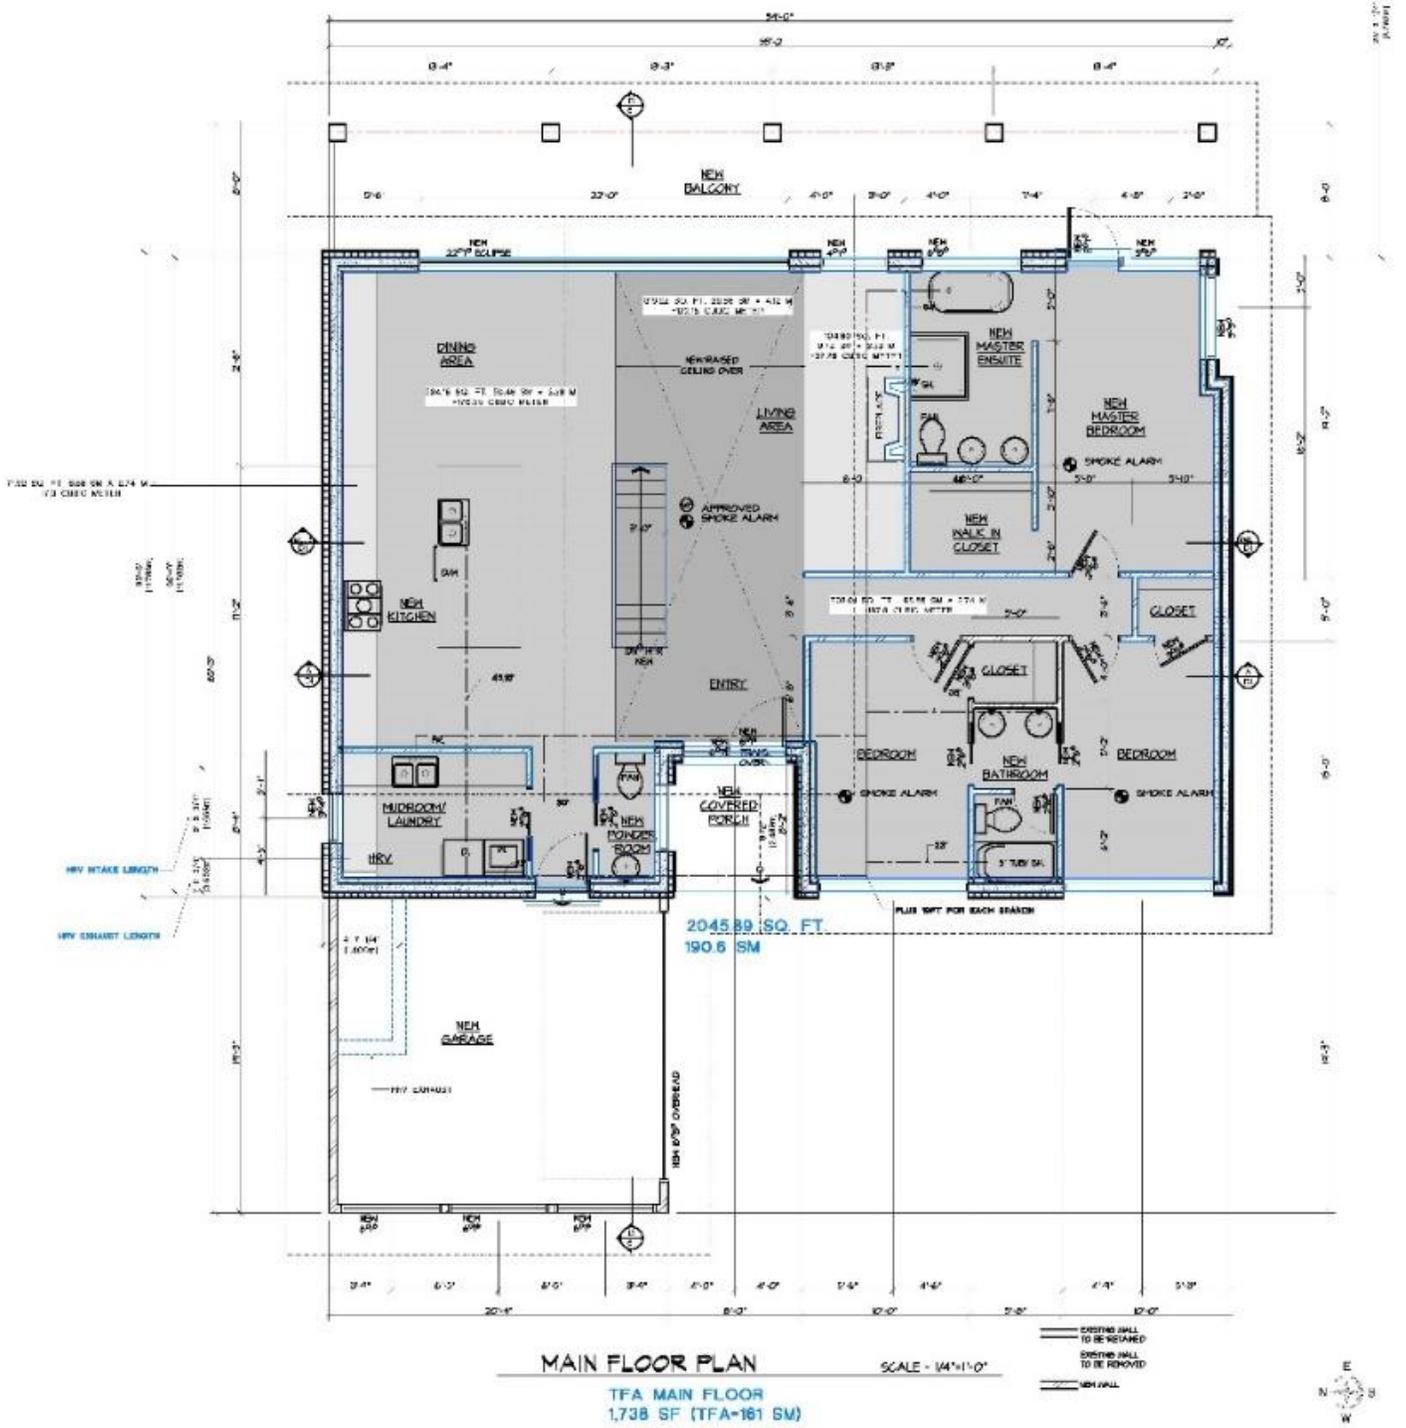
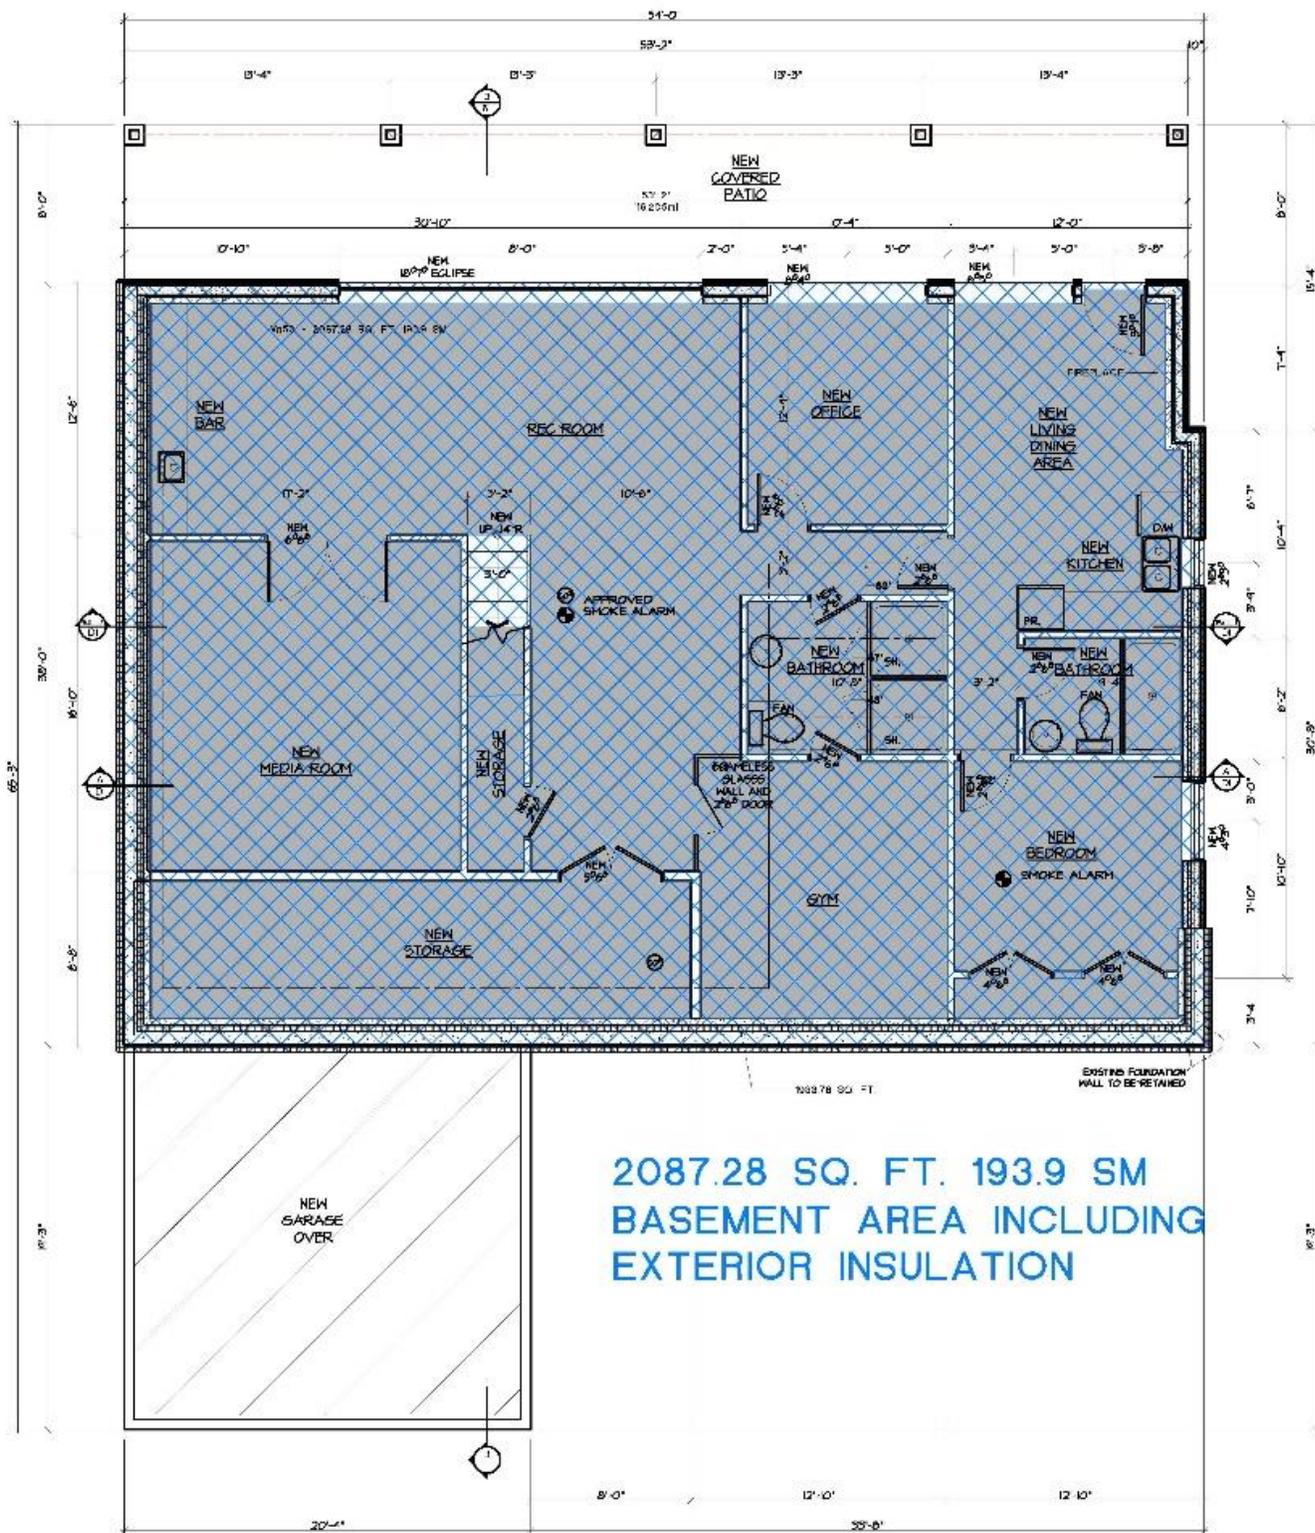
**BASEMENT FLOOR PLAN**

2087.28 SQ. FT. 193.9 SM  
 BASEMENT AREA INCLUDING  
 EXTERIOR INSULATION

**TFA BASEMENT**  
 1757.39 SQ. FT. (163.27 SM)

- EXISTING HALL TO BE RETAINED
- EXISTING HALL TO BE REMOVED
- NEW HALL

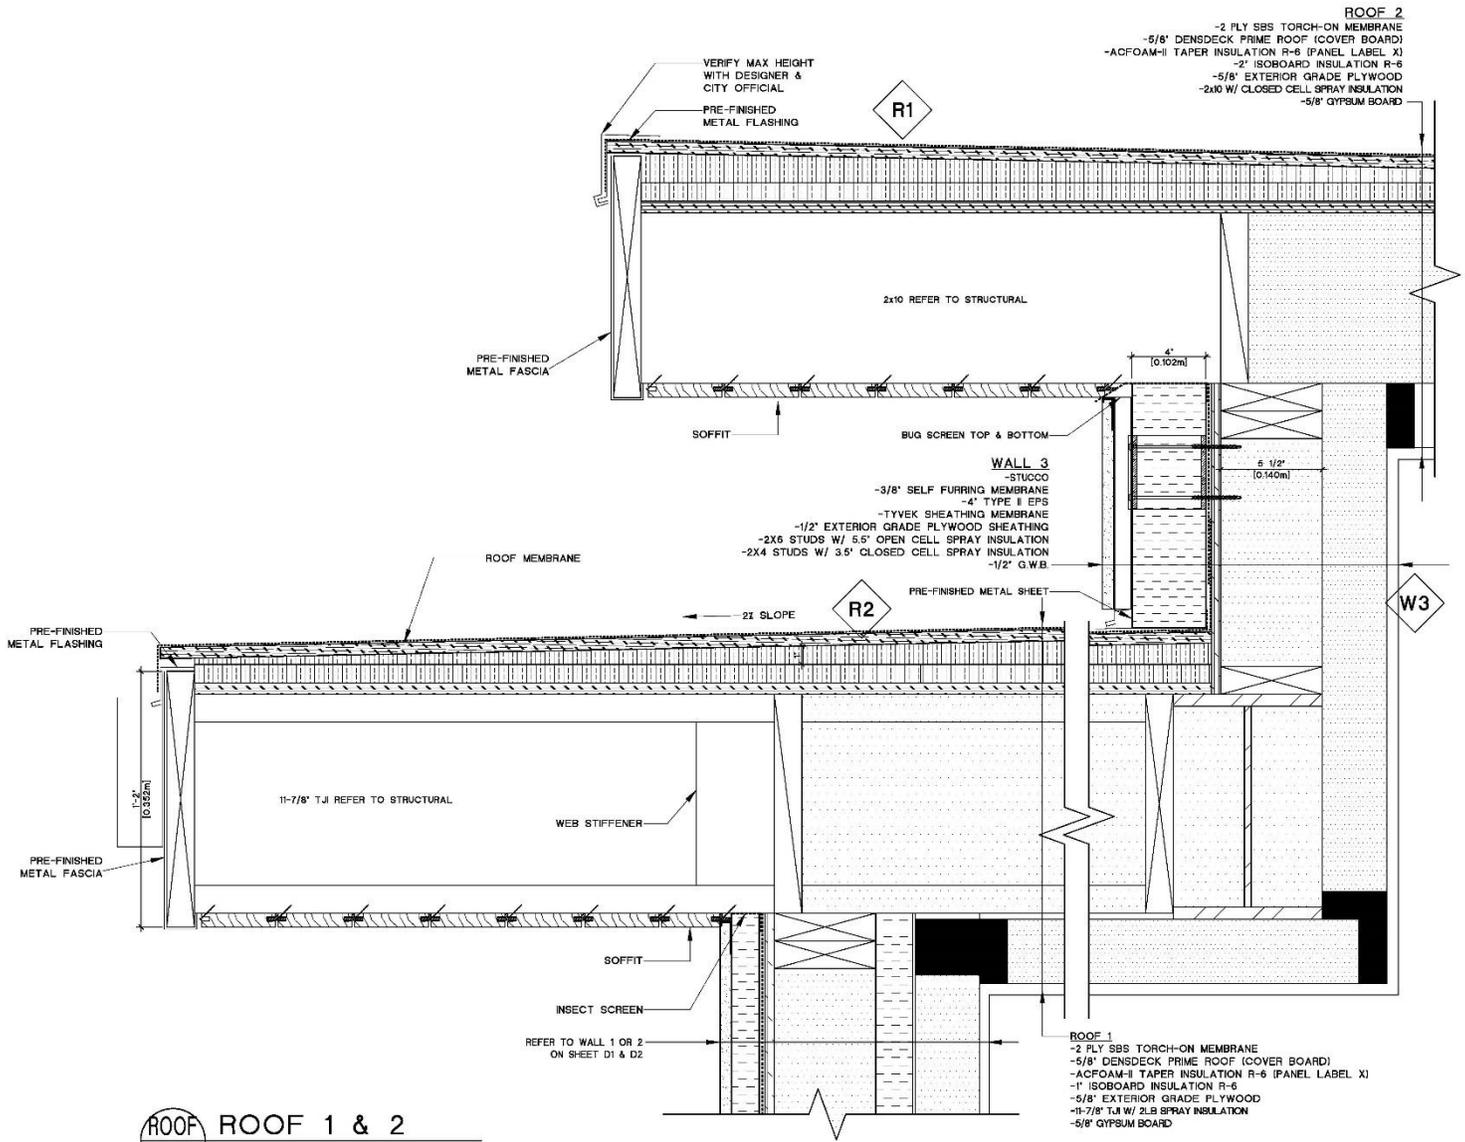
Steel I-beam was specified by Structural Engineer to support the upper roof. This detail show 2x4 furring below the I-beam as well as inside face with closed cell insulation. Type 2 EPS provided over the roof. Closed cell insulation sprayed within roof joist. This was analysed in THERM and was thermal bridge free.

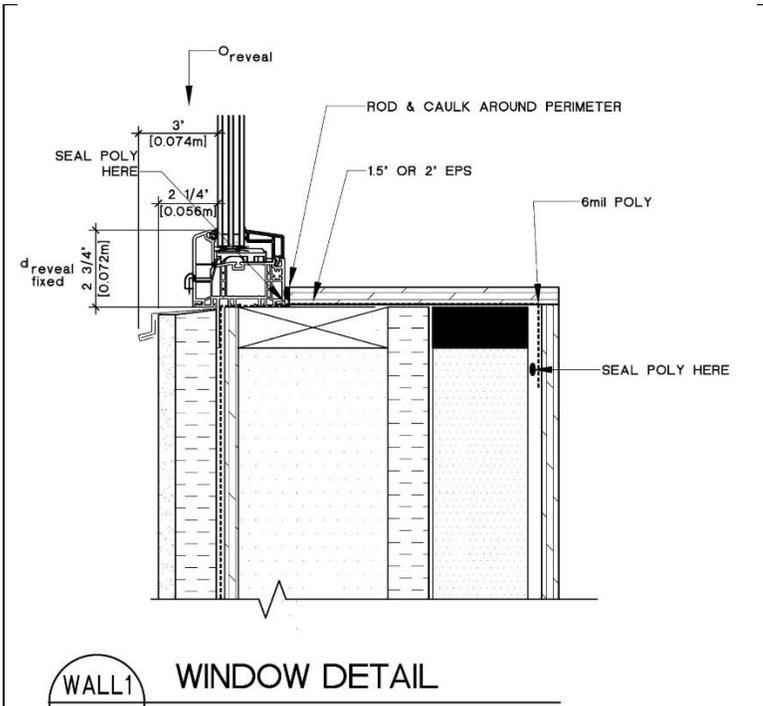
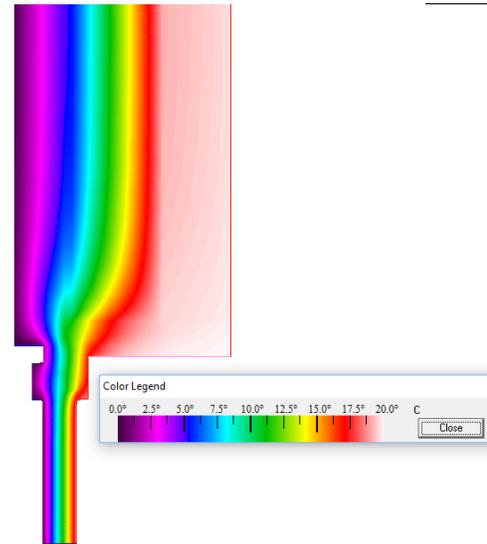
EuroLine 4700 Series, ThermoPlus PHC triple pane windows were used with PVC frame with insulation fillings of expanded polystyrene (0.031 W/(mK)).

U-value frame 0.78 W/(m<sup>2</sup> K)

Solar factor (g) 0.55

Pane thickness: 44 mm (4/16/4/16/4), spacer: Super Spacer TriSeal / T-Spacer Premium

The window U-values were calculated for the test window size of 1.23m \_ 1.48m with U<sub>g</sub> = 0.70 W/(m<sup>2</sup> K).

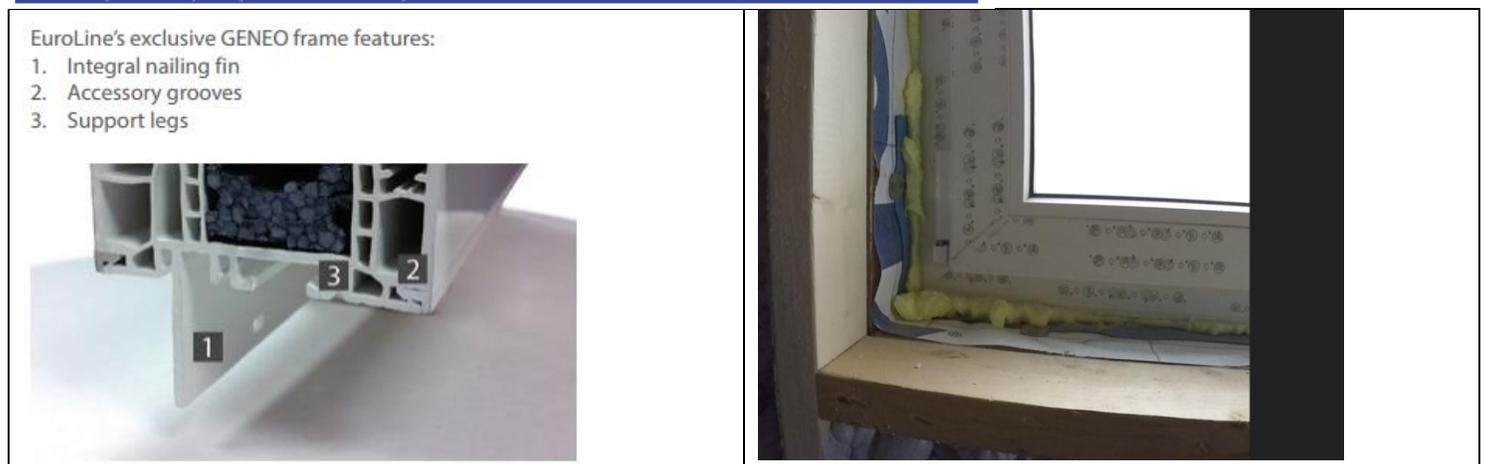
The integral nailing fin is welded together with the rest of the frame, making it air and water tight, and much stronger than a snapped-in or glued-on fin could be.

Grooves on the exterior and interior of the frame allow for easy snap-in installation of brickmoulds, drywall returns and other accessory profiles – they also aid in the connection of mullied units, as cover caps can be snapped into the grooves, further strengthening the connection.

Support legs transfer the load of the unit onto the sill of the window opening through shimming and are designed in such a way that strap anchors can be fastened without having to screw them into the frame. The flat surface facilitates proper application of rod and caulk.

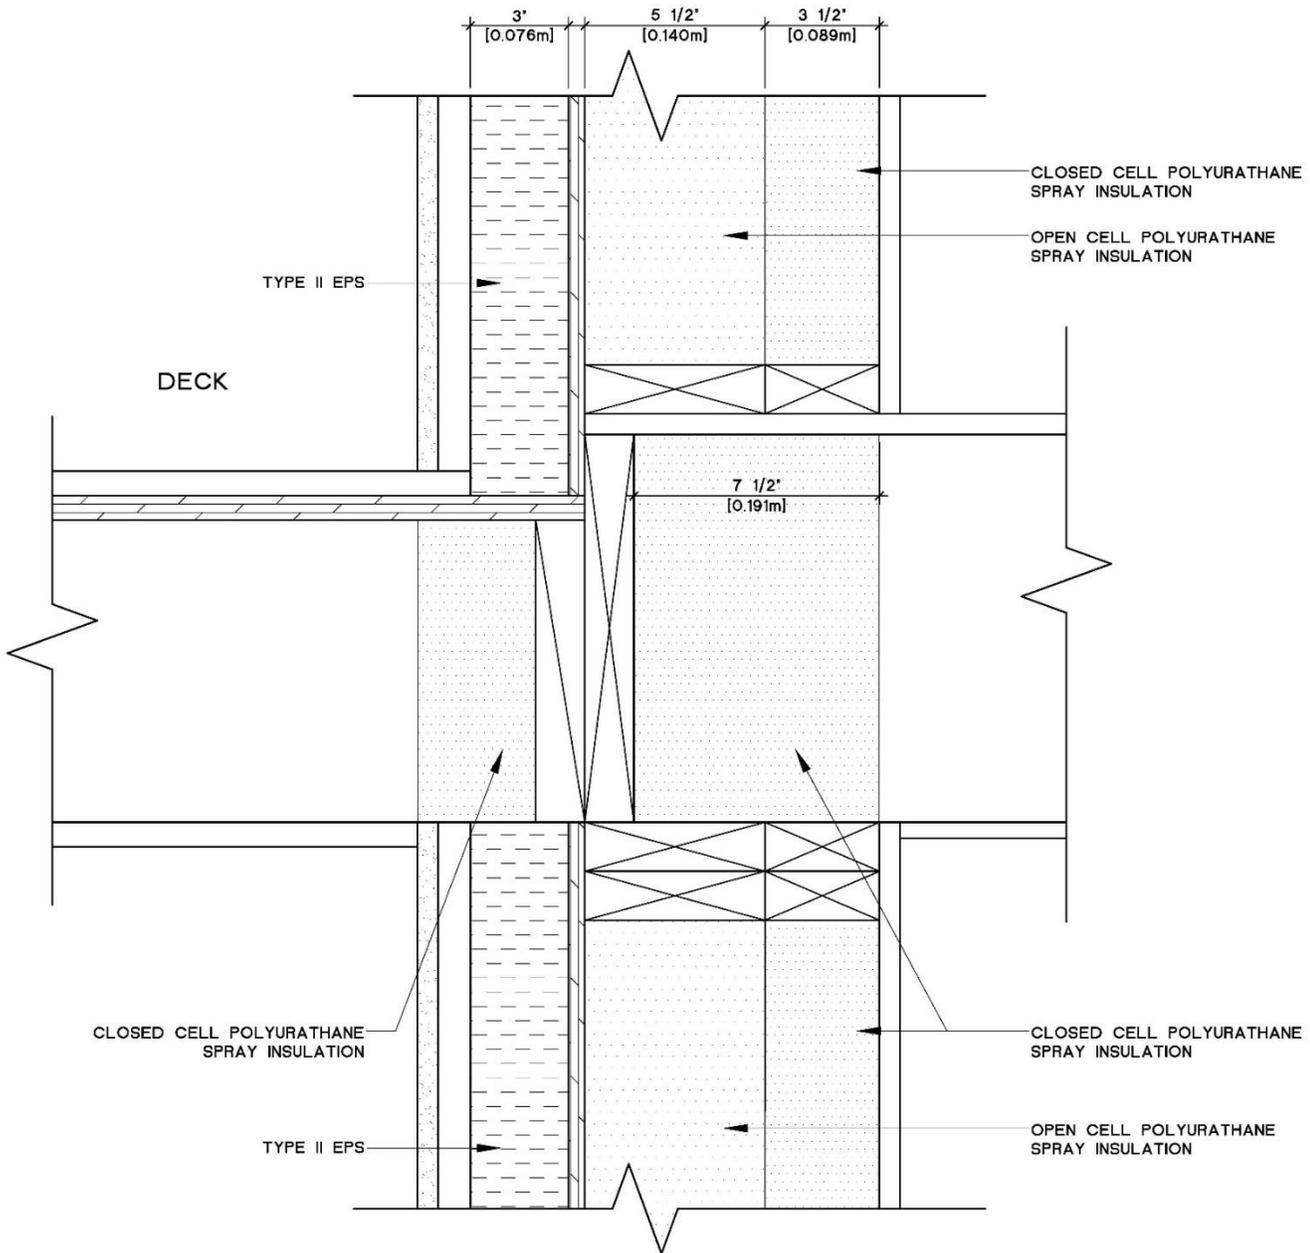
## BALC. DETAIL @ BALCONY

Spray foam insulation had been specified to avoid condensation on the rim joint. This also helped mitigate thermal bridging. The 2x6 exterior wall framing and the 2x10 floor joist are existing. Type 2 EPS has been provided on the exterior plywood and 2x4 with open cell insulation provided on the interior side.

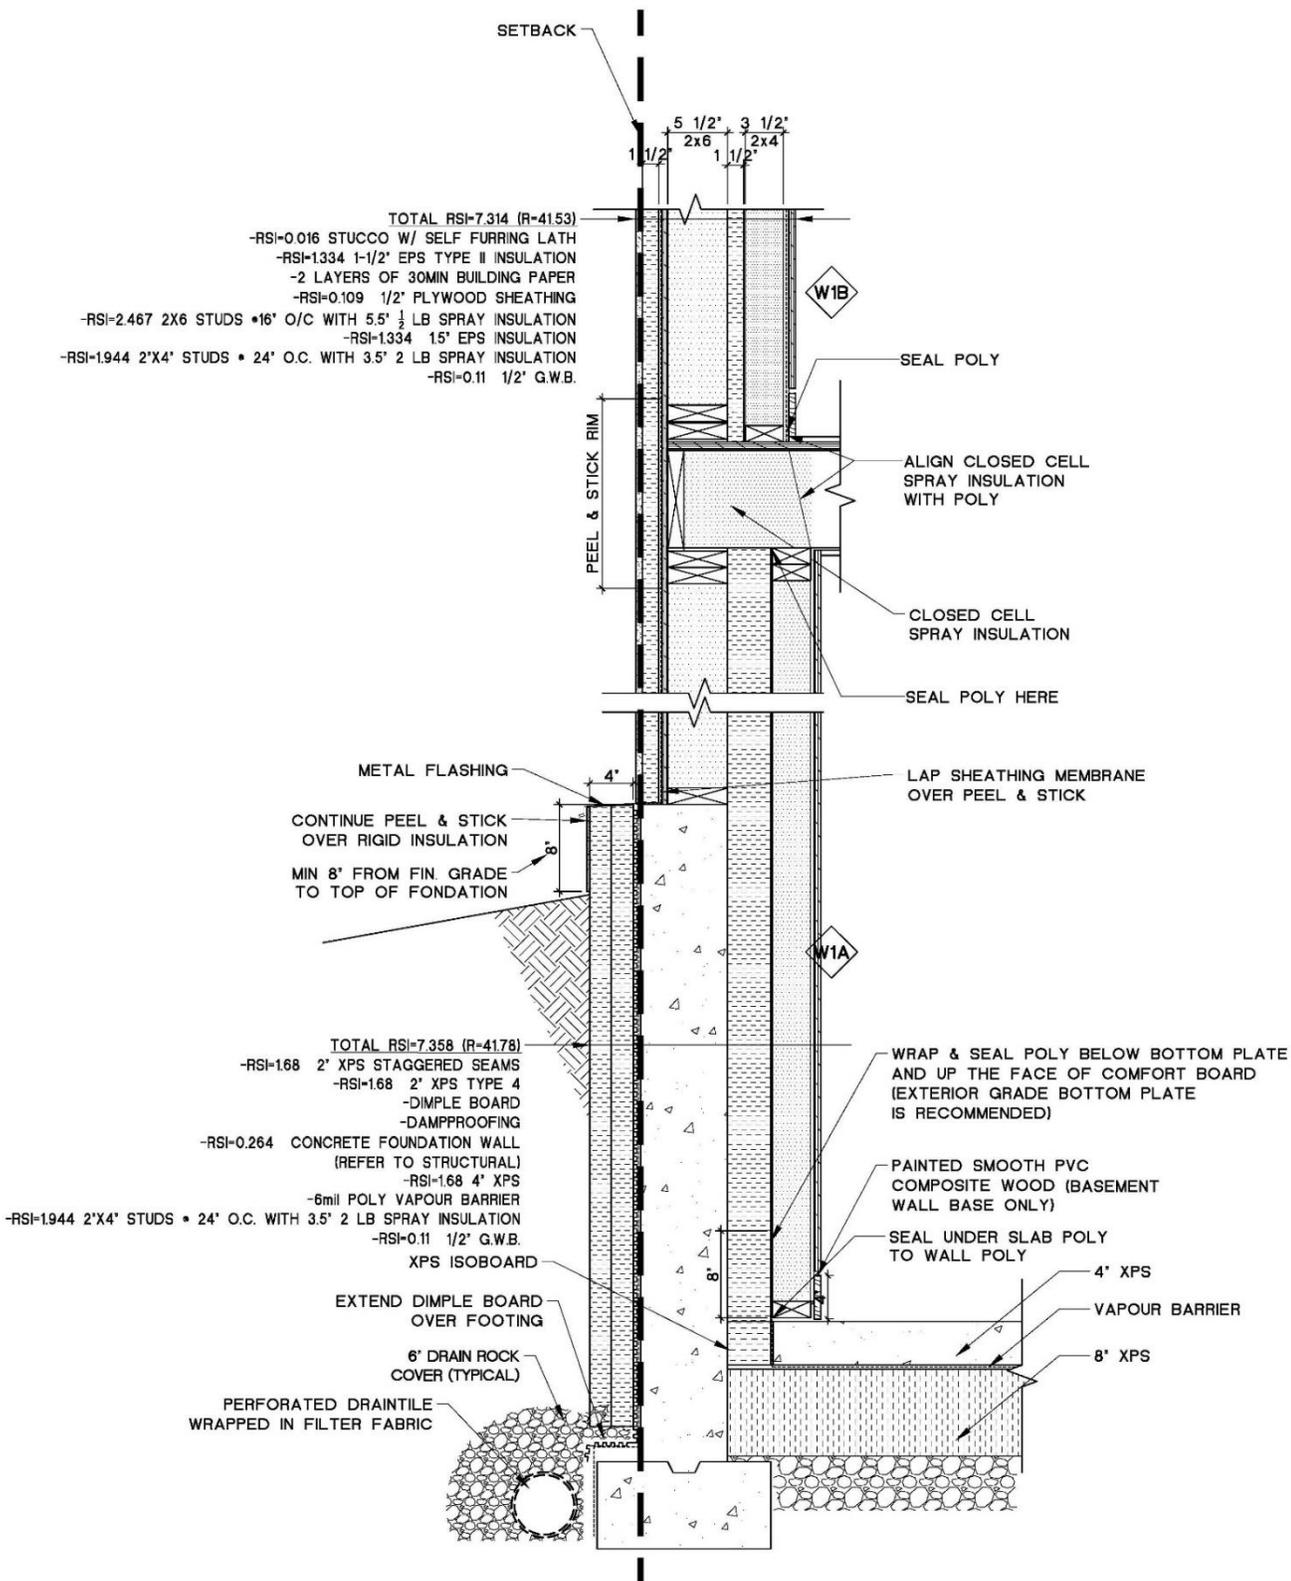
**WALL1 EXTERIOR WALL AT SETBACK**

U-Value 0.122 W/(m<sup>2</sup>K) This is the south side wall detail which was almost against the required setback, 1.5" EPS was the thickest insulation the city allowed to avoid setback encroachment. However, 4" Type 2 EPS were provided on the remaining exterior walls. The City did allow 4" XPS along the foundation and 8" above grade. The U-Value of slab on grade is 0.122 W/(m<sup>2</sup>K) and the foundation wall is 0.107 W/(m<sup>2</sup>K).

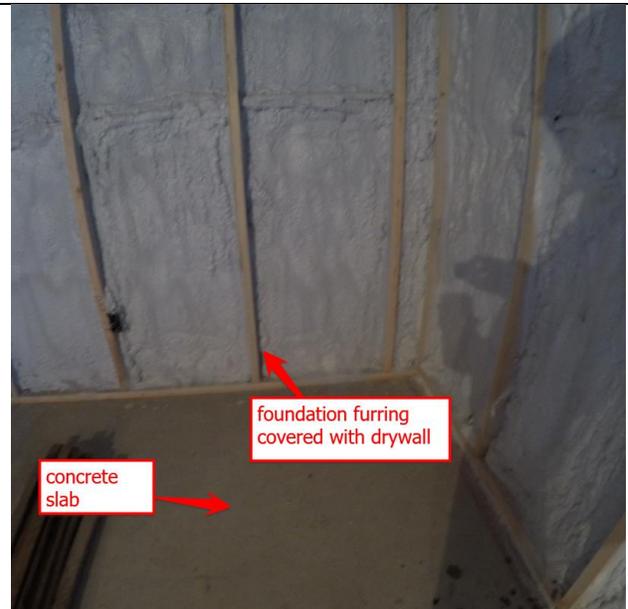
100mm concrete slab on poly vapour barrier on 200mm Extruded Polystyrene. There are no floor overhangs. Vapour barrier was sealed and taped to wall poly between 2x4 service wall and 100mm extruded polystyrene.

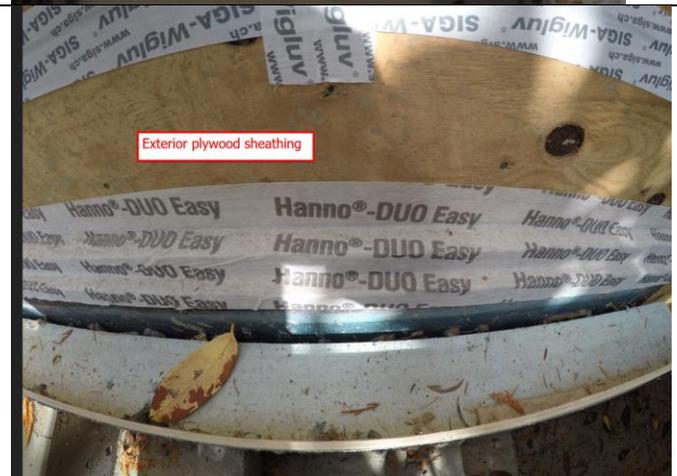
Exterior plywood sheathing were taped. The main concern was the rimjoist, which was sealed wit polyurethane spray insulation. 6mil Poly vapour barrier used on the warm side of walls. Drywalls applied on all interior wall surface from top of concrete slab or subfloor to underside of ceiling and floor joist. Drywalls were also taped and sealed.

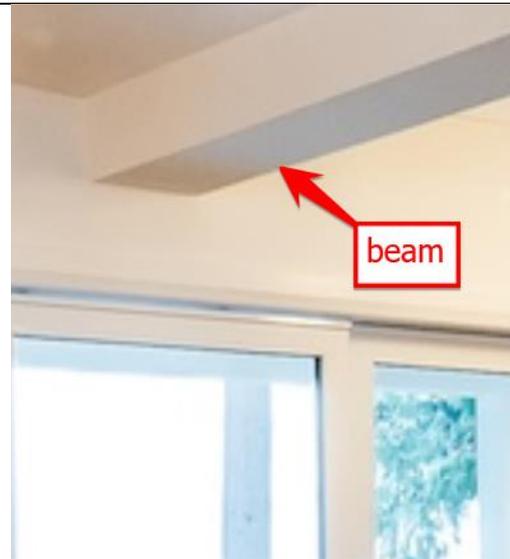
6mil UV poly vapour barrier used on warm side of ceiling. Poly was taped and sealed to wall poly. Drywall were taped and sealed.

Basement ceiling was covered with similar manner.

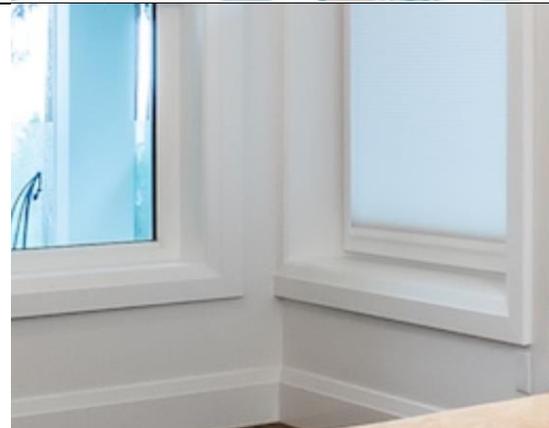
The window frame are sealed with polyurethane spray, rod and silicone caulk to the perimeter framing. 6mil poly vapour barrier sealed to sheathing air barrier. Window opening were covered with 12.7mm drywall.

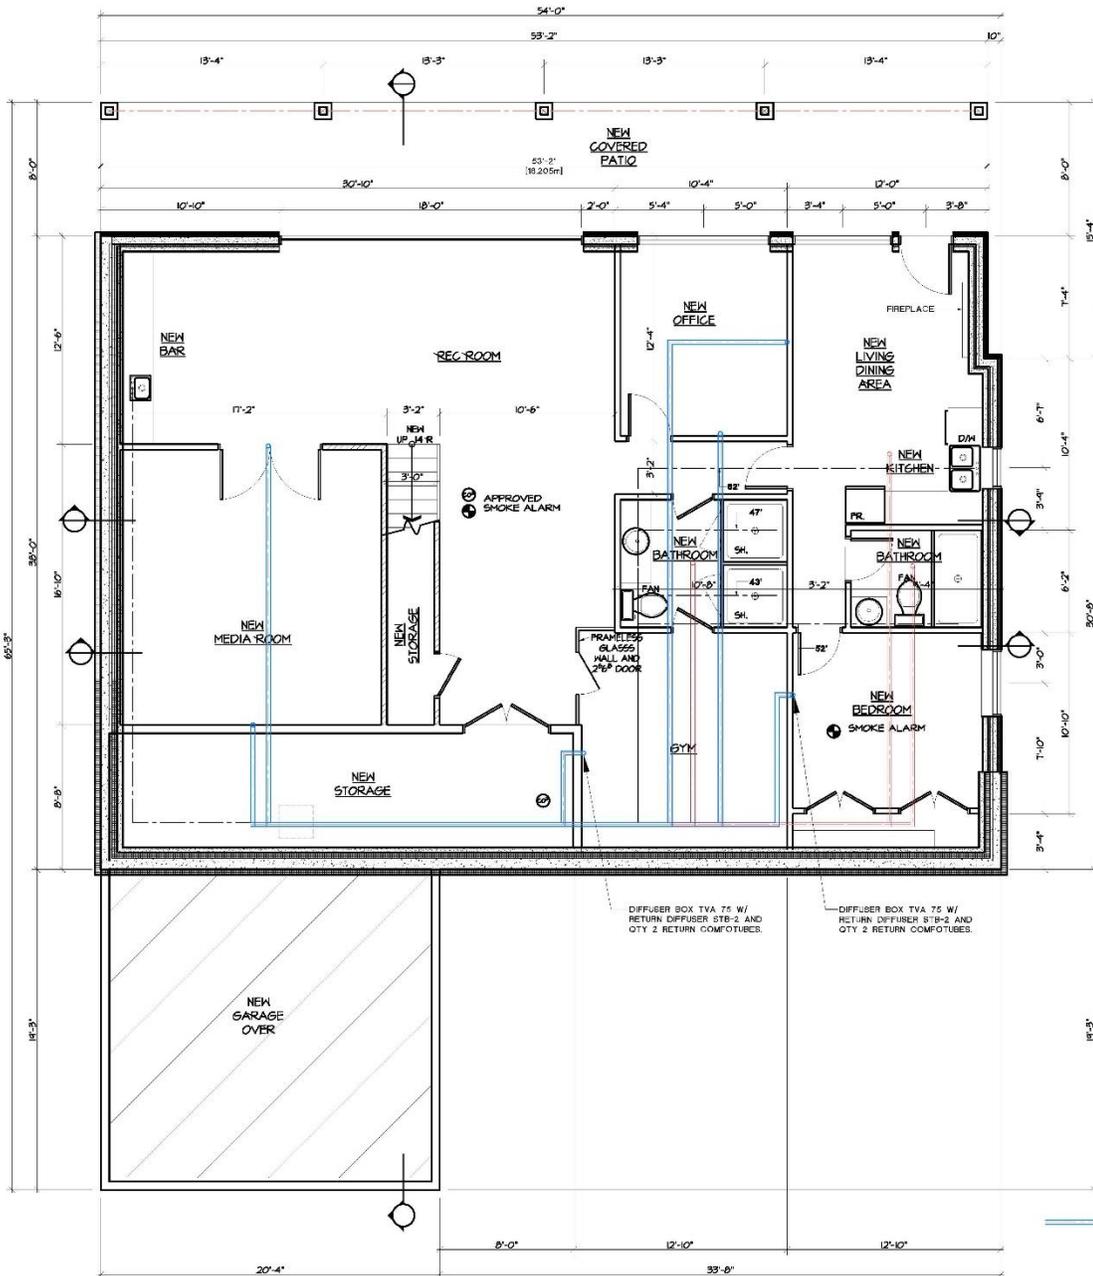
**BASEMENT FLOOR PLAN - DUCT LAYOUT** SCALE - 1/4"=1'-0"

SUPPLY. NOSING NEAR TOP OF WALL FOR COANDA EFFECT  
 DIFFUSER BOX TVA 75 W/ SUPPLY DIFFUSER KE125 AND 2 SUPPLY COMFOTUBES.

EXTRACT  
 DIFFUSER BOX TVA 75 W/ RETURN DIFFUSER STB 2 AND QTY 2 RETURN COMFOTUBES.

Heat recovery ventilator (Comfoair 550) was use of up to 324 cfm with 83.4% efficiency with an electric power consumption of 0.31 Wh/m<sup>3</sup>. 75mm insulation used to wrap both exhaust and intake duct. To reduce thermal bridging, exhaust duct was placed through interior wall between PH envelope and semi heated garage. Air transfer takes place through 1" air gap between floor and bottom of doors.

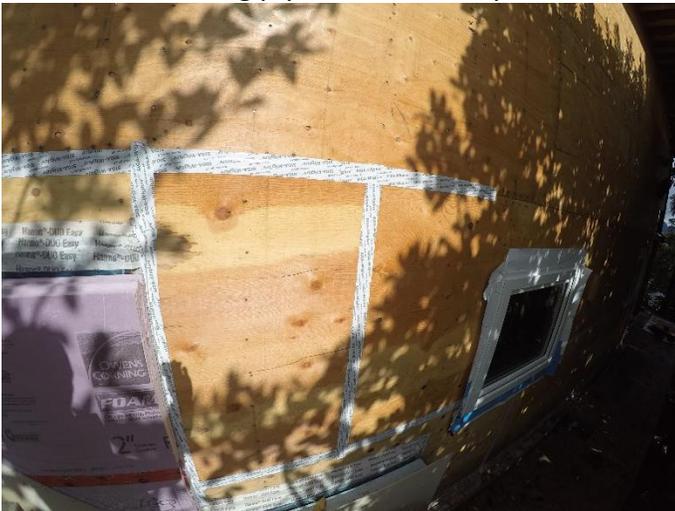
South side showing plywood seams taped
