2740/42 Fifth St Passive House aka “Urban Green”

Project Documentation

New residential duplex, constructed in 2017, in Victoria, BC (Canada)

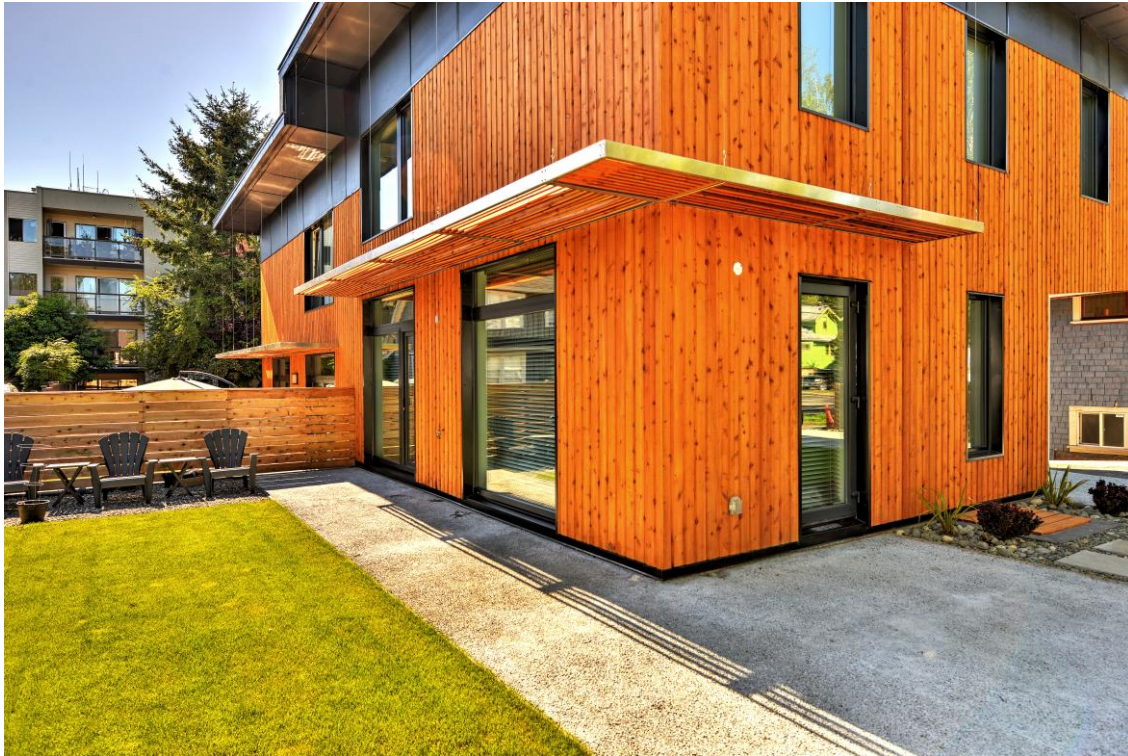
South West; building shading element highlighted. Pervious concrete used for all paved surfaces.

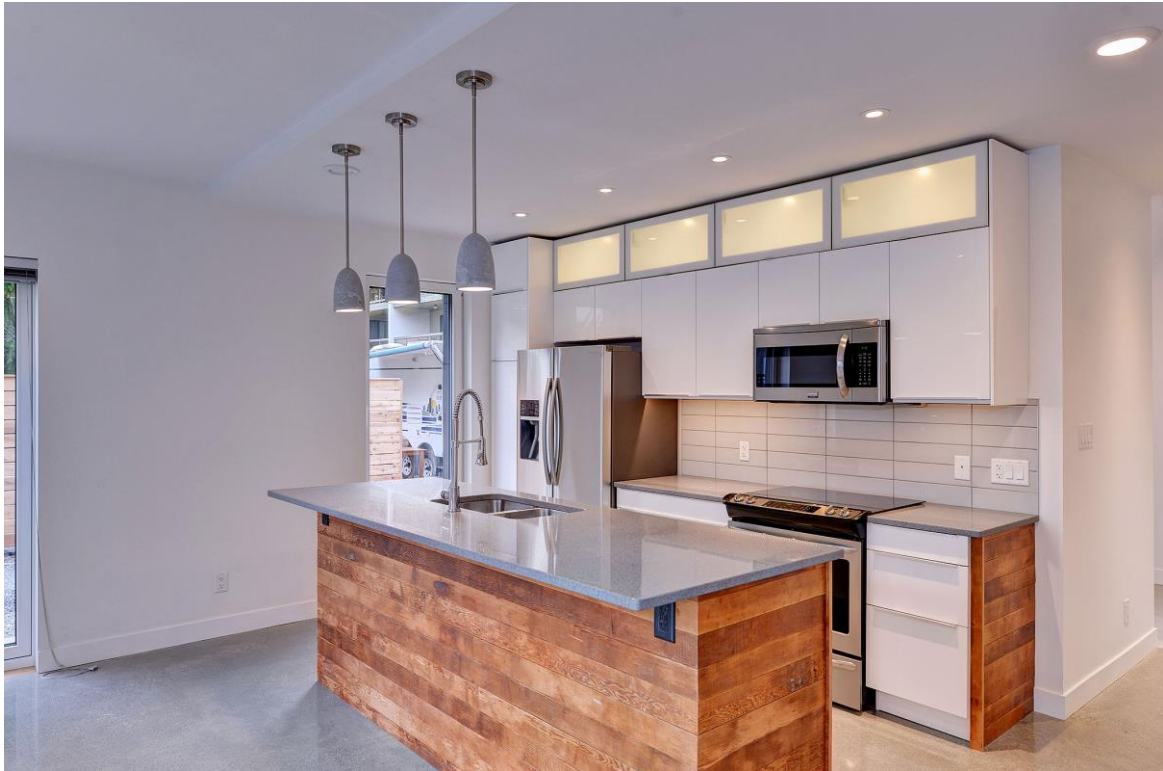
East unit kitchen; re-used demolished building's subfloor for kitchen trim.

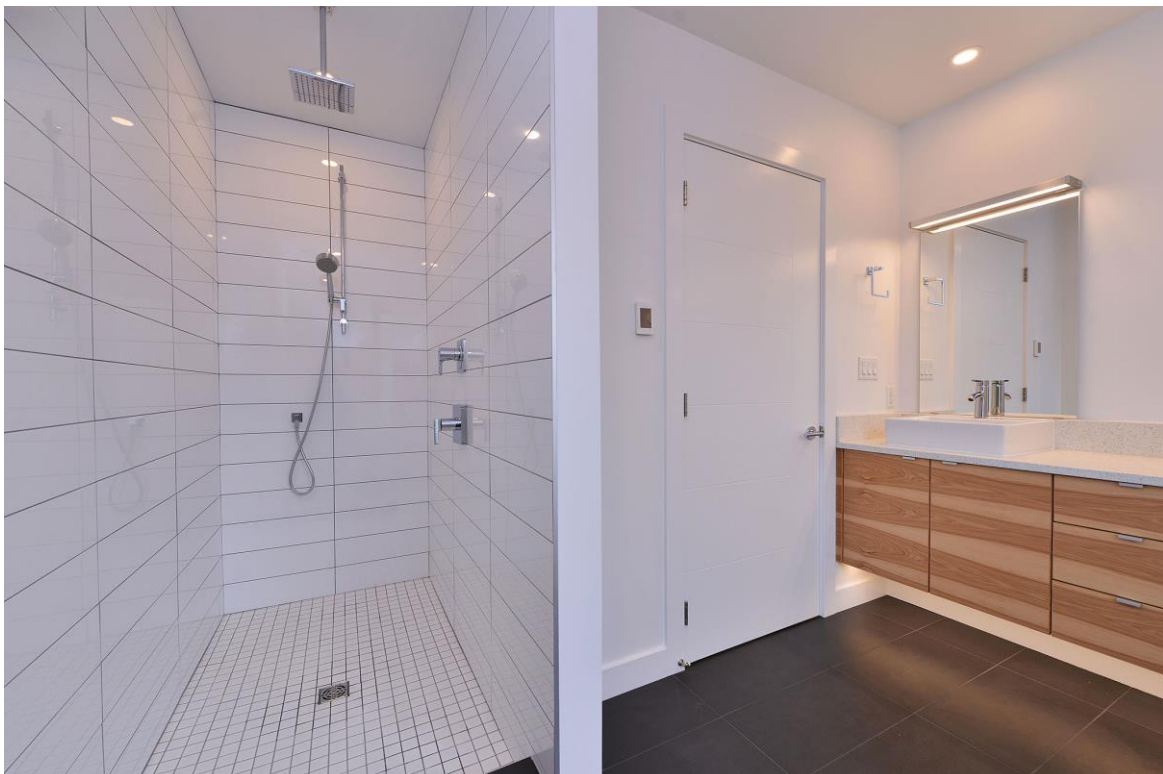
East unit master ensuite bathroom; electronic heated floors controlled by smart unit provide majority of active heating system.

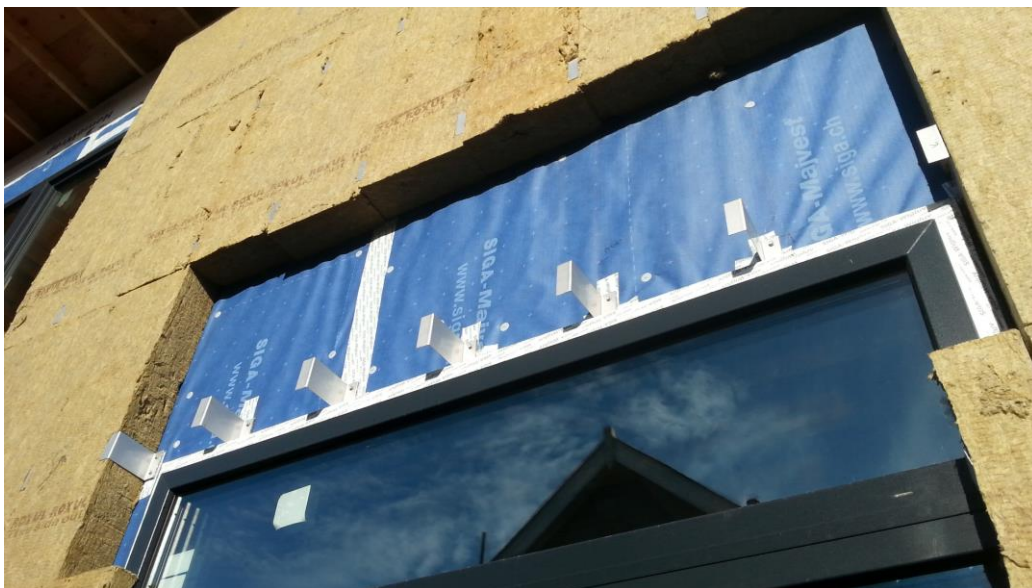
Z-grit clips and insulation. The clips proved easy to install, and didn't create any air leakage during testing. They are a sturdy base for the cedar & cement fibreboard cladding.

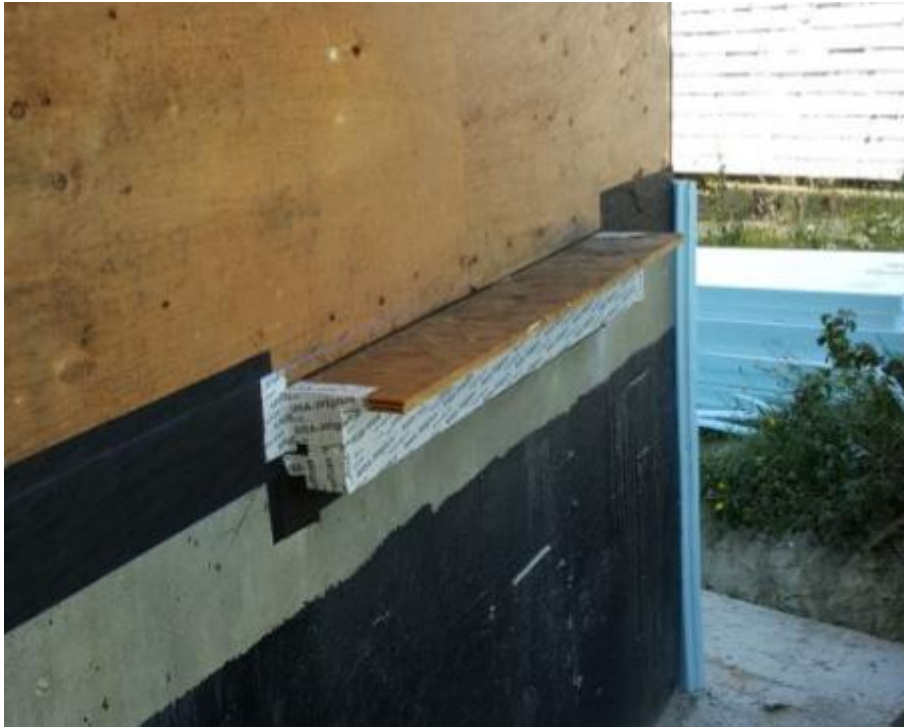
Sills for floor to ceiling windows and doors received notches in the concrete, which were framed with plywood and filled with XPS insulation. This prevented the fenestration units from being framed onto concrete foundations, thus minimizing Psi-values.

All window & door headers & jambs were overlapped with exterior insulation. 2D THERM modelling was done, and yielded a Psi-value of 0.006 W/(m²*K).

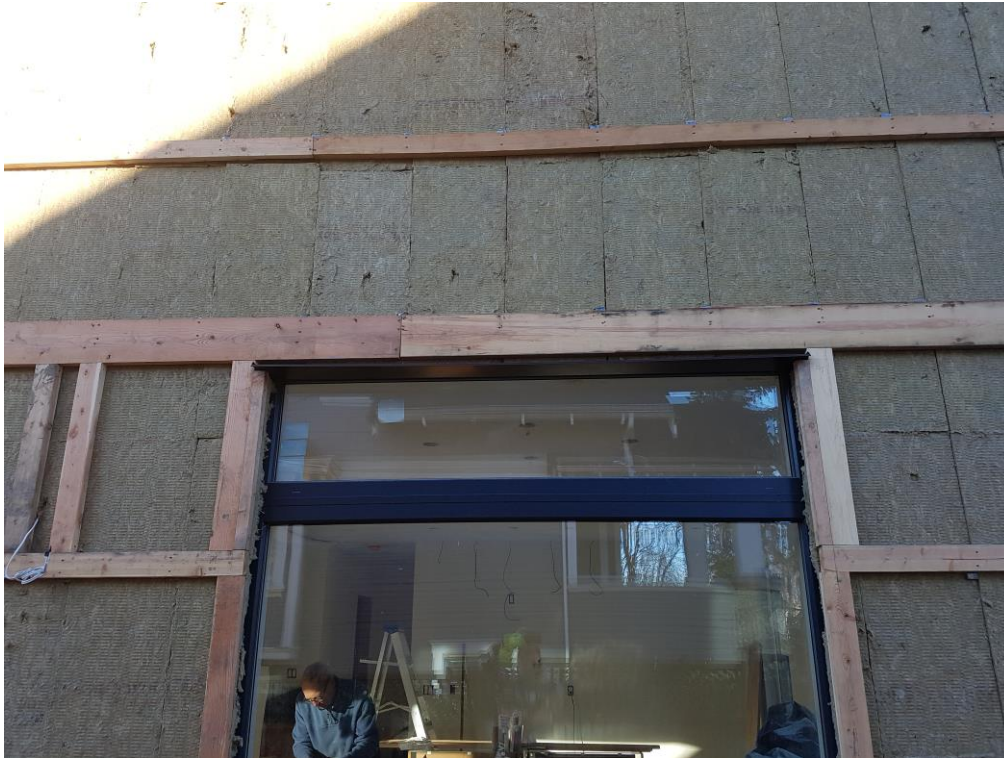
West unit dining room window, pre cladding. Framing around windows protected insulation and provided support from metal window trim.

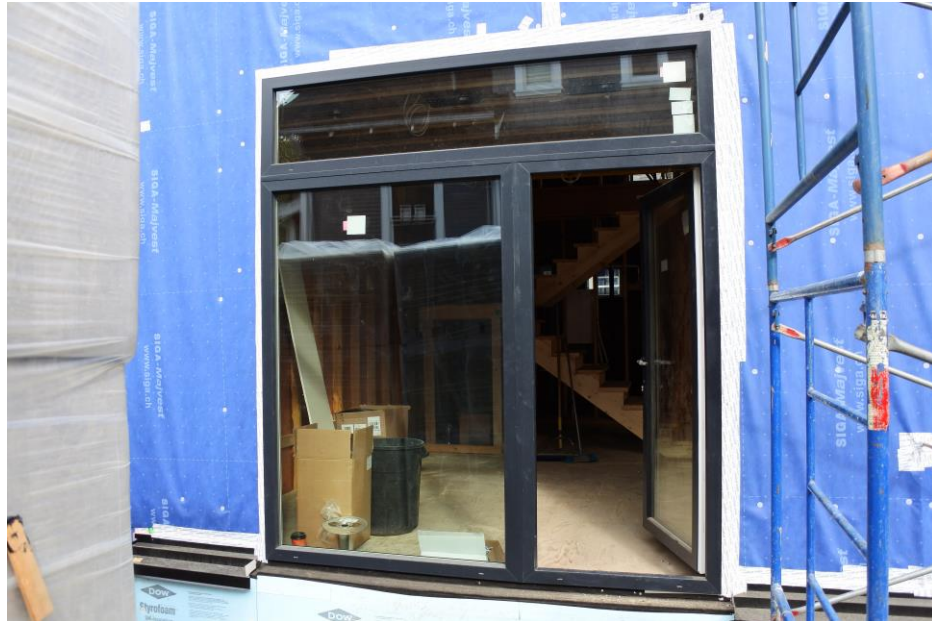
East unit living room window. All window swing and tilt inward.

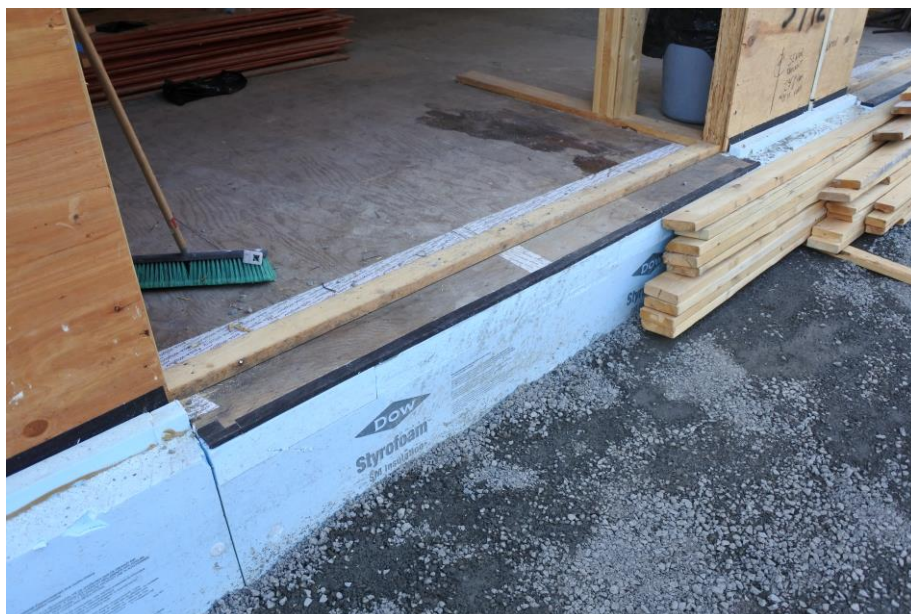
Window sill rough framing at foundation buck assembly.

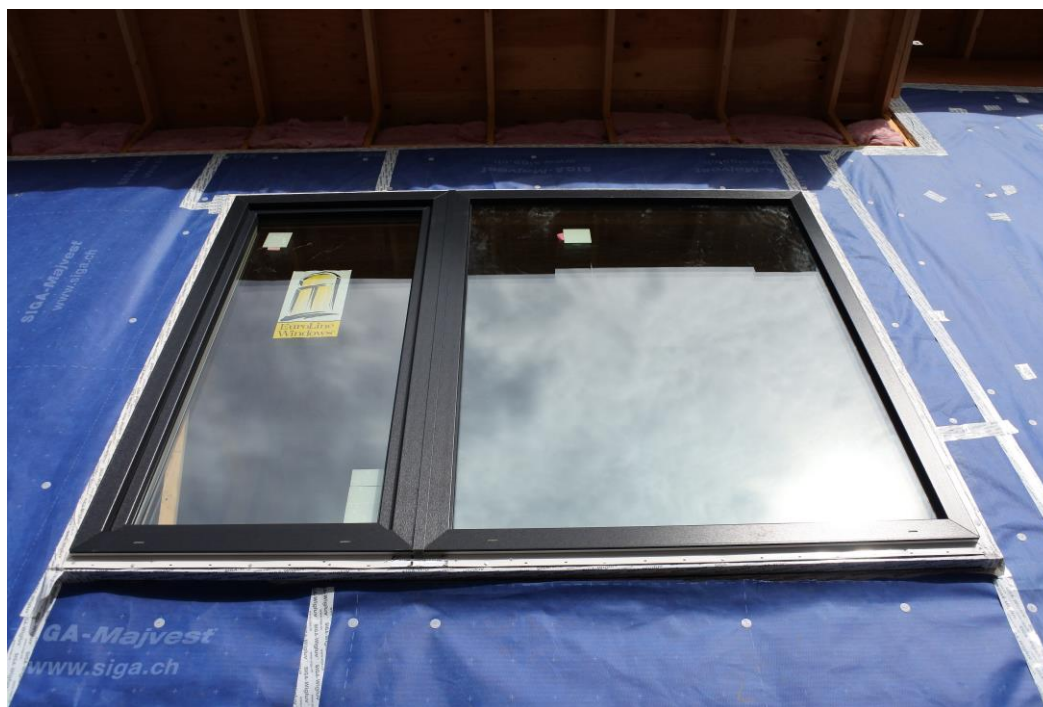
The windows were installed in exterior sub-frames to better align the units in the plane of insulation. The exterior insulation was also wrapped over the frames to minimize thermal bridging.

West unit master bedroom window. Window sits a few inches proud of wall.

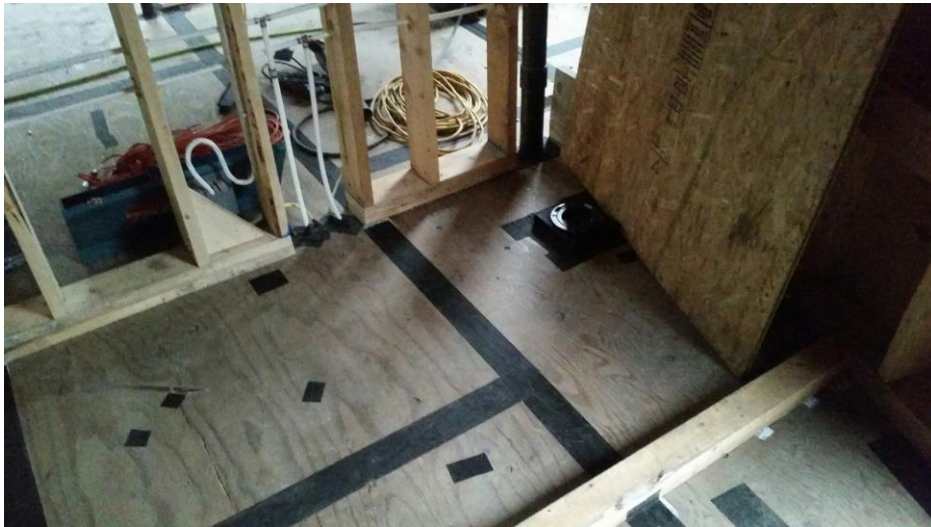
The plywood subfloor of the first floor (above the unheated crawlspace) runs continuously under the exterior wall plates, which enables it to be taped to the plywood wall sheathing. All joints and penetrations were sealed with Siga tape.

Bathroom floor; penetrations and plywood joints sealed.

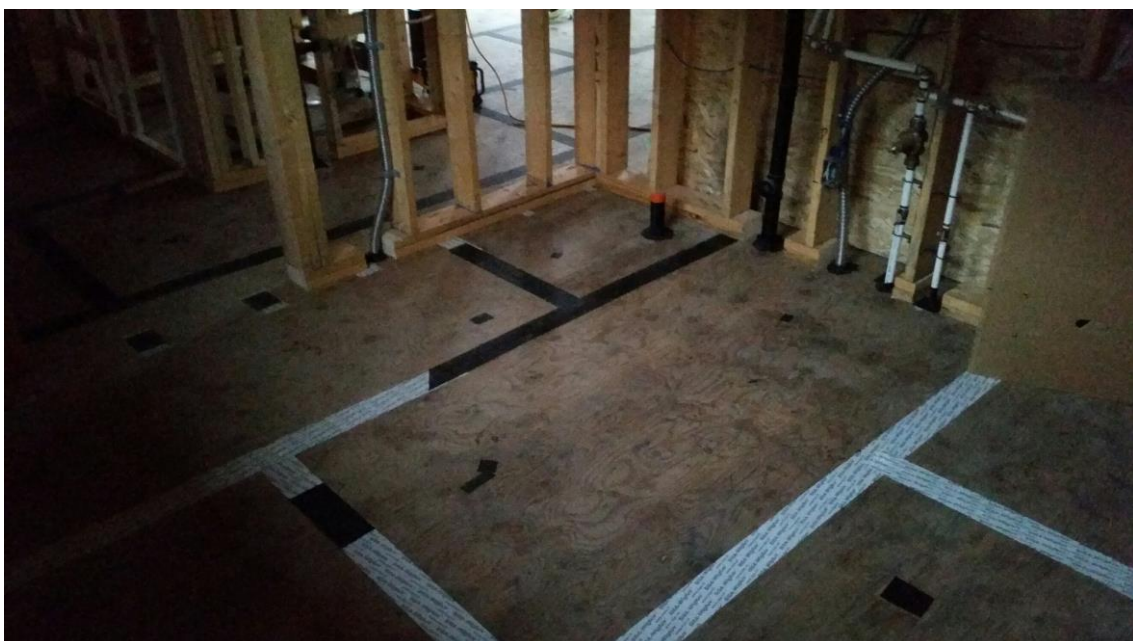
Service room floor; penetrations and plywood joints sealed.

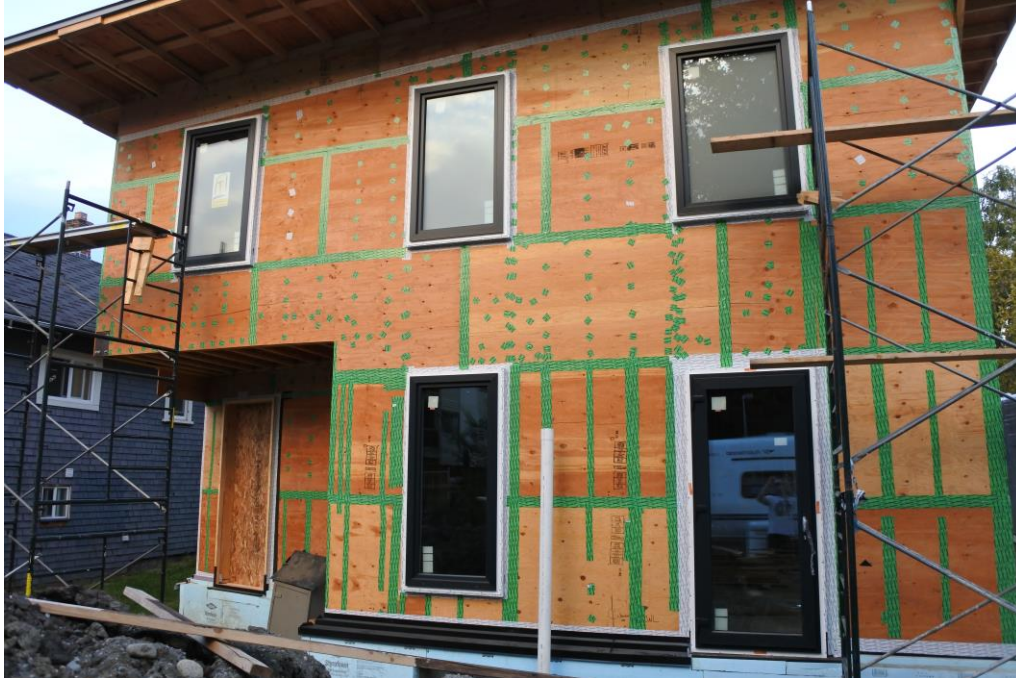
The plywood wall sheathing saw all joints and penetrations sealed with Siga tape. The plywood subfloor and the OSB roof system air barrier (shown later) were sealed to the wall sheathing with Siga tape.

Wall sheathing sealing. Taped and sealed.

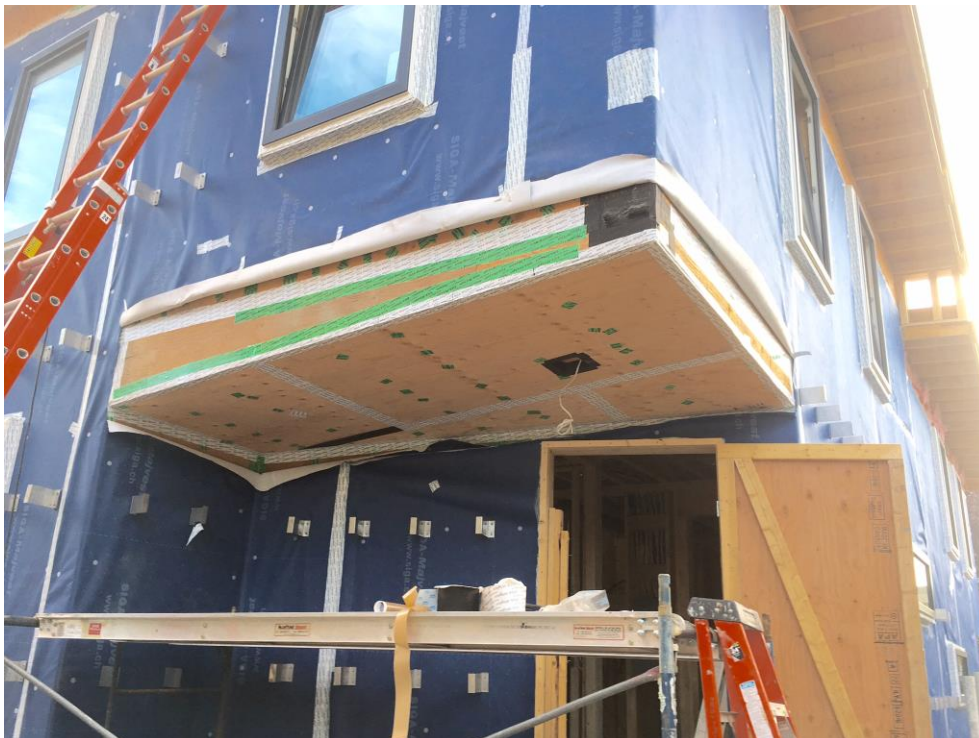
Second floor overhang air barrier installed.

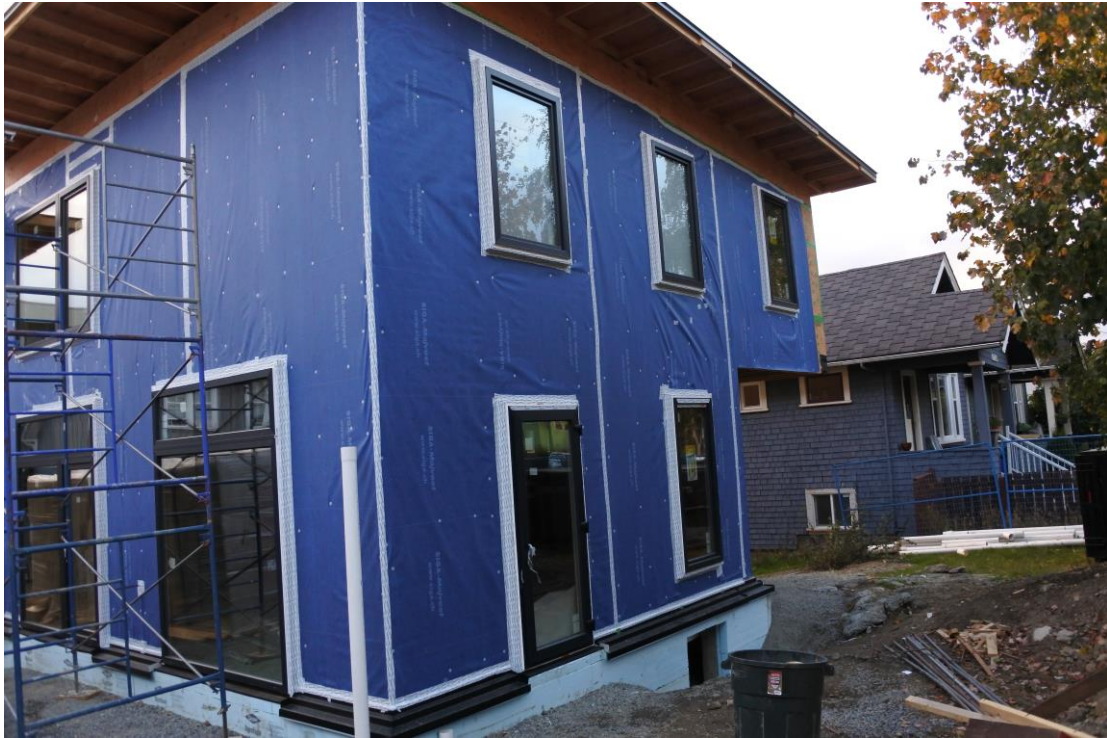
When the weather barrier was contemplated, Siga Majvest was selected. It was a good product to work with on site, as it wasn't prone to tearing. In addition, its vapour permeability are higher than typical local products such as Tyvek, which make it a good choice for coastal BC climates.

Once installed, its joints and penetrations were also sealed to help improve the wall air barrier system.

Weather barrier membrane, installed and sealed.

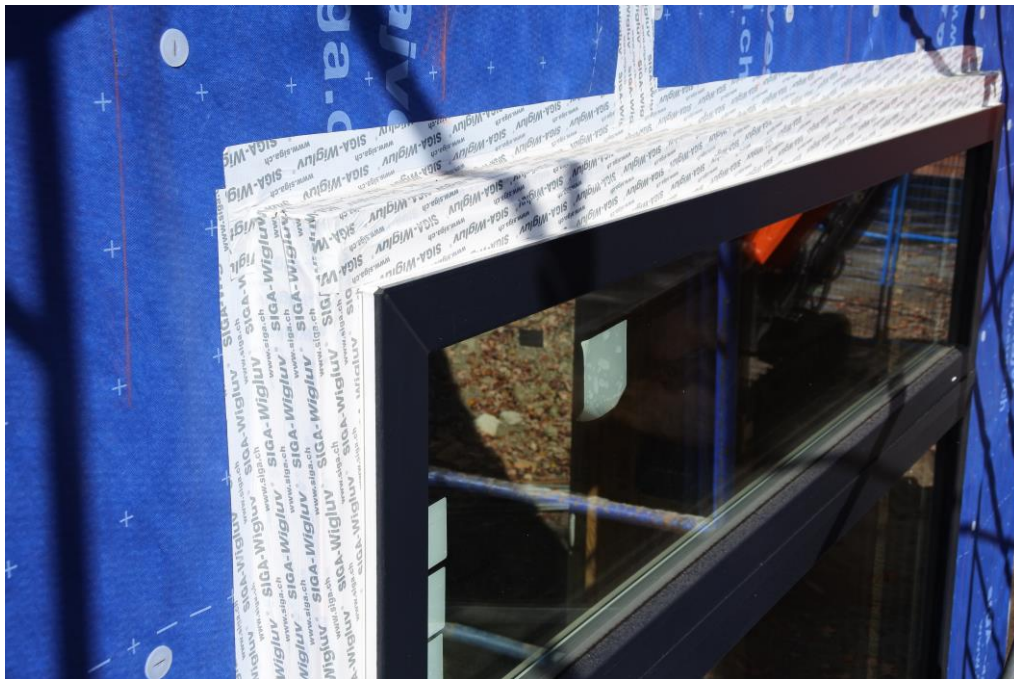
Windows sealed to Siga weather barrier.

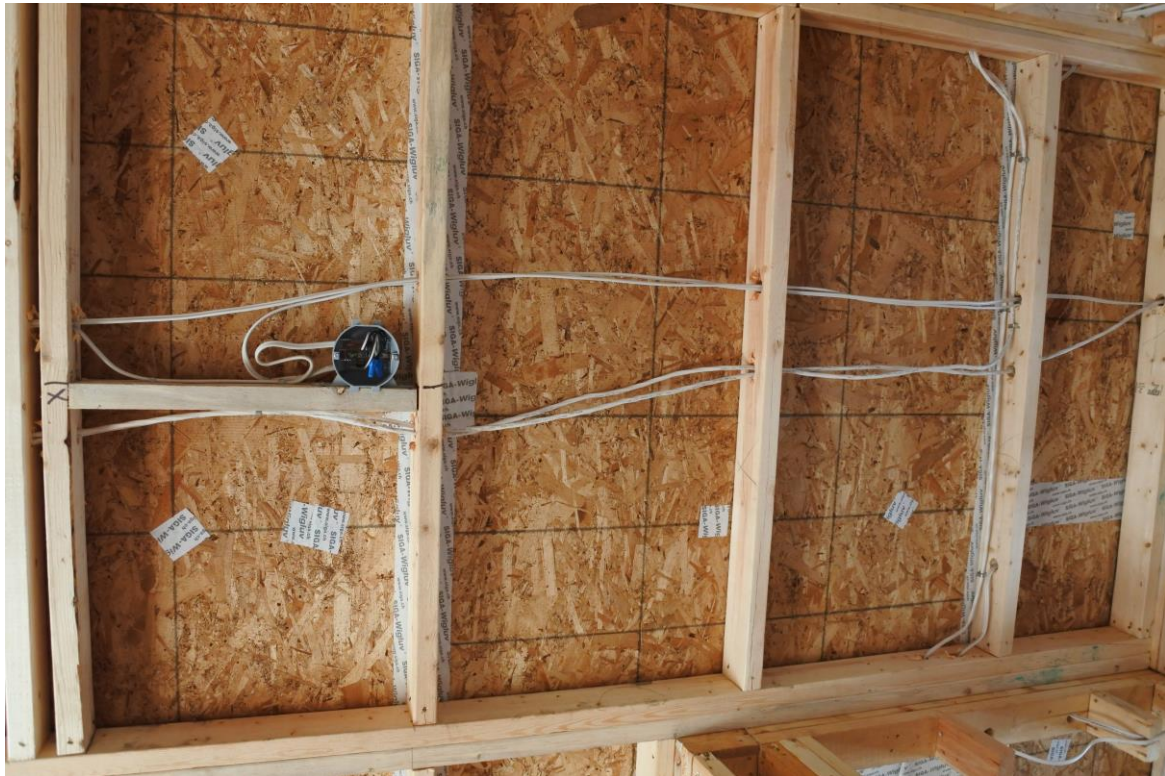
The underside of the roof trusses saw a layer of OSB, with all joints and penetrations sealed. The OSB runs continuously under the roof trusses and on top of the wall plates, enabling it to be sealed to the wall sheathing. To maintain air barrier continuity (and incorporate additional thermal barrier continuity as well), a dropped ceiling was installed to house all services and electrical equipment. This reduced the roof air barrier penetrations to one plumbing vent and two wire penetrations in each unit.

Roof assembly air barrier and dropped ceiling.

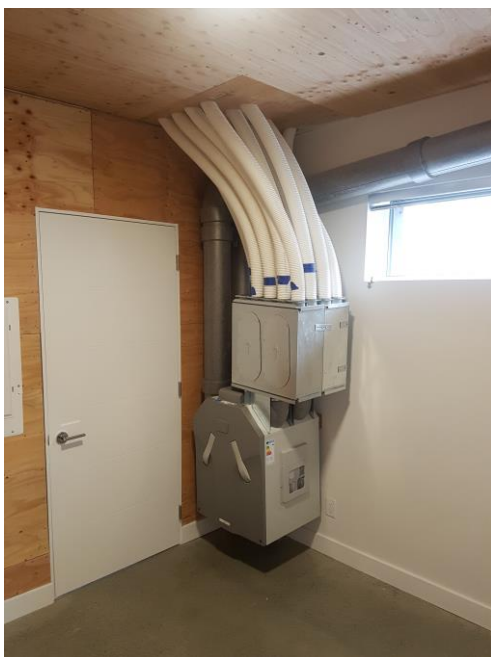
West unit HRV.

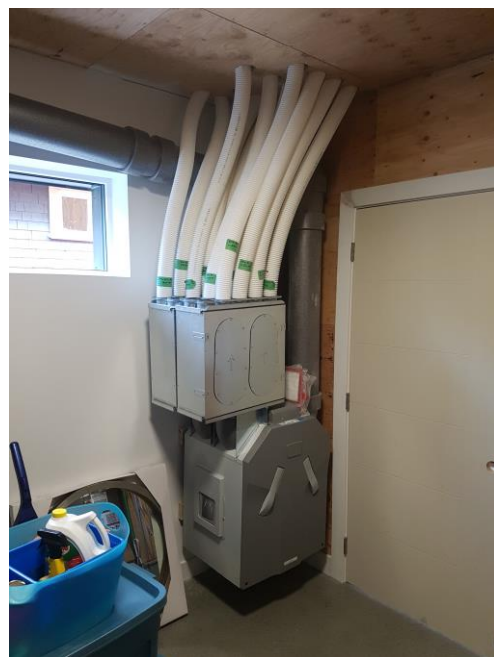
East unit HRV.

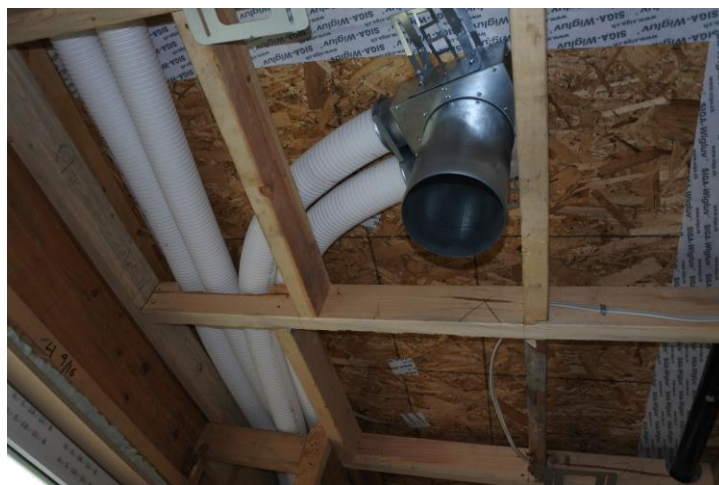
Each unit uses Zehnder ComfoTube ducting, and a manifold. This system was easy to install, which was completed by the owner and the carpenters. It was favoured by the owners because it didn't require the contracting of a sheet metal installer for duct work, rather the ducts were fed through the building to each room as directed by the manufacturer's design team.

West unit upper bathroom ducting and room connection.

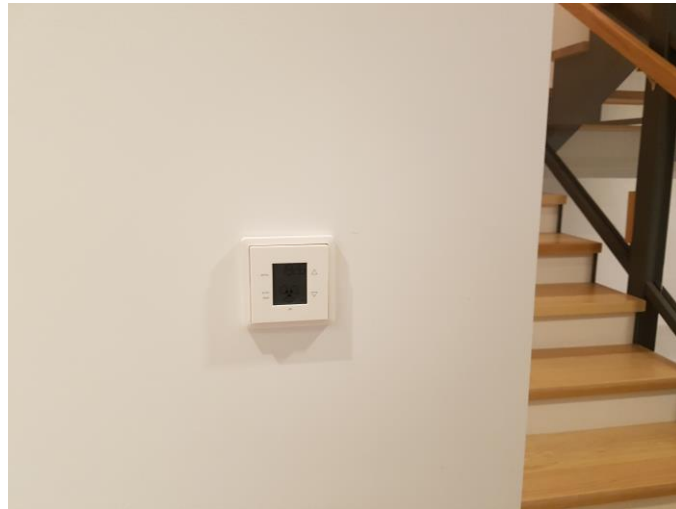
The ventilation control units are located in the hallway between the entry foyer and the kitchen.

Zehnder Comfo Controller.

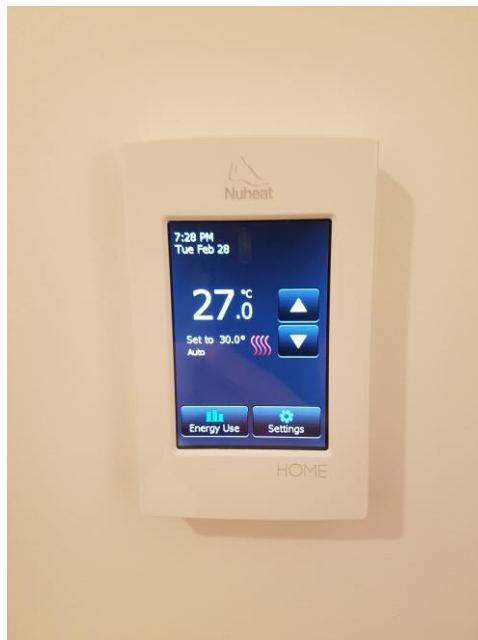
Smart control devices installed to individually control each heated bathroom floor.

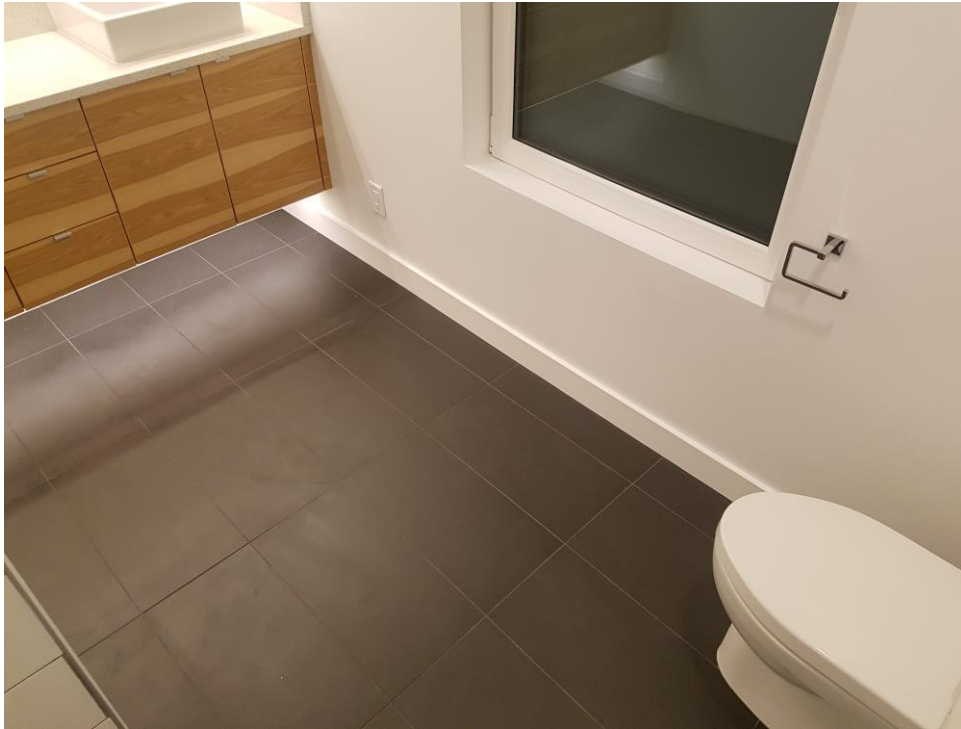
West unit master bathroom tiled floor (heating cables beneath).

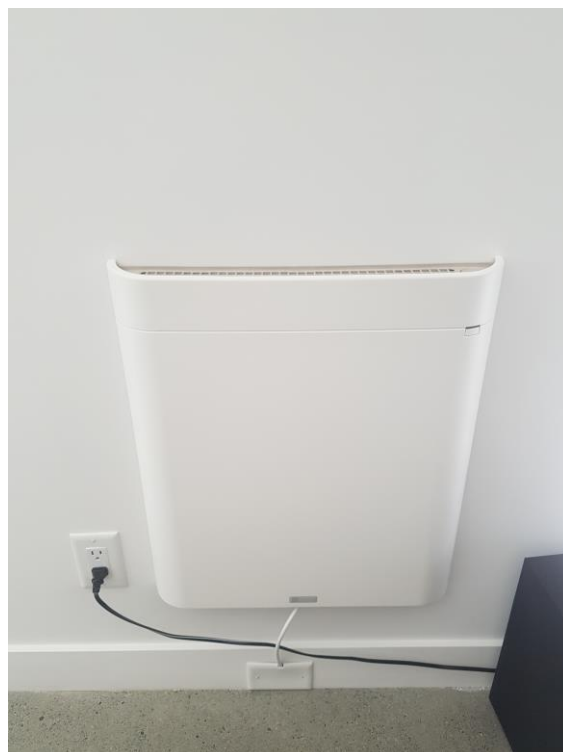
East unit living room wall mounted convection heater.

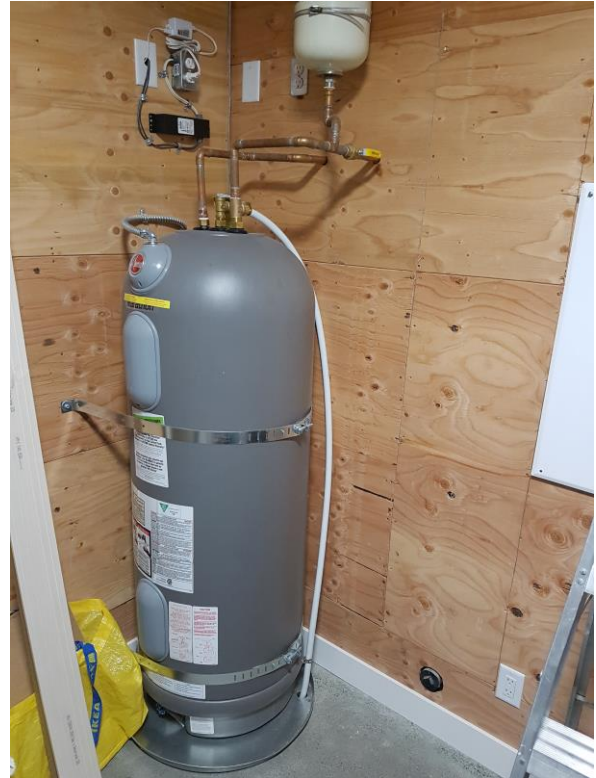
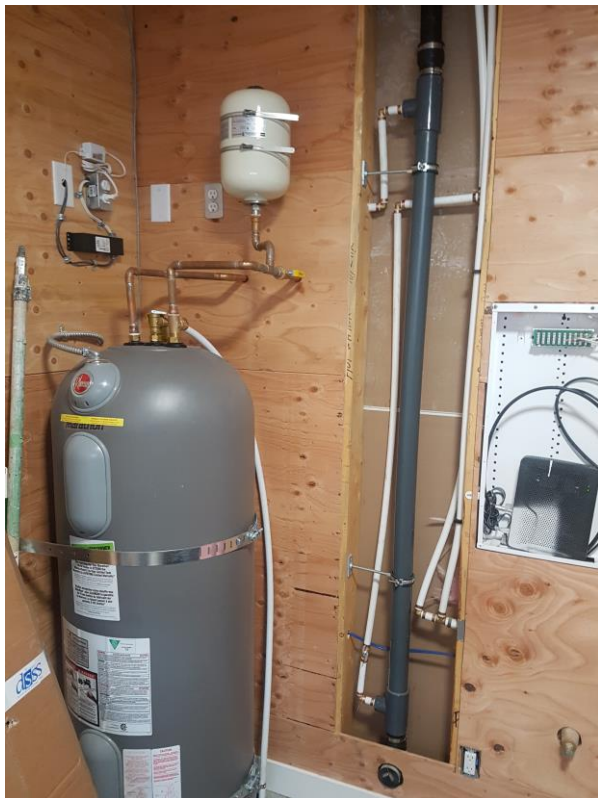
Domestic hot water is supplied to each unit by an electrically powered residential storage tank. Rheem Marathon tanks were selected for their reliability and lifetime warranty, as well as their high level of tank insulation.

To supplement the water heater, each tank is connected to a heat recapture system that is plumbed from the shower drains. A Dutch Solar Systems model 800 was chosen, as it was a product recognized by PHI. This was an easy addition to incorporate, as the building was being built new and the plumbing could be installed as desired.

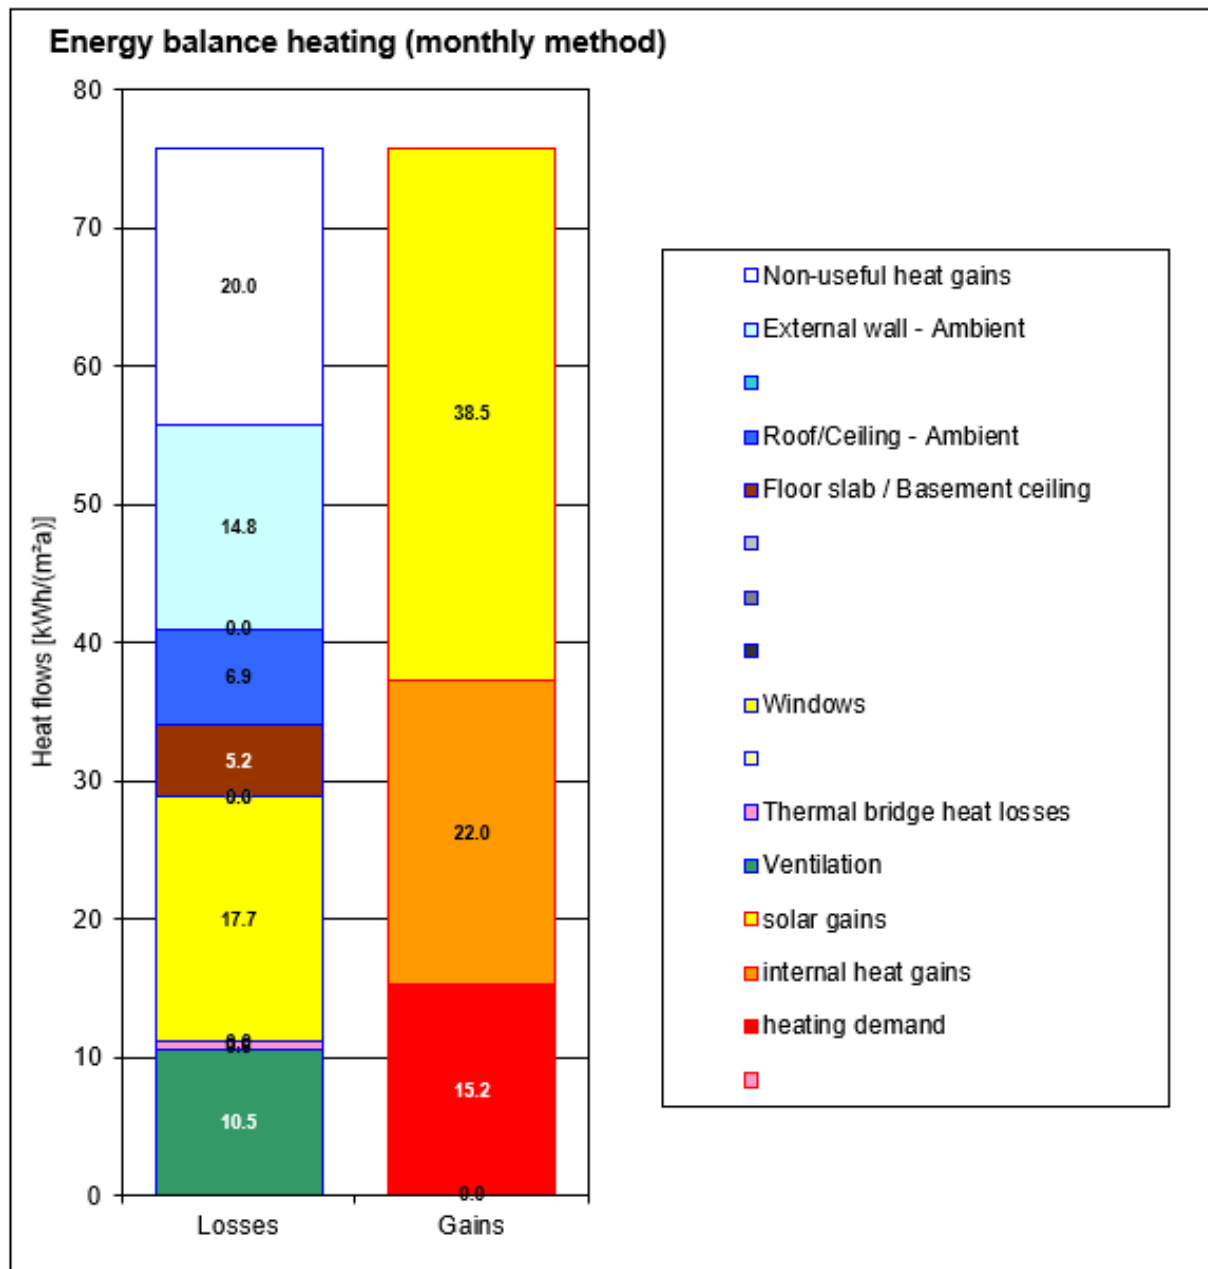
Heating energy balance calculated using PHPP

Window solar gains more than doubled energy losses, which enabled the building to have more windows on the Northern face and improve natural lighting.
