Project Documentation

Hiberna Strawbale House

Year of construction Baujahr	2020	Space heating Heizwärmebedarf	10.53 kWh/(m ² a)
U-value external wall U-Wert Außenwand	0.154 W/(m ² K)		
U-value basement U-Wert Kellerdecke	0.171 W/(m ² K)	Primary Energy Renewable (PER) Erneuerbare Primärenergie (PER)	76 kWh/(m ² a)
U-value roof U-Wert Dach	0.136 W/(m ² K)	Generation of renewable Energy Erzeugung erneuerb. Energie	59 kWh/(m ² a)
U-value window U-Wert Fenster	0.9 W/(m ² K)	Non-renewable Primary Energy (PE) Nicht erneuerbare Primärenergie (PE)	34 kWh/(m ² a)
Heat recovery Wärmerückgewinnung	86.1 %	Pressurization test n Drucktest n ₅₀	0.6 h ⁻¹
Special features Besonderheiten	Low embodied energy materials. Reclaimed materials. Solar PV. No combustion. Low VOC finishes. Niedrig verkörperte Energiematerialien. Aufgearbeitete Materialien. Solarphotovoltaik-Module. Keine Verbrennung VOC-arme Oberflächen

A two storey family home in Wanaka, NZ. One of the few two storey strawbale structures in NZ, it is the first strawbale certified Passive House in NZ. The structure is an isolated slab on 200mm of polystyrene, post and box beam hybrid strawbale wall structure on both storeys and a framed ro

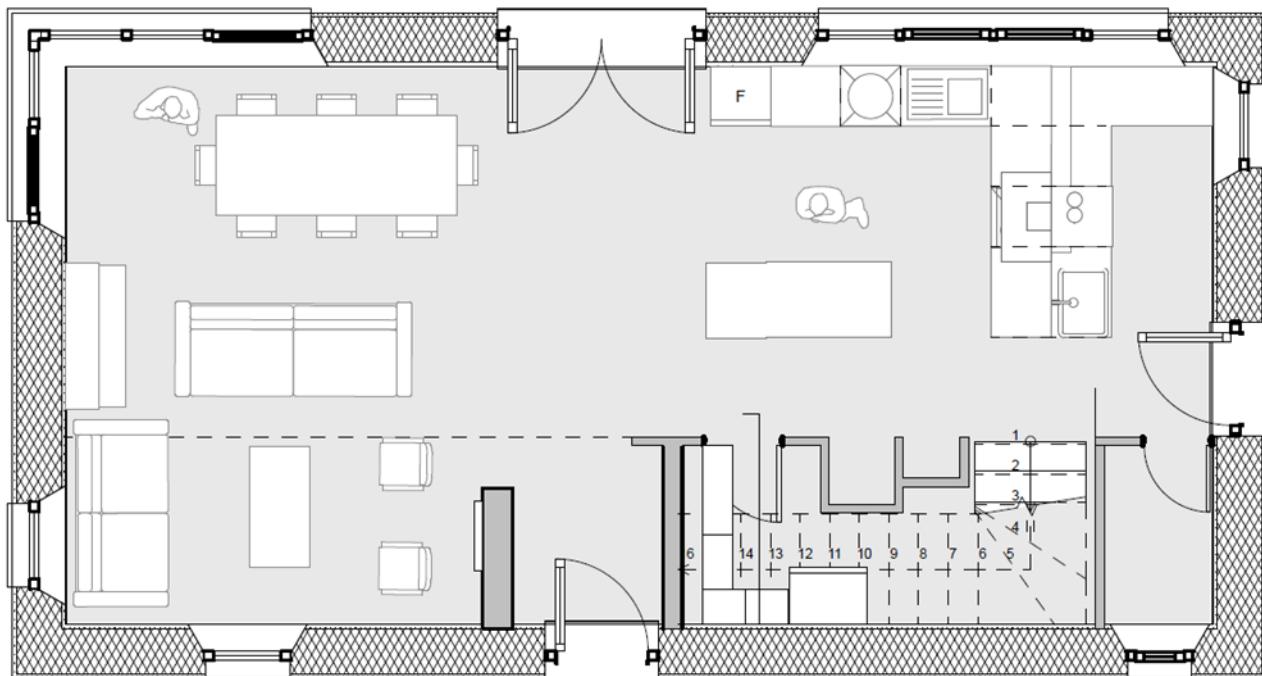
Ground Floor Plan

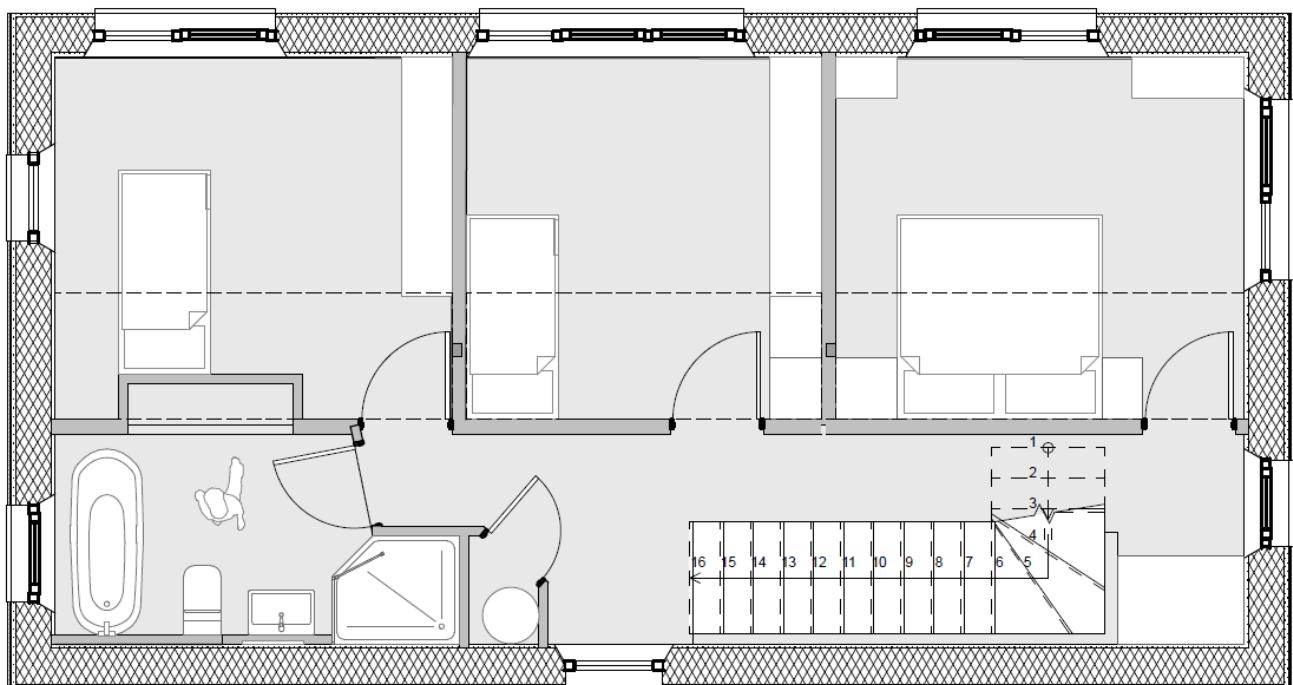
First Floor Plan

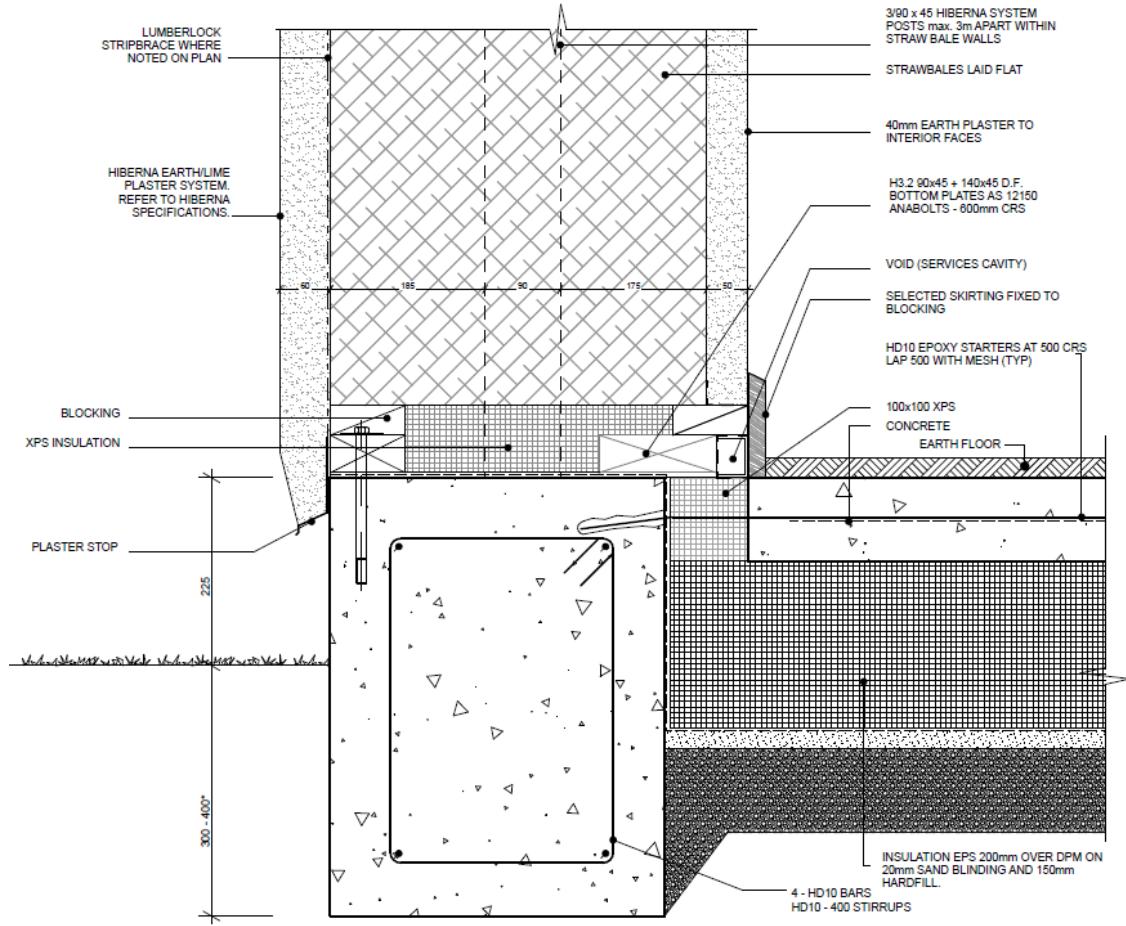
5. Floor slab/ basement ceiling construction including insulation Konstruktion der Bodenplatte

25mm earth floor on 100mm concrete slab, 200mm EPS polystyrene

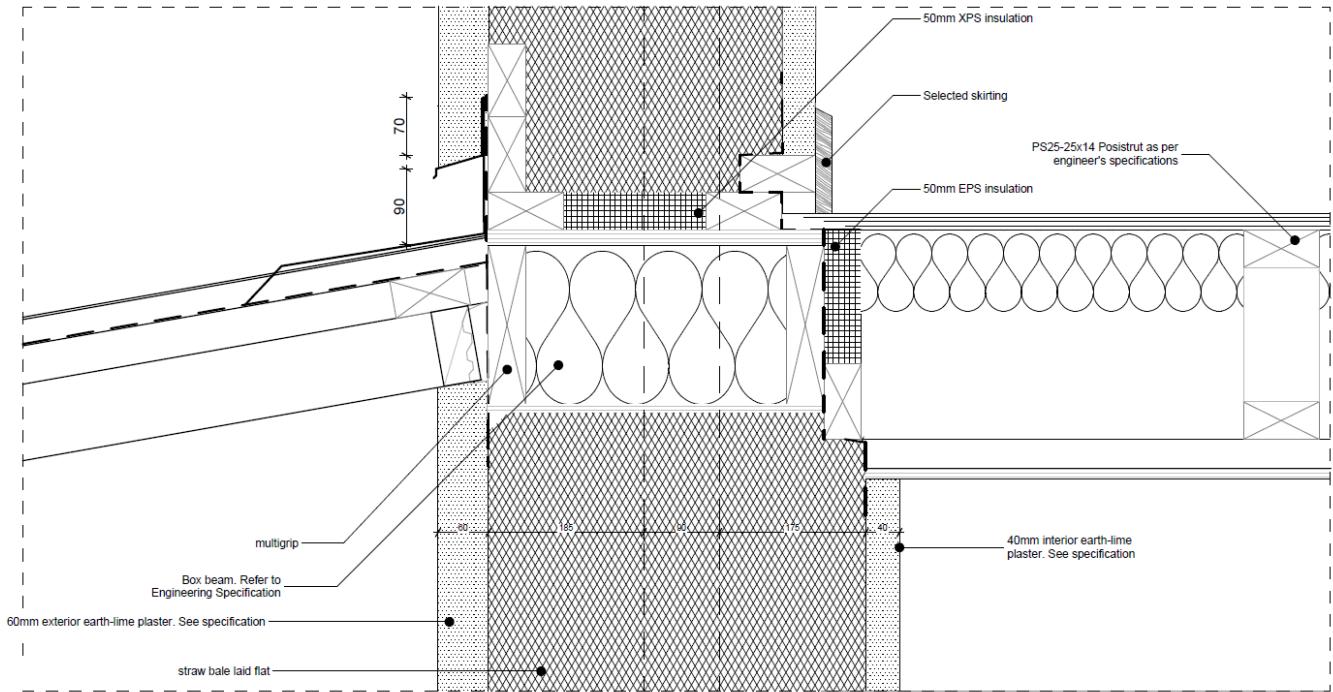
6. Wall construction including insulation - Konstruktion der Außenwände

Post and beam hybrid strawbale structure with earth/lime plasters inside and out.
Ground floor (bales on flat): 0.154
First floor (bales on edge): 0.128

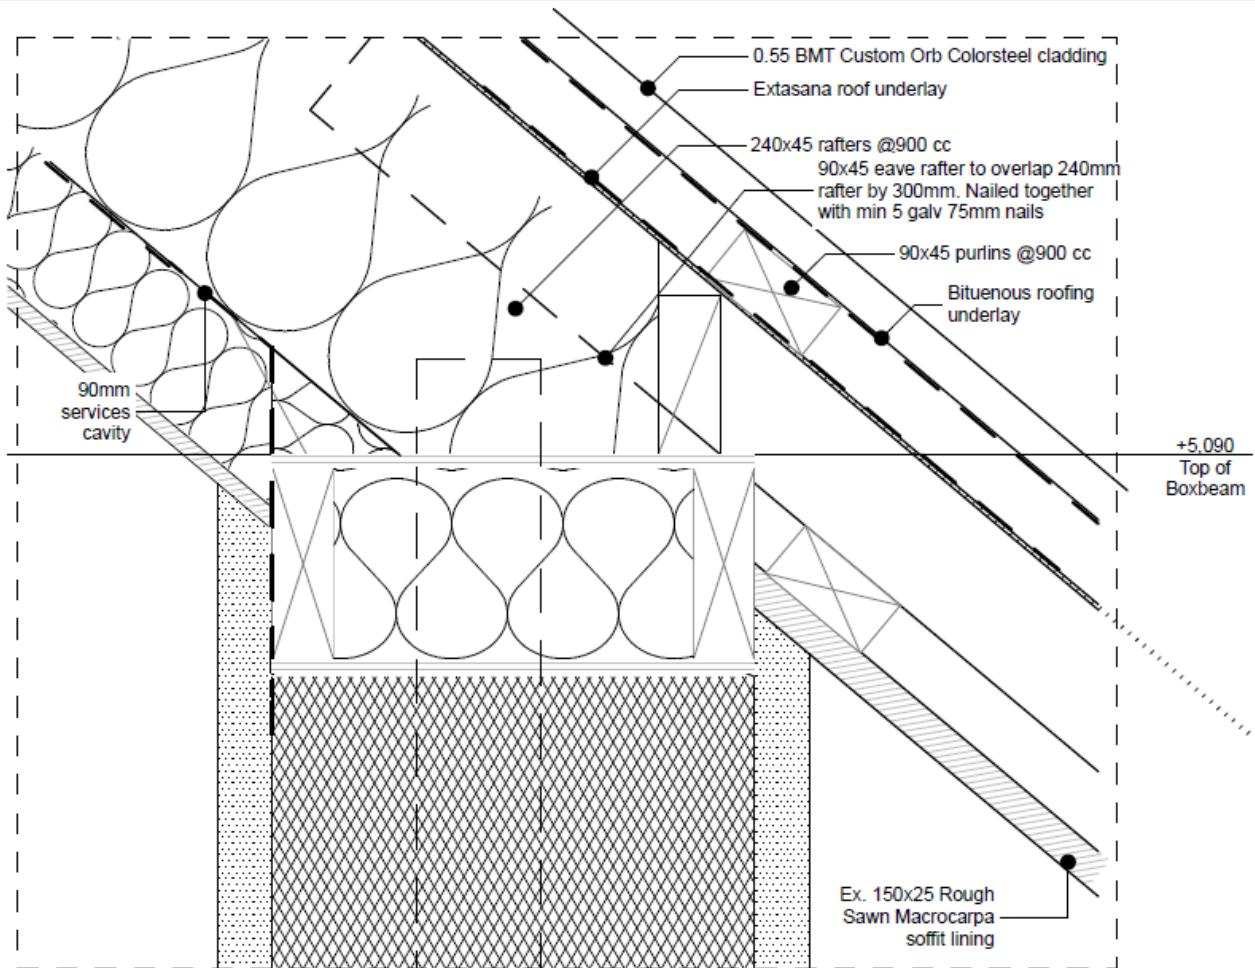
7. Roof construction including insulation - Konstruktion des Daches

Skillion roof: 240mm rafters insulated with sheeps wool, 90mm insulated services cavity internally U=0.136

Flat ceiling: 380mm sheeps wool, 90mm insulated services cavity internally U=0.099

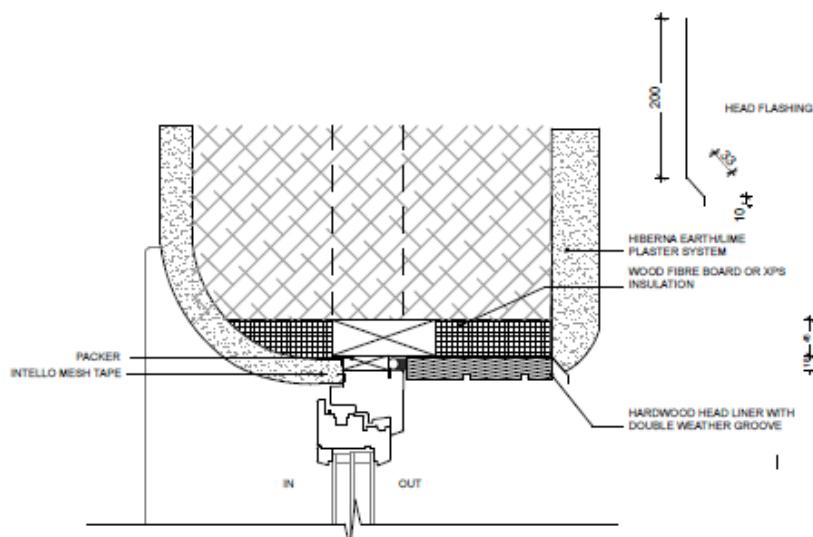
1 Window Head Detail 1:5

The windows are 90mm larch frames with triple glazing. The windows on upper storey have an aluminium facing.

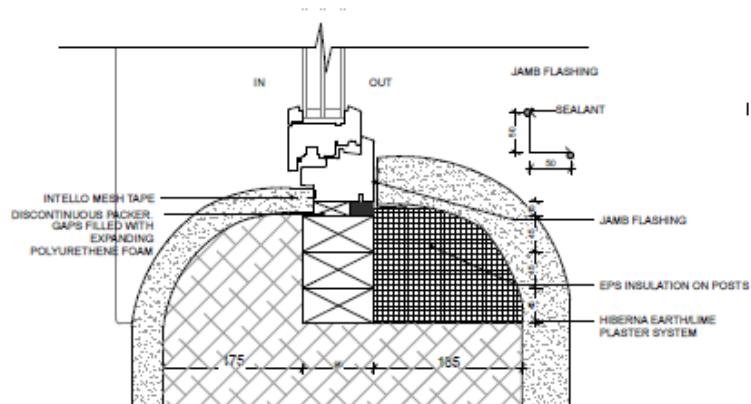
3 Window Jamb Detail 1:5

U g-value = 0.53 W/(m²K)

g -value = 53 %

Uf values (average) = 1.17 W/(m²K)

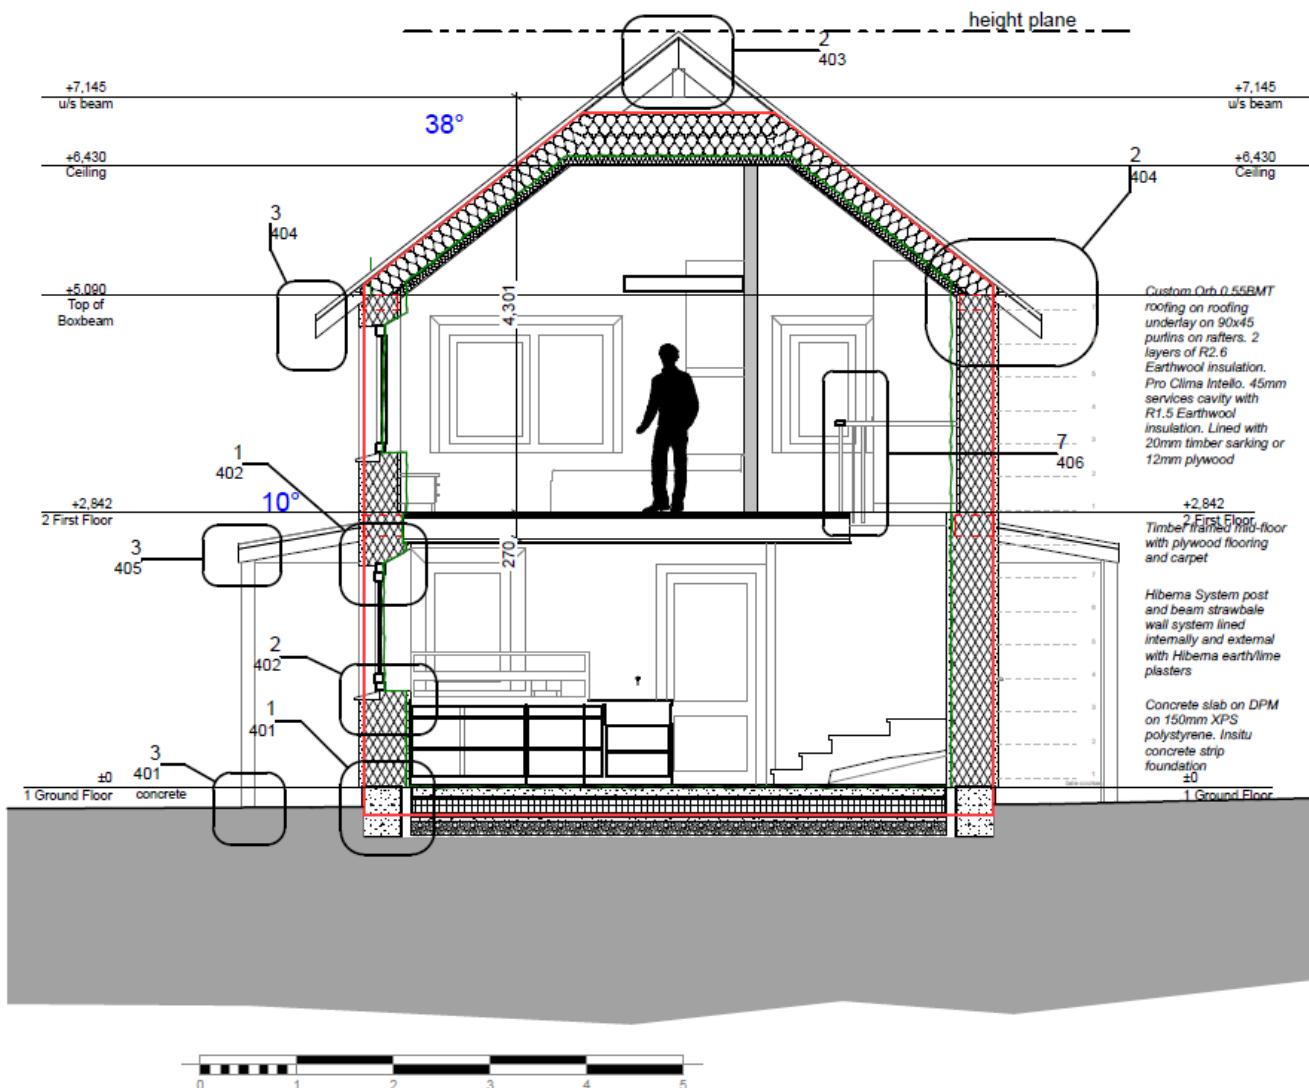
9. Air leakage testing - Beschreibung der luftdichten Hülle

The air control layer is marked in green. It is formed by the concrete slab, internal plaster and air control membrane in the roof. Around the midfloor the plaster is connected with a strip of membrane. The plaster is connected to windows and other airtight elements with tape connected to mesh.

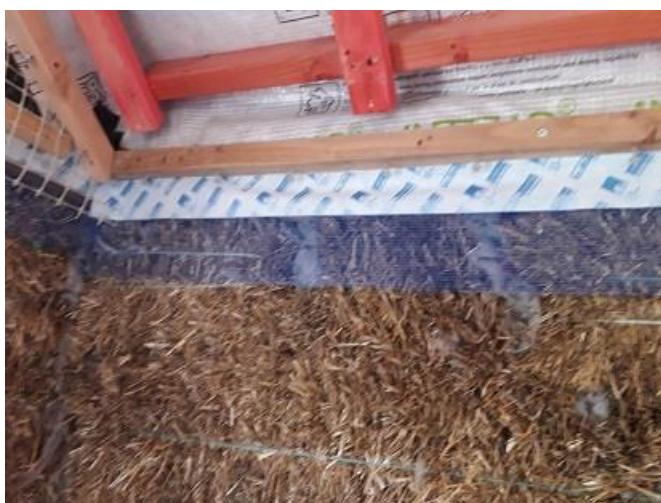
Mesh/tape ready for plastering

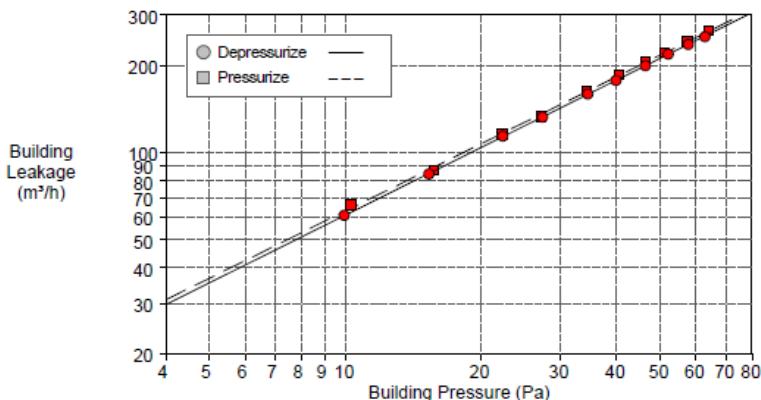
Building Leakage Curve:

Air Flow Coefficient (C _{env}) m ³ /(h·Pa ⁿ)	10.1 (+/- 1.6 %)	10.6 (+/- 6.5 %)
Air Leakage Coefficient (C _L) m ³ /(h·Pa ⁿ)	10.2 (+/- 1.6 %)	10.6 (+/- 6.5 %)
Exponent (n)	0.777 (+/- 0.005)	0.772 (+/- 0.018)
Coefficient of Determination (r ²)	0.99995	0.99915

Depressurization	Pressurization	Average
q ₅₀ : m ³ /h (Airflow)	212 (+/- 0.3 %)	218 (+/- 1.3 %)	215
n ₅₀ : 1/h (Air Change Rate)	0.58	0.60	0.59
Q _{F50} : m ³ /(h·m ²) Floor Area)	3.27	3.36	3.31
Q _{E50} : m ³ /(h·m ²) Envelope Area)	0.69	0.70	0.69

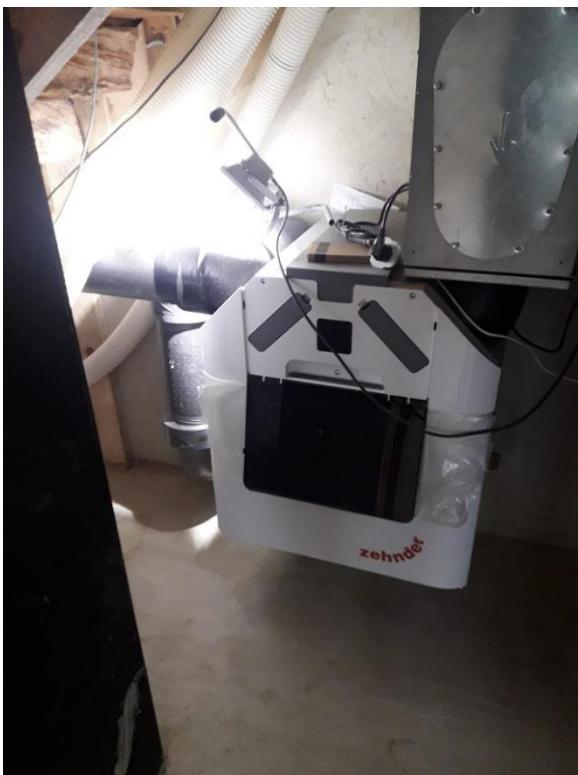
10. MVHR - Lüftungsgerät

Zehnder Q350
86.1%
Pel,spec=0.24 Wh/m³

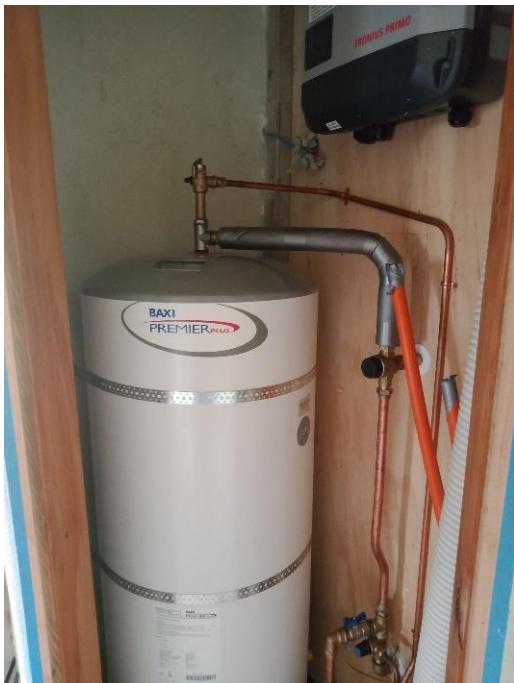
Domestic hot water is heated by an Exceed heat pump. The two radiators are fed from a scavenging coil in the HWC.

Hot water cylinder

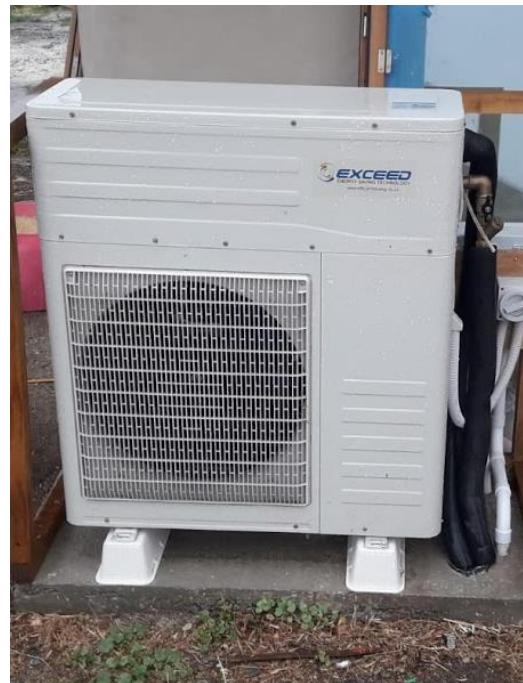
Heat pump external unit

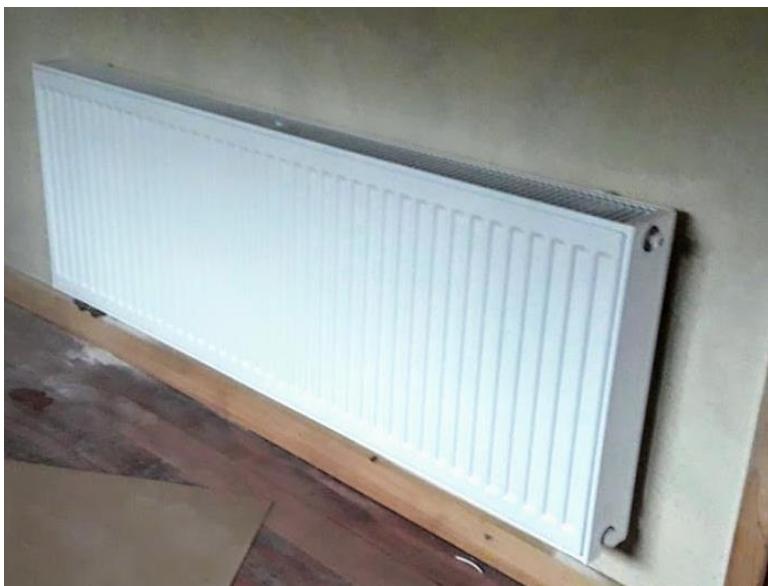
Upstairs radiator
