Passive House Project Documentation

Waitetuna Passive House, Raglan 3295, New Zealand. PHI ID: 3918

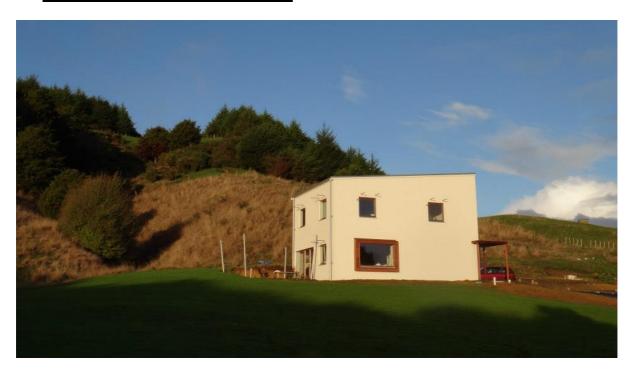
1.0 Photograph of front of the house

This is the second certified Passive House in New Zealand. It is situated in a rural setting close to the coastal town of Raglan. The project brief was to build a certified Passive House with a minimalistic approach that would capture the views to the bush and windfarm. The house is two levels, with external ICF walls, timber mid-floor and roof, and a concrete slab foundation.

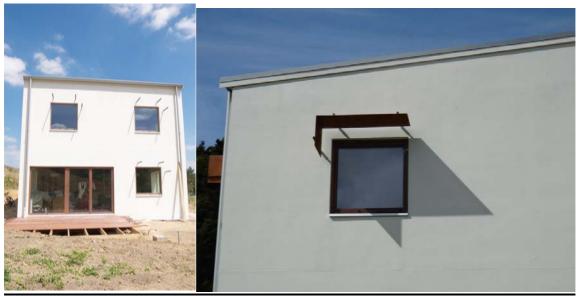
North façade, timber deck and sunshade above window.

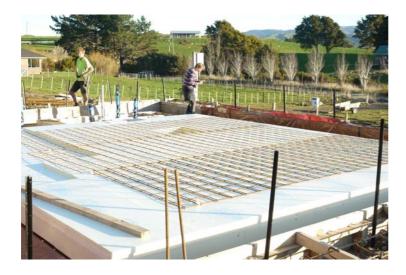
5.1 Footing/slab connection

Footing isolated with ridged foam insulation, 100mm thick concrete slab and footings poured all at once. ICF block formed outer boxing of footing.

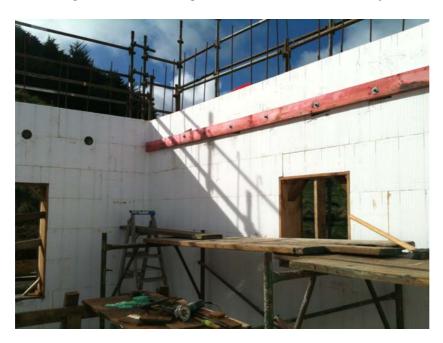
5.2 Exterior walls

The exterior walls are ICF block with a 0.150m concrete core. These walls are the total height of the building. The mid-floor is thermally isolated.

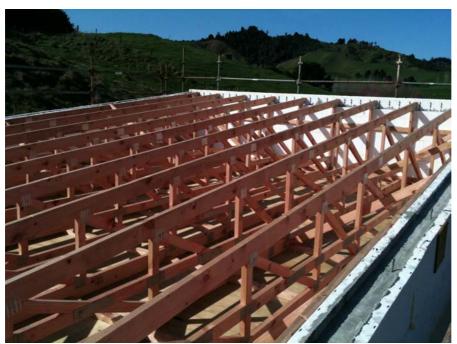
5.3 Roof

The ICF block is built to the underside of the roofing material. The timber trusses are inside the ICF to improve thermal performance. The timber trusses have two layers of thermal insulation blanket at the ceiling level. The ceiling uses an air-tight membrane to make the ceiling meet the PH air-tightness criteria.

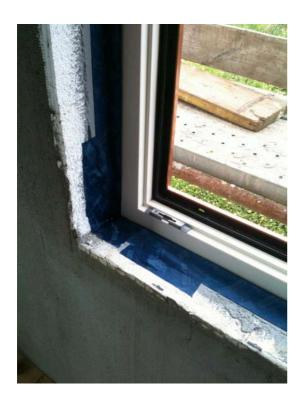
5.4 Window frame

Product frame: Product glass (double glazed): Window: V-Isolux frame, spruce with Purenit core (Uf 0.95) ISOLAR Neutralux Low-e, argon filled (Ug 1.1) Uw 1.21W/(m2K). g value = 62%

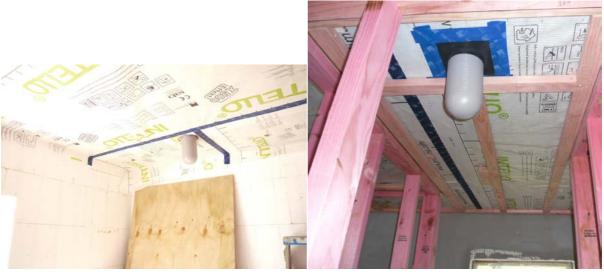
6.0 Air-tight envelope

The air-tight envelope is created by the continuous concrete slab on ground (no basement). The walls have a continuous internal layer of wet Gypsum plaster applied to the ICF block. The ceiling has an internal air-tight membrane (Intello) installed to the underside of the timber trusses, this is then taped to the Gypsum walls at the perimeter of the ceiling. The building form, and therefore the air-tightness membrane, was keep particularly simple so to meeting the PH air-tightness criteria.

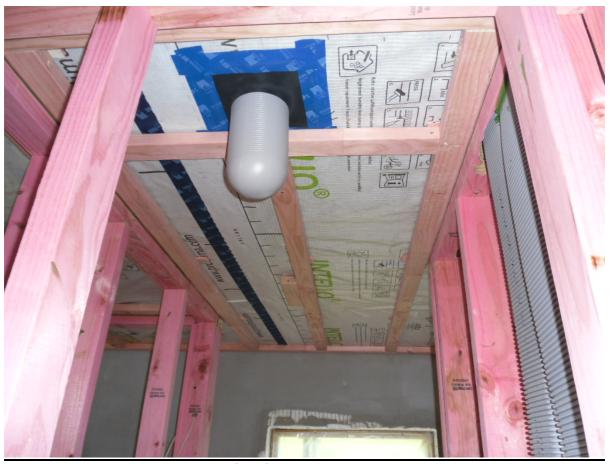
First Floor Duct and Vent Layout (as-built)

Ventilation ducts installed in the first floor ceiling

The HRVU unit is positioned in the laundry on the ground floor. The ducts are distributed in the timber framed mid-floor and roof trusses. All ducts are inside the thermal envelope. Zehnder filters and outlets are used. The system was commissioned and balanced by the New Zealand Zehnder supplier and installer (Fantech NZ). There is a supply vents to each bedroom and two in the living area (shown below on drawings in blue). The extract vents are positioned in the kitchen, WC, laundry, bathroom and ensuite (shown below on drawings in red).

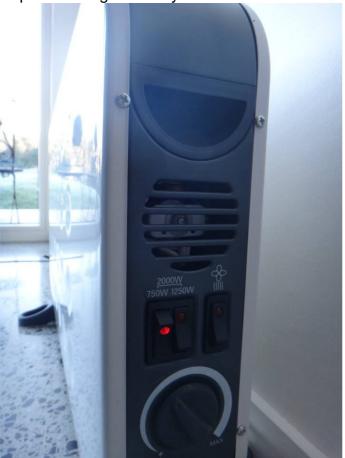
The additional heating demand is provided by an electric heater. This heating source is a manually operated unit that the occupants plug into the house and use as required throughout the year. The unit has a 2kw output

Main and only heating source in project
