# Passive House Project Documentation

Semi-detached house with new extension and refurbished to the EnerPHit standard,  
Dublin Ireland

Passive house designer      Ann-Marie Fallon (formally of Joseph Little Architects)

Year of construction      2011-2012

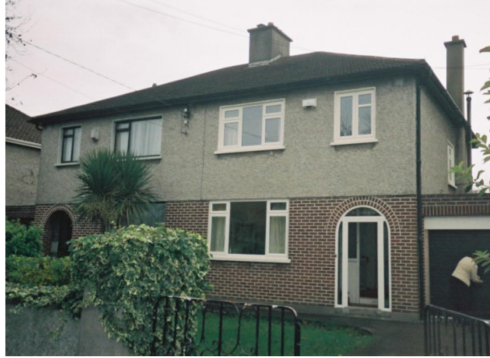
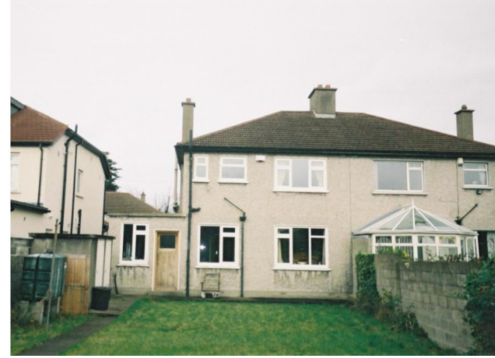
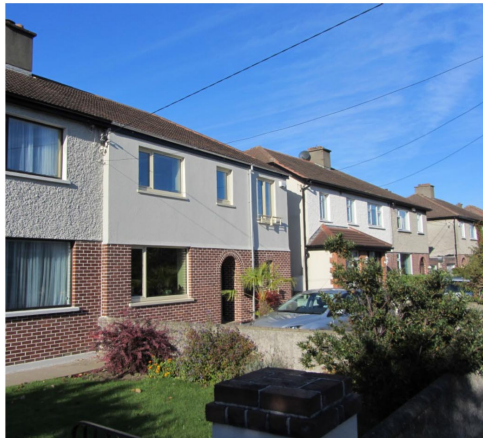
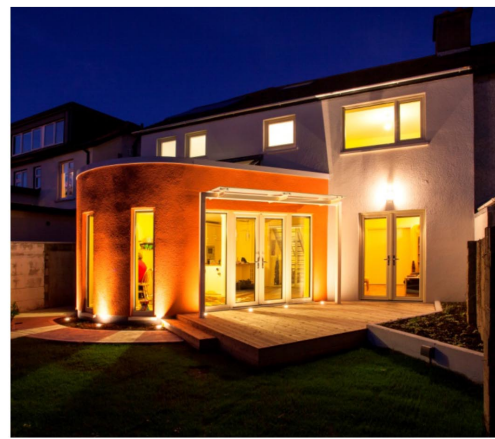
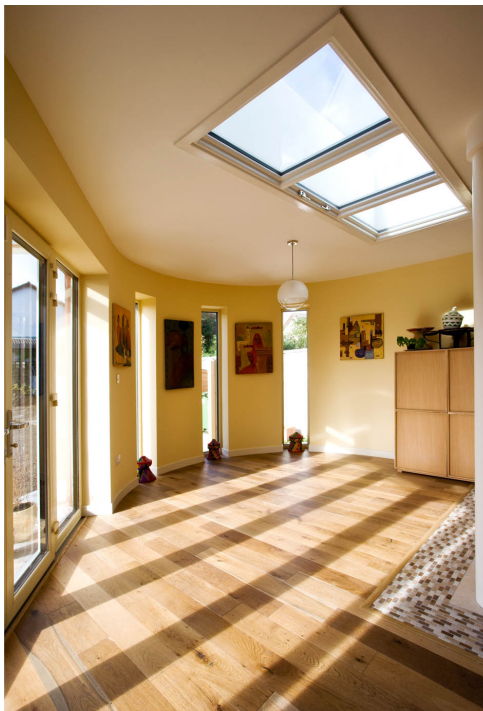
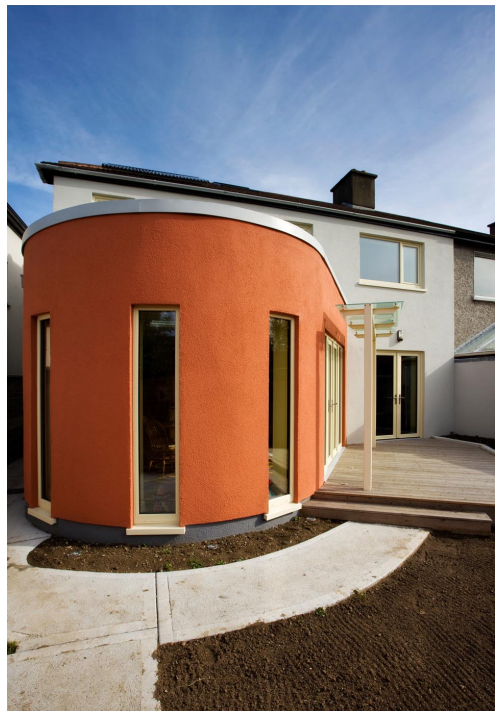
The photos below describe the house in its existing state in 2007 and the finished refurbishment and extension in 2012.

Fig 1 photos of Monkstown EnerPHit before and after (real photos not computer renders)

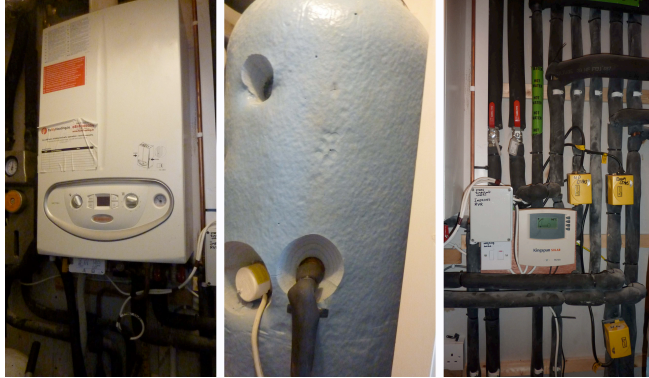
The main heating supply was mains gas to a small modulating gas boiler (1.9-12kW modulating). Domestic hot water was also supplemented by solar heating.

There was 4m<sup>2</sup> of solar panels feeding the insulated cylinder and this contributed to 70% of the useful heat required for domestic hot water.

Fig 21 showing modulating boiler 100mm insulated cylinder and insulated pipework

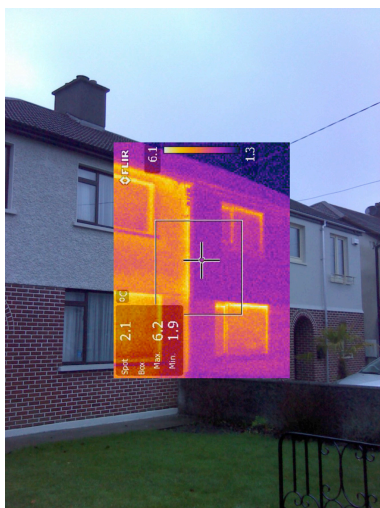
A comparison image between the adjacent semi detached building is shown below showing the huge improvement in heat loss in the building envelope but a little heat loss around the window pane areas.

Fig 24 thermal image overlay of photo elevation showing temperature differences
