# Project Documentation

Detached single family house in Castrillón (Asturias),  
Spain

### Passive House Piedras Blancas

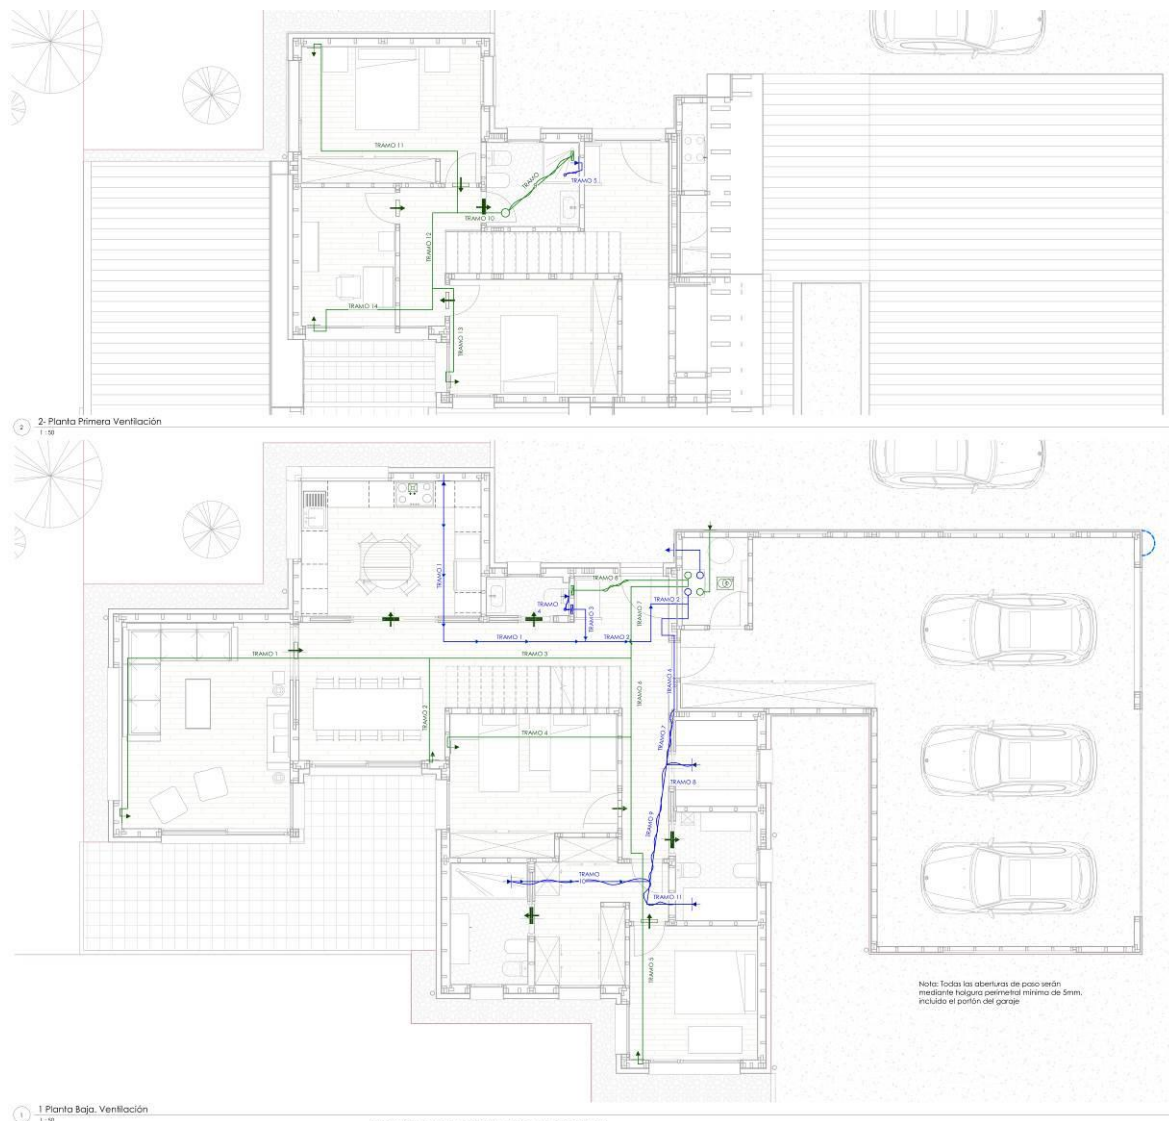
Ventilation plans

There is a mechanical ventilation with heat recovery that provides a constant supply of fresh filtered air, maintaining the air quality whilst being practically imperceptible. This machine extracts the air from the polluted sources and supplies air to the “living” rooms.

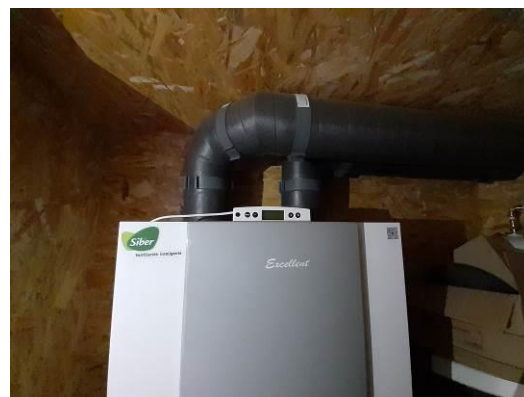
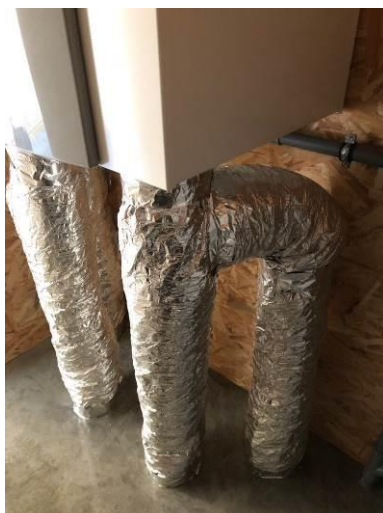
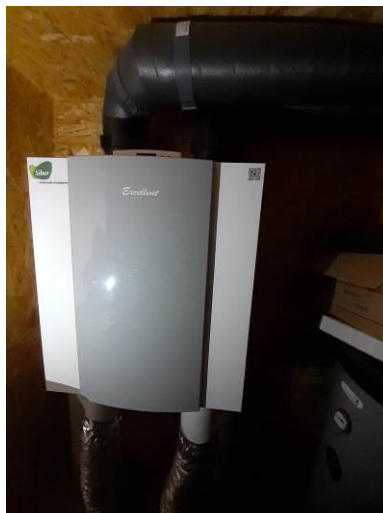
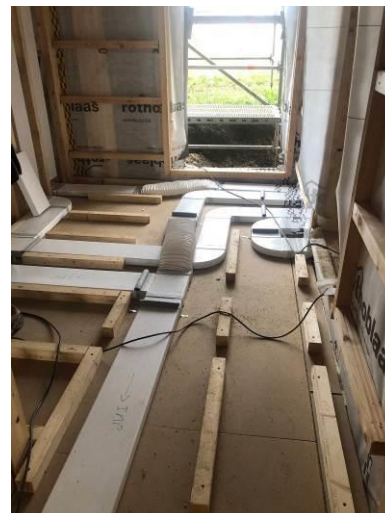
Category: **Air handling unit with heat recovery**  
 Manufacturer: **Siber Zone, S.L.U.**  
 Spain  
 Product name: **SIBER DF EXCELLENT 3 (Plus)**

Specification: Airflow rate < 600 m³/h  
 Heat exchanger: Recuperative

Heat recovery rate  $\eta_{HR} \geq 75\%$   
 Specific electric power  $P_{el,spec} \leq 0.45 \text{ Wh/m}^3$   
 Leakage  $< 3\%$   
 Comfort Supply air temperature  $\geq 16.5^\circ\text{C}$  at outdoor air temperature of  $-10^\circ\text{C}$

| Airflow range |
|---|
| 59–235 m³/h |
| $\eta_{HR} = 84\%$ <sup>1)</sup> |
| $P_{el,spec} = 0.26 \text{ Wh/m}^3$ |

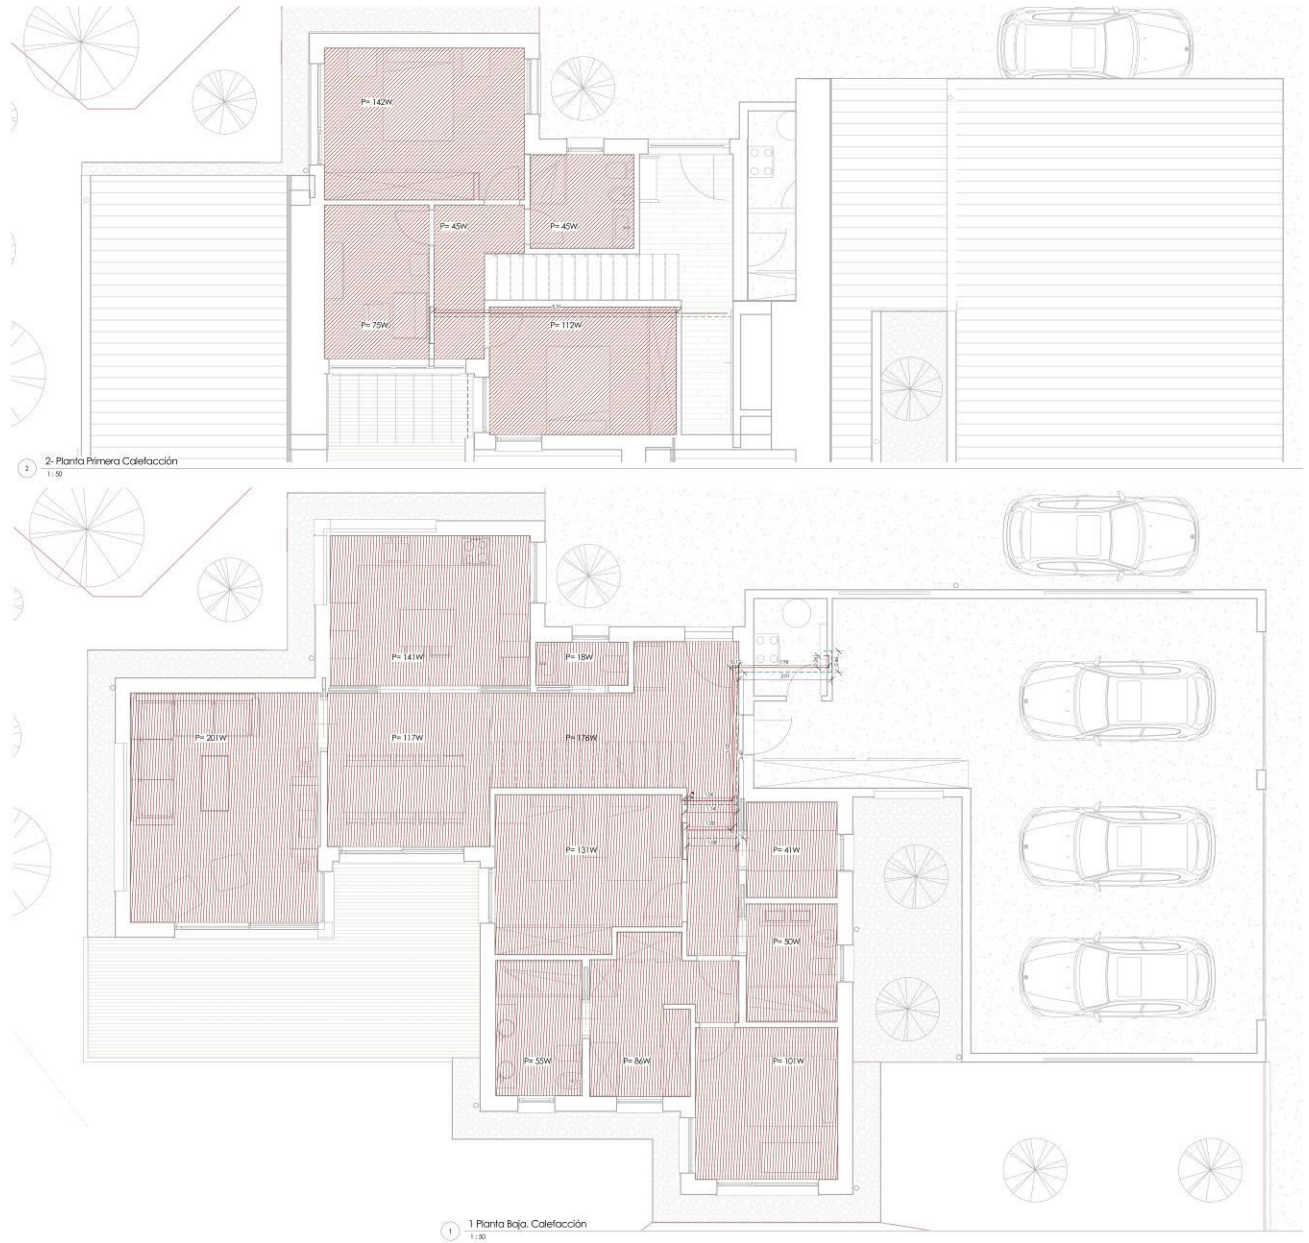
To provide heating, radiant floor has been installed and connected to an air-to-water heat pump that provides heat water.
