Project Documentation Gebäude-Dokumentation

Ballina Passive House

Located in Northern New South Wales, Australia near the Richmond River in Ballina, a certified 'classic' passive house home has been built. This location is considered sub-tropical locally (warm temperate to PHI) where the midges and mosquitoes are required to be kept out of buildings with fly screens and termites kept away through construction methods and materials. This building is of timber construction boldly finished externally, with a more relaxed and lowkey interior, is home to the client who likes to entertain and have guests stay.

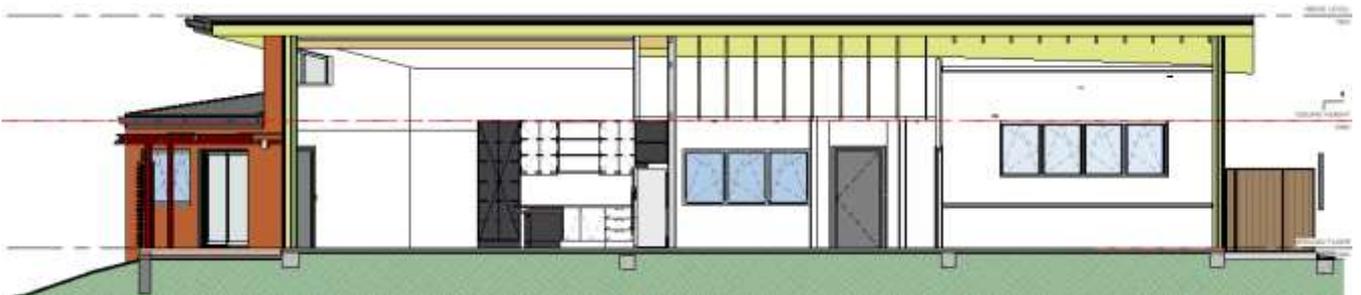
LONGITUDINAL SECTION A-A

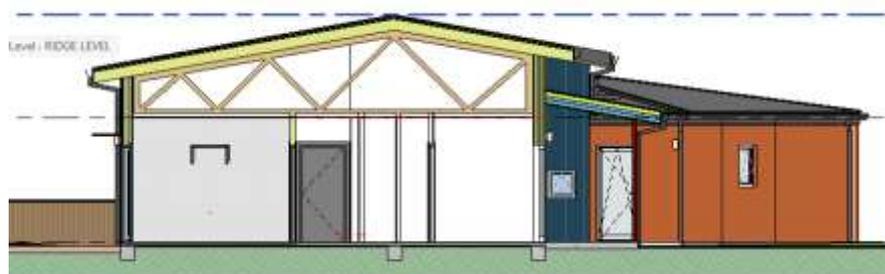
CROSS SECTION D-D

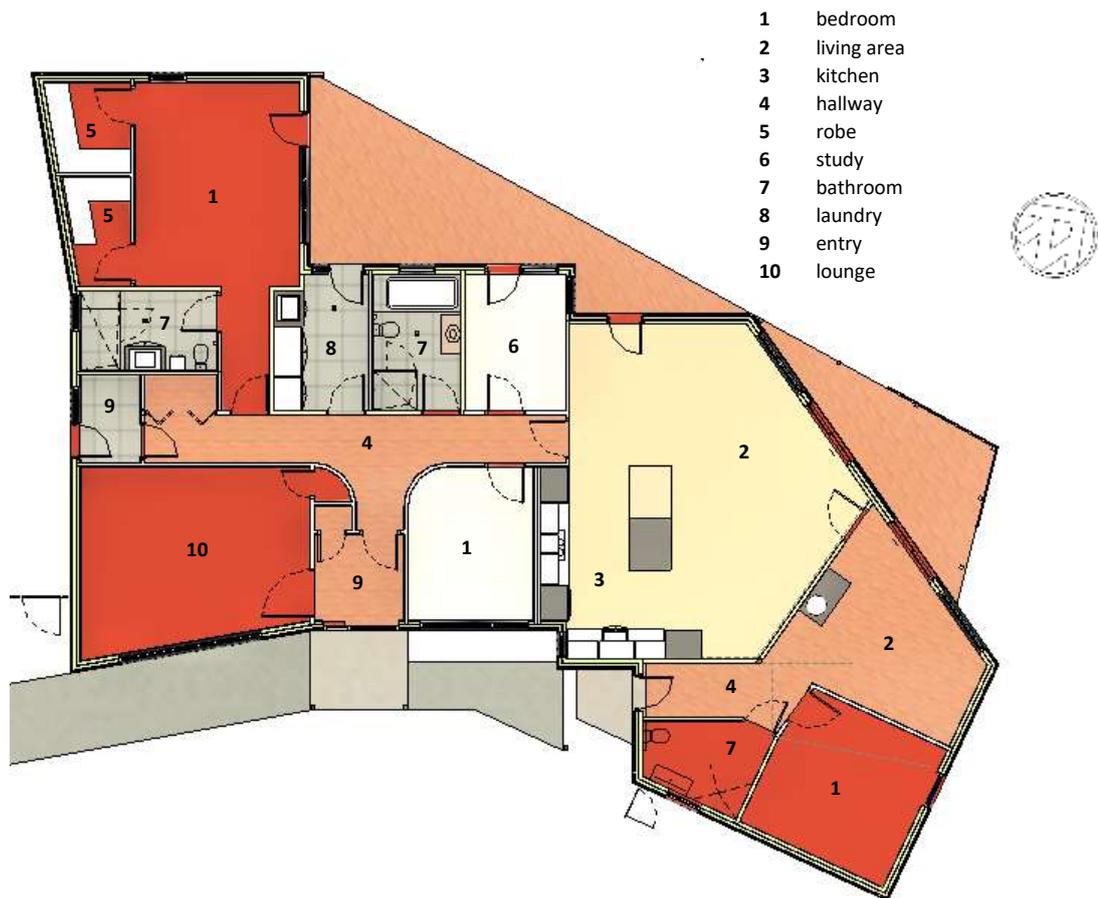
FLOOR PLAN

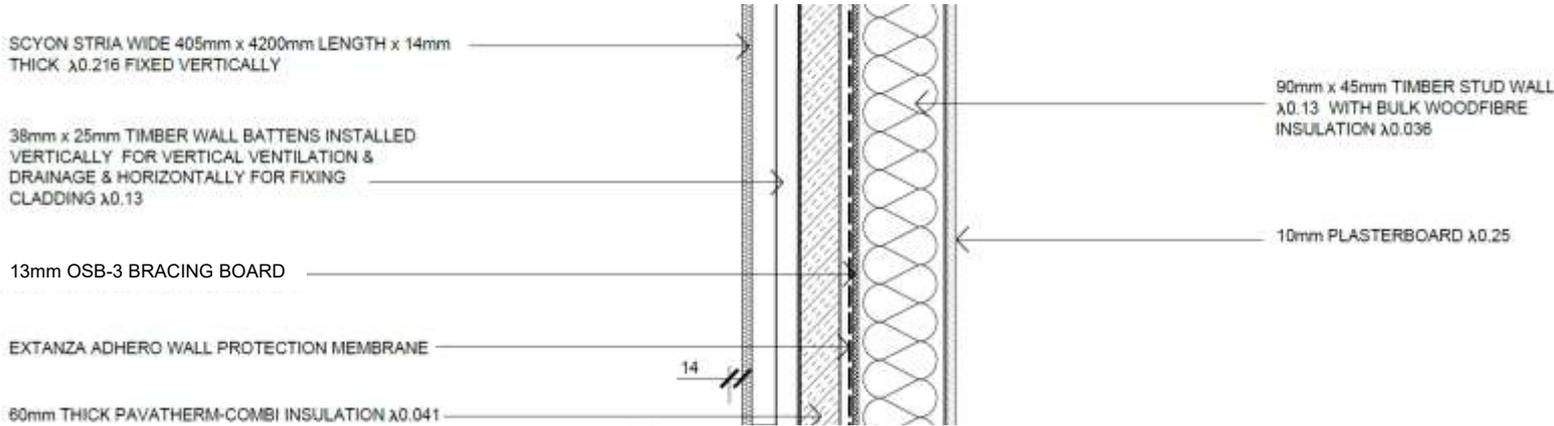
Frame: Timber Frame with bulk insulation and plasterboard painted finish within & woodfibre insulation external of WRB on structural OSB-3 typical U-Value 0.23W/(m²K)

TYPICAL WALL ENVELOPE DETAIL

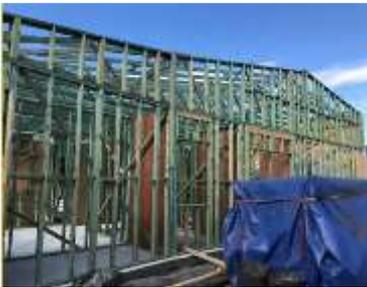
Timber framing prior OSB-3 installation on concrete slab.

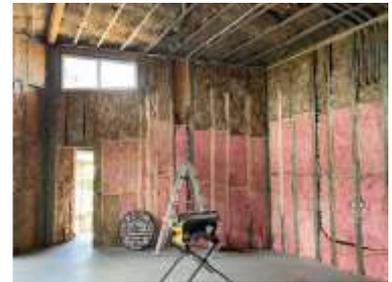
Bulk insulation to living room.

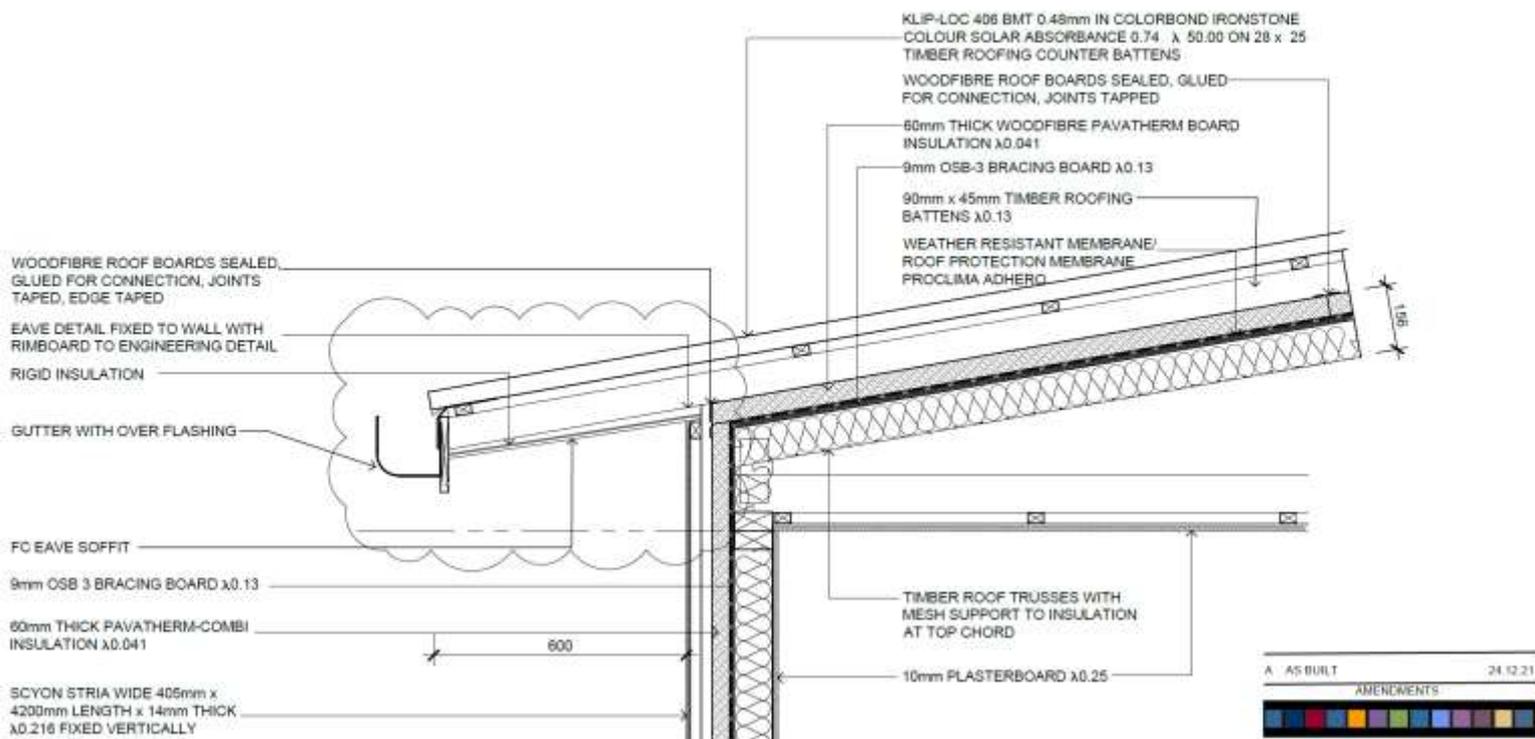
TYPICAL WALL & TRUSS CEILING DETAIL

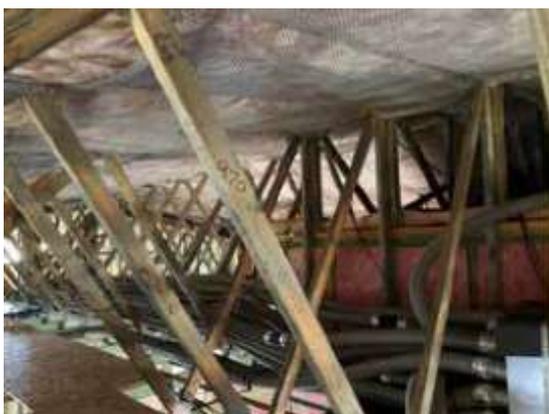
Trussed roof with bulk Earthwool insulation batts R2.7 held in position with netting at top chord. Image also shows ductwork distribution within truss web and access walk in ceiling space.

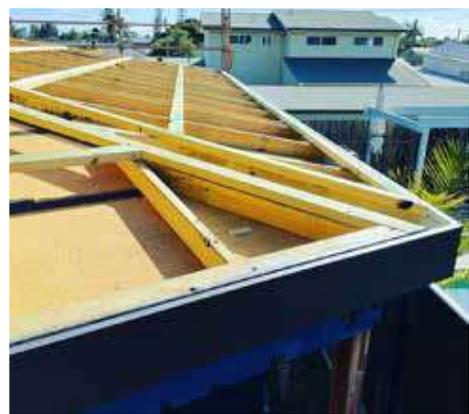
Ventilated roof frame on woodfibre insulation board λ0.043 prior to metal sheet installation with ventilated ridge and fascia board.

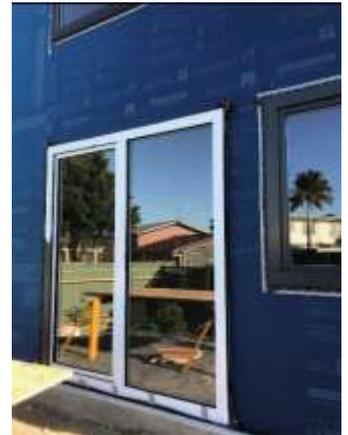
Doors & Windows installed prior to woodfibre & cladding install taped to air weather barrier.

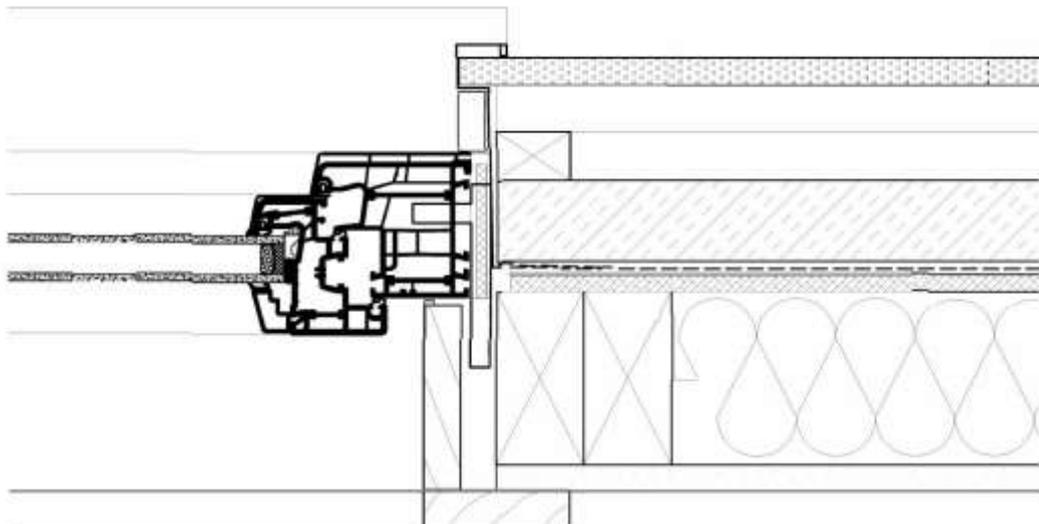
3 TYPICAL WINDOW JAMB 1:2

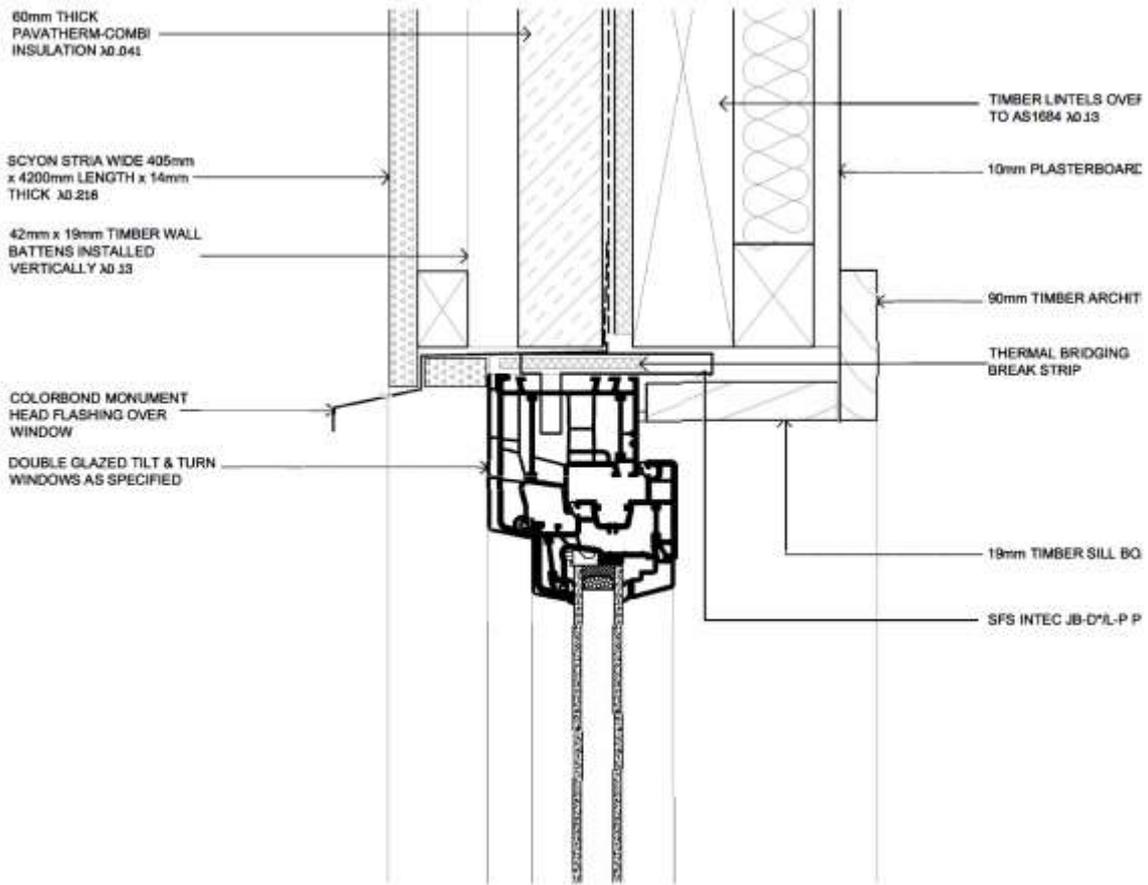
1 TYPICAL WINDOW HEAD
1:2

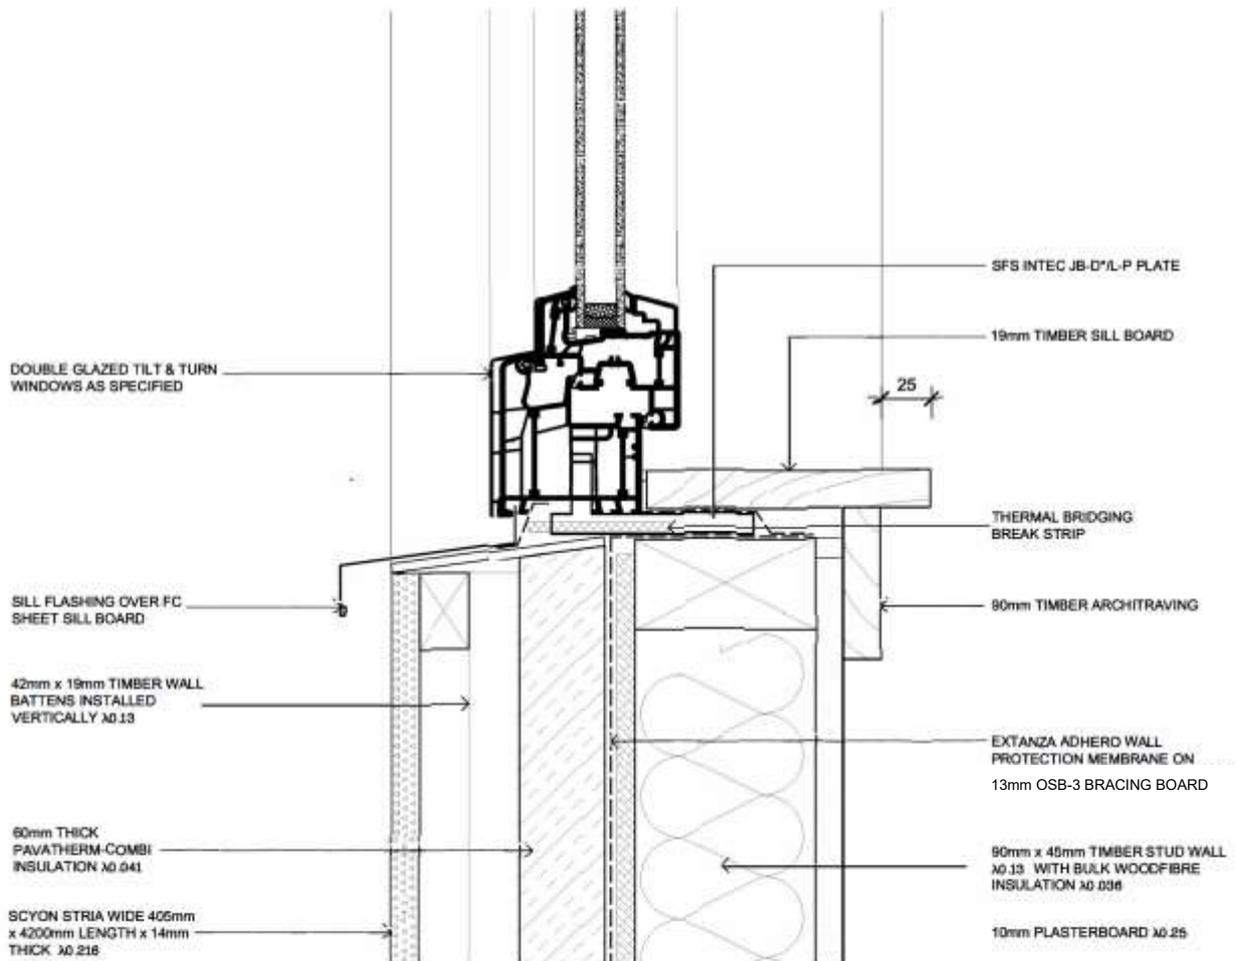
2 TYPICAL WINDOW SILL
1:2

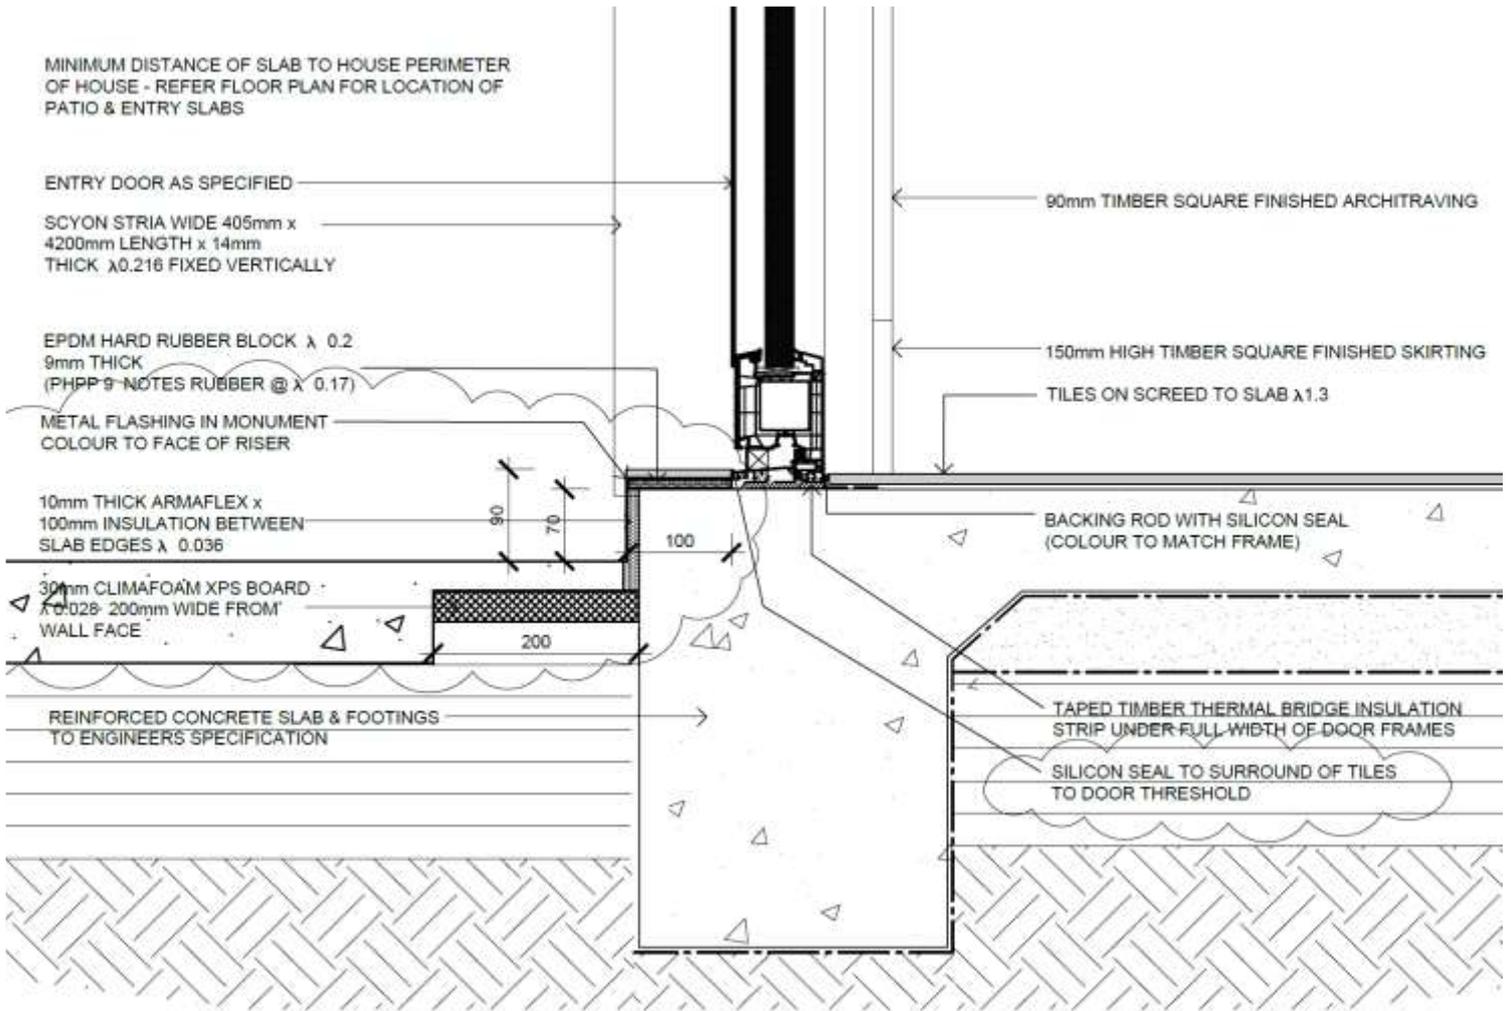
TYPICAL DOOR THRESHOLD

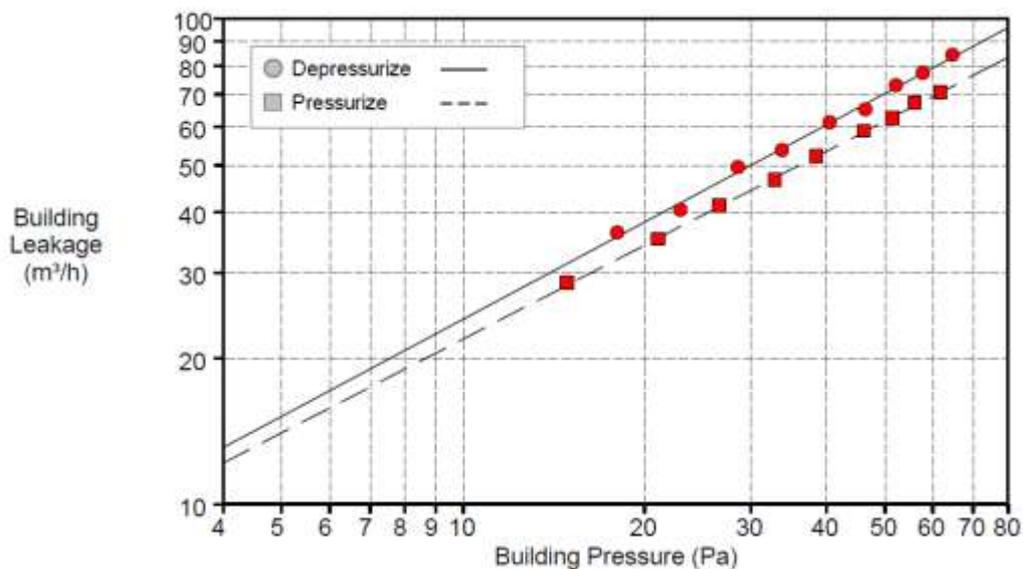
Test Results at 50 Pascals:

<u>Depressurization</u>	<u>Pressurization</u>	<u>Average</u>
q ₅₀ : m ³ /h (Airflow)	70 (+/- 2.0 %)	62 (+/- 0.8 %)	66
n ₅₀ : 1/h (Air Change Rate)	0.11	0.10	0.10
q _{F50} : m ³ /(h·m ² Floor Area)	0.28	0.24	0.26
q _{E50} : m ³ /(h·m ² Envelope Area)	0.10	0.09	0.09

Air pressure test done by Air Tightness Testing Services Australia Pty Ltd.

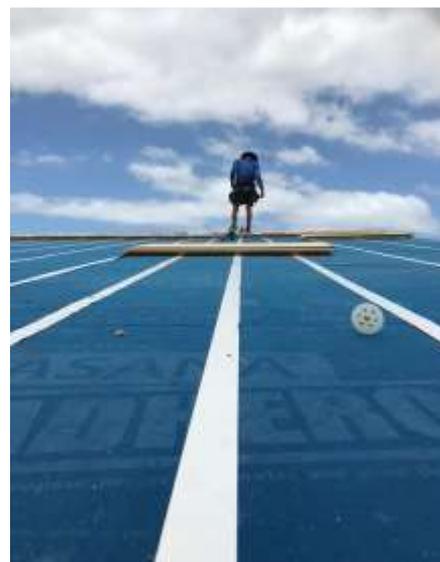
Adhesive air control barrier installed on roof, woodfibre panels being installed over.

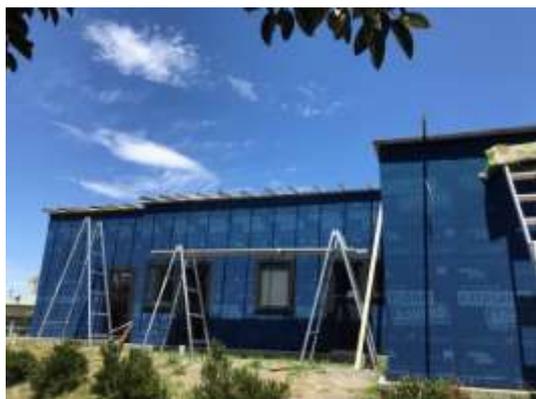
Adhesive air control barrier installed on exterior walls prior to external insulation installation.

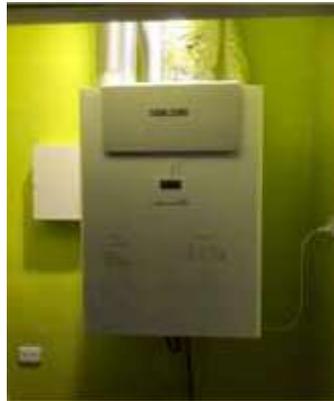
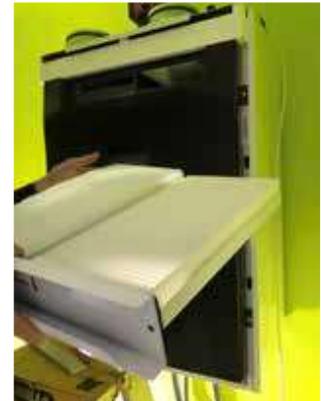
Steible Eltron LWZ 280 HRV

Heat recovery efficiency 0.84

Electrical efficiency 0.27 Wh/m³

Left: Unit installed in MVHR cupboard.
Right: Filters at installation prior commissioning.

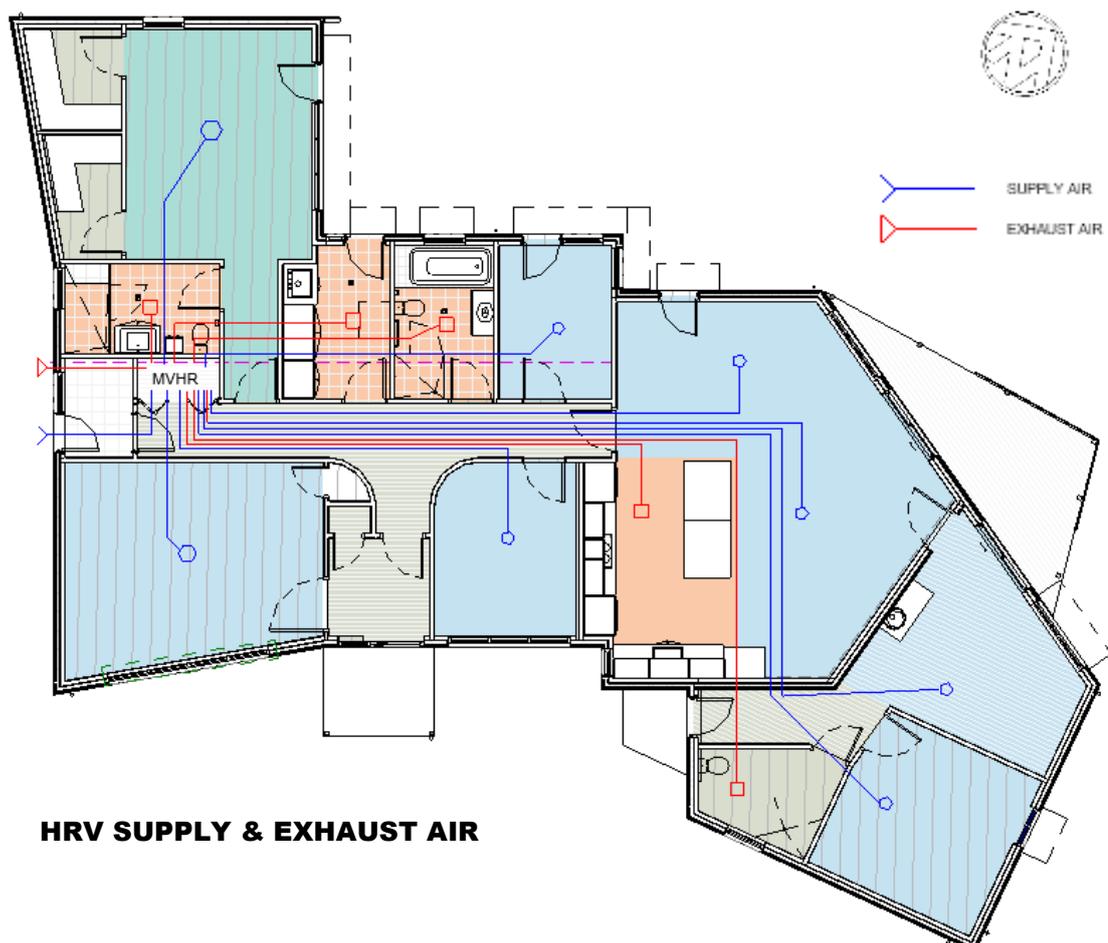
All 820mm internal wide doors had a 10mm undercut to provide return air within the dwelling.

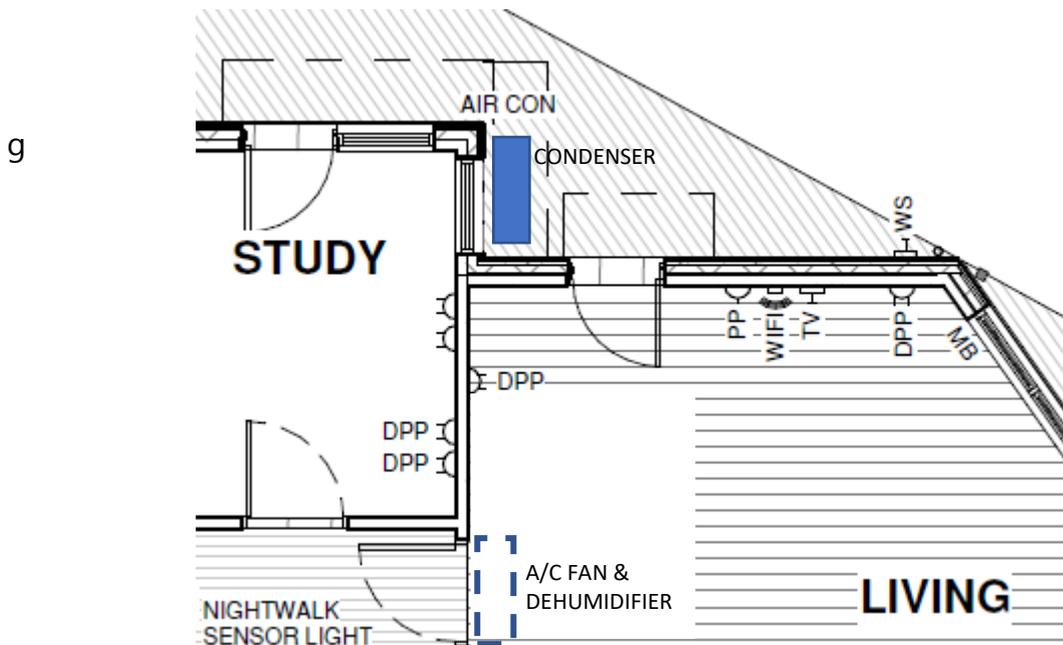
Location of internal (dashed blue line) and external (solid blue rectangle) AC units.

COOLING & DEHUMIDIFICATION

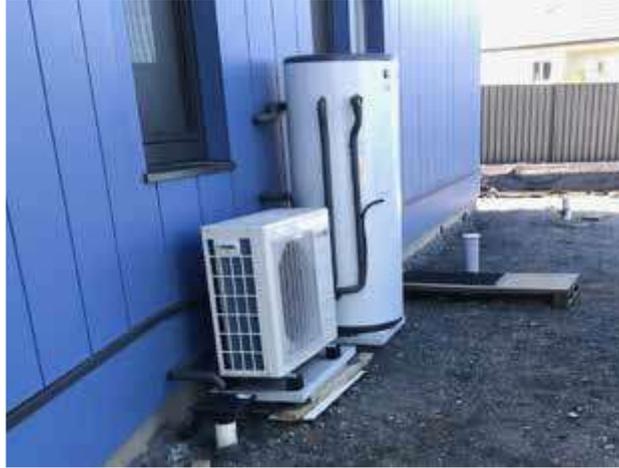
Hot Water: Sanden heat pump with storage tank outside the thermal envelope

HWU & heat pump located externally to ensuite (prior to external building works).
