# Passivhaus Project Documentation

## Howe Park Passivhaus, Milton Keynes, UK

Single family detached five bedroom home in Milton Keynes, England

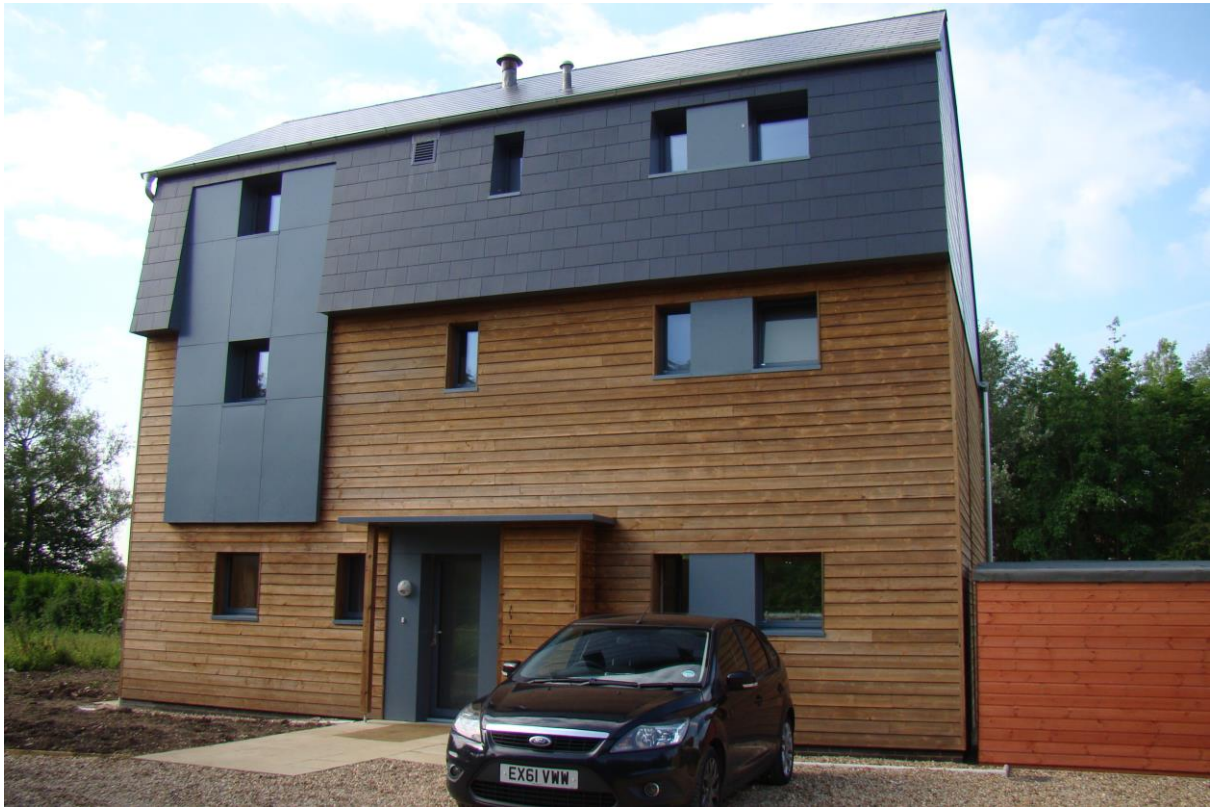
Front entrance elevation, north facing with smaller windows, and slate hung second floor to reduce visual height.

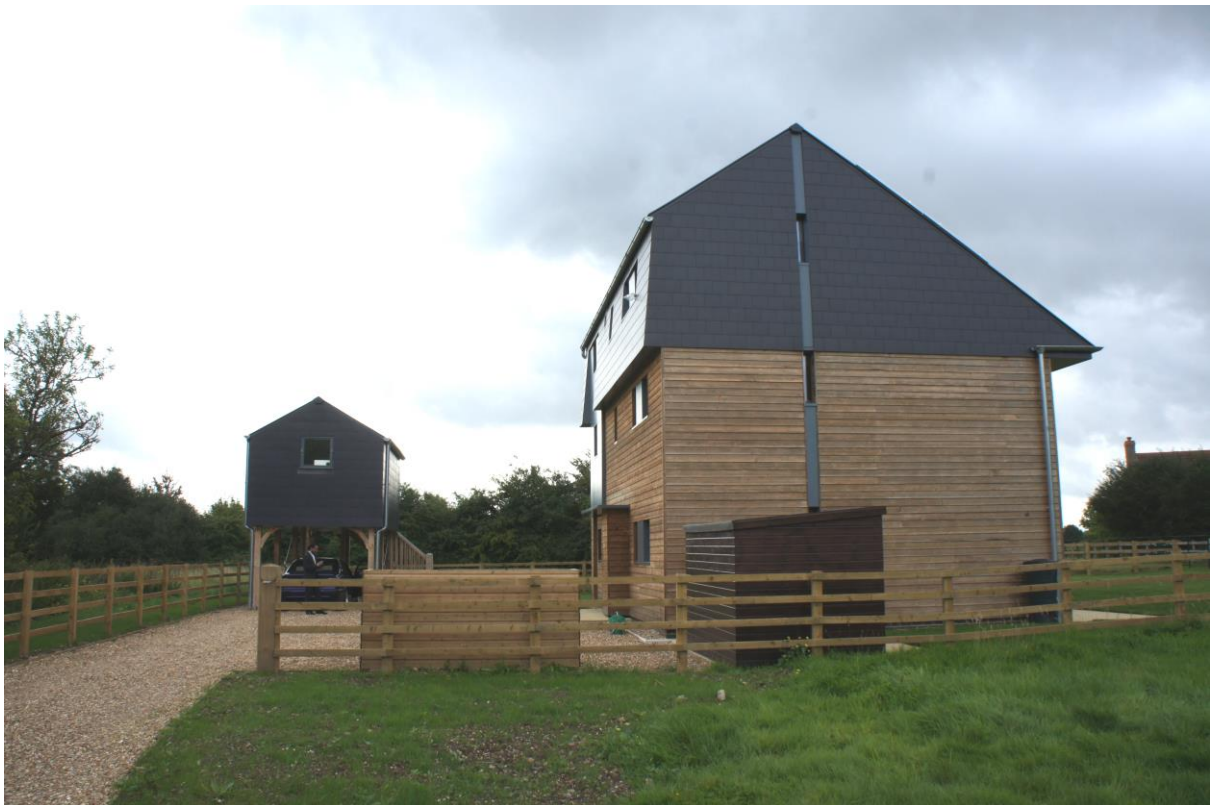
Approach to the house from west, showing narrow slit windows to give view of those approaching but also privacy.

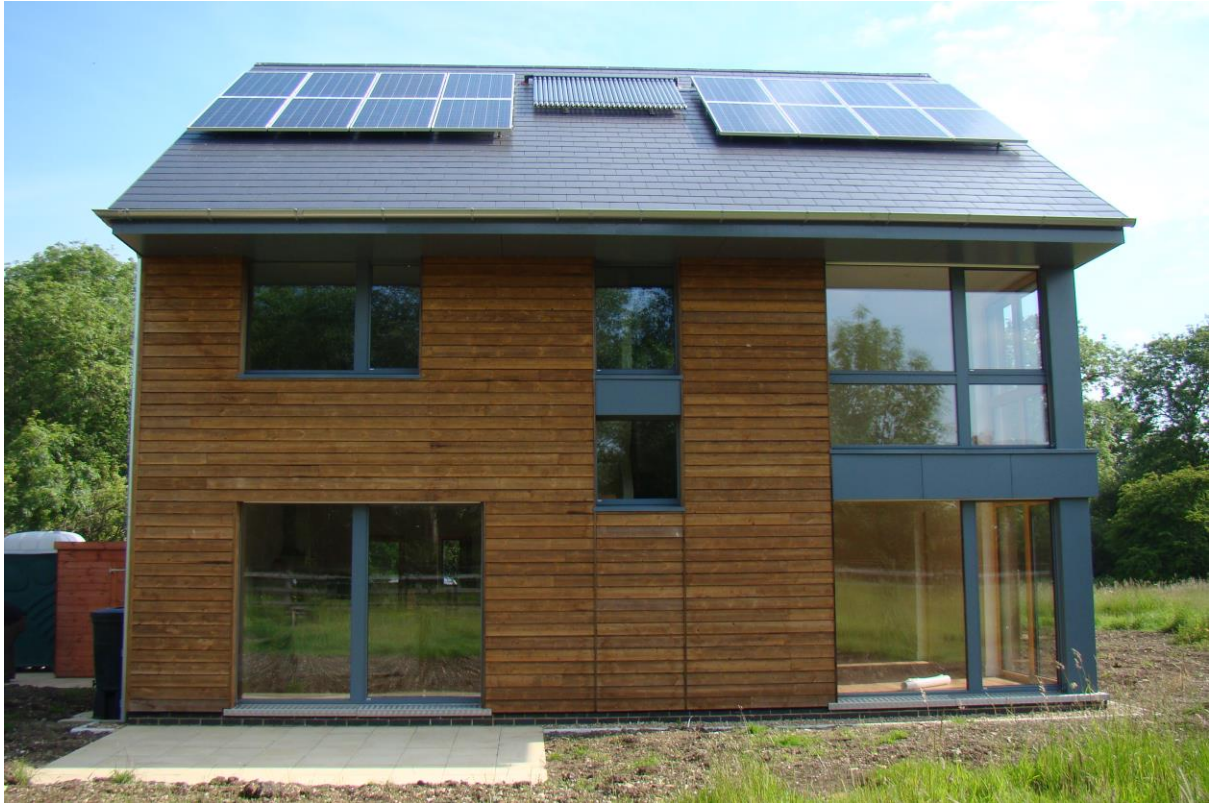
Rear South Elevation facing garden with larger windows. External blinds are used in summer.

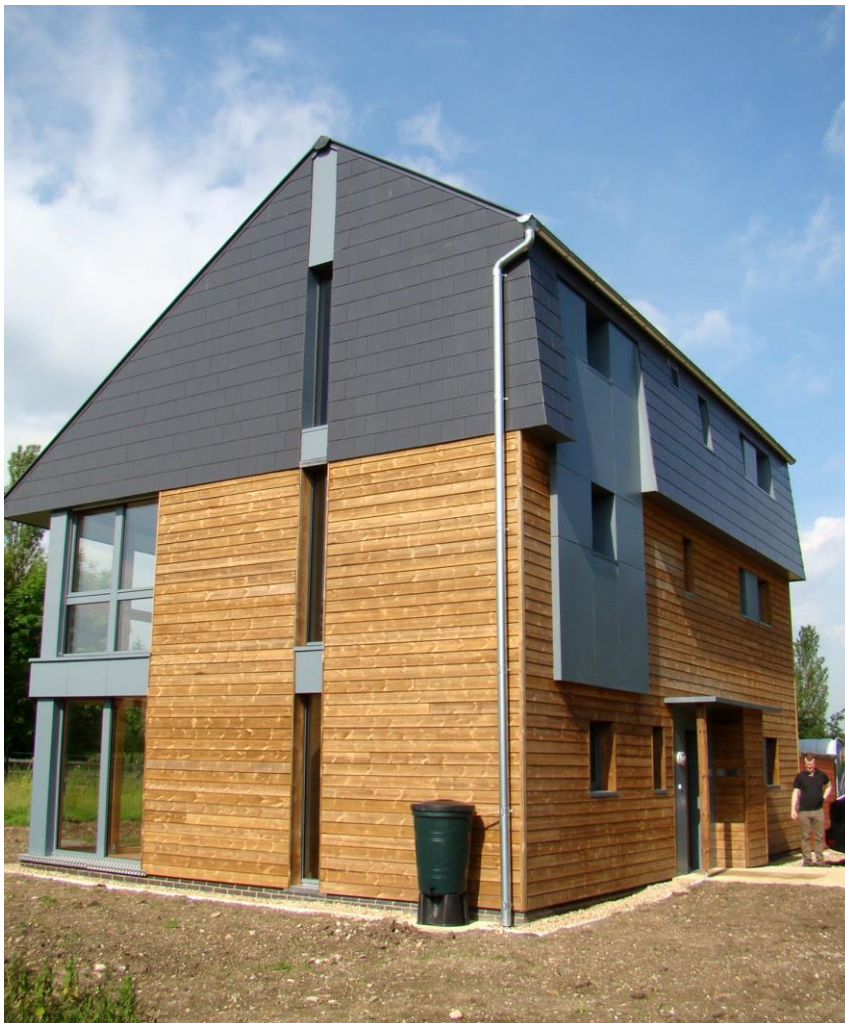
East elevation, showing rain water butt, and long slit windows providing views out of the children's rooms at low level.

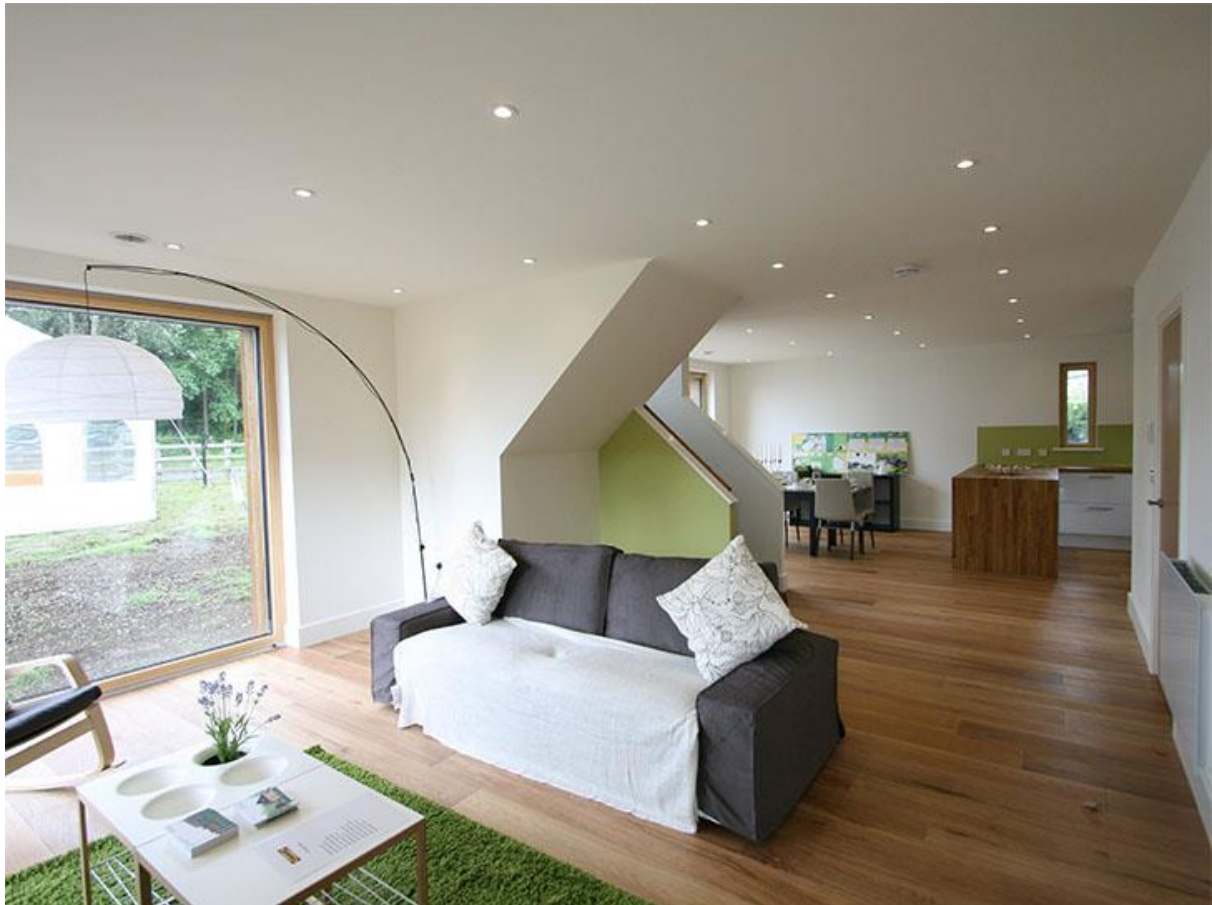
Interior of main living space looking towards kitchen and dining area, and stairs to first floor, notice the electric panel heater on the right used to heat the house (also supplemented with electrical towel rails in bathrooms).

Heating is provided by a 2KW Dimplex Girona electric panel heater in the lounge and electric towel rails in bathrooms. Domestic hot water is provide by solar hot water systems consisting of 30 Baxi Solar hot water tubes on the roof supplying a 210 litre megaflow eco cylinder with an electrical immersion heater top up / backup.

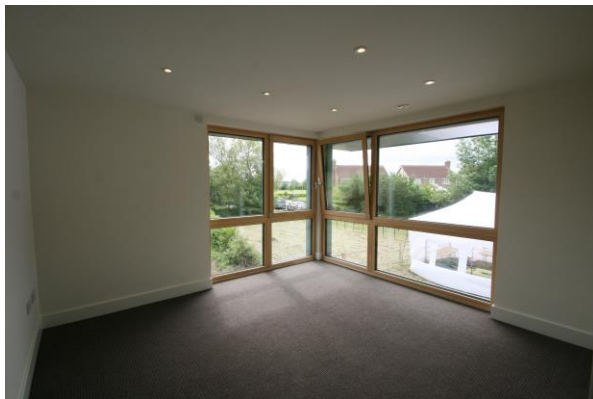
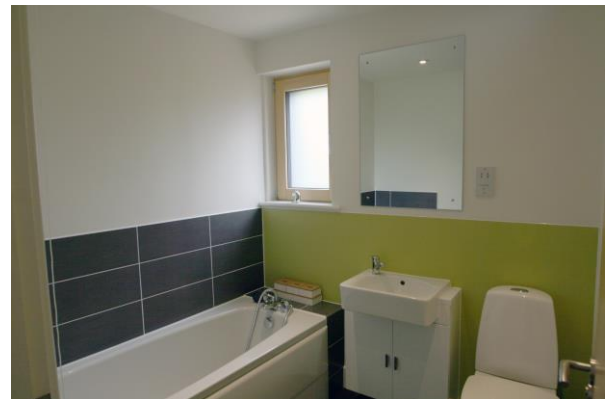
Further interior views, showing bedroom 2, main bathroom and second floor shower room, with MVHR cupboard.

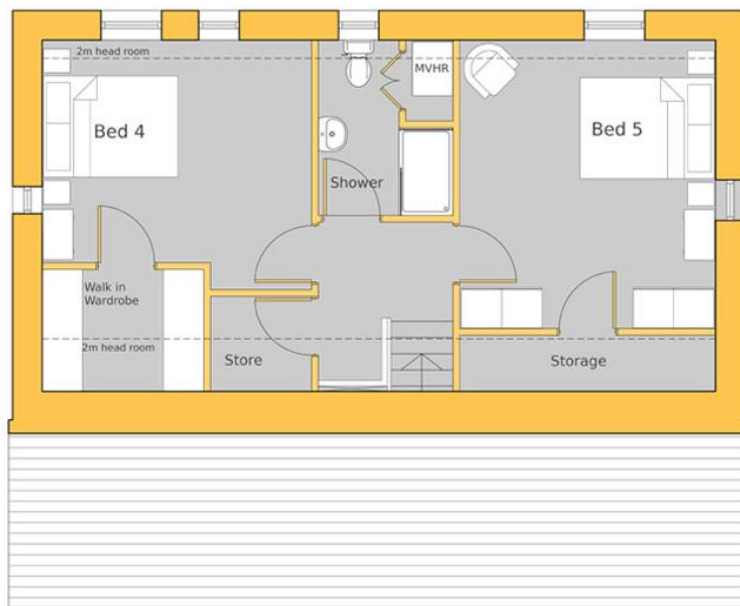
**Second Floor Plan**

The second floor provides 2 bedrooms, storage and shower room. The shower room also contains the MVHR unit with intake through the wall and extract out of the roof. No roof lights were included on the Southside as at the time they were difficult to install in Passivhaus's due to high thermal bridging.

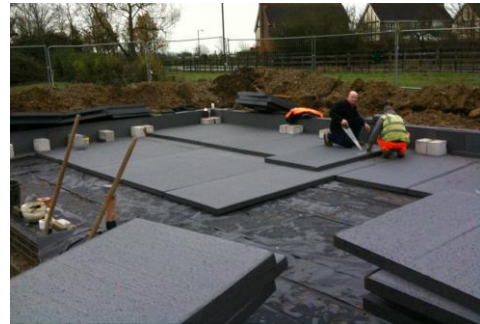
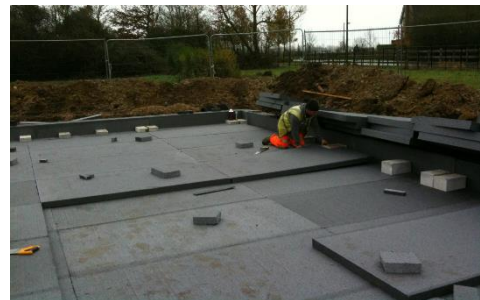
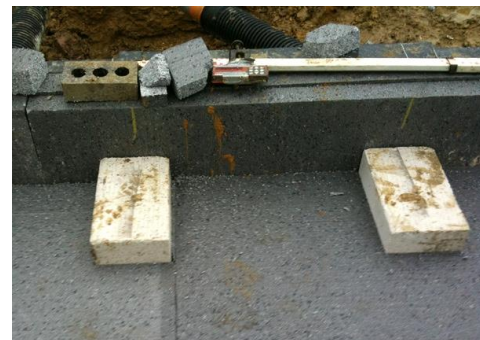
### 5.1 Ground floor slab

The ground floor is constructed of a 200mm concrete slab floating on 325mm of EPS insulation. Individual light weight insulating blocks are used as secondary support for the slab at pre-determined load points around the perimeter. The need for a timber sole plate was illuminated and replaced with an I beam – reducing thermal bridging and potential settlement. The heavy patio and front doors are supported on GRP angles supported on bolts cast into the slab.

Power Floated Concrete Floor slab, 200mm thick  
Springvale premium EPS 325mm thick,  
including Durox lightweight block around perimeter at load points.  
DPM  
Sand blinding

U-value = 0.09 W/(m<sup>2</sup>K)

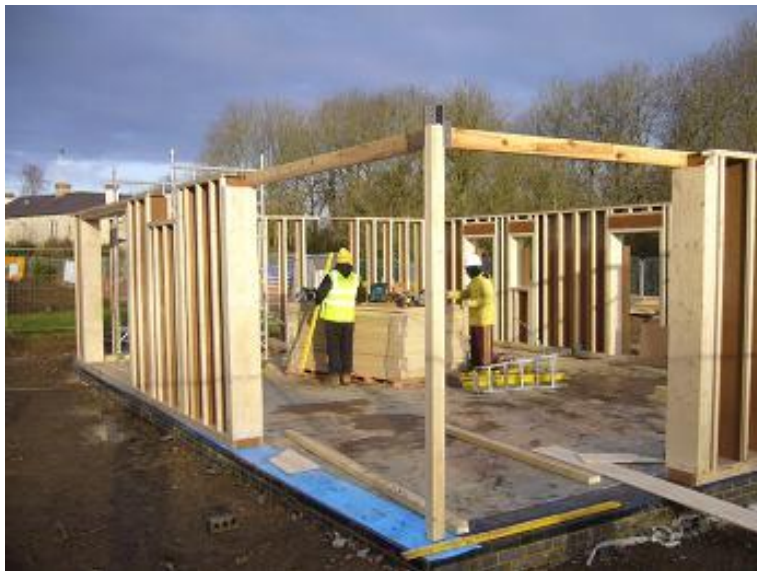
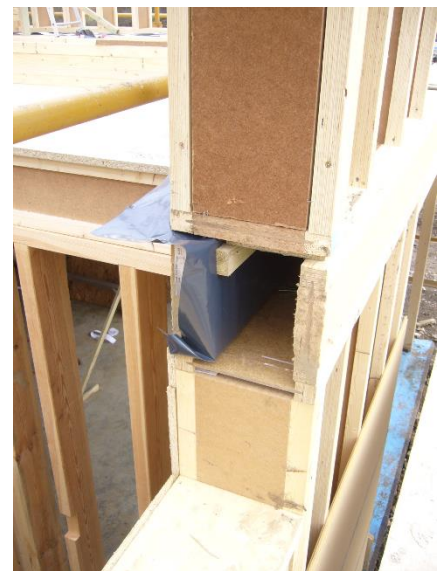
## 5.2 Exterior walls

The external walls were constructed by Touchwood homes, using 300mm 'I' beams filled with Warmcell (recycled newspaper) insulation. An inner finish of taped OSB formed the airtightness barrier and care was taken at the first floor junction to ensure the continuity of the airtightness layer (grey membrane) and minimising cold bridging.

- 15mm Plasterboard
- 38mm Service void, formed with battens
- 18mm OSB3 as airtightness layer
- 300mm 'I' Beams filled with Warmcell insulation
- Agepan DWD wind tight, exterior protection board.
- 38mm timber battens
- 21mm Kebony timber cladding

U-value = 0.136 W/(m<sup>2</sup>K)

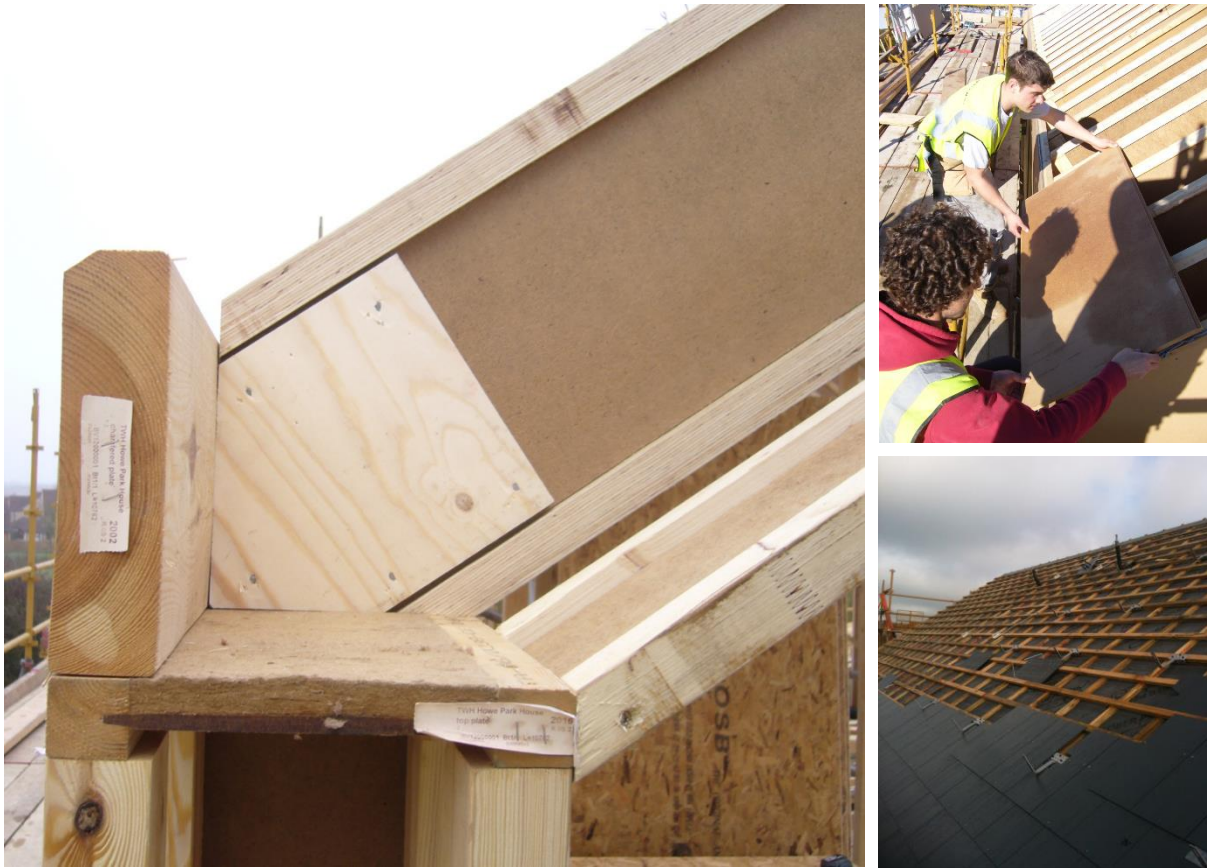
## 5.3 Roof

The roof was constructed like the walls with I beams spanning from the eaves to a ridge beam, and filled with Warmcell insulation. An inner finish of taped OSB formed the airtightness barrier, followed by a service void and plasterboard. Care was taken to select slim LED lights that fitted into the service void. Careful detailing at the eaves also kept the thermal bridging to a minimum.

- 15mm Plasterboard
- 38mm Service void, formed with battens
- 18mm OSB3 as airtightness layer
- 400mm 'I' Beams filled with Warmcell insulation
- Agepan DWD wind tight, exterior protection board.
- Roofing felt
- Battens & Counter battens
- Eternit Slates

U-value = 0.111 W/(m<sup>2</sup>K)

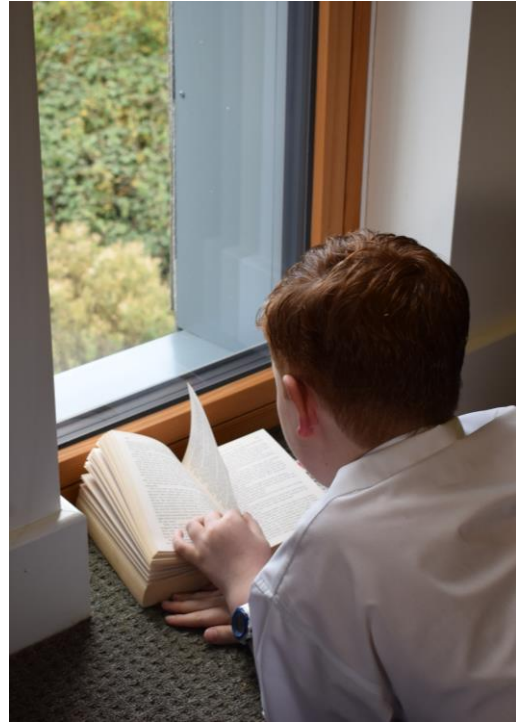
## 5.4 Windows

The windows selected for this project were the Optiwin, Alu2wood, Wood / aluminium having thermally broken frames, the U value of the frame was  $1.03 \text{ W}/(\text{m}^2\text{K})$ . Thermoseal super black spacers were used with a variety of triple glazed glass specifications, including laminated safety glass and others with a white coating providing higher g values. The  $U_g$  varied from 0.55 to 0.69 and the g value from 48% to 64%.

Sliding doors were selected over bifold due to their superior air tightness, and a fully glazed front door was selected for its good thermal performance. The windows selected open to the inside allowing additional insulation to be added around the frame on the outside, reducing the area of visible frame and consequential heat losses considerably. Internal comfort around the windows is high enabling sitting and reading by them even on the coldest days.

The overall average U value for the windows was  $0.85 \text{ W}/(\text{m}^2\text{K})$ .

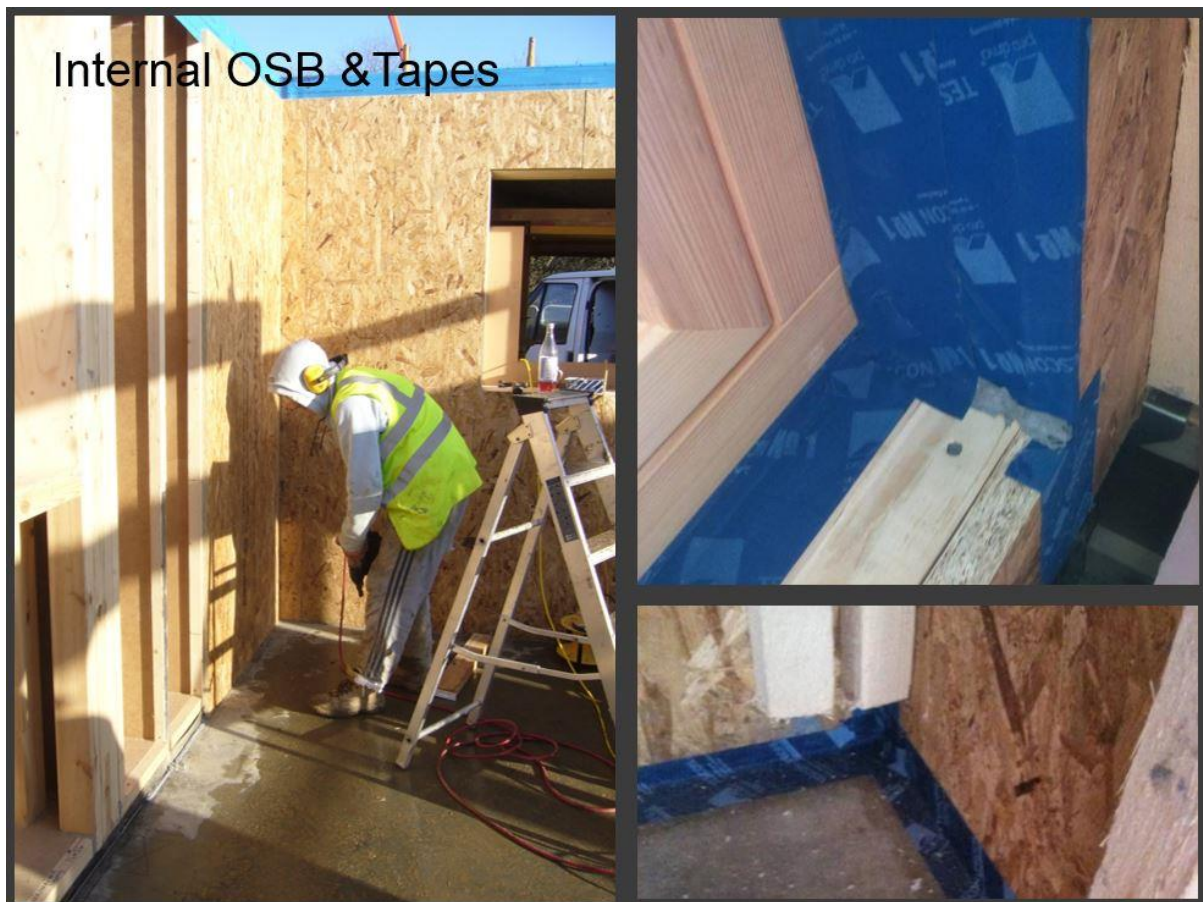
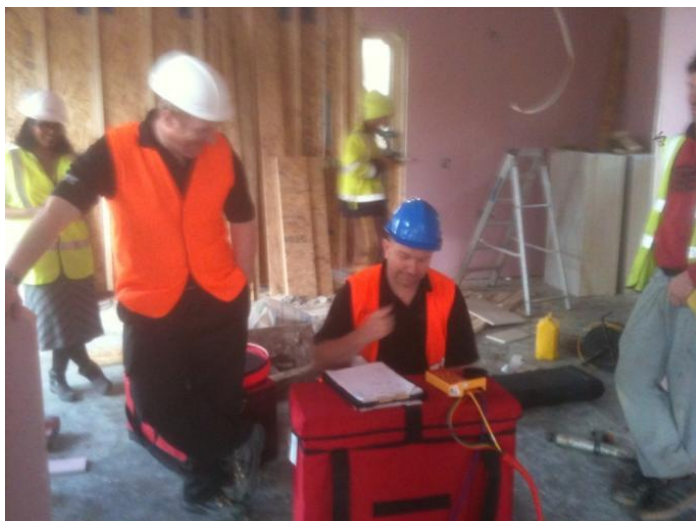
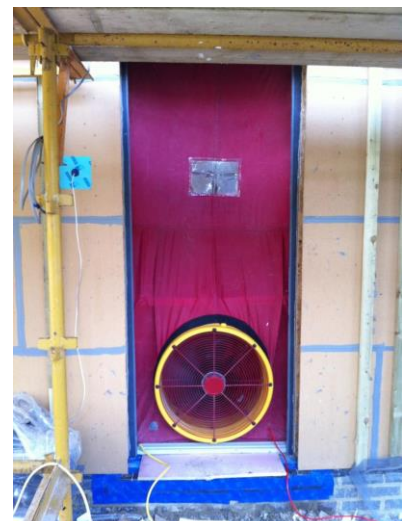
## 6.0 Airtight envelope

The Airtightness strategy involved lining the inside of the external walls and the roof with 18mm OSB3 taped with Pro Clima airtightness tapes at all joints and junction with the concrete slab, window openings and service penetrations. At intermediate floor junctions an airtightness membrane was used to link together the OSB on the walls above and below. In addition to this a good wind tight barrier was formed on the outside using the Agepan DWD board sealed with non-setting mastic.

The resulting air pressure tests carried out by Peter Williams of Stroma, provided an air change rate of just  $0.07 \text{ h}^{-1}$  @50 Pa, depressurised and  $0.06 \text{ h}^{-1}$  @50 Pa. Which we believe is one of the lowest ever in the UK.

A continuous air tight layer is essential in keeping draughts out and meeting the Passivhaus standard. All detailed drawings showed the airtightness layer in red, this included, the concrete slab, OSB3 boards, tapes, window frames and glass.

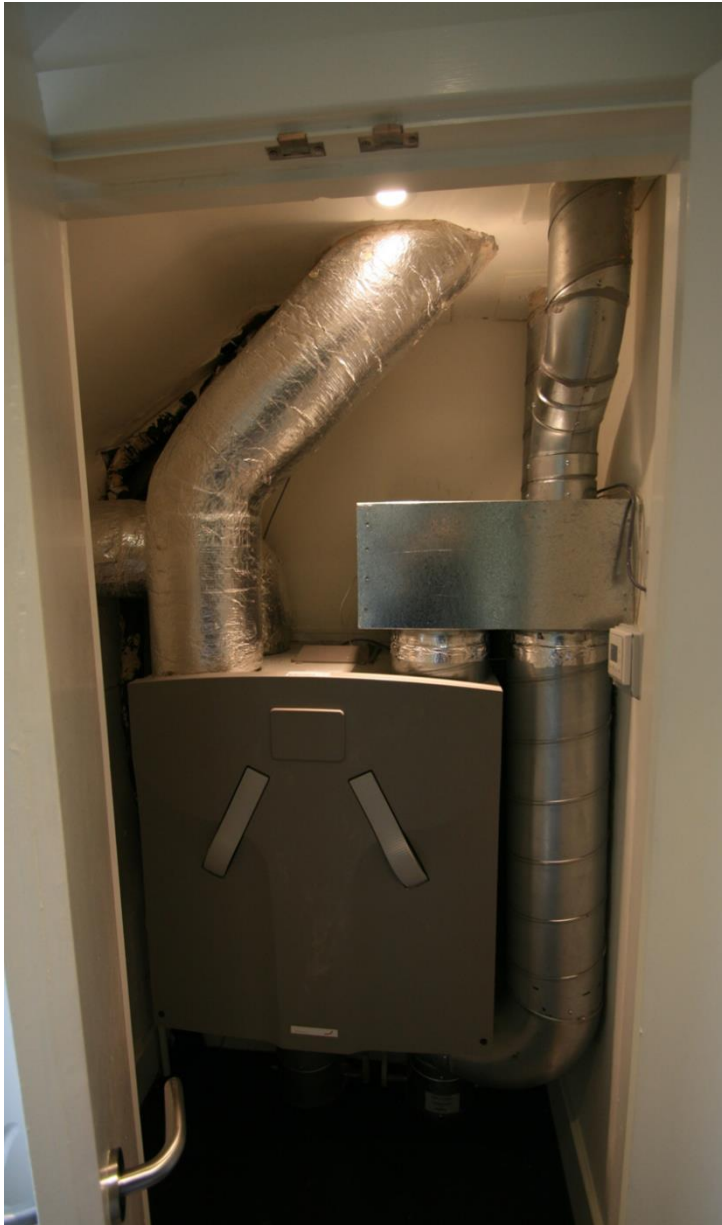
## 7.2 Ventilation Unit

Ventilation is provided by the Passivhaus Institute certified Zehnder, Comfoair 550. Located in a cupboard in the second floor shower room.

This supply and extract heat recovery system, has an effective heat recovery efficiency of 82.5% and an electrical efficiency of  $0.29\text{Wh/m}^3$ .

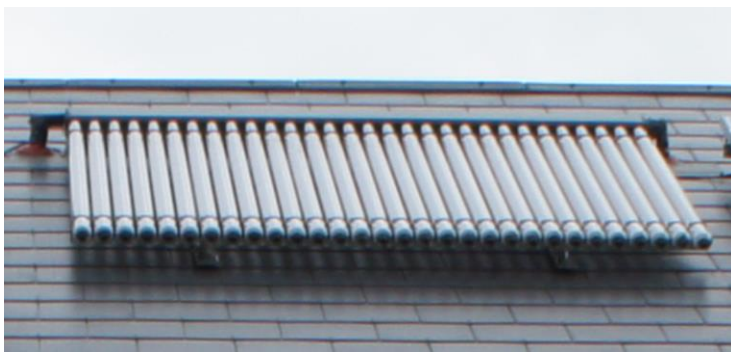
30 Baxi evaluated solar hot water tubes on roof, feeding 210 litre Megaflow hot water cylinder.

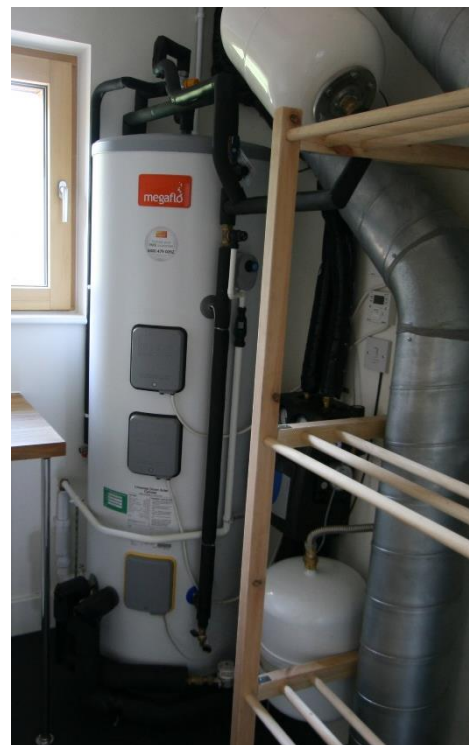
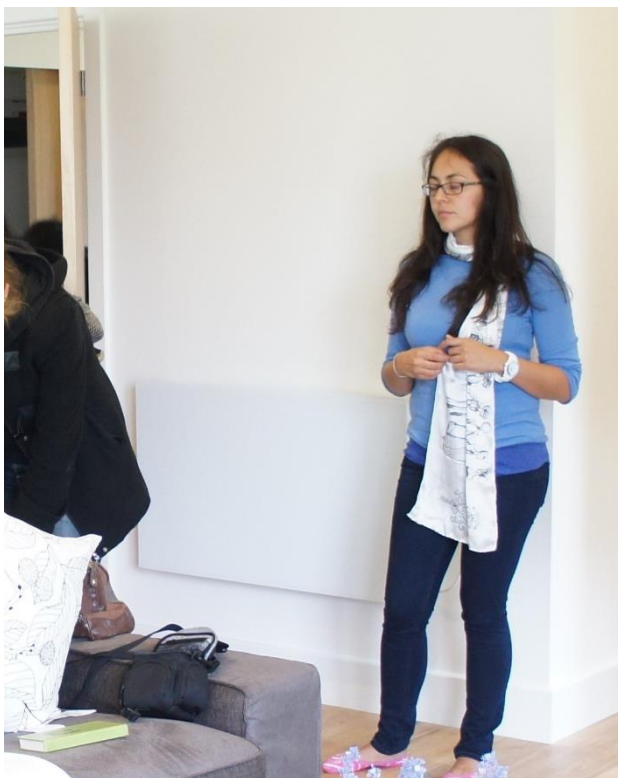
Dimplex Girona 2kW electric panel heater in lounge

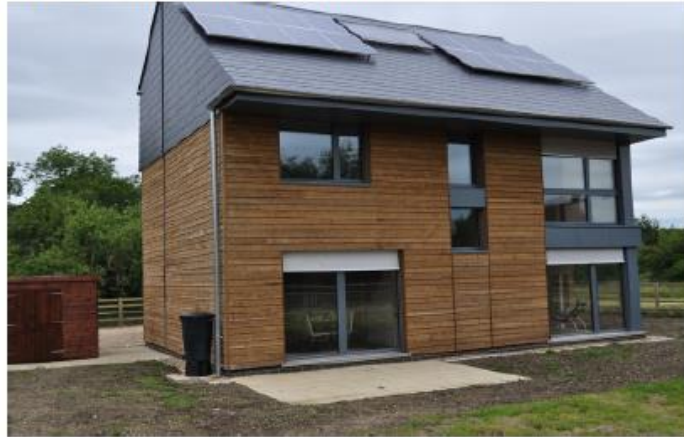
### Passive House Verification

Building:	Howe Park Passivhaus		
Location and Climate:	Milton Keynes	Thames valley	
Street:	Hengistbury Lane		
Postcode/City:	MK4 3BF Milton Keynes		
Country:	England		
Building Type:	Detached House		
Home Owner(s) / Client(s):	Milton Keynes Parks Trust Ltd		
Street:	Campbell Park Pavilion, 1300 Silbury Boulevard		
Postcode/City:	MK9 4AD, Central Milton Keynes		
Architect:	Eco Design Consultants Ltd		
Street:	3 Parklands, Great Linford		
Postcode/City:	MK14 5DZ, Milton Keynes		
Mechanical System:			
Street:			
Postcode/City:			
Year of Construction:	2012		
Number of Dwelling Units:	1	Interior Temperature:	20.0 °C
Enclosed Volume $V_{e,}$ :	718.0 m <sup>3</sup>	Internal Heat Gains:	2.1 W/m <sup>3</sup>
Number of Occupants:	5.0

Specific Demands with Reference to the Treated Floor Area				
Treated Floor Area:	174.9	m <sup>2</sup>		
Applied:	Monthly method	PH Certificate:	Fulfilled?	
Specific Space Heating Demand:	14	kWh/(m <sup>2</sup> a)	15 kWh/(m <sup>2</sup> a)	Yes
Heating Load:	10	W/m <sup>2</sup>	10 W/m <sup>2</sup>	
Pressurization Test Result:	0.07	h <sup>-1</sup>	0.6 h <sup>-1</sup>	Yes
Specific Primary Energy Demand (DHW, Heating, Cooling, Auxiliary and Household Electricity):	120	kWh/(m <sup>2</sup> a)	120 kWh/(m <sup>2</sup> a)	Yes
Specific Primary Energy Demand (DHW, Heating and Auxiliary Electricity):	77	kWh/(m <sup>2</sup> a)		
Frequency of Overheating:	2	%	over 25 °C

The results of the PHPP show that it meet the requirements.
