# Passivhaus Project Documentation

## Wrexham Passivhaus

### 1 Abstract

Detached two storey, 4 bed, dwelling nr Wrexham, Wales, constructed in 2016. This new build Passivhaus replacing a previous dwelling on the same site. Some of the brick from the previous house was reused and is exposed in the dining room and lounge, the brick plinth wall around the outside is actually brick slip in order not to compromise the insulation thickness. There are large overhangs to South and motorised external blinds for shading. A covered walkway is to the North and East. It is certified as Passivhaus Classic.

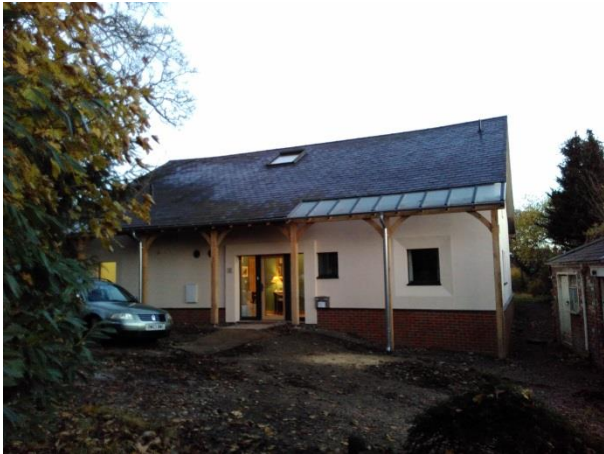
Front of the building facing North.

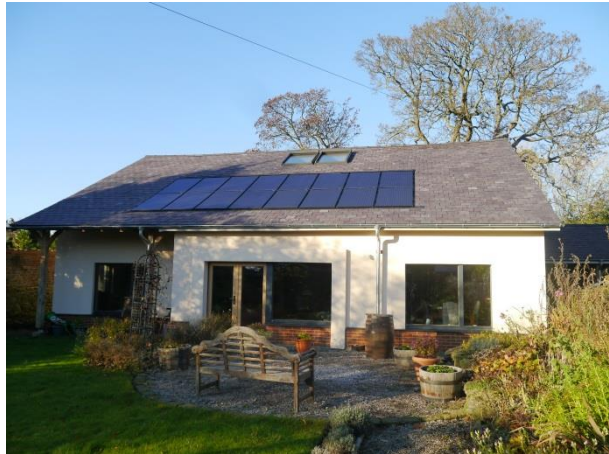
South Elevation, facing the garden.

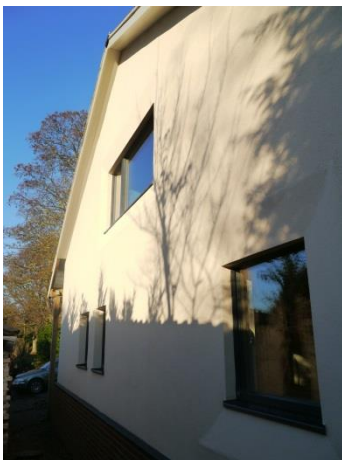
West Elevation, close to a neighbouring wall.

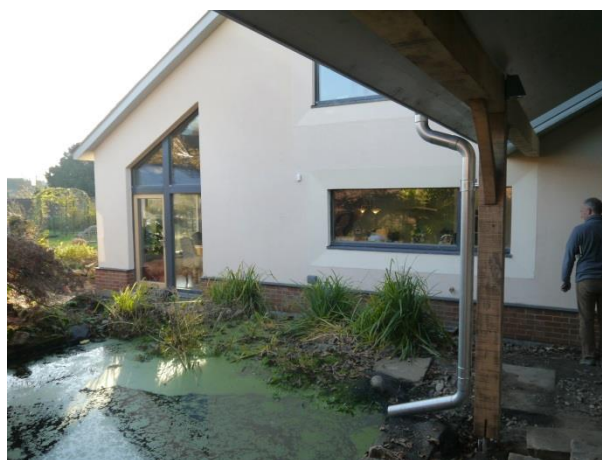
East Elevation, kitchen, dining room and pond.

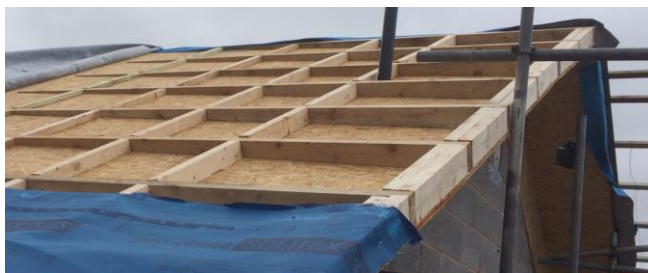
## 9 Construction of Roof

This building has a large roof constructed of I-beams resting on interior and exterior walls. The Warmcel insulation  $k=0.040W/mK$ , links well with the external insulation of the wall. The diagram below also shows large overhangs to the South to give shading in summer. The form of ladder truss used at the gable was chosen by the architect and is shown below.

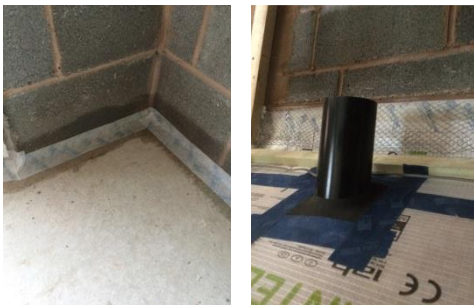
## 11 Airtightness

Airtightness is provided by the plaster layer on interior walls, airtightness membrane for the roof and the concrete slab. Airtightness tape was used at the join between the wall and the floor before the walls were plastered. The image on the left shows this tape with the surfaces primed beforehand. Wherever there pipes or cables passed through the airtightness layer proprietary seals were used, below right shows a seal around the soil and vent pipe in the roof. With these measures the airtightness achieved a very respectable 0.4 air changes per hour.

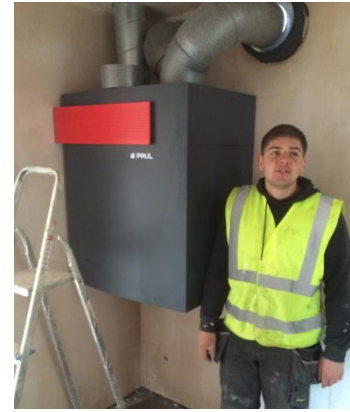
### 13 Ventilation Unit

The Paul Novus 300 unit is insulated and Passivhaus certified. The unit is installed in a cupboard that allows rapid drying of clothes without adding moisture to the house. The unit has a Specific power input of  $0.24\text{Wh/m}^3$  and the Effective Efficiency of heat recovery of the system is 90.6%. The image right shows the unit before the cupboard was built around it.

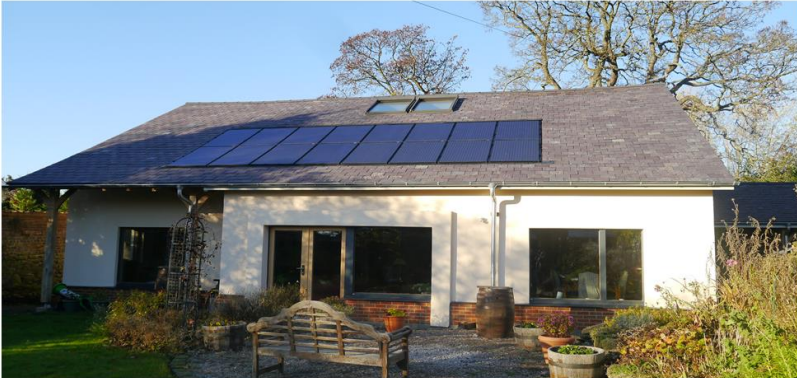
Passive House verification

Building:	Confidential			
Street:				
Postcode / City:				
Country:				
Building type:				
Climate:	[UK] - West Pennines (Fairfield)	Altitude of building site (in [m] above sea level):	75	
Home owner / Client:	Confidential			
Street:				
Postcode/City:				
Architecture:	Simmonds Mills			
Street:	57 Portfield Street			
Postcode / City:	Hereford, HR1 2SE			
Mechanical system:				
Street:				
Postcode / City:				
Year of construction:	2016	Interior temperature winter:	20.0 °C	
No. of dwelling units:	1	Interior temperature summer:	25.0 °C	
No. of occupants:	5.3	Internal heat sources winter:	2.1 W/m²	
Spec. capacity:	180 W/mK per m² TFA	Ditto summer:	3.2 W/m²	
		Enclosed volume V <sub>e</sub> , m³:	660.4	
		Mechanical cooling:		
Specific building demands with reference to the treated floor area				
Treated floor area: 186.7 m²				
Space heating	Heating demand	14.0 kWh/(m²a)	15 kWh/(m²a)	yes

Heating load	9.5 W/m²	10 W/m²	yes
Space cooling	Overall specif. space cooling demand	kWh/(m²a)	-	-
	Cooling load	W/m²	-	-
	Frequency of overheating (> 25 °C)	0.5 %	-	-
Primary energy	Heating, cooling, dehumidification, DHW, auxiliary electricity, lighting, electrical appliances	103 kWh/(m²a)	120 kWh/(m²a)	yes
	DHW, space heating and auxiliary electricity	49 kWh/(m²a)	-	-
	Specific primary energy reduction through solar electricity	39 kWh/(m²a)	-	-
Airtightness	Pressurization test result n <sub>50</sub>	0.4 1/h	0.6 1/h	yes
